Tree Information Report v2.0

Submitted as part of Committee of Adjustment Application to the City of Ottawa

Date of Report: October 26, 2023
Property Address: 81 Boyce Avenue
Prepared for: 2501308 Ontario inc. c/o Justin Mastromattei; theboulevardottawa@gmail.com
Prepared by: Kevin Myers, ISA Certified Arborist; kevin.myers@dendronforestry.ca
Date of Site Visit: September 6, 2023

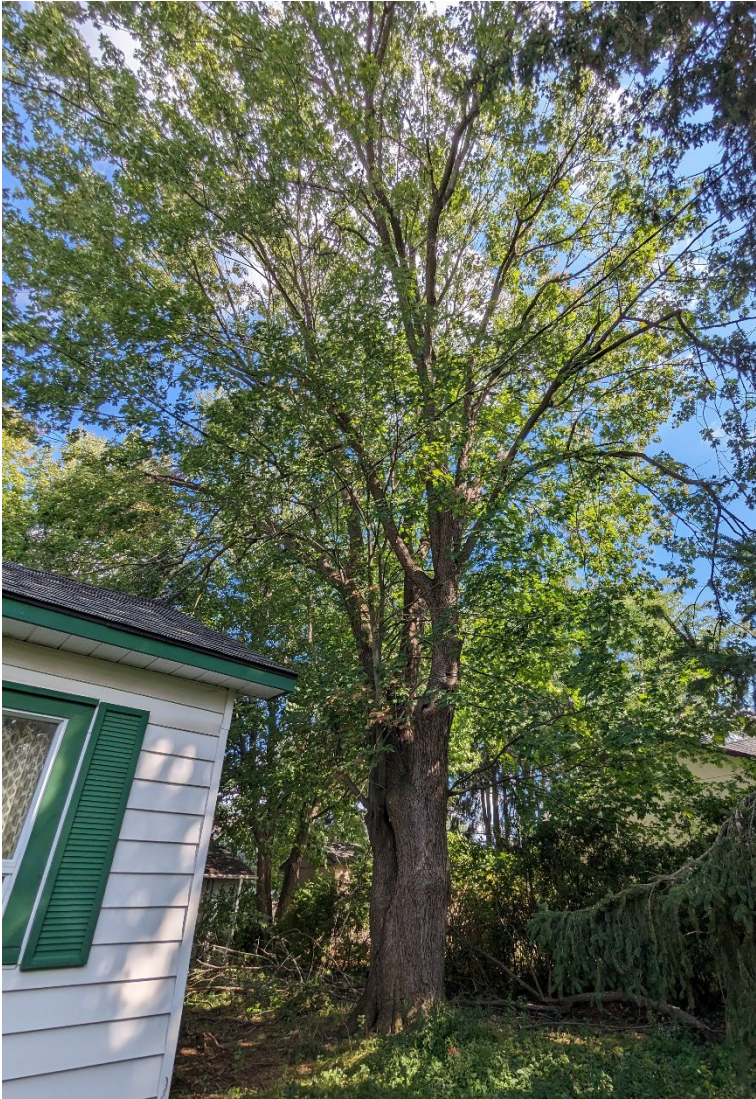
Tree ¹	Species	DBH (cm)	Ownership ²	Tree health			Approximate distance to excavation (m)	Action	Forester recommendation
				Roots/Root collar	Trunk	Crown			
1	Silver maple (<i>Acer saccharinum</i>)	114	Subject property	Good	Fair: large cavities in both main stems; poor growth fusing on north side	Fair: canopy is slightly thin	0 – within footprint	Remove	Remove: within building envelope. Tree permit required for removal
2	Silver maple (<i>Acer saccharinum</i>)	48, 46	Subject property	Good	Good – codominant stems, but main union looks good	Good	1.5	Retain	Retain and protect as per the City of Ottawa Tree Protection Specifications (March 2021). Roots along the line of excavation are to be revealed and cleanly severed by hand prior to excavation. Excavation is to come no closer than 2m to the trunk of the tree.
3	Silver maple (<i>Acer saccharinum</i>)	57	Subject property	Good	Fair/Poor: southern stem has included bark extending down one half length of trunk and is seeping	Good	6	Retain	Retain and protect as per the City of Ottawa Tree Protection Specifications (March 2021)

Above: Tree 1 - private maple to be removed.

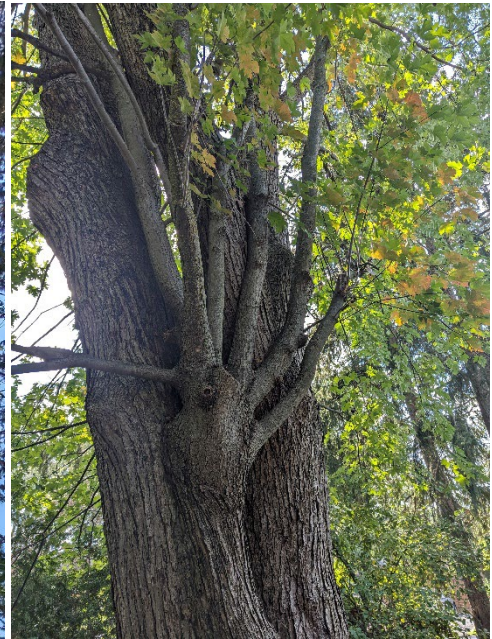
Right upper: west side of trunk of Tree 1.

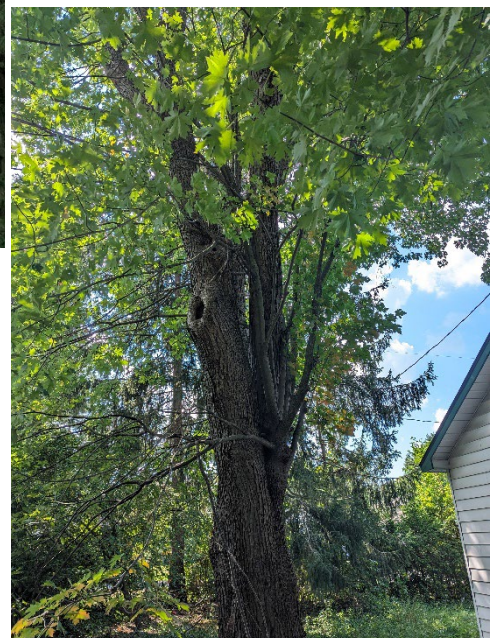
Right lower: north side of trunk of Tree 1

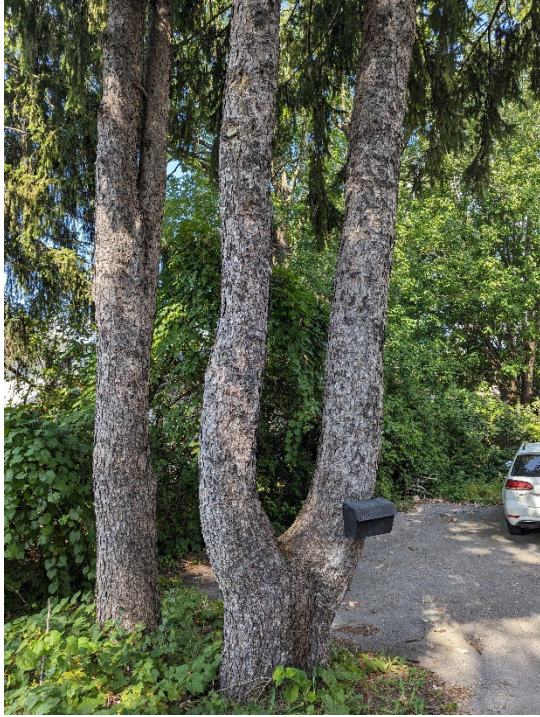
Trees 6 and 7 are large *P. abies* on the adjacent property. Their CRZs come into the subject property, and mitigation measure 1) is to be followed during installation of the driveway. It is expected these trees are far enough that the disturbance to their roots will not cause severe stress.

Trunk of Tree 6 (left) and Tree 7 (right).

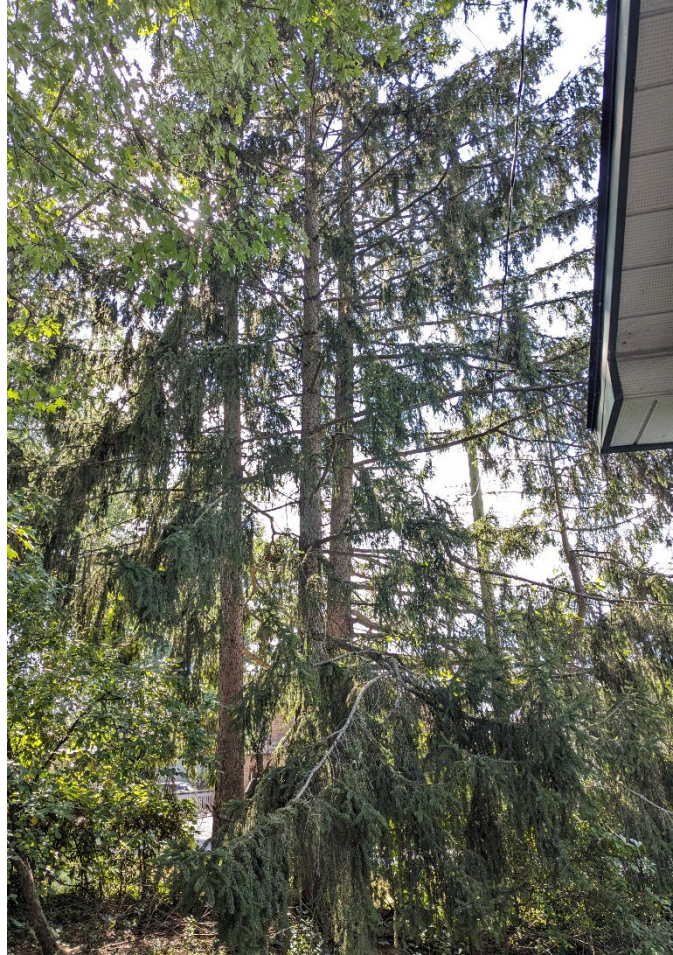
Tree 4 is a large Norway spruce (*Picea abies*) with two stems. The stems split at 0.6m from ground level and one grows at a right angle before correcting upwards. This structure appears solid and there is not an imminent concern at this time about the two stems failing. While the disturbance in this tree’s CRZ will be notable, it is possible the available rooting space along Boyce Avenue and in front of the existing dwelling will allow it to recover from the stress caused by construction. Mitigation measure 1) from above is to be followed.

4	Norway spruce (<i>Picea abies</i>)	47, 68		Good	Fair: tree has two large leaders – both appear healthy but one is growing at a right angle from the other	Good: pruned from wires	House: 4 Driveway: 1.5	Retain	Retain and protect as per the City of Ottawa Tree Protection Specifications (March 2021). Any roots encountered during excavation and installation of the driveway are to be cleanly severed by hand.
5	Norway spruce (<i>Picea abies</i>)	53		Good	Good	Good: pruned from wires	Driveway: < 1	Remove	Remove: proximity to driveway will cause severe much root loss. Tree permit required for removal
6	Norway spruce (<i>Picea abies</i>)	47		Good/Fair: close to adjacent driveway – potentially limiting root development	Good	Good/Fair: pruned from wires; some defoliation	Driveway: 3.5 House: 6	Retain	Any roots encountered during installation of the driveway are to be cleanly severed by hand.
7	Norway spruce (<i>Picea abies</i>)	38, 44		Fair: close to adjacent driveway – potentially limiting root development	Fair: tree has two large leaders – both appear healthy but one is growing at a right angle from the other; leaning to the south	Good/Fair: pruned from wires; some defoliation	Driveway: 4.5 House: 7	Retain	Any roots encountered during installation of the driveway are to be cleanly severed by hand.

Double stems of Tree 4 (right) and trunk of Tree 5 (left) - view from the east.

- 1) To prevent tearing, roots are to be revealed along the line of excavation and cleanly severed by hand prior to machinery removing soil.
