TREE CONSERVATION REPORT

1983 Carling Ave

Tree Conservation Report submitted as Partial
Requirements for a Site Plan Control Application

January 28, 2022

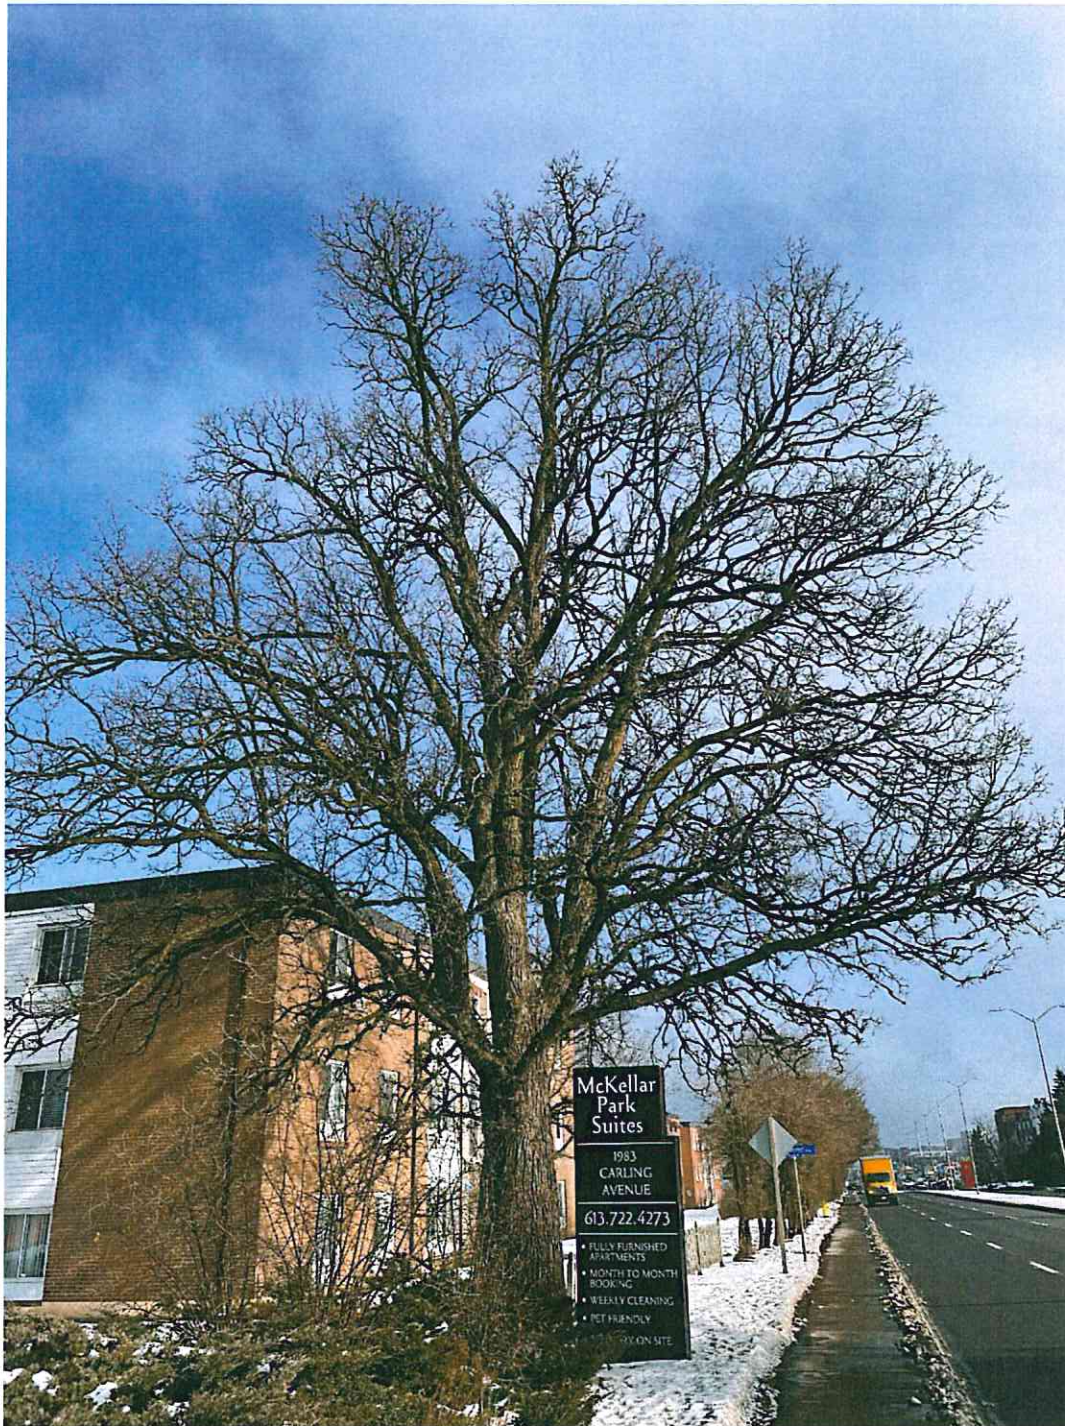
The large bur oak located close to the sidewalk and along Carling Avenue is the tree of concern that will be most impacted by the proposed development. This tree has a diameter of 111 cm, and its root system likely extends at least 11 m in all directions, except for where there is infrastructure such as the road and building. Although the tree appears in good health, it does have some health concerns to note. The crown is extensive, but since this tree is overhanging a major thoroughfare, it has been damaged by salt spray which is visible along the south side. Also, there is a large cavity at the base of the tree that measures 80 cm long; 15 cm wide; and 40 cm deep. A metal rod was inserted and extended past the cavity wall an additional 30 cm. Therefore, the decay and cavity extend 70 cm into the trunk at the widest point. The extent of decay is over 1 m up the tree in the centre of the decay column – the 1 m rod did not reach the end. These observations on decay were made using tools for a basic assessment. To understand better the extent of internal decay in this tree, a Level 3 risk assessment would be required using an advanced technique such as sonic tomography or resistance drilling. These tools can map out the decay in the stem at different heights up the trunk and are relatively non-invasive. Combining these results with a good understanding of the dynamics of how internal decay impacts large oak trees would help to assess the structural integrity of the tree. Although extensive decay can give the impression of structural weakness, this may not always be the case. Trees can learn to adapt to weaknesses by refocusing their growth on strengthening their stem and reducing the crown weight naturally.

Figure 1: Large bur oak along Carling, facing east

Based on the impacts to the tree as noted above, tree removal is the recommended option.

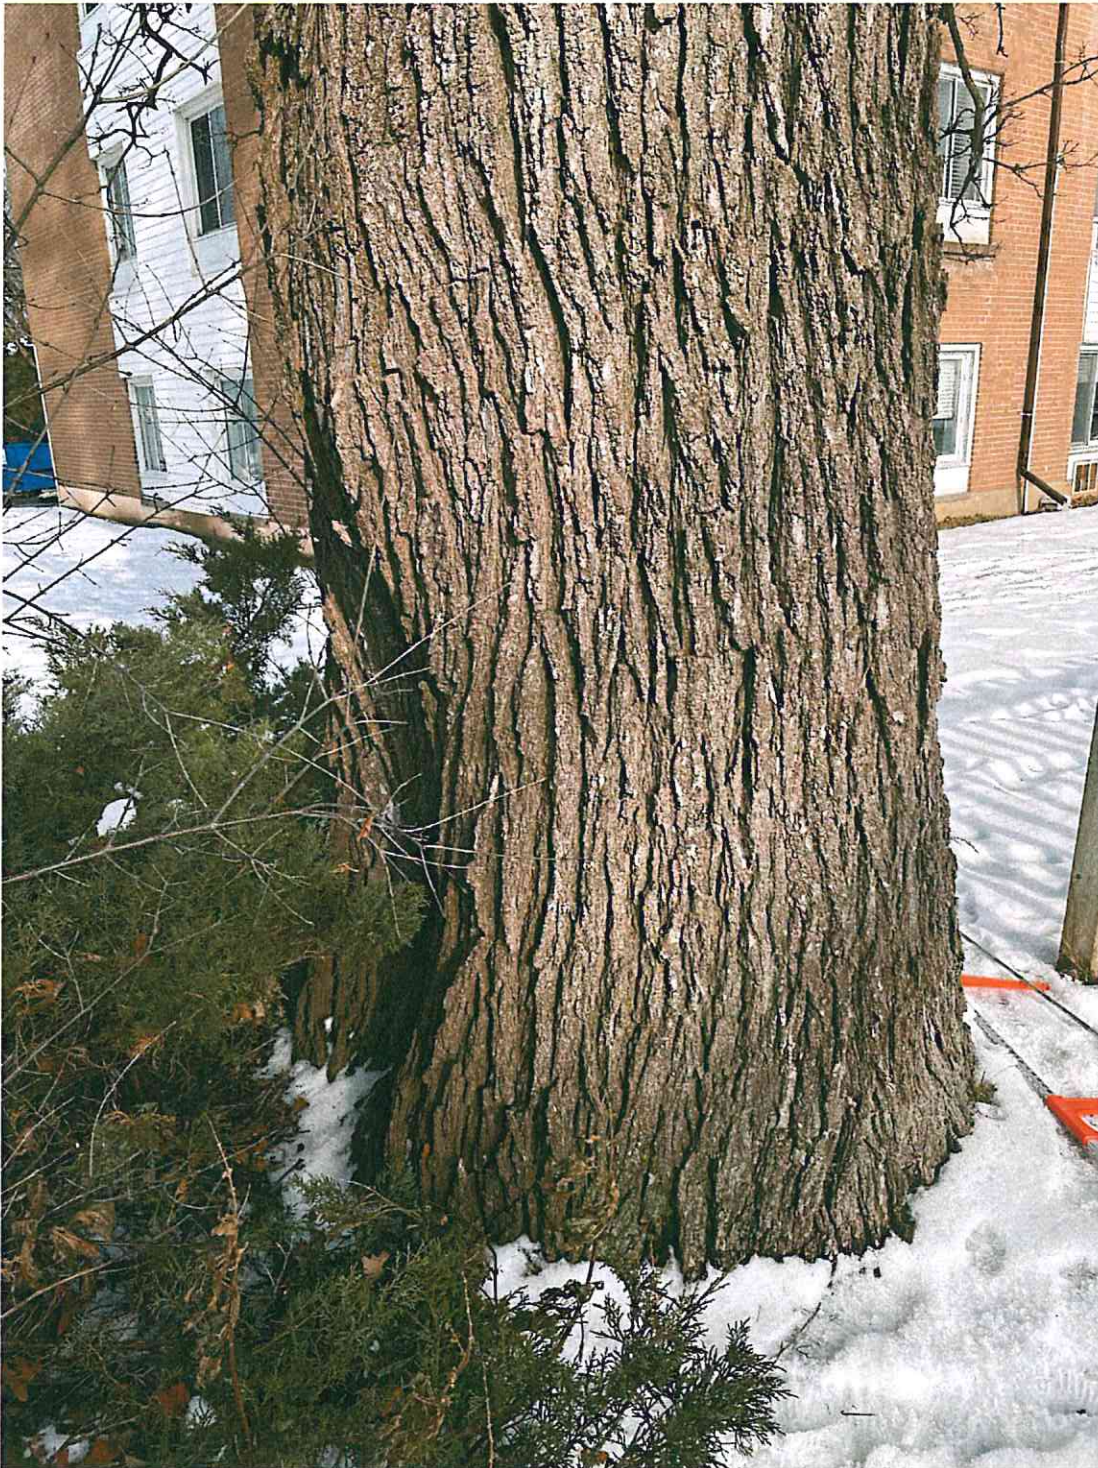
Figure 2: Wound at base of trunk along the west side

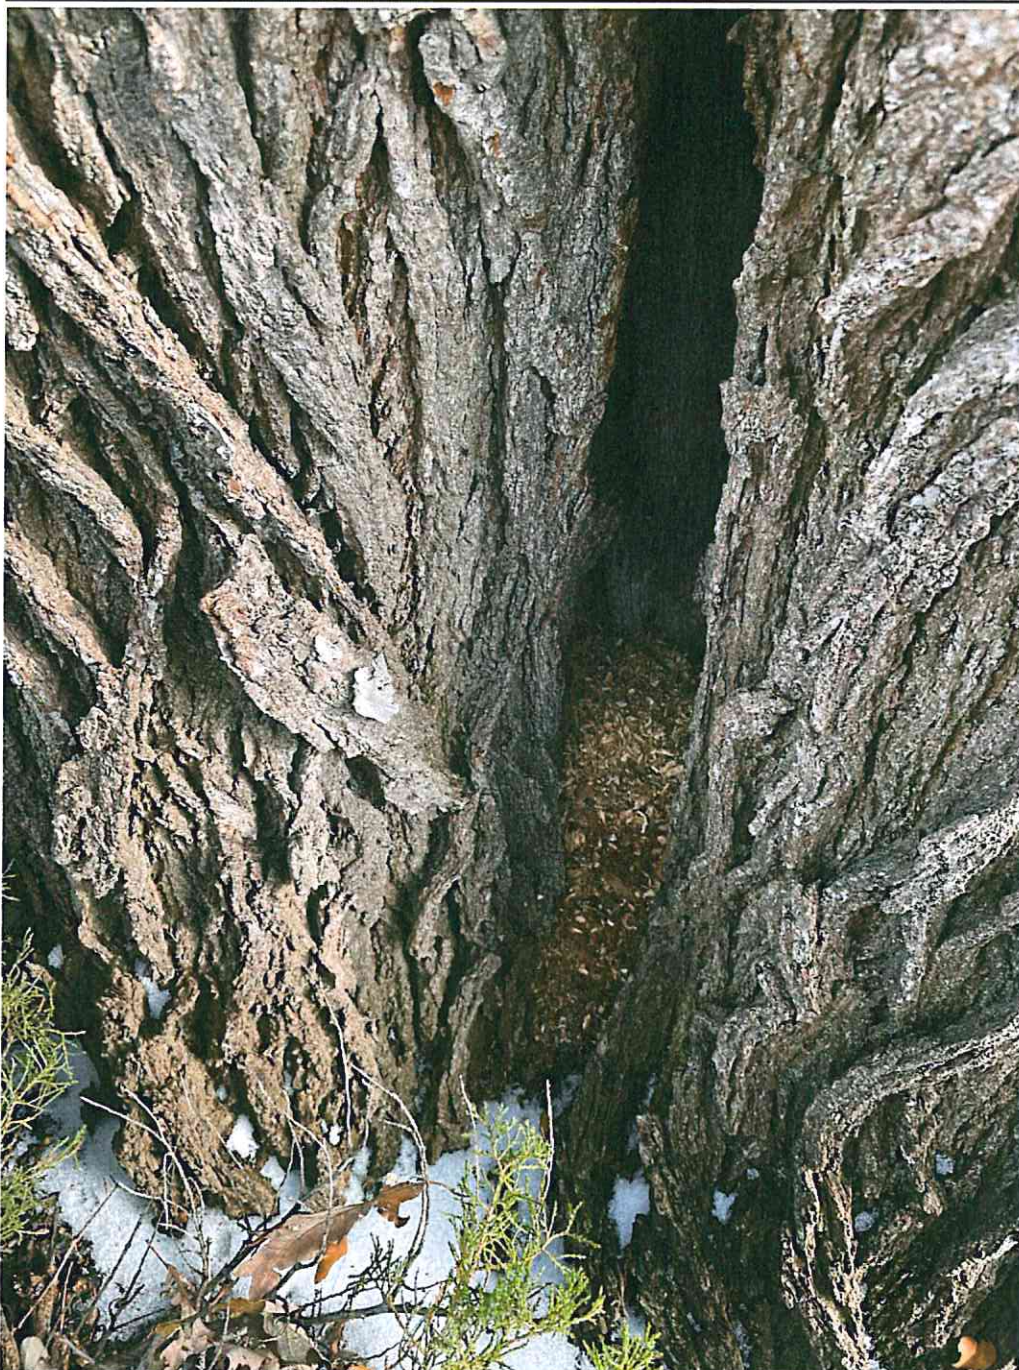
Figure 3: Picture showing cavity. Decay and cavity extend 70 cm into tree

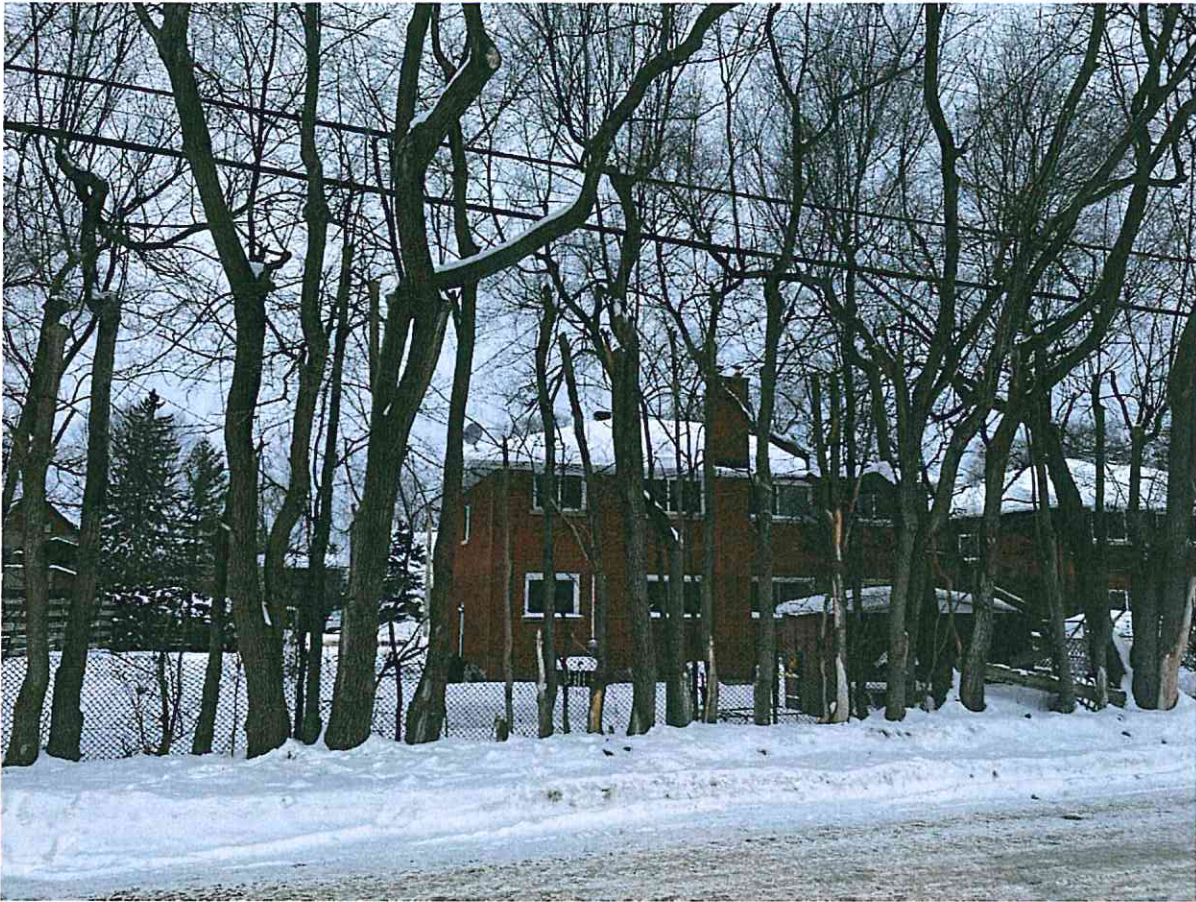
The intention is to retain the trees along the northern property line, particularly those that are jointly owned with the adjacent property owners. The area is currently covered in asphalt, and the asphalt will be replaced with new asphalt. The Landscape Plan prepared by Stantec shows that there will be some of the asphalt will be replaced with soft landscaping around tree grouping #9.

Figure 4: Trees grouping #9 - Siberian elm along northern property line under hydro – to be retained

- Avoid tearing of the roots. If the roots do tear, they should be pruned with a clean cut to increase the likelihood of sealing properly and reduce the risk of pathogens from entering the tree.
- Roots should not be left exposed and be covered with soil as quickly as possible, or temporarily with a moist, organic material such as mulch and/or burlap

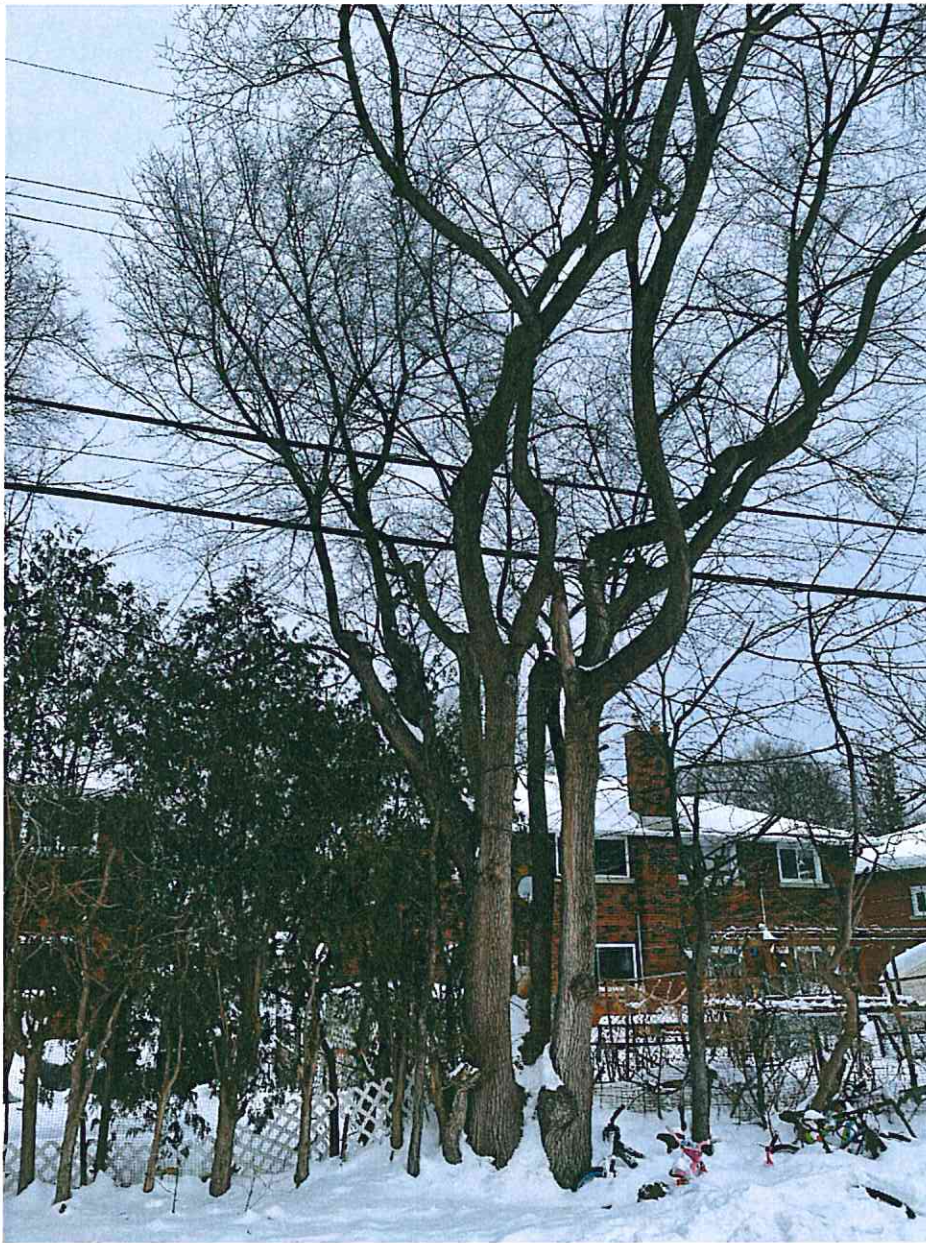
Figure 5: Tree 8, Siberian elm to be retained

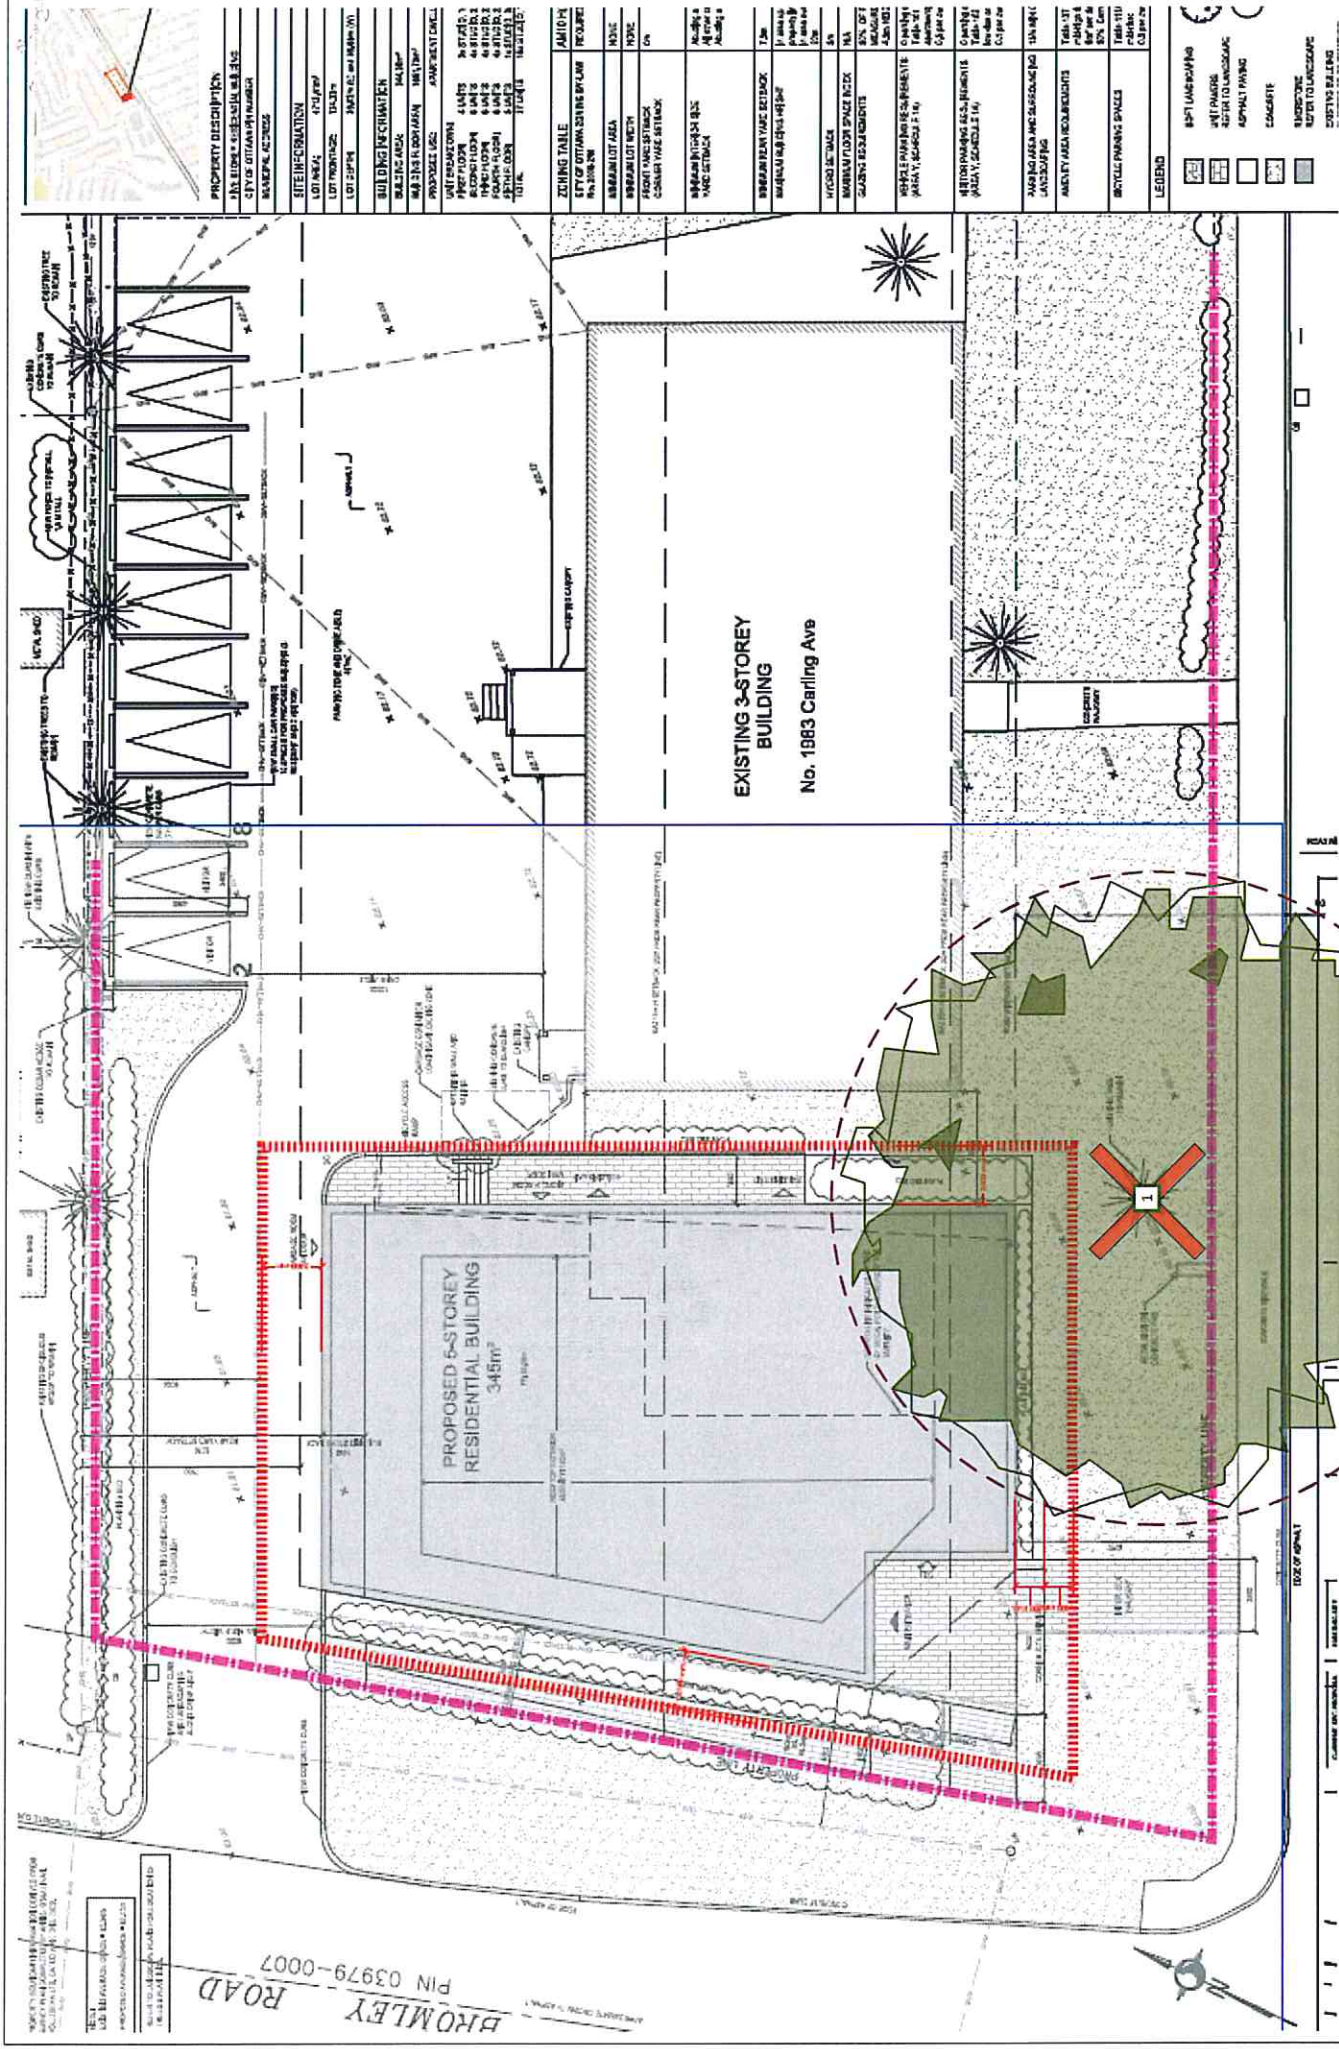
Tree Conservation Report – 1983 Carling Ave
 Proposed Development and Conserved Vegetation (excavation zone)
 Tree layer prepared by Dendron Forestry Services
 Version 1.0, January 27, 2022
 For more information, please contact info@dendronforestry.ca

- 1) Excavation zone (refer to Proposed Development and Conserved Vegetation (excavation zone) map): The excavation will extend well into the critical root zone as well as the static root zone to less than 2 m from the edge of the tree. A large portion of the critical root zone will be lost during the excavation which would impact both the long-term viability of the tree and possibly the structural integrity.
