INTEGRATED
FORESTREE
SERVICES INC.

September 7, 2023

RE: TREE INFORMATION REPORT (SHORT) FOR 998 COLONEL BY DRIVE

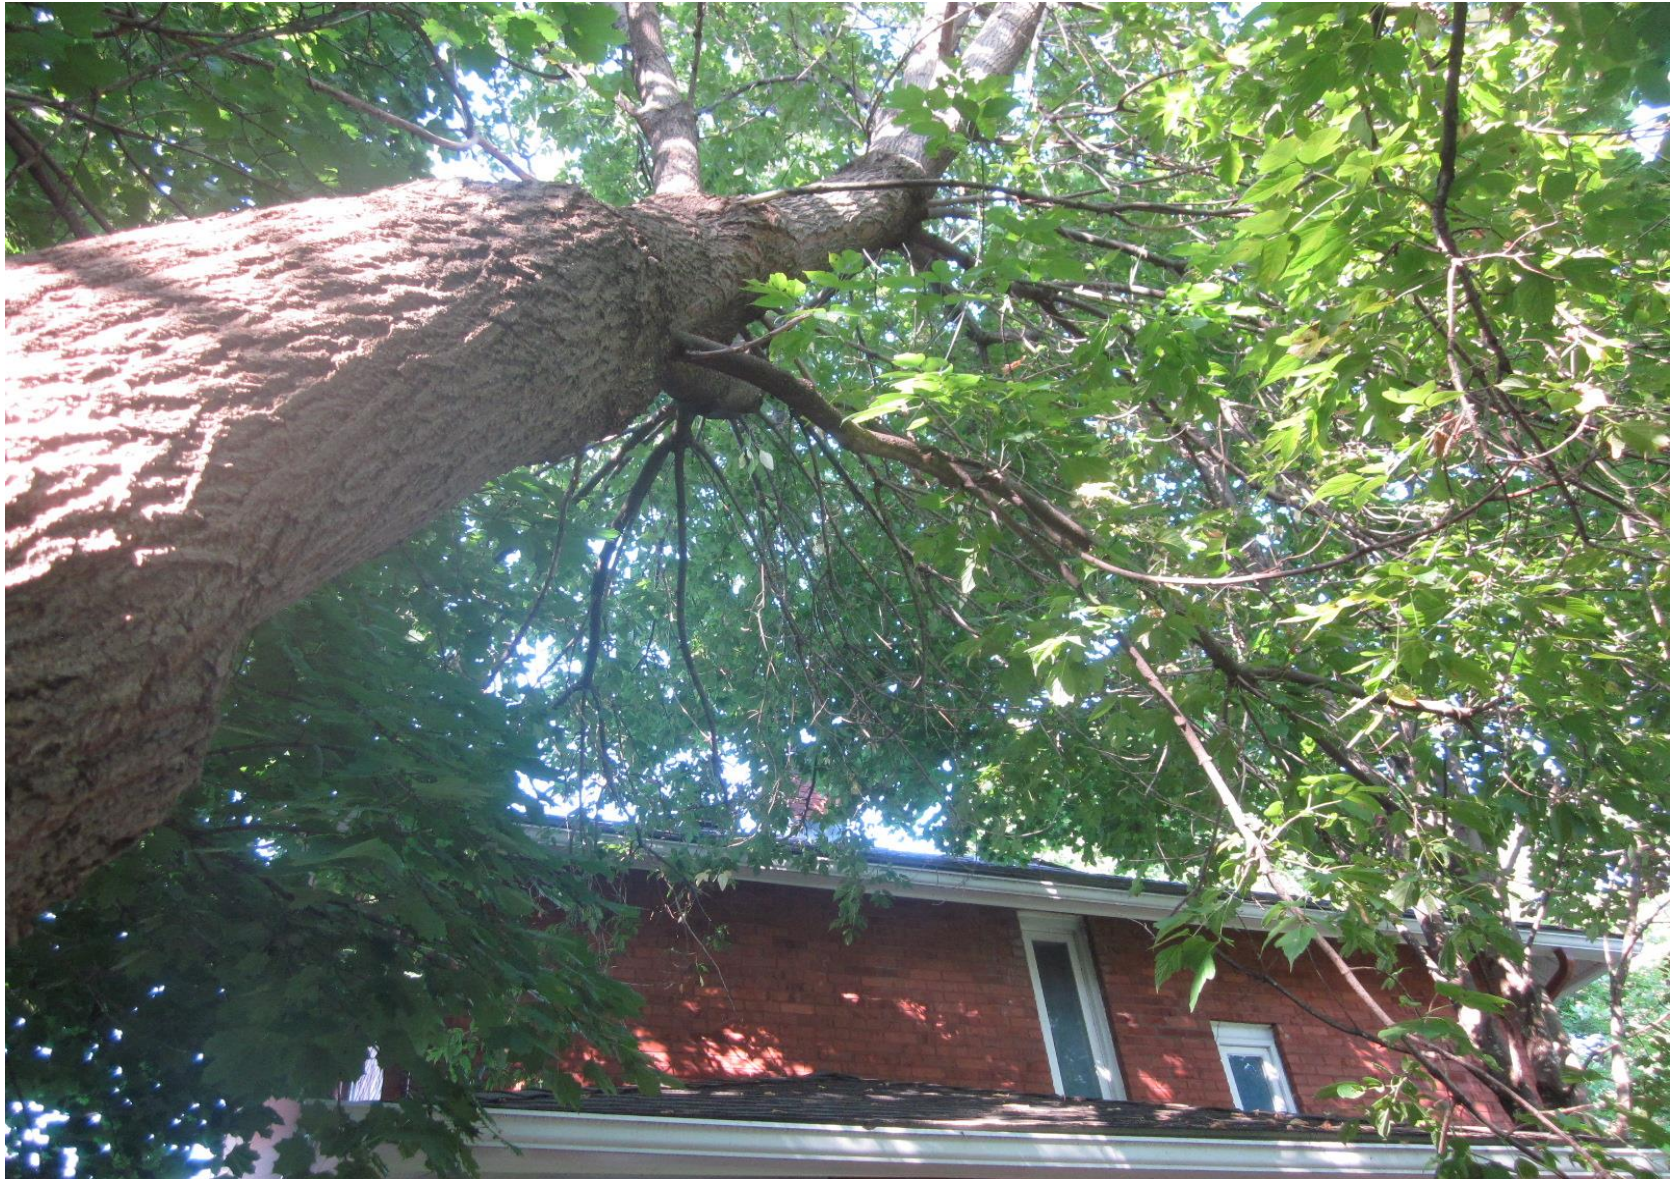
Tree No.	Tree species	Ownership & Location	DBH ¹ (cm)	Tree condition, age class, condition notes & origin	Reason for removal	Forester's opinion re. removal
1	Manitoba maple (<i>Acer negundo</i>)	Private; backyard	36.5	Poor; maturing; growth form strongly divergent over house; living crown fully over first and second floor roofs; species is known to be prone to failure under ice, snow and wind loads; naturalized species	Tree poses a threat to house and blocks access to rear portion of narrow driveway	Tree and stump should be removed

Picture 1. Manitoba maple in back yard of 998 Colonel By Drive (note heavy lean over house)

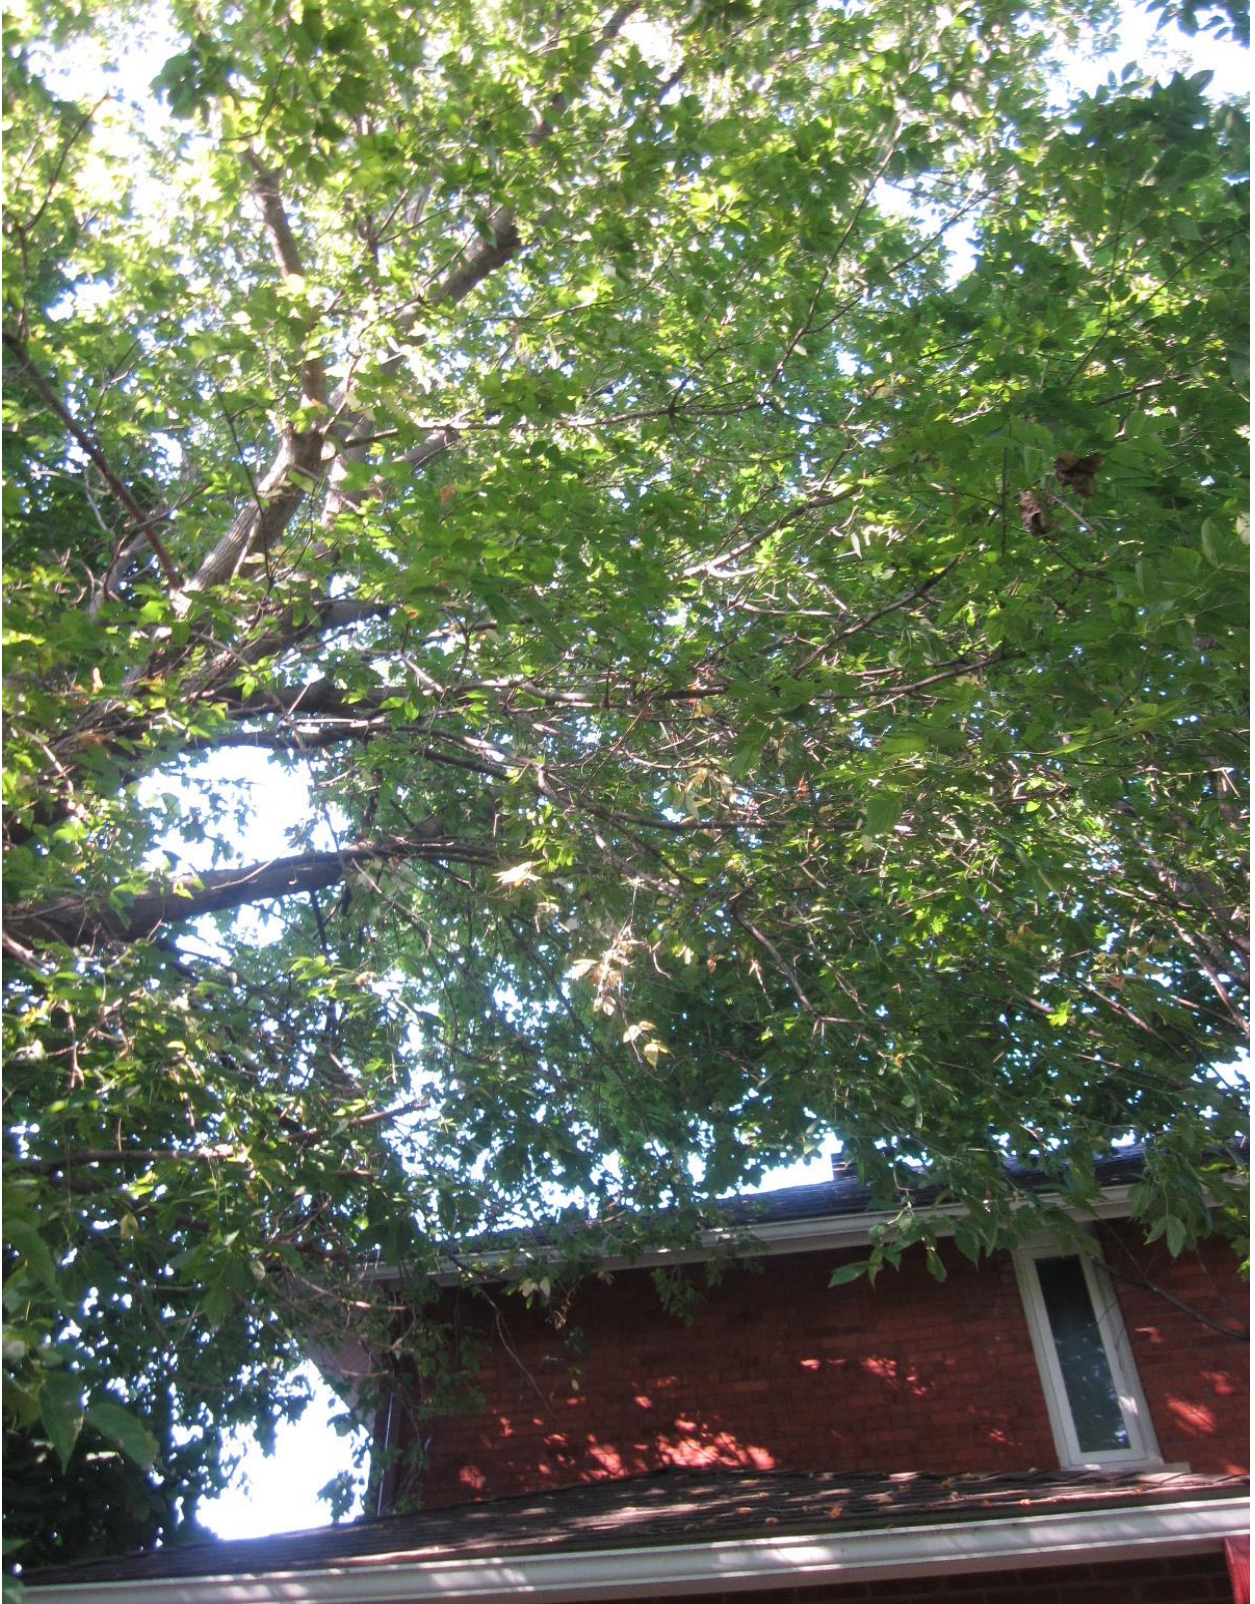
Picture 2. Manitoba maple in back yard of 998 Colonel By Drive (note crown over both roofs)

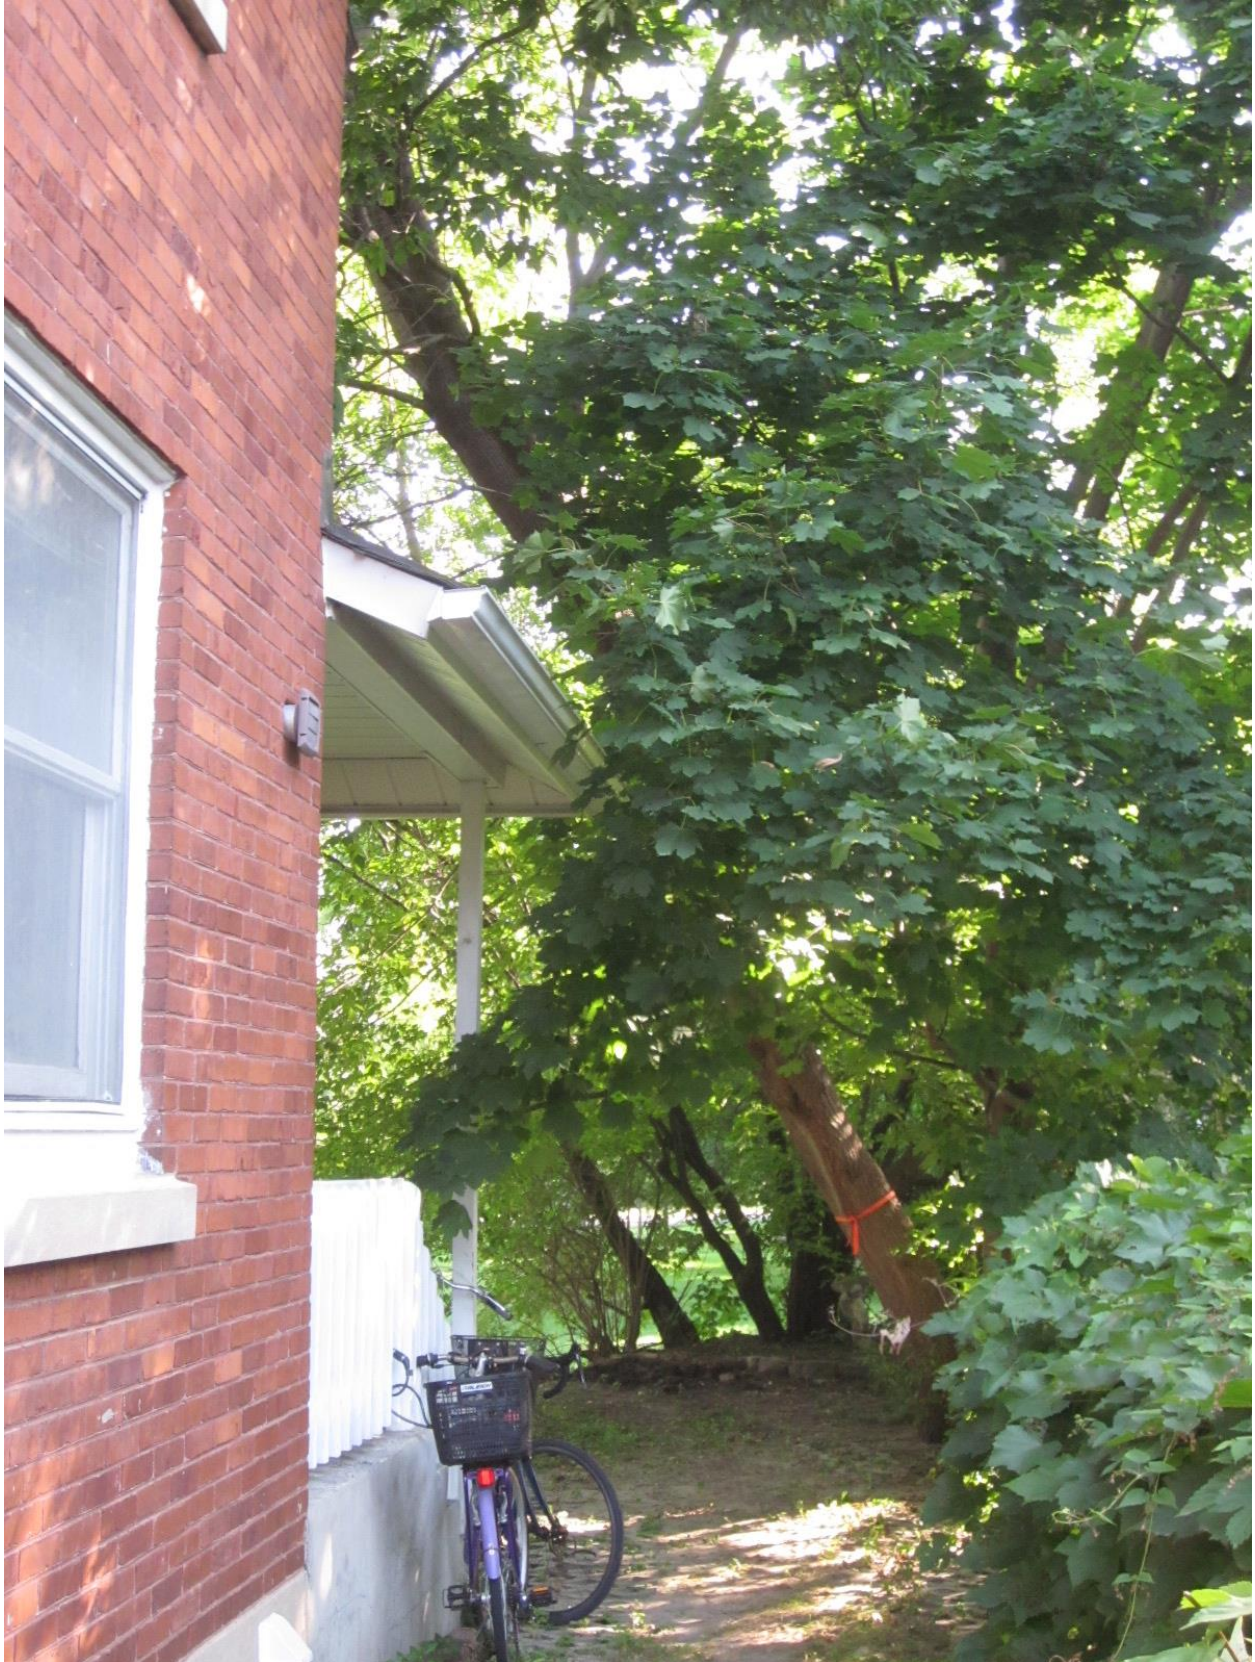
Picture 3. Manitoba maple in back yard of 998 Colenel By Drive (lower bole blocks end of driveway)
