Tree Information Report

Submitted as part of Committee of Adjustment Application to the City of Ottawa

Address: 882-884 Smyth Road
Date of Site Visit: March 30, 2023
Date of Report: April 3, 2023
Prepared by: Kevin Myers, ISA Certified Arborist®
info@dendronforestry.ca
Client: Tristan Philippe, tristan.j.philippe@gmail.com

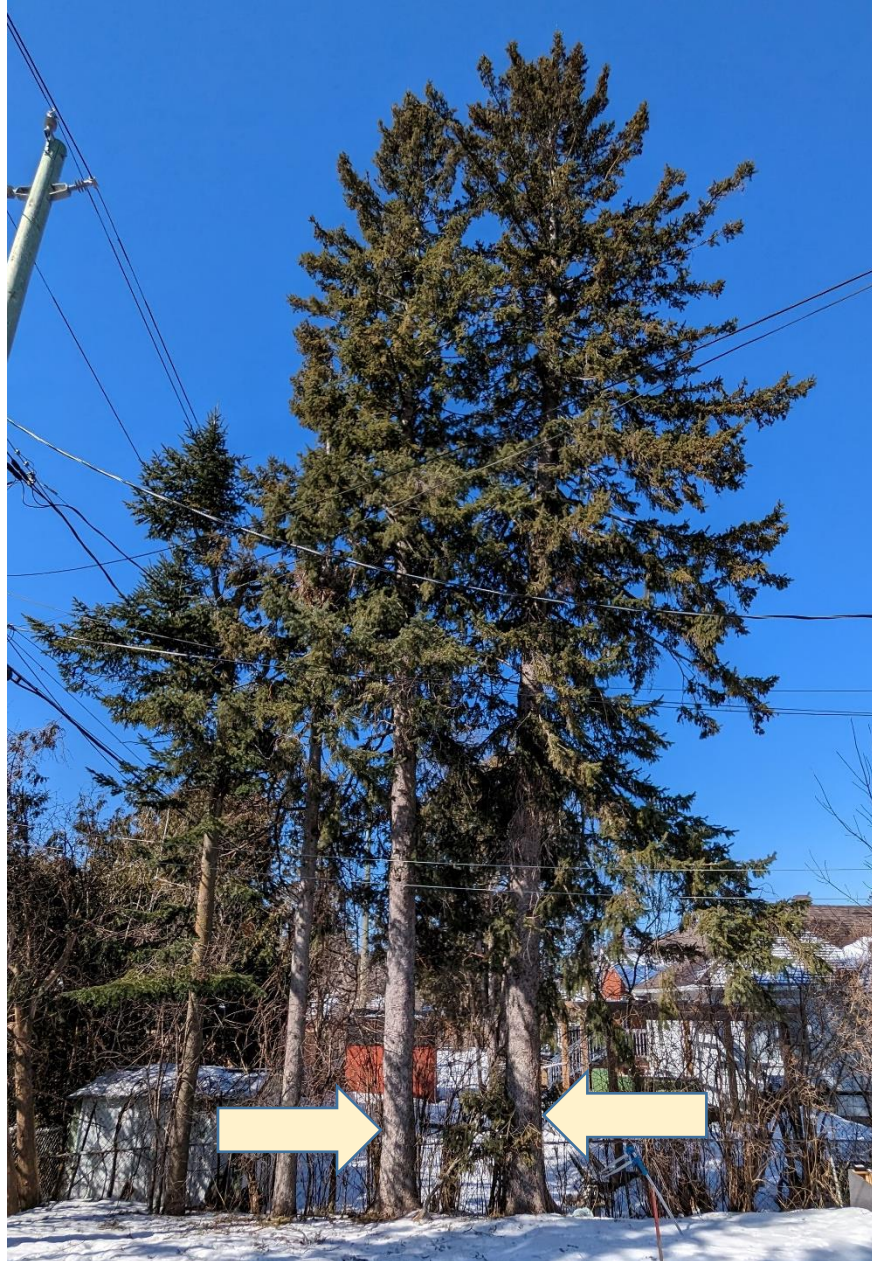
| Tree ¹ | Species | Diameter at breast height (cm) | Ownership ^{2,3} | Condition | Action | Recommendations |
|---|---|---|---|--|---|---|
| 4 | White spruce (<i>Picea glauca</i>) | 43 | Private – Subject property | Good/Fair: minor sweep in trunk; minor defoliation | Remove | Remove due to proximity of new build |
| 5 | White spruce (<i>Picea glauca</i>) | 36 | Private – Subject property | Good/Fair: minor defoliation | Remove | Remove due to proximity of new build |

Figure 1 - Trees 4 (on right) and 5 (on left): private spruces to be removed.

Trees 4 and 5 are within the area of excavation for the western coach house, and therefore are recommended for removal.

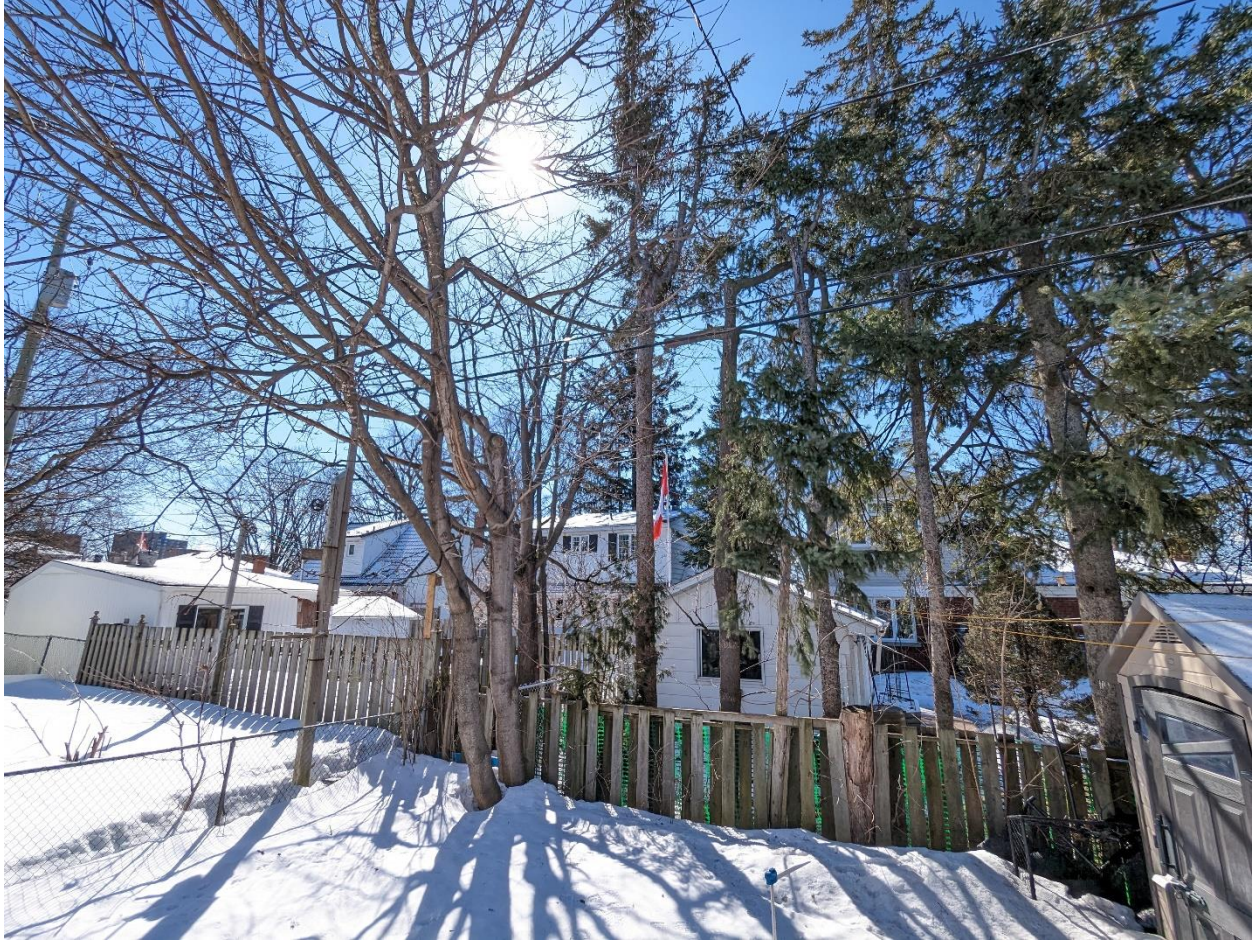
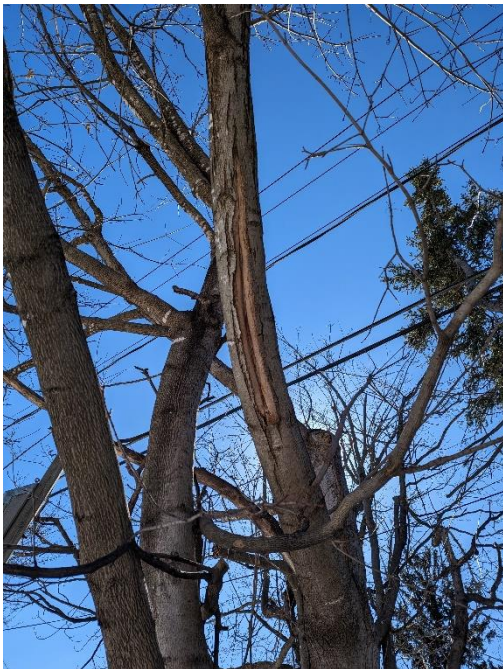
| 6 | Norway maple (<i>Acer platanoides</i>) | Multi-stem: 27, 30 | Private – Subject property | Fair/Poor: topped – asymmetric crown due to pruning around wires; old wounds with decay present; cracks in scaffold branches and stem | Retain | Retain and protect as per the City of Ottawa Tree Protection Specifications (March 2021) |

Figure 2 – (Above) Line of trees at the rear of the property - including Trees 6-8. (Left) Sealing crack on Tree 6

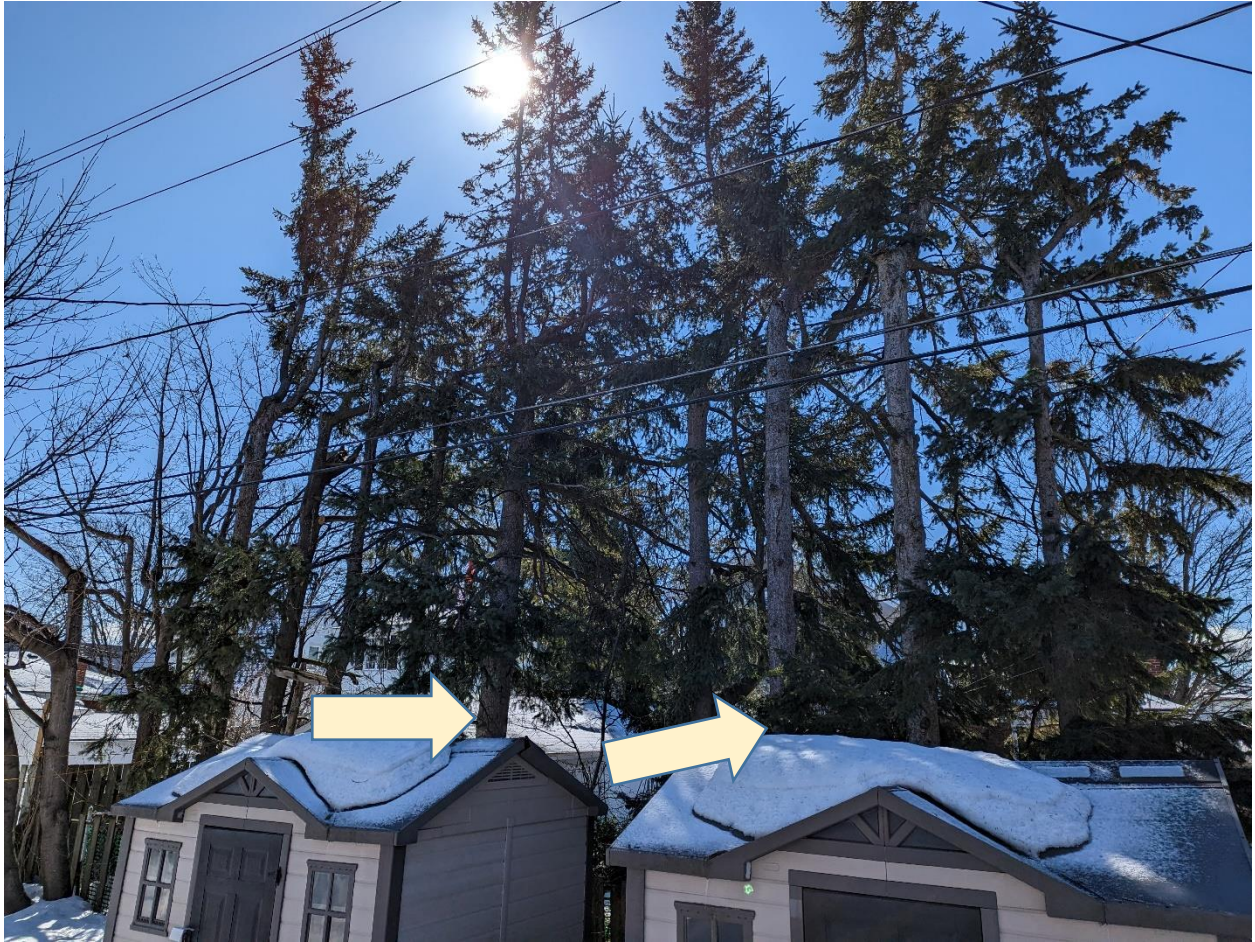
| 8 | White spruce (<i>Picea glauca</i>) | 34 | Adjacent – 883 Hamlet Road | Fair: asymmetric crown due to pruning around wires | Retain | Retain and protect as per the City of Ottawa Tree Protection Specifications (March 2021) |
| 9 | White spruce (<i>Picea glauca</i>) | 30 | Adjacent – 883 Hamlet Road | Fair: asymmetric crown due to pruning around wires | Retain | Retain and protect as per the City of Ottawa Tree Protection Specifications (March 2021) |

Figure 3 - Tree 8 (left) and Tree 9 (right): adjacent spruces to be retained.

Trees 7-9 are part of a long line of adjacent trees on the adjacent property. As large a tree protection area as is feasible, as shown in the attached Tree Information Map, will help protect all the trees from unintended root damage from site works.
