## Tree Information Report

**Date of Report:** July 31, 2024  
**Property Address:** 1551 Vercheres Street  
**Prepared for:** Justin Seguin; justin@justinseguin.ca  
**Prepared by:** Kevin Myers, ISA Certified Arborist®; [kevin.myers@dendronforestry.ca](mailto:kevin.myers@dendronforestry.ca)  
**Date of Site Visit:** July 29, 2024

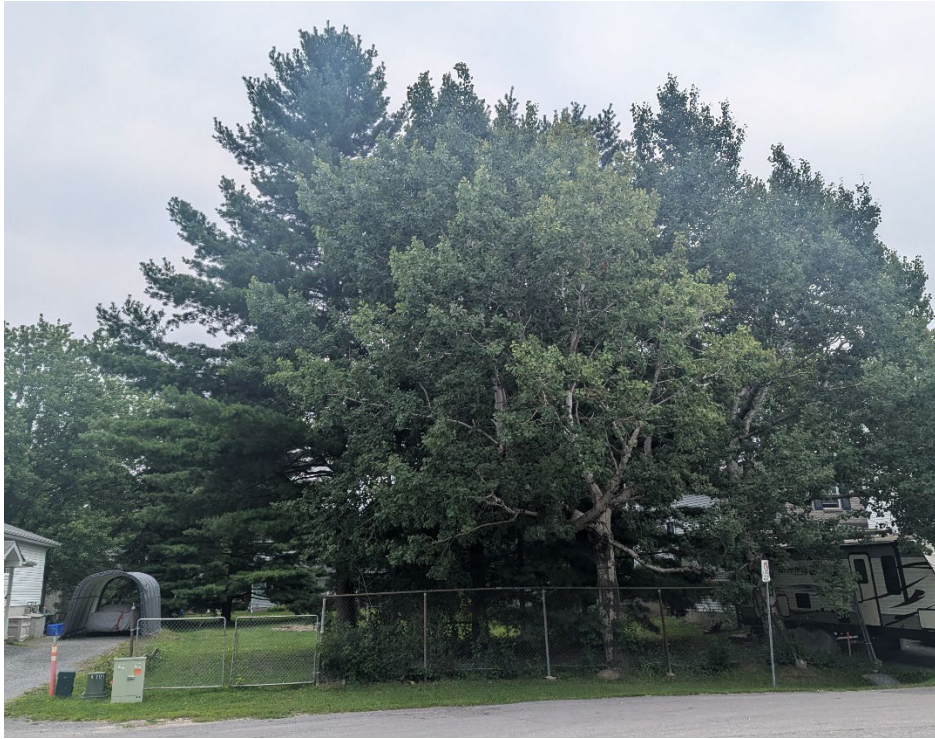
*Above: view of the property from Vercheres street.*

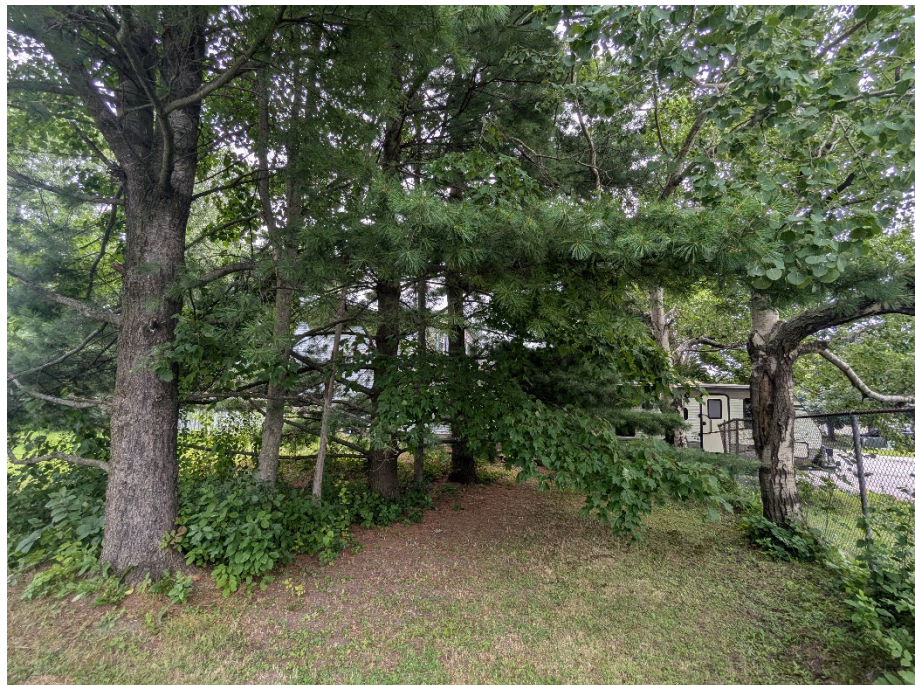
*Below: trunks of Trees 5, 4, 3, and 1 – trees to be removed.*

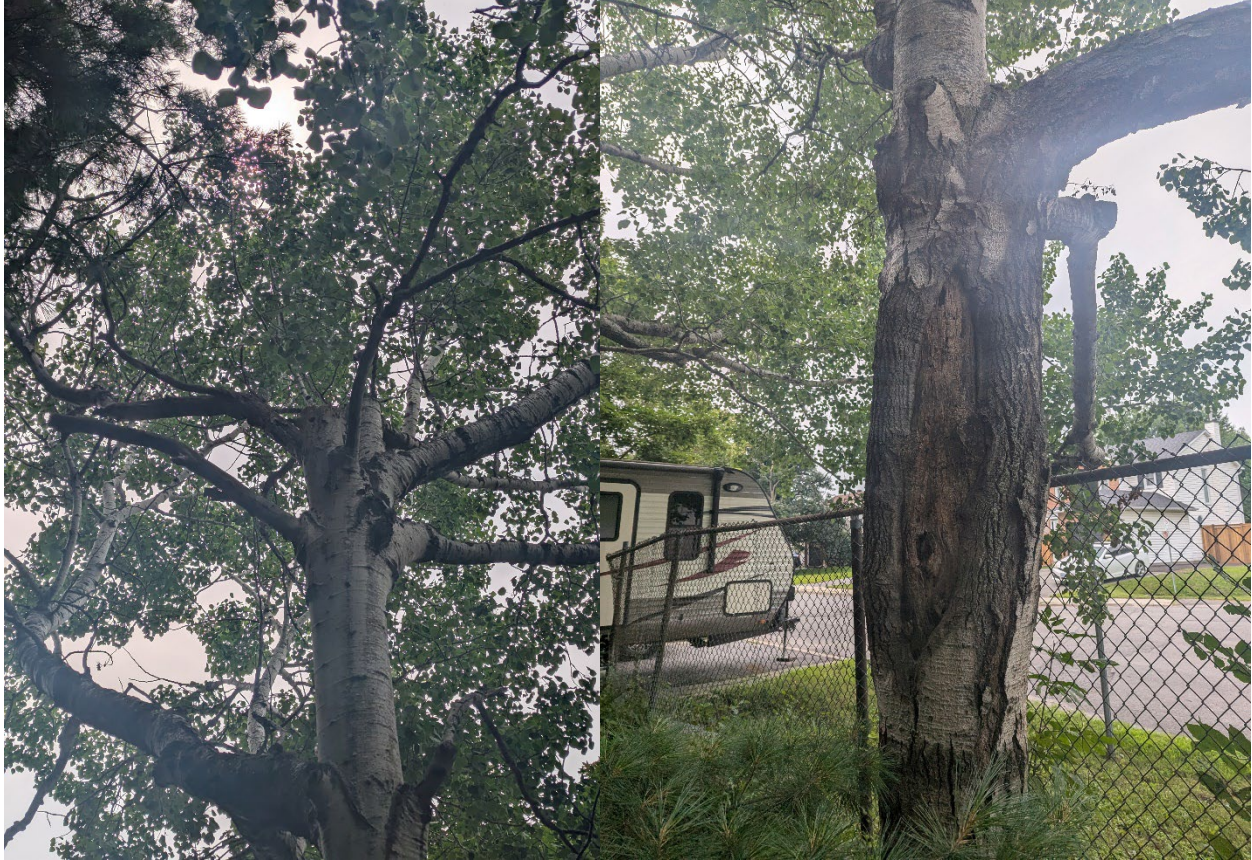
*Above left: broken top and decay in Tree 1.*

*Above right: wound with decay on trunk of Tree 1.*

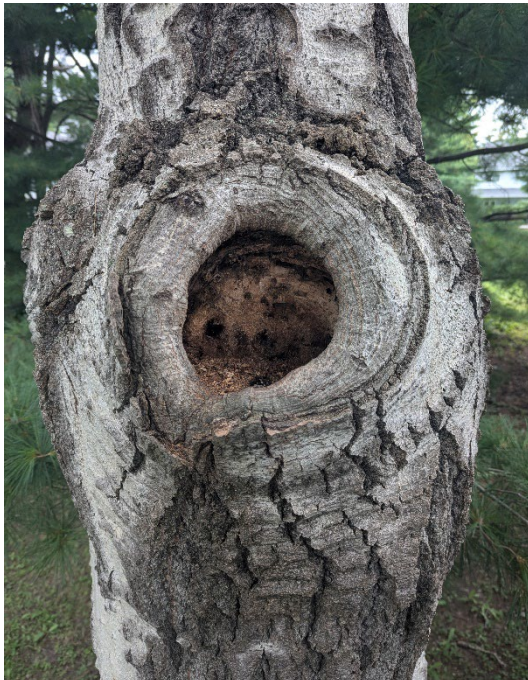
*Below: branch attachment wound with decay on Tree 2.*

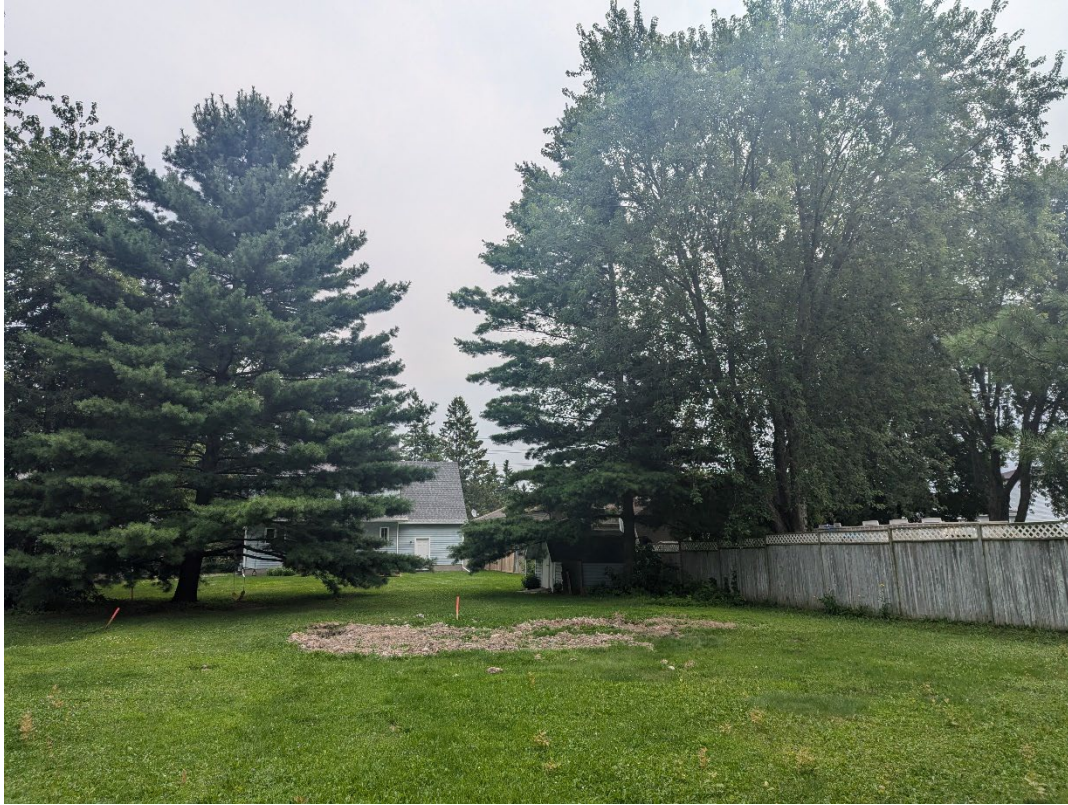
*Rear of the property with Trees 6, 7 and 8.*

**Tree 6** is to be preserved. To best protect this tree, roots along the line of excavation for the new parking spaces are to be revealed using an air spade or hydrovac or very carefully by hand, and cleanly severed prior to construction of the parking begins. If large roots are found (> 3” in diameter), a certified arborist is to make a determination on the stability of the tree going forward. Fencing is then to be installed as described below and shown in the map.

**Tree 8** is an adjacent silver maple approximately 3m from the fence separating the rear yard of 1555 Vercheres from the subject property. Root-cutting along the line of excavation (as described above) is to occur prior to construction of the parking spaces.

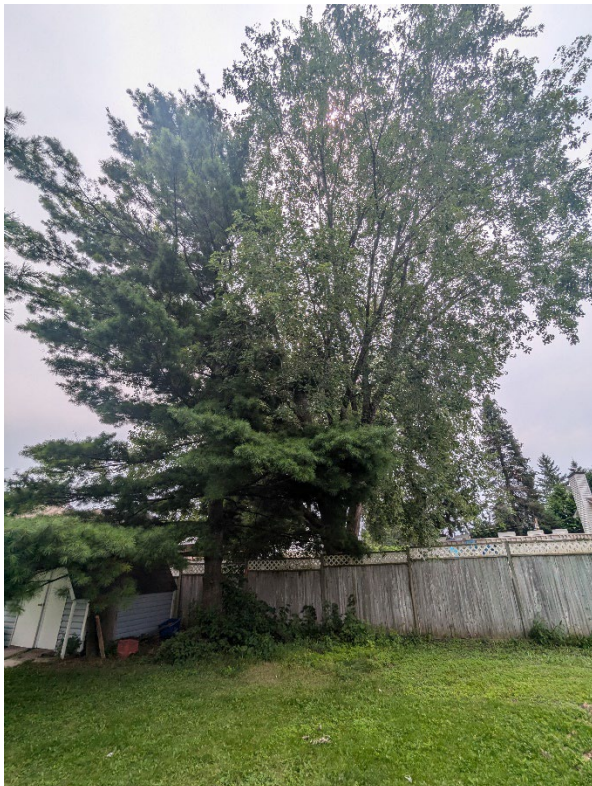
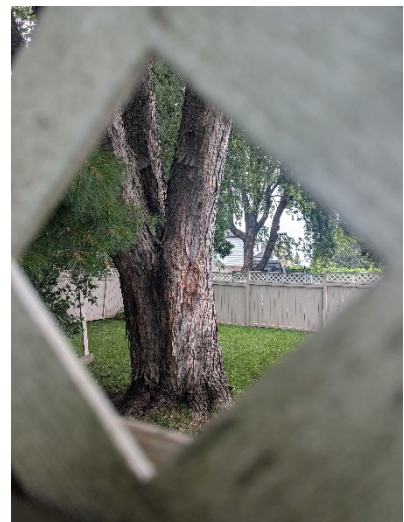
*Below left: Tree 7 – boundary pine to be removed and Tree 8. Below right: trunk of Tree 8 (view through fence)*
