# Preliminary Tree Information Report

**Address:** 633 Edison

**Date of Report:** October 7, 2022

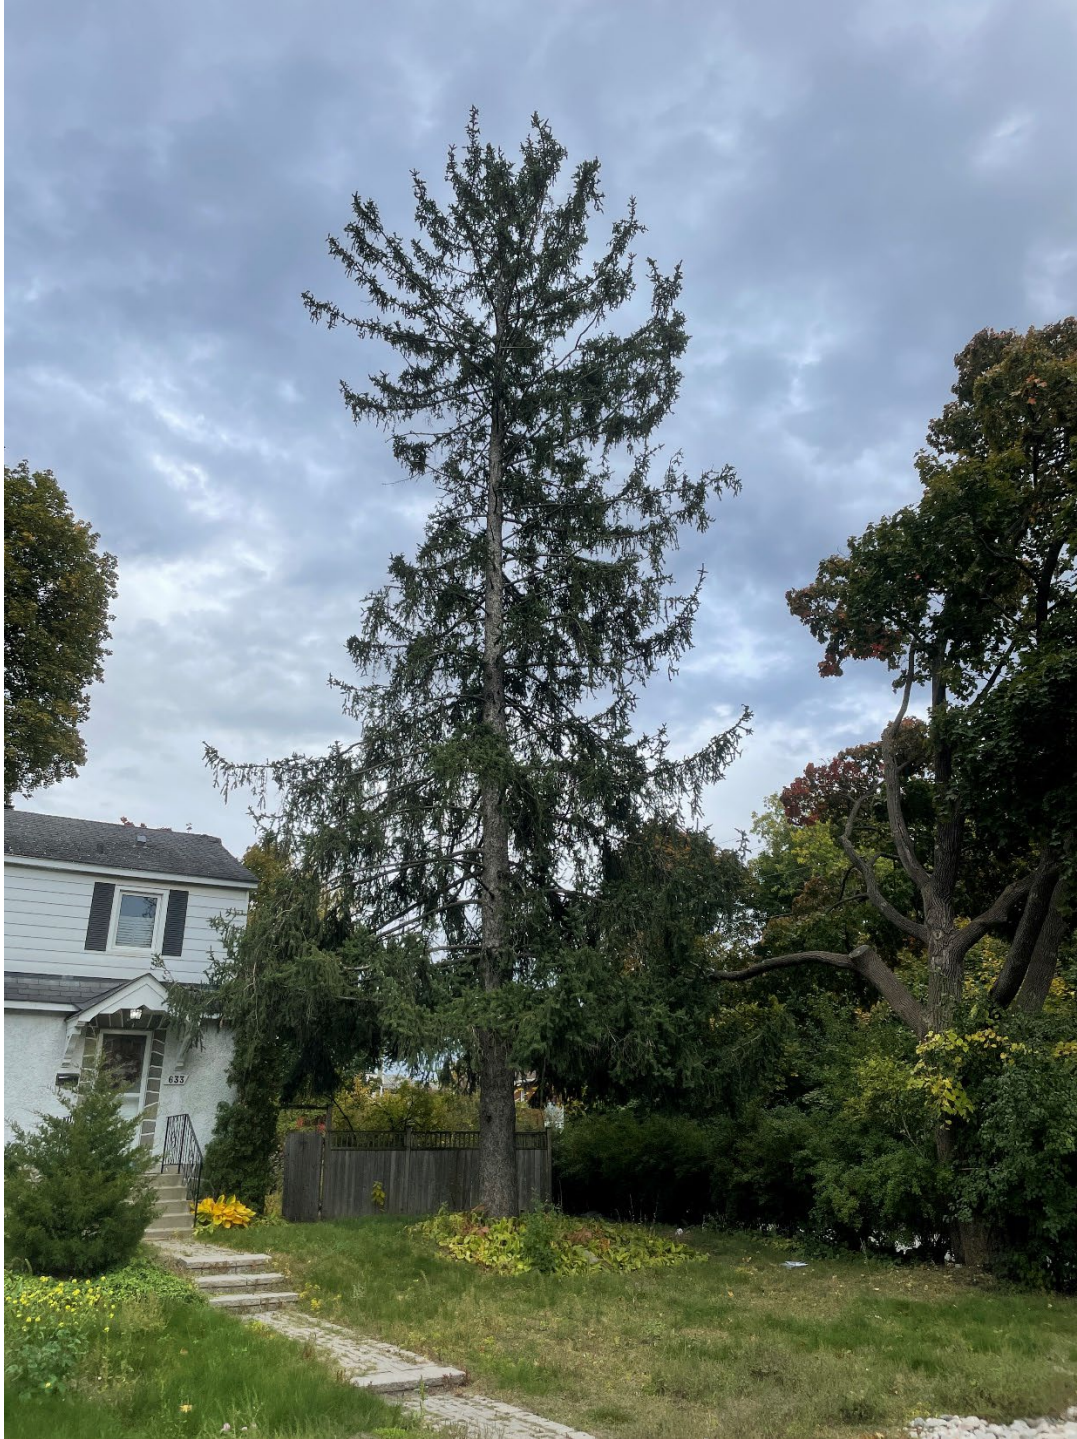
Tree <sup>1</sup>	Species	Diameter at breast height (cm)	Ownership <sup>2,3</sup>	Condition	Recommendations
1 <sup>4</sup>	Norway spruce ( <i>Abies abies</i> )	56 cm	Private	Good/fair; asymmetric crown due to shading by previous Norway maples	Most likely within building footprint with any level of intensification on the site
2 <sup>4</sup>	Norway maple ( <i>Acer platanoides</i> )	89 cm	To be confirmed, possibly jointly owned with city	Fair/poor; wound (60 X 100 cm) at 1.3 m on upper side of lean with significant decay – tree was unable to fully close wound; large 2 <sup>nd</sup> wound (canker), 130 X 80 cm at base of tree on underside of lean; 20% of roots are girdled, and canker and dieback present in crown; decay pockets in old pruning wounds throughout crown	Not a suitable candidate for retention during construction; in the absence of construction, tree should be monitored annually; assessment for removal likely over the next 2-3 years

*Figure 1: Tree 1, Privately owned Norway spruce*

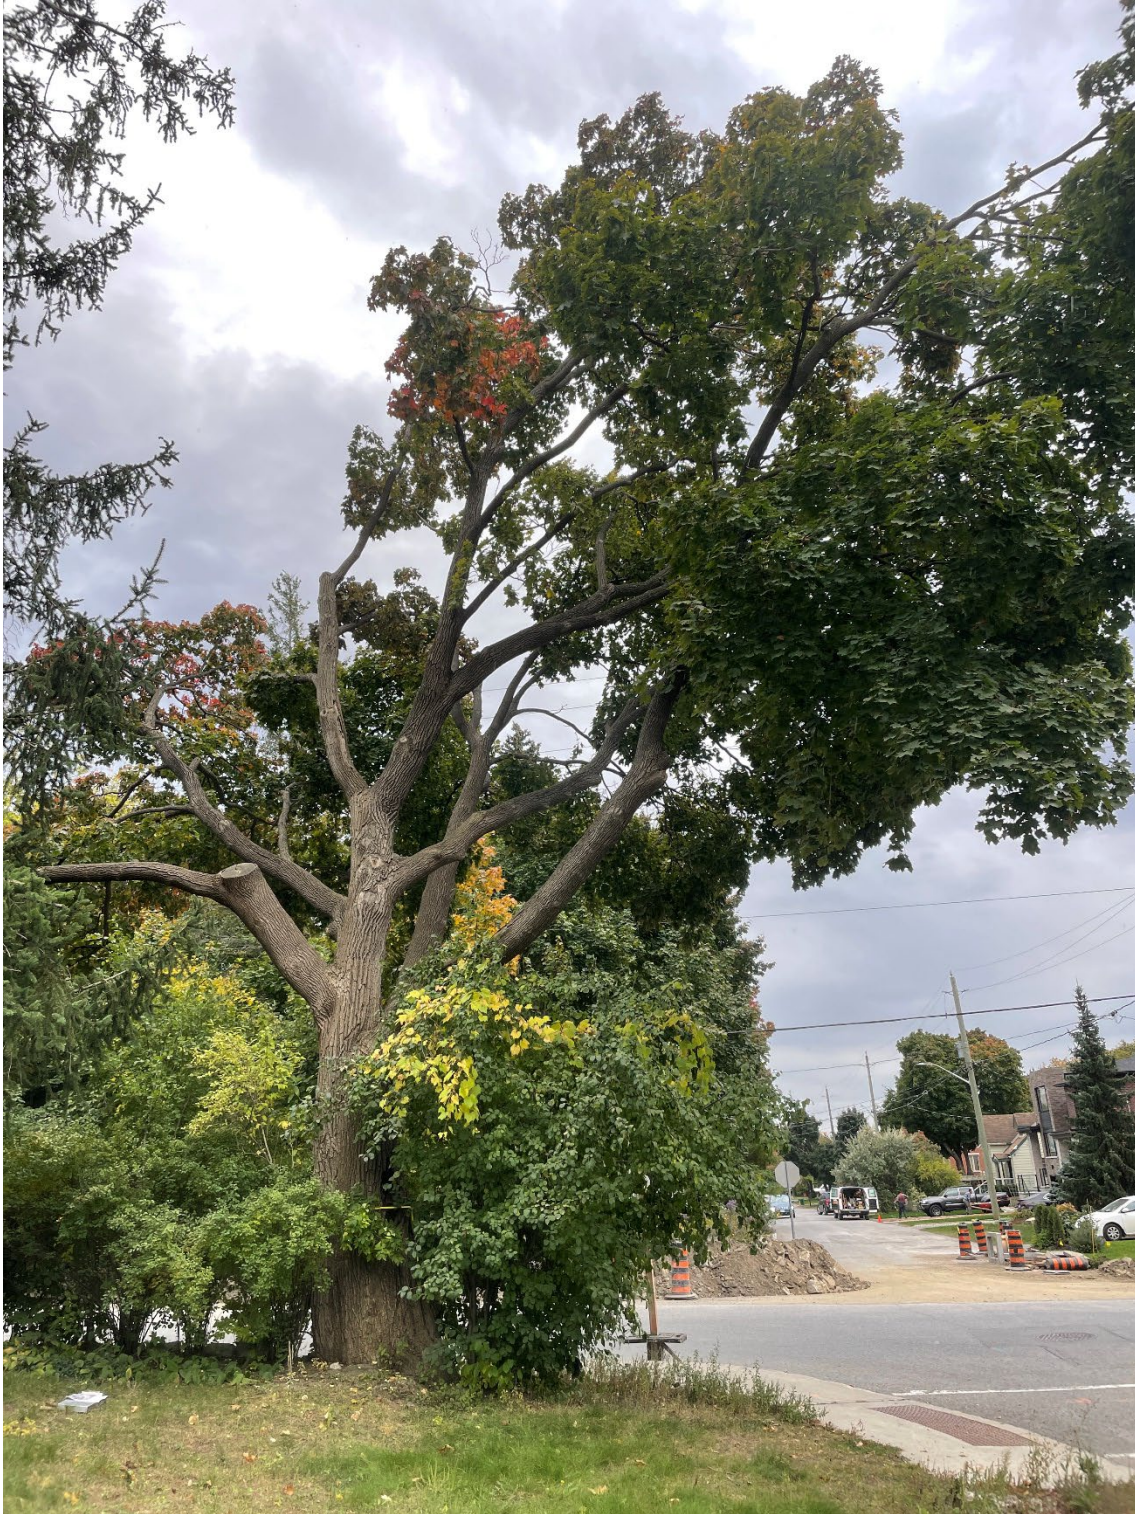
*Figure 2: Tree 2, Norway maple in fair/poor condition, ownership undetermined*

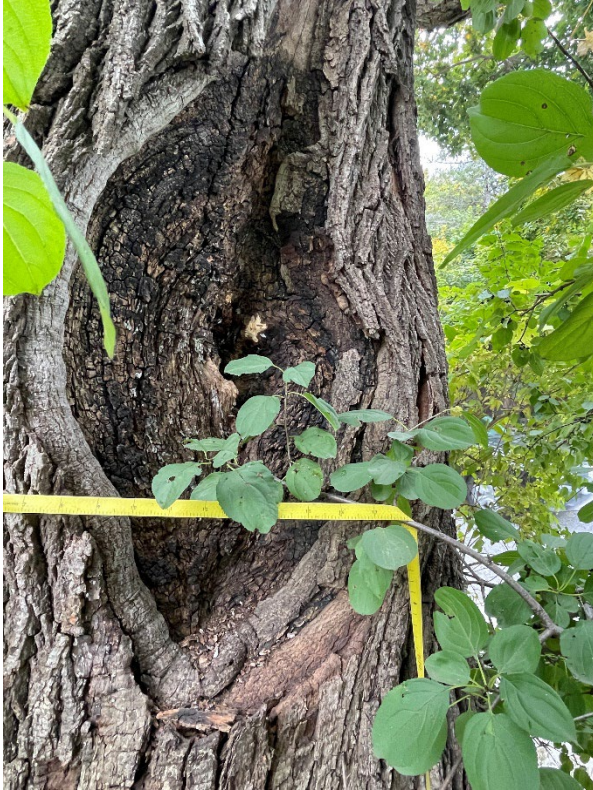
*Figure 3: Tree 2, large wound on trunk, tree has attempted to seal it off, but has been unsuccessful as decay extends 20 cm into trunk*

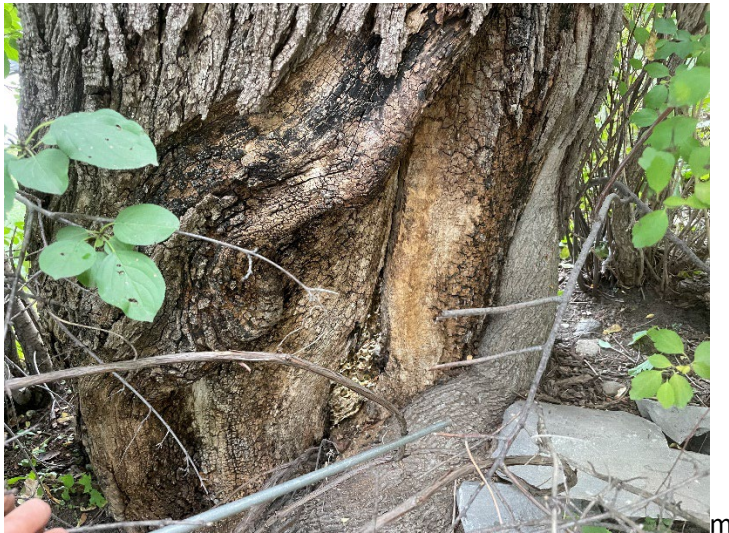
*Figure 4: Tree 2, large wound (possibly canker) at base of tree on underside of lean*

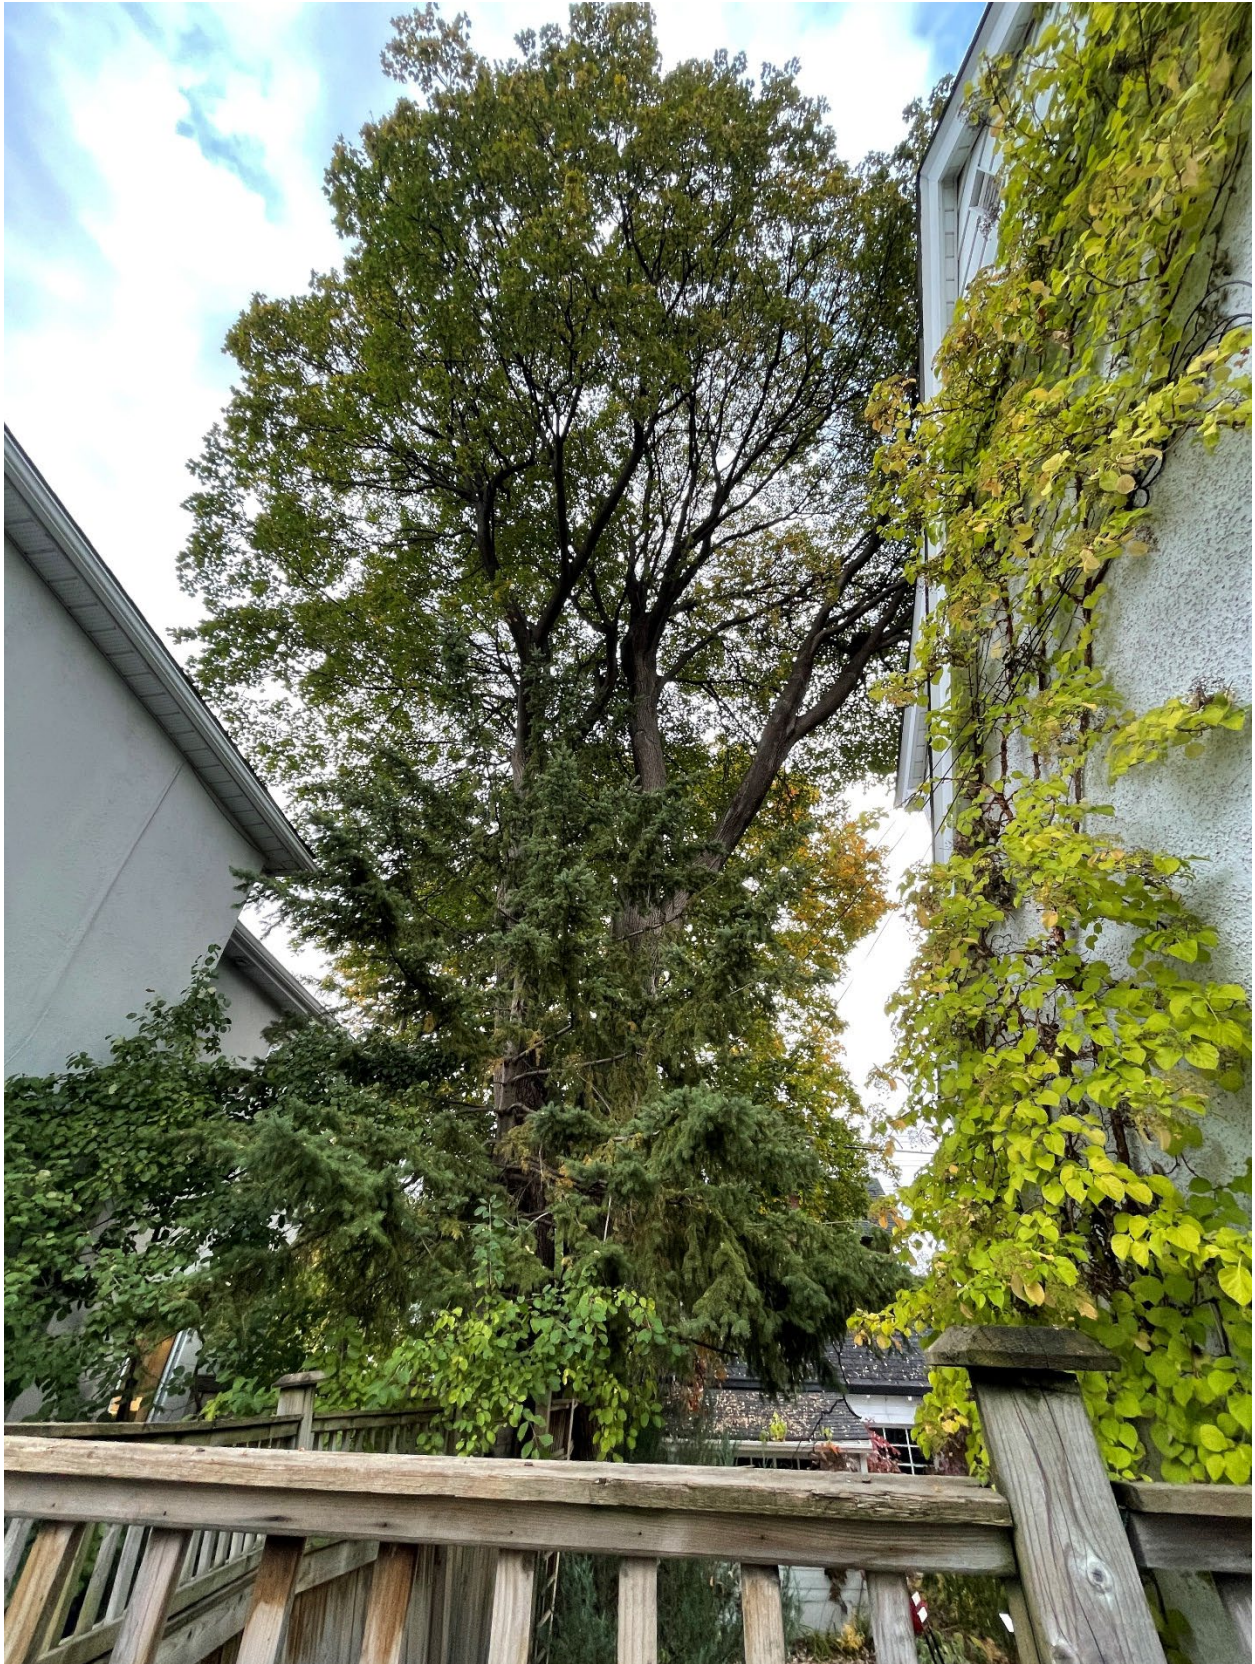
3 <sup>4</sup>	Norway maple ( <i>Acer platanoides</i> )	100 cm (estimate)	To be confirmed with survey; likely jointly owned with adjacent	Full assessment not possible as access to rear yard not provided; from a distance, large canker as well as included bark for junction of 2 codominant stems visible, large wound in stem leaning over	Large branch hanging over property will likely conflict with any new building; depending on further assessment and level of decay in stem leaning over subject property, either

*Figure 5: Tree 3, appears to be jointly owned with neighbour at 631 Edison (taken from Edison looking east)*

property at 631 Edison	subject property likely with decay leading up trunk	full branch or full stem removal will be recommended
--	--	--	---------------------------	--------------------------------------------------------	------------------------------------------------------------

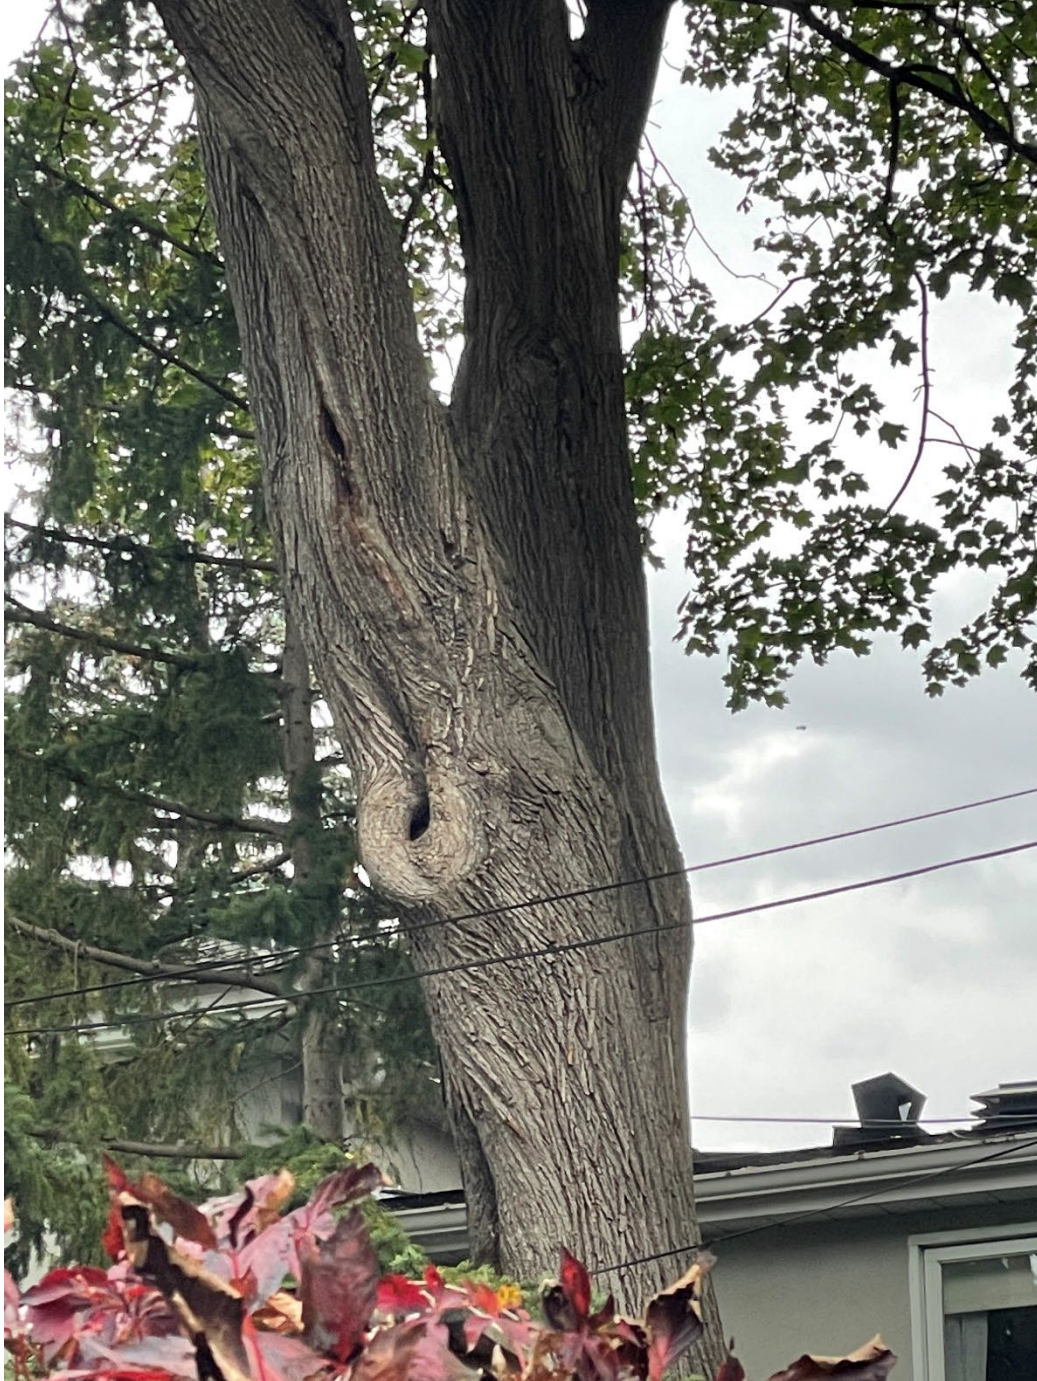
*Figure 6: Tree 3 taken from end of driveway of 633 Edison, facing north; note the old branch wound, likely with significant decay extending up along the stem*
