**Ruisseau Park Ravine (Blue Willow)  
Rehabilitation Phase 1: Class Environmental  
Assessment (EA) and Functional Design**

City of Ottawa

Project # TPB208018

Wood Environment & Infrastructure Solutions  
3450 Harvester Road, Suite 100  
Burlington, ON L7N 3W5 Canada  
T: 905-335-2353

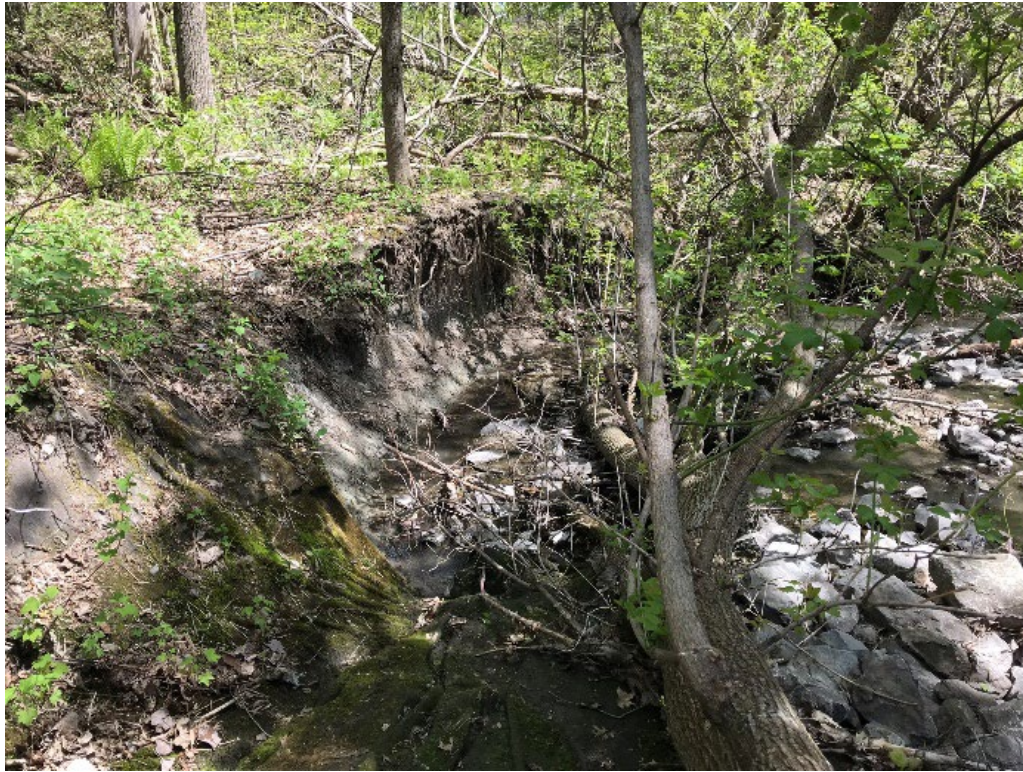
A stream morphology assessment has been undertaken by Coldwater Consulting on May 21, 2020, to assess the geomorphology and erosion conditions from the upstream end of the Ruisseau Park Ravine toward the stormwater management facility. The stream conveyed through Ruisseau Park Ravine is presently in a degraded condition and undergoing a rapid morphological evolution which is leading to the geotechnical instability of the steep banks of the ravine within which it runs. It is considered that the rate with which this stream is evolving has likely been accelerated by the impacts of urbanization of the local area in the early 1990's. The increased imperviousness of the contributing drainage area resulting from urbanization, in addition to the implementation of the major and minor drainage network, has led to the stream experiencing an increase in discharge from rainfall events. The resulting downcutting and planform migration of the stream has led to slope instability issues at several locations which have the potential to endanger adjacent properties. Examples of the erosion are provided in Figures 3.7 to 3.9.

**Figure 3.7. The left bank is eroded, located in the upper reach of the channel**

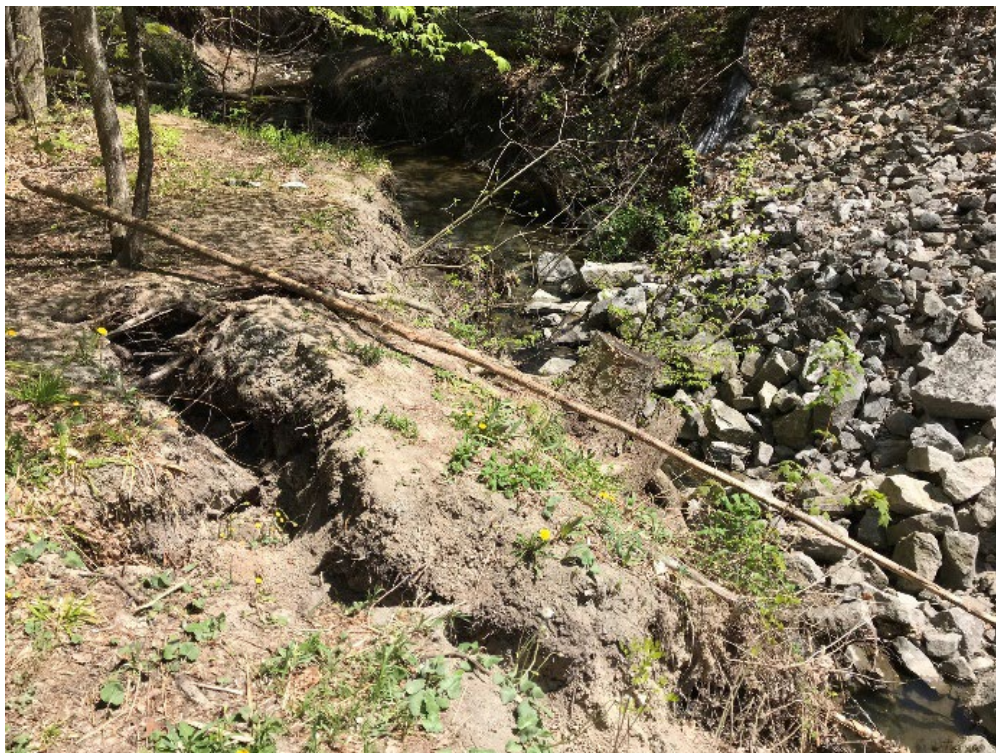
**Figure 3.8. Failure of the left bank opposite a rip rap protected slope**

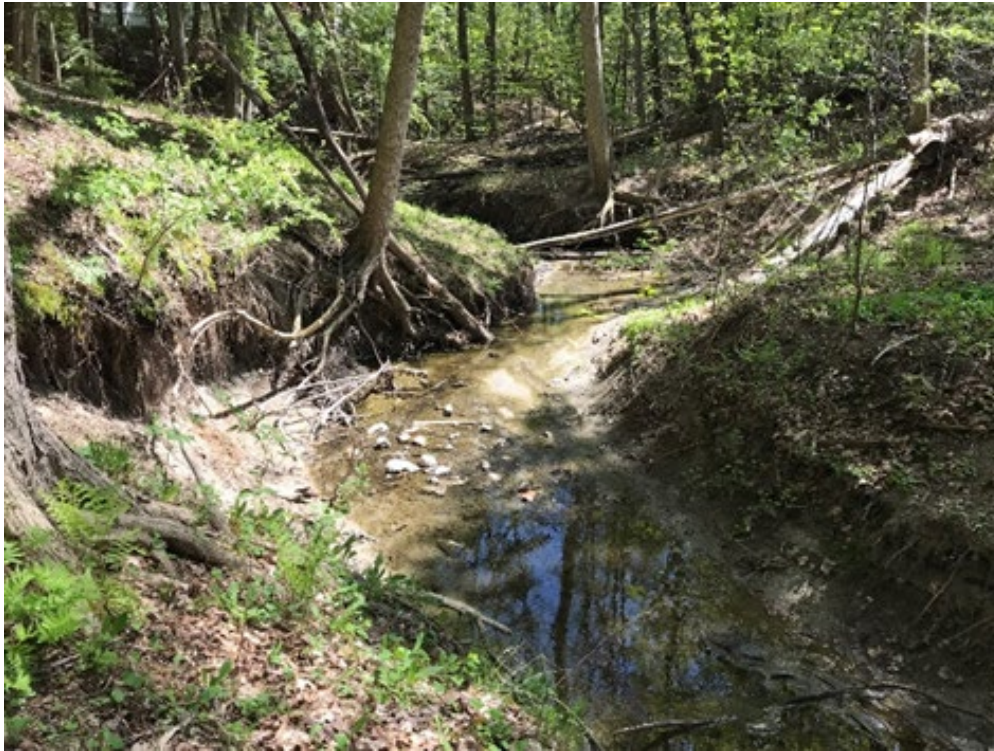
**Figure 3.9. Eroded banks and the roots of an established tree have been exposed**

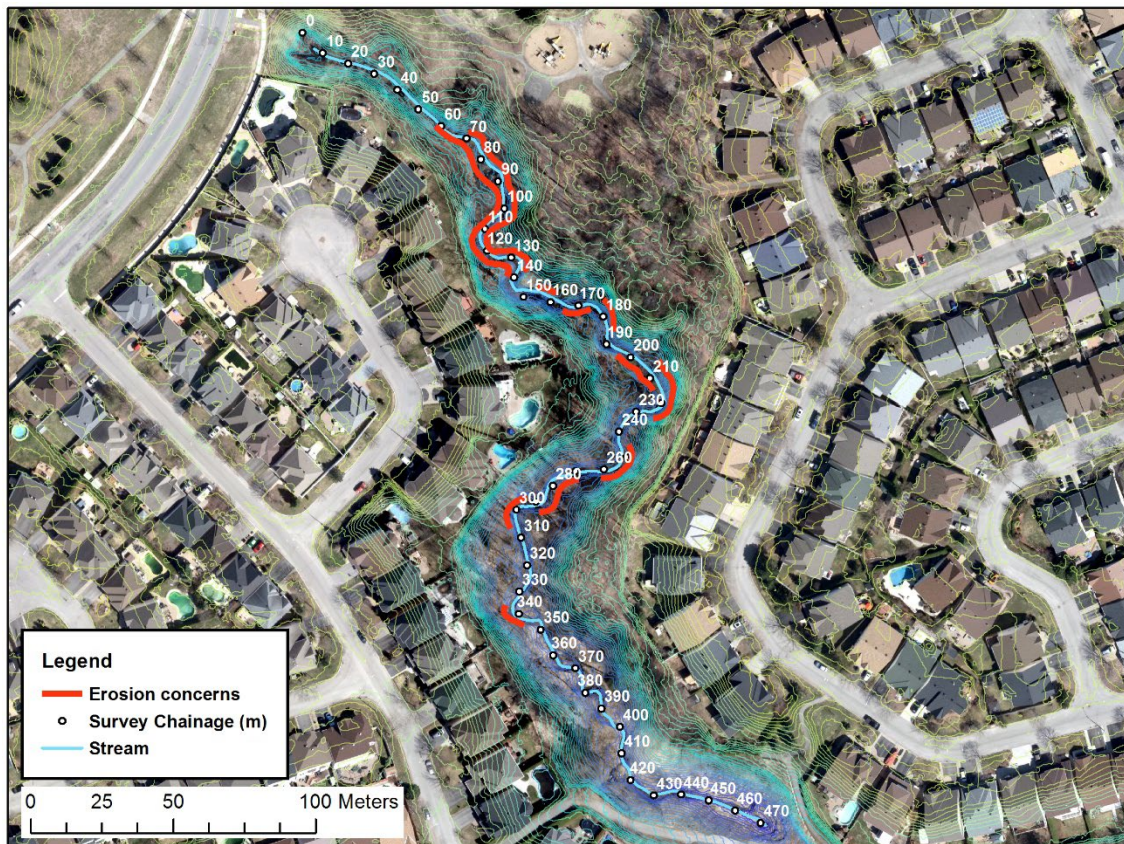
The stream is undergoing active erosion along most of its length; areas of special concern where erosion is cutting into a high bank or where continued erosion could lead to property damage are identified in the Stream Morphology Existing Conditions Report (Appendix E) and in Figure 3.10. It is recommended that these areas at a minimum be addressed as part of the rehabilitation; however, isolated interventions may only protect those areas addressed and new erosion hotspots may develop. It is therefore recommended that a mitigation approach be adopted that offers protection to the entire stream.

**Figure 3.10. Locations of Erosion Concern**
