# **Tree Information Report v2.0**

Submitted as part of Building Permit Application to the City of Ottawa

**Date of Report:** April 16, 2024

**Property Address:** 1598 Prince of Wales Drive

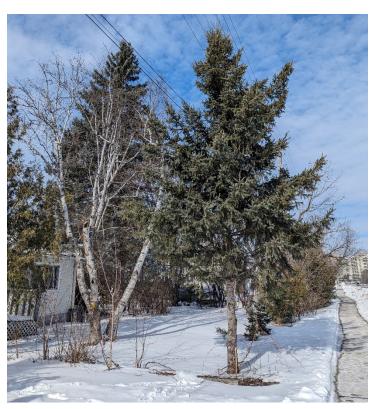
Tree 1 (right) - city spruce to be retained, and Tree 2 (left) - private birch to be removed.

**Tree 1** can be preserved for future canopy on site – care is to be taken not to tear roots when removing the existing driveway – if any roots are torn the damaged portions are to be cleanly cut off by hand at the nearest union. Fencing should be installed as shown in the map and described below.

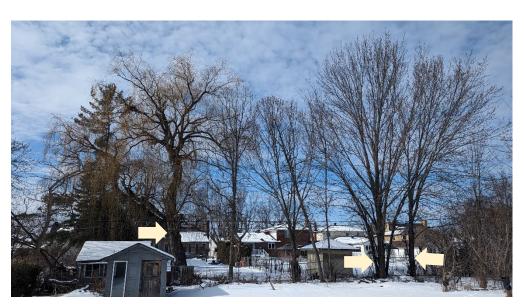
Trees along the rear property line. Tree 3 (left) - adjacent willow to be retained. Trees 4 and 5 (right) - private red maples to be removed.

**Tree 3** is far enough on the adjacent property that stability will not be a concern – to protect its rooting space, fencing is to be installed at the rear of the property as indicated in the map and described below.

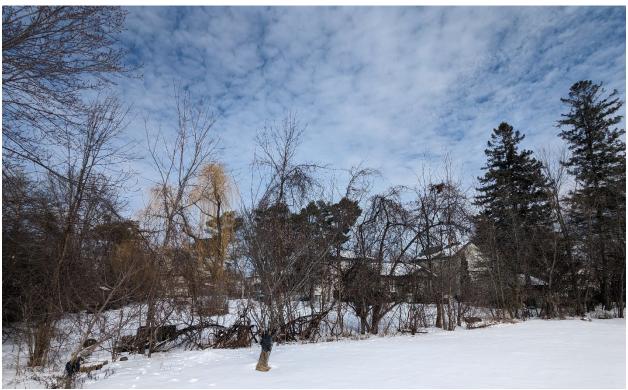
Above: Trees along the south property line - largely unmaintained and in poor condition.

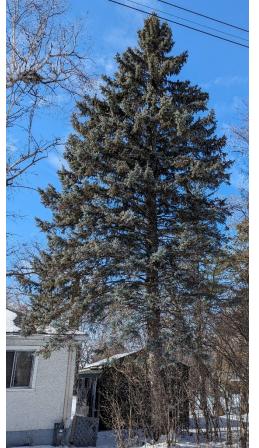
Right: Tree 6 – private spruce to be removed.

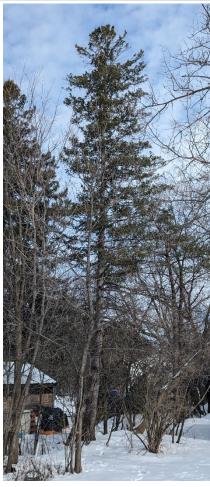
Left: Tree 8 – private spruce to be removed.

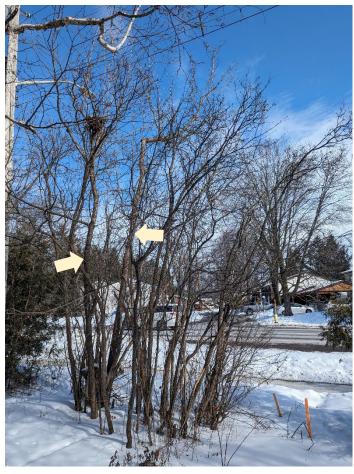
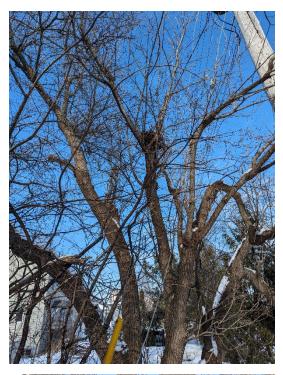
Canopy of Tree 7.

Base of Tree 7.

**Tree 7** is a multi-stemmed Manitoba maple (*Acer negundo*) – most of which is growing and leaning away from the subject property. This tree sits on the south side of an existing drainage ditch that runs along the southern property boundary. It is expected that this tree will be able to endure construction. While it is unclear how many roots may have developed past the drainage ditch, protective fencing should be erected as shown in the map to protect the CRZ on the subject site.

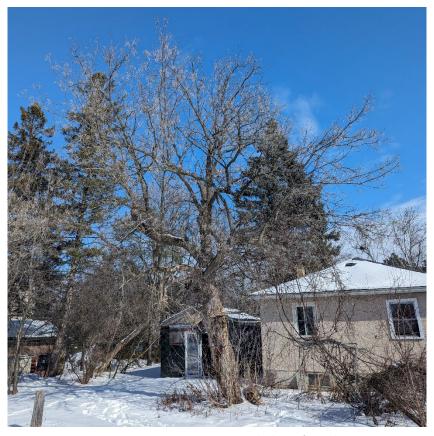
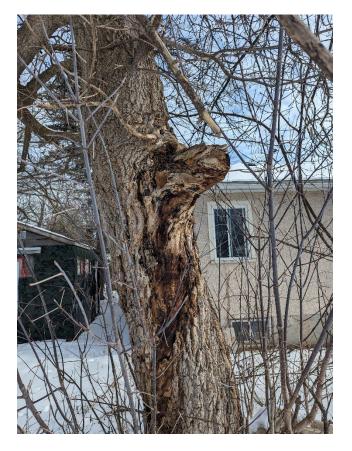
Clockwise from above: Tree 9 - private Manitoba maple in poor condition to be removed.

Base of Tree 9 with decay in the small cavity.

Decay on the stem of Tree 9.
