Dendron Forestry Services 024-09-23

Tree Information Report

Date of Report: July 31, 2024

Property Address: 633 Edison Avenue

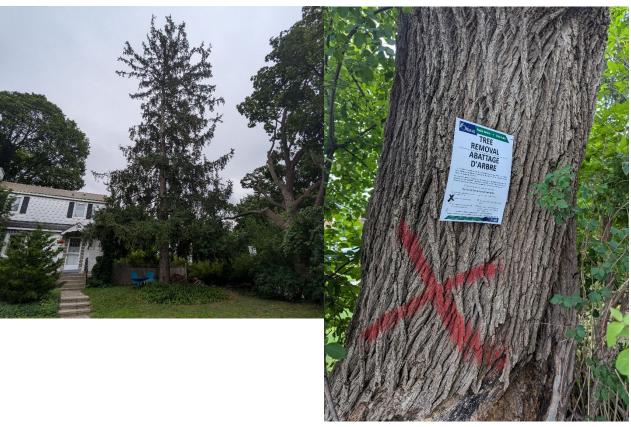
Tree 2 already has a permit for removal – the sign was posted on the tree during the site visit. The tree is in very poor condition.

Left: Tree 1 - private tree to be removed. Right: Tree removal permit posted on trunk of Tree 2 during site visit July 31

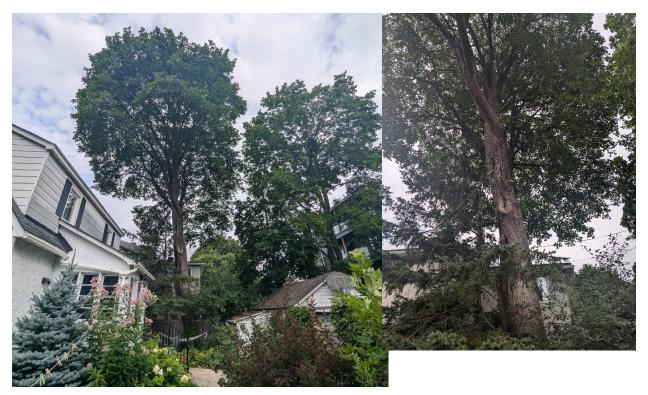
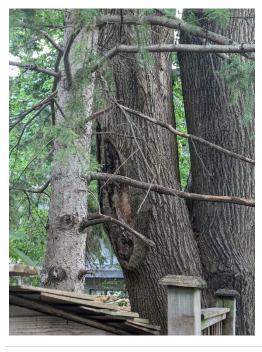
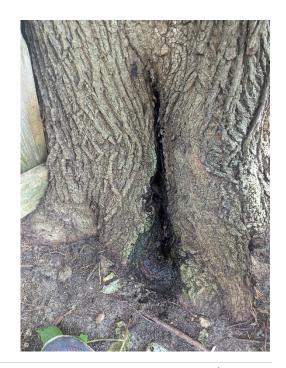
Tree 3 is a mature Norway maple in poor condition. The tree is recommended for removal based on its health, and removal will become logistically and financially more burdensome once construction is complete. However, the plans have been developed to accommodate the tree at this time, and the current intention is to retain it during construction. The proposed parking is to be constructed above grade so as not to disturb the roots, with permeable materials to allow for water to infiltrate to the roots. It is expected that with these accommodations, the tree can endure construction. Care is to be taken not to tear roots during removal of the existing garage or demolition of the existing house. If any roots are torn, they are to be cleanly severed back to the nearest union and covered as quickly as possible with soil or a moist organic material.

Tree 4 has potentially been impacted by the new development at 630 Churchill. The amenity space proposed at the southwest corner of the subject property should allow rooting space for the tree after construction. Care is to be taken not to tear roots when removing the existing garage. If any roots are damaged, they are to be cleanly severed at the nearest union. Roots in the amenity area are to be covered with soil as soon as the garage is removed, and tree protection fencing as described below and shown in the map is to be installed immediately following removal of the garage.

Clockwise from above: Canopies of Tree 3 (left) and 4 (tall tree at right); Seams and cavity on stem of Tree 3; Seeping from small cavity at base of Tree 3; Large cavity on stem of Tree 3
