A CONSERVATION PLAN

CHAMPLAIN OIL COMPANY SERVICE STATION

70 RICHMOND ROAD OTTAWA, ONTARIO

FINAL April 30, 2022

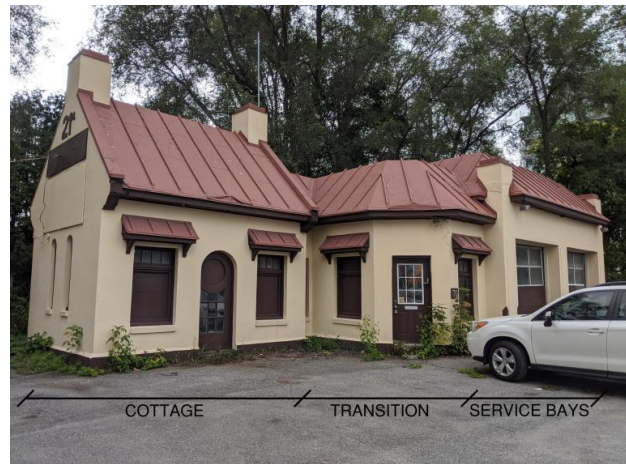
Figure 1: View of the Service Station with the 3 sections cottage, transition, and service bays.

The roof structure, over the administration section and service bay, consists of a built-up Montreal style standing seam Mansard profile. The framing consists of rough sawn 2" x 10" joists at 24" c/c supported on a steel beam running down the middle of the double bay. The metal roofing in the transitional area has failed and there is significant water infiltration. Cooke's report suggests that significant portions of the roof structure are deteriorating.

The service bay area is an open space framed by two exterior block walls, the interior brick wall and the north (front) wall with a single block pier and two large garage door openings. The interior cinder block loadbearing wall separating the transitional area from the service bay is in poor condition, with a large fracture across the doorway opening at the back of the building, and a variety of cracks in the wall at the front. The flooring in this space appears to be a concrete slab on grade. The exterior masonry walls are in fair to poor condition with localized vertical cracking noted in several locations. Based on a few

limited areas, where holes in the masonry were noted, the masonry does not appear to be grouted nor reinforced. The Service Station will require stabilization in preparation for the move.

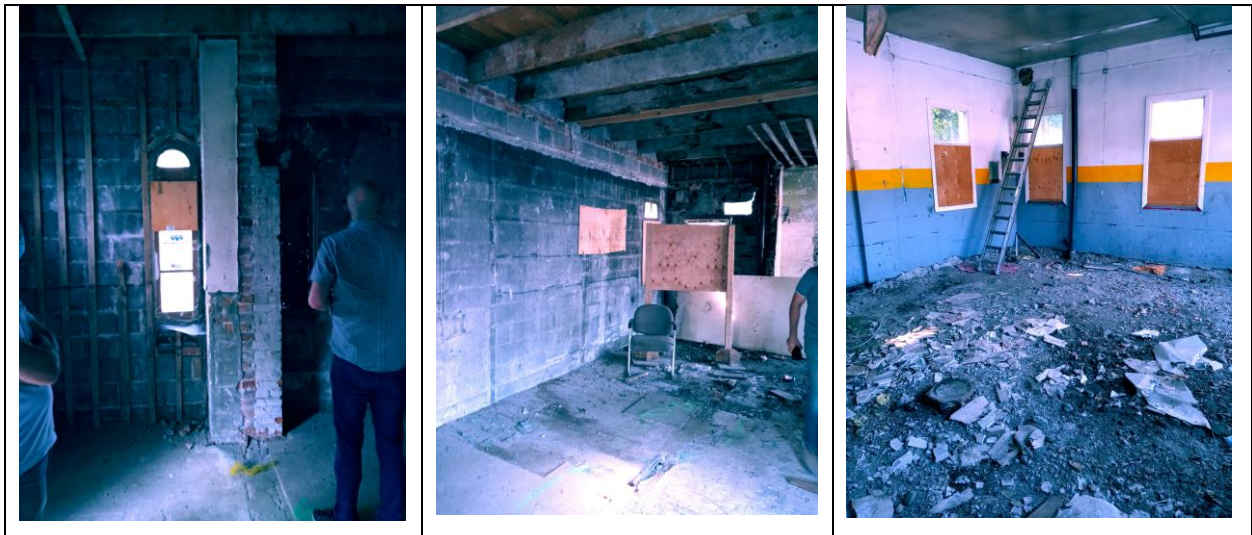
Figure 6: Interior views illustrating the condition, with the interior stripped down to the block walls.

The interior walls will be strapped and insulated with spray foam to improve the energy efficiency of the building and ensure the long-term conservation of the cinder block walls assuming that the areas will be air conditioned. A separate A/C unit will be installed in the Service Station.

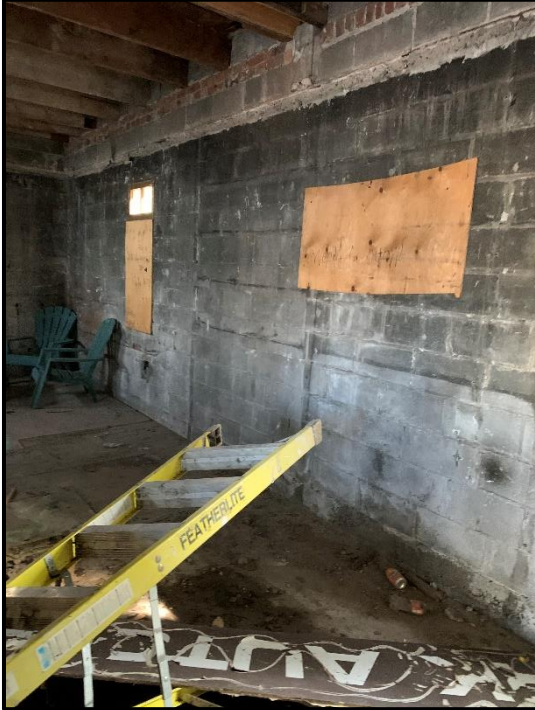
The masonry walls were in overall fair to poor condition with localized vertical cracking noted in several locations. Based on a few limited areas, where holes in the masonry were noted, the masonry does not appear to be grouted nor reinforced.

Exposed Masonry Wall Administration Area

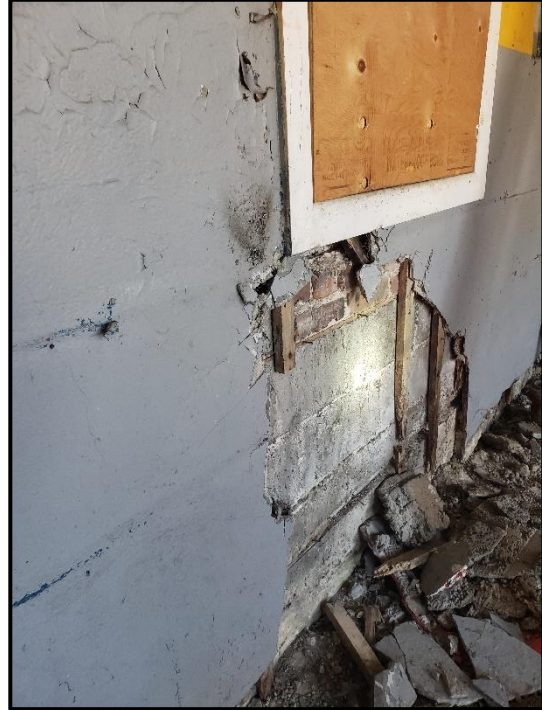
Masonry Wall Behind Plaster Lath - Service Bay

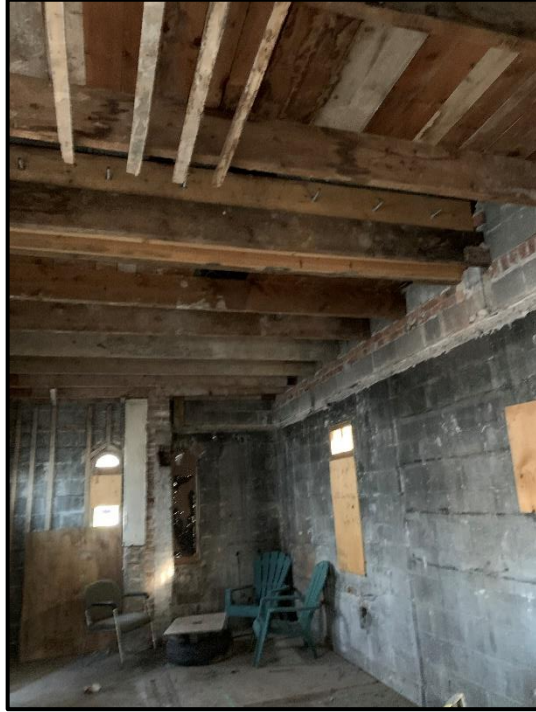
The roof framing has been subject to water infiltration and modification/patching over the years but remains in fair and sound condition.

Roof framing administration area
