November 18th, 2024

**Re: 79 Guigues Avenue, Ottawa
Structural Review Fire and Water Damage
Our Reference Number: 24-8613**

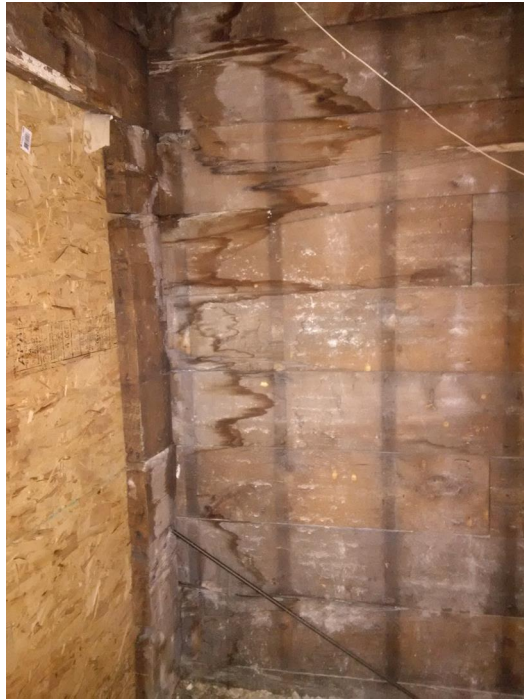
- The plank wall framing has sustained continuous moisture penetration at numerous locations over the decades. Particularly at openings in the building and East Elevation of the building (See Photos One and Seven). This has led to the deterioration of the wood in planks in several locations.
- The wood framing of the roof is in poor condition. There had been water infiltration of numerous years. See attached pick of opening that has rotted thru the roof (See Photo Two). This has occurred at multiple locations. The existing roof planking is in a state of rot needs to be completely replaced over the entire roof area. The roof rafters and joist so signs of dry and wet rot. However, due to the condition of the poor condition of the roof we were opinion that trying to access this area was not safe.

Photo One – Moisture Penetration

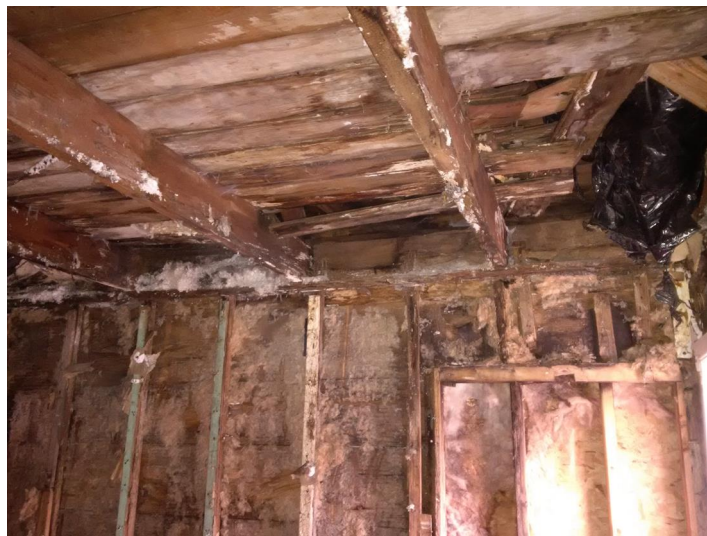
Photo Two – Water Damaged Roof Framing and Rot

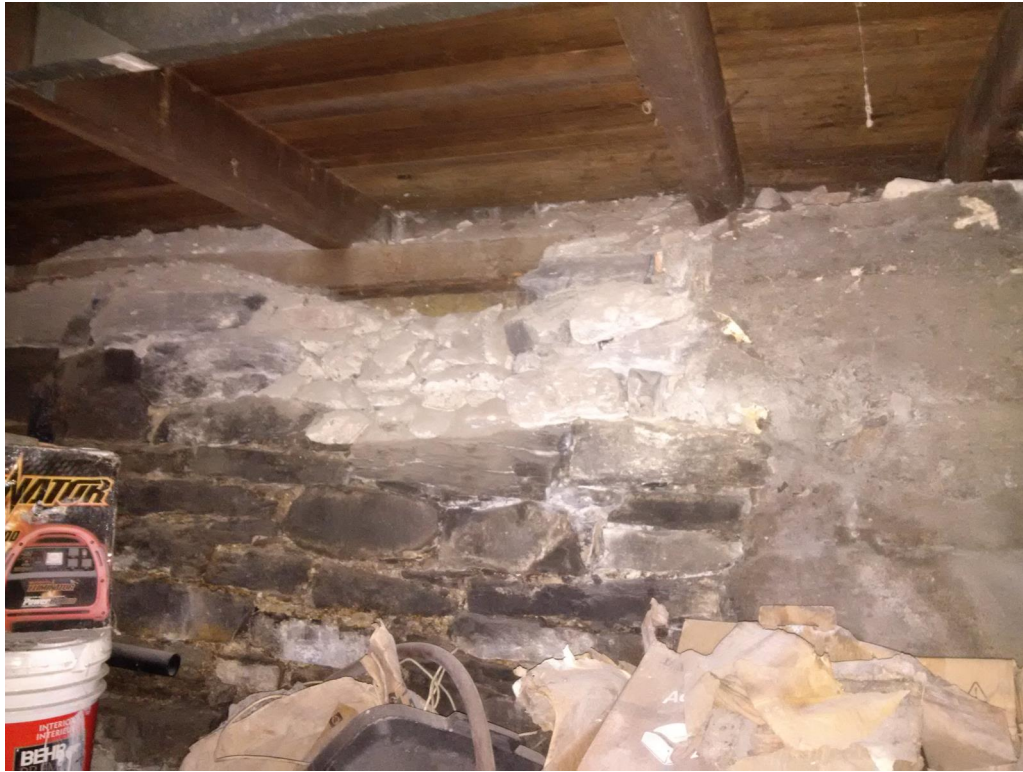
Photo Three – Dry Rot on Wood Framing

- Areas of dry rot are present in the basement, primarily where the floor joists are embedded in the rubble stone walls (See Photo Three). Which is common with this era of construction.

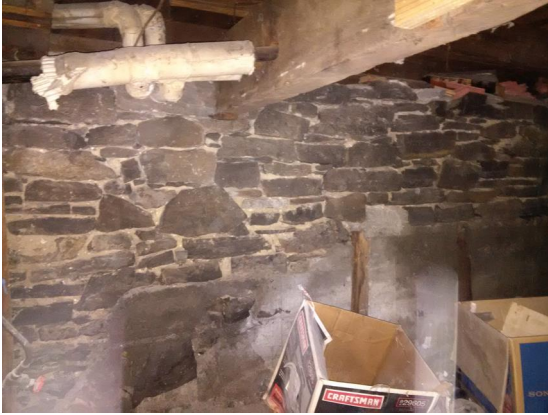
- The foundation walls are constructed of rubble stone and are in poor condition. The mortar joints are very soft, to non-existent in many locations with signs of obvious water infiltration. The areas where the mortar was still present could easily be scraped away with a screwdriver to the full depth of the screw driver (See Photos Four and Five).

Photo Four – Rubble Stone Wall

2. The foundation deterioration has progressed to a point that complete removal and reconstruction is required of the rubble stone foundation wall. A house of this nature would require it be lifted into the air in order to replace the foundations in order to get access to the East wall which is right on the property line. However, the current conditions would likely result in the building collapsing if a lift was attempted.

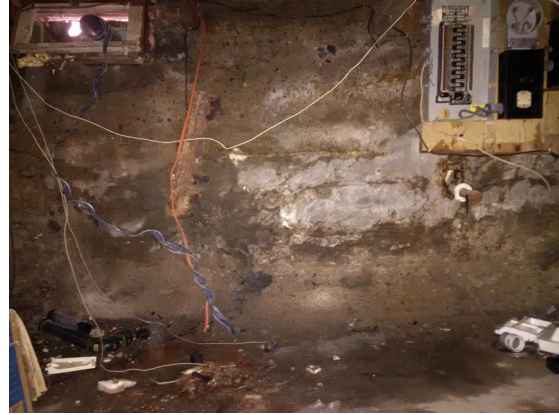
- There are locations of apparent “underpinning/remediation” with concrete. These repairs were poorly executed and are not providing the necessary support that they were originally intended too. When hammer sounded these mass pours are hollow, indicated that they are relatively thin and not bonded to the stone. For all intense purposes they are strictly non-structural and veneer in nature (See Photo Five).

Photo Five – Underpinning/Remediation

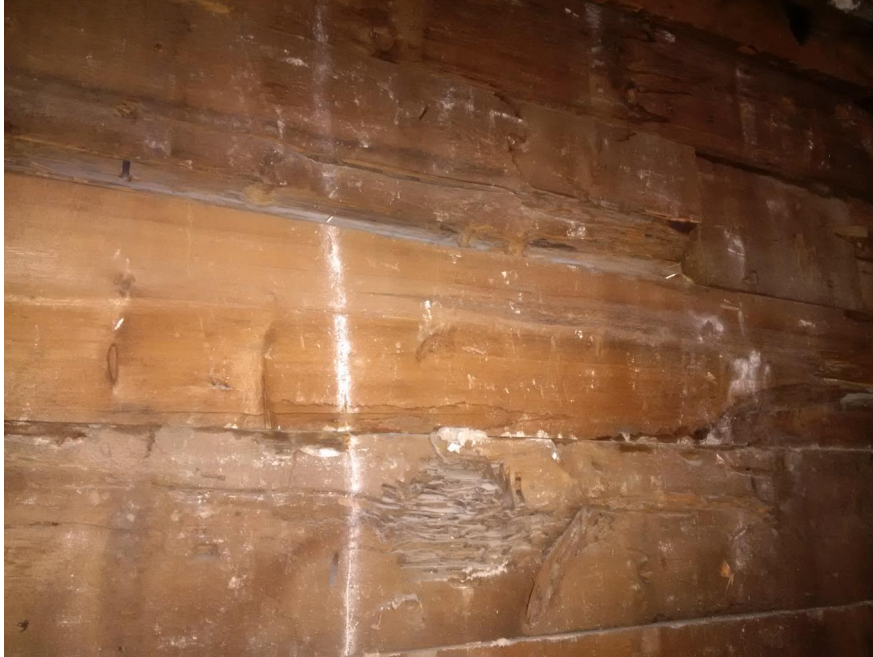
- The plank log walls have had significant carpenter ant damage over the years. Several boards have been structurally compromised. Replacing these boards is extremely difficult due to their stacking nature (See Photo Six).

- The front of the building has been structurally modified over the years with larger windows and openings which has structurally compromised the integrity of the plank framing system to support gravity and lateral forces. Most of the walls are no longer plumb and are in the early stages of buckling out (See Photo Six).

Photo Six – Carpenter Ant Damage

3. Deterioration of the log walls from dry rot, wet rot, and carpenter ants, are to such an extent that to try and repair/replace with involve the complete removal and reinstatement of complete walls, which is realistically not possible in our opinion.

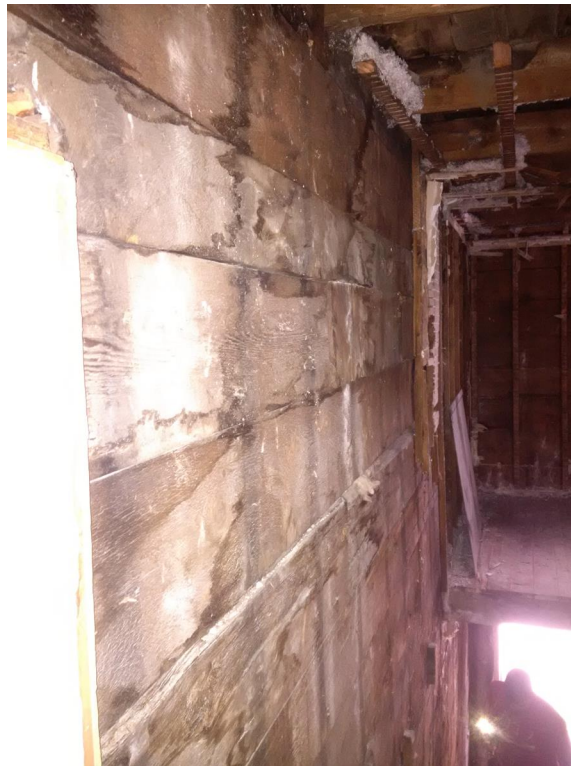
Photo Seven – Out of Plumb Wall/Water Infiltration

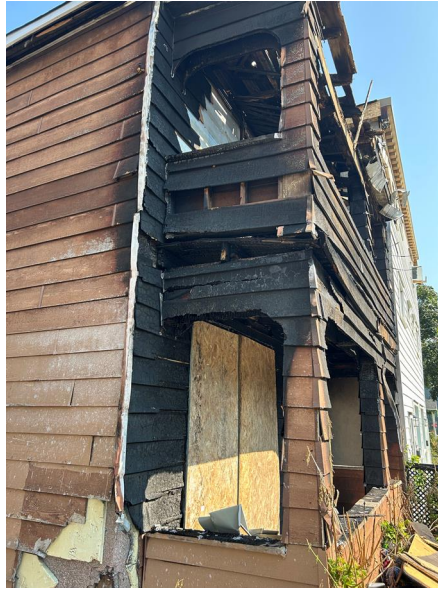
- The Front Balcony was severely damaged as a result of fire, to the point that it is no longer safe and must be demolished. Beams, columns, joists, and rafters have been damaged beyond repair at the roof and balcony level.(See photo Eight)

Photo Eight Fire Damage

4. The building has suffered another fire, it is our recommendation that the building be demolished, as it has suffered catastrophic fire and smoke damage that is unrepairable.

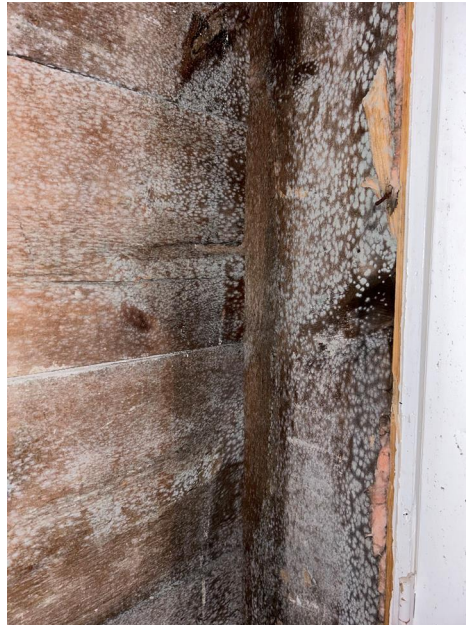
- Extensive mold damage on the inside of the building as a result of firefighting operations soaking the structure to ensure the fire was extinguished. There is most-likely mold on the exterior face of the plank structure trapped behind the multiple layers of exterior finish. (See Photo Nine)

Photo Nine Mold

5. There is now extensive mold inside the wood building as result of the fire fighting operations. This clean up would require the removal of all exterior finishes to ensure a proper remediation of the building. The removal of the exterior finishes would further compromise the structure and cause it to become unstable and collapse.
