Tree Information Report v2.0

Submitted as part of Committee of Adjustment Application to the City of Ottawa

Date of Report: September 10, 2024
Property Address: 660 Hochelaga Street
Prepared for: Philip Augustine; phil.augustine7@gmail.com
Prepared by: Kevin Myers, ISA Certified Arborist®; kevin.myers@dendronforestry.ca
Date of Site Visit: July 29, 2024

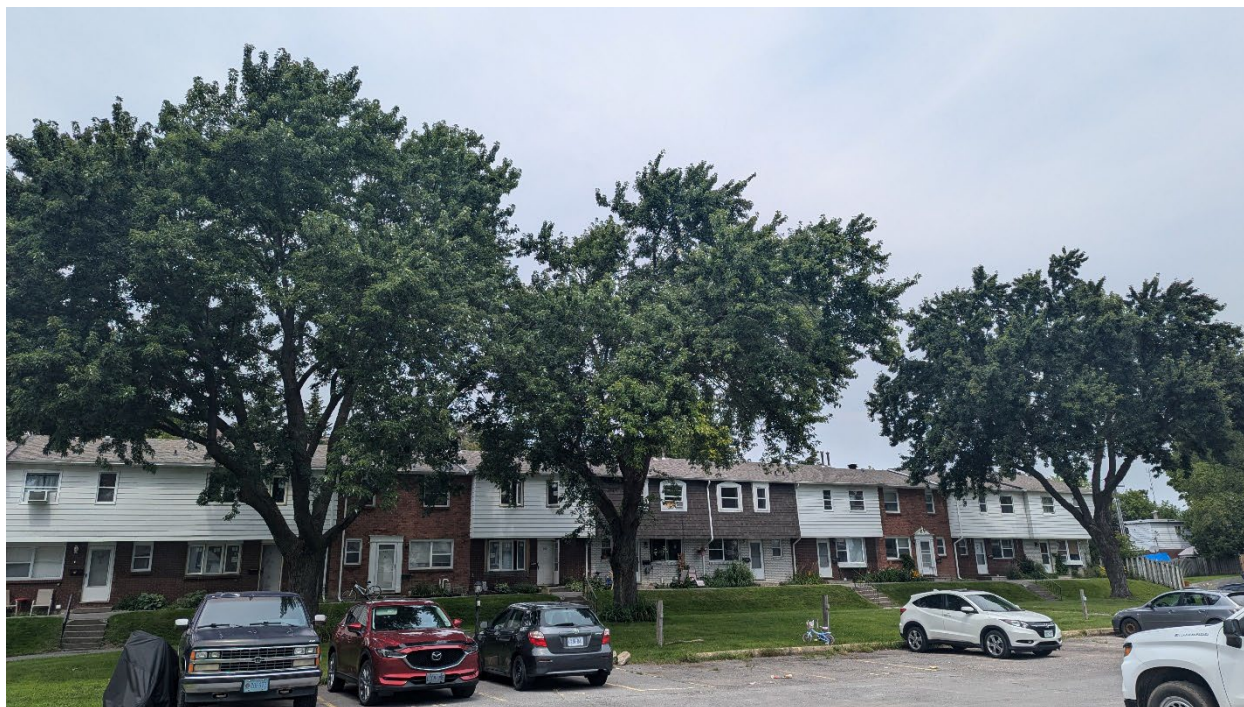
On the north side of the parking lot, it is expected that **Trees 7-9** have roots that spread across the entire grassed area and likely beyond – underneath existing walkways, ending at any curbs or foundations. Maximizing the size of tree protection areas will help these trees endure construction – fencing as described below and shown in the map is to be installed immediately following the removal of the current pathway between trees 7 and 8.

Above: Trees 7 -9 - private maples to be retained.

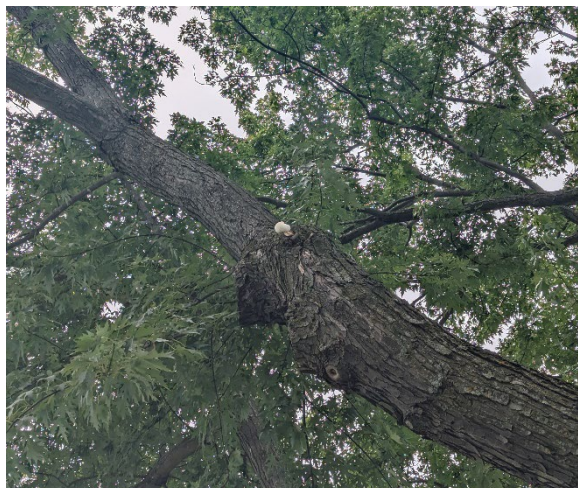
6	Colorado spruce (<i>Picea pungens</i>)	9	Subject property	Good	3	Retain	Retain and protect with fencing.
7	Silver maple (<i>Acer saccharinum</i>)	89	Subject property	Fair/Poor: fungal body on scaffold branch; branch attachment wounds with decay; small wound at base. Has been well cared for – good pruning	3.5	Retain	Retain. Any roots encountered during installation of new walkways are to be cleanly severed by hand.
8	Silver maple (<i>Acer saccharinum</i>)	87	Subject property	Fair: branch attachment wounds with decay; broken branch with decay in top of canopy. Has been well cared for – good pruning	3	Retain	Retain. Any roots encountered during installation of new walkways are to be cleanly severed by hand.
9	Silver maple (<i>Acer saccharinum</i>)	79	Subject property	Good/Fair: branch attachment wound with decay; slight lean. Has been well cared for – good pruning	3	Retain	Retain during severance; mitigations to be determined when development is proposed. Any roots encountered during installation of new walkways are to be cleanly severed by hand.

Below: fungal body on scaffold branch of Tree 7.

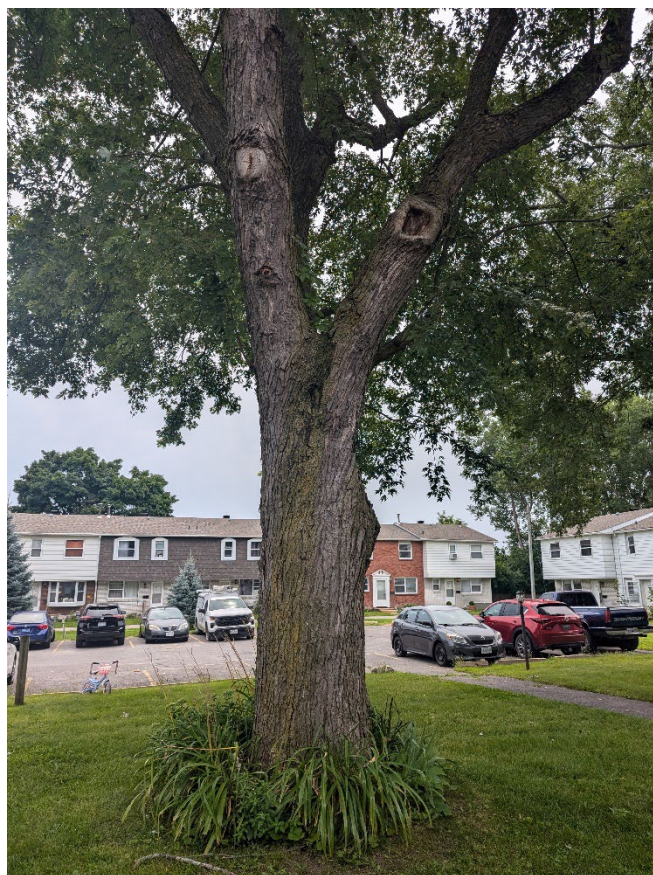
Right: main union and wound on Tree 7.

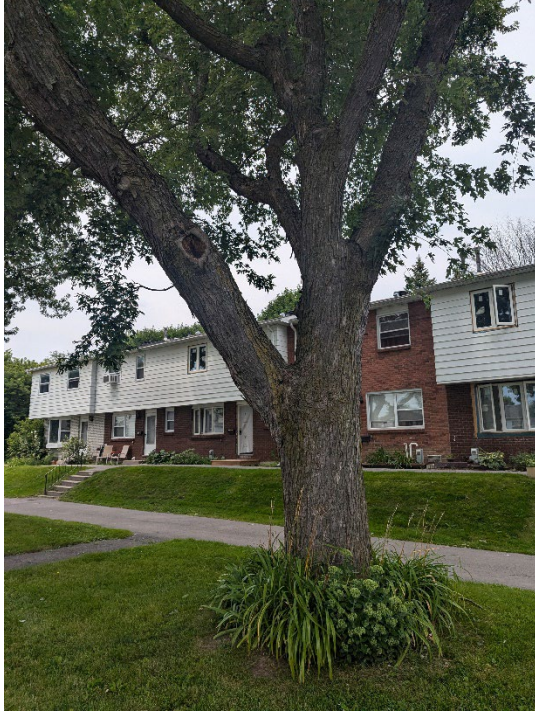
Above left: trunk and scaffold branch with wound of Tree 8.

8	Silver maple (<i>Acer saccharinum</i>)	87	Fair: branch attachment wounds with decay; broken branch with decay in top of canopy. Has been well cared for – good pruning	Retain. Any roots encountered during installation of new walkways are to be cleanly severed by hand.
9	Silver maple (<i>Acer saccharinum</i>)	79	Good/Fair: branch attachment wound with decay; slight lean. Has been well cared for – good pruning	Retain during severance; mitigations to be determined when development is proposed. Any roots encountered during installation of new walkways are to be cleanly severed by hand.

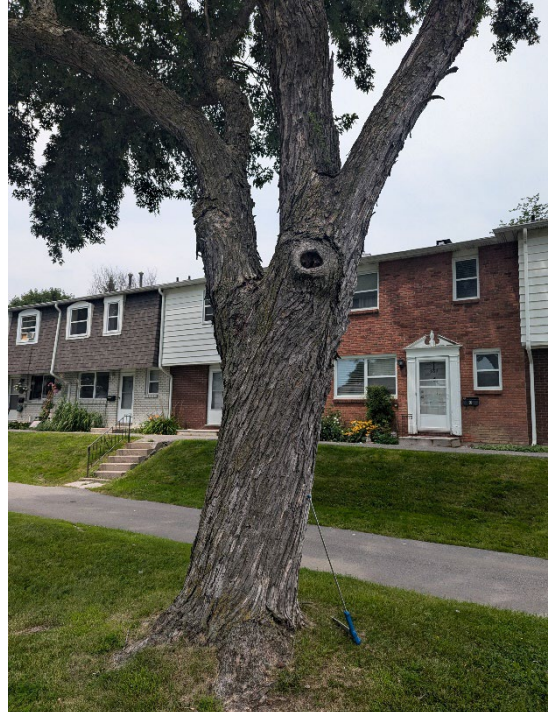
Above right: Trunk and wound on Tree 9.

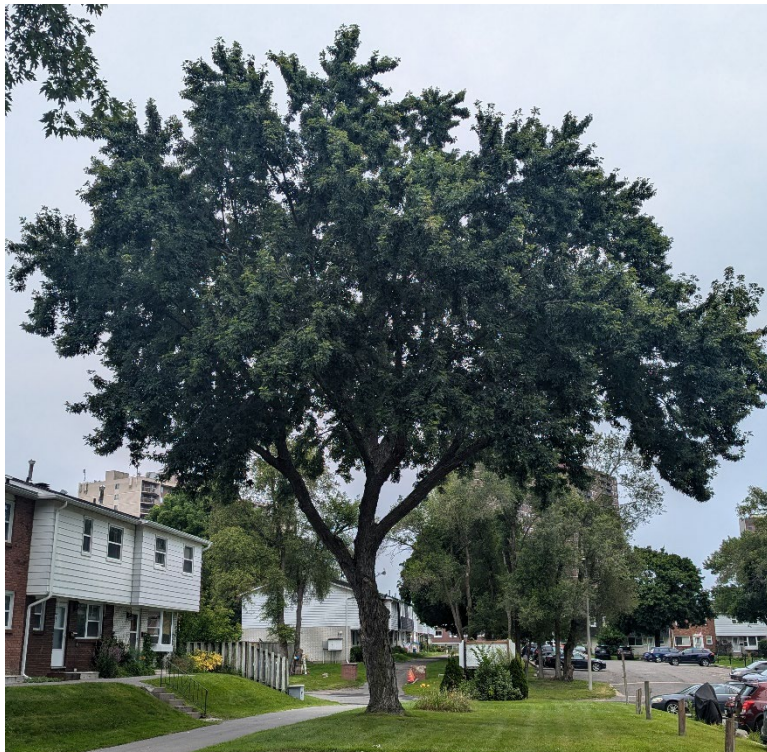
Below: Tree 9

The severed parcel is intended to be sold for development. Tree preservation measures for **Tree 9** will be addressed at such time as development is proposed for that lot.
