**Re: 79 Guigues Avenue, Ottawa
Structural Review Fire and Water Damage
Our Reference Number: 24-8613**

As requested, Cleland Jardine was on site on Sept 4th, 2024 to review the damage done at 79 Guigues Avenue, Ottawa. .

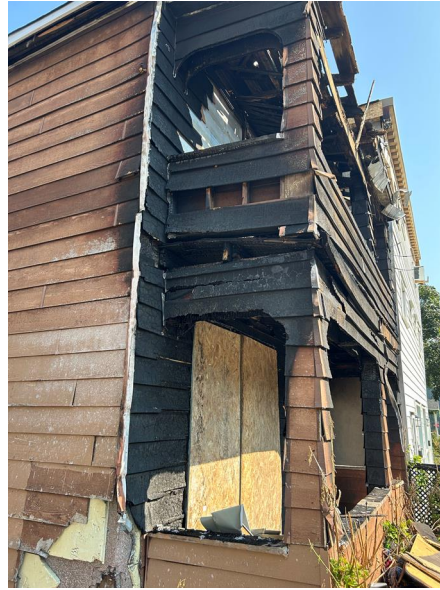
- The Front Balcony was severely damaged as a result of fire, to the point that it is no longer safe and must be demolished. Beams, columns, joists, and rafters have been damaged beyond repair at the roof and balcony level.(See photo Eight)

Photo Eight Fire Damage

4. The building has suffered another fire, it is our recommendation that the building be demolished, as it has suffered catastrophic fire and smoke damage that is unrepairable.

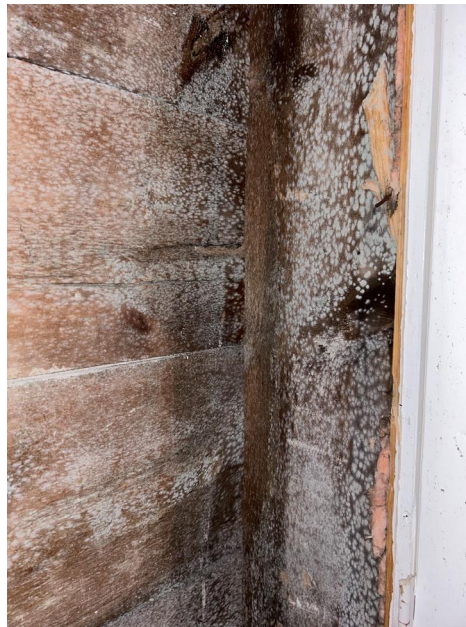
- Extensive mold damage on the inside of the building as a result of firefighting operations soaking the structure to ensure the fire was extinguished. There is most-likely mold on the exterior face of the plank structure trapped behind the multiple layers of exterior finish. (See Photo Nine)

Photo Nine Mold

5. There is now extensive mold inside the wood building as result of the fire fighting operations. This clean up would require the removal of all exterior finishes to ensure a proper remediation of the building. The removal of the exterior finishes would further compromise the structure and cause it to become unstable and collapse.
