TREE CONSERVATION REPORT

6001-6005 Renaud Road

Tree Conservation Report submitted as Partial
Requirements for a Site Plan Control Application,
August 15, 2024

Address: 6001-6005 Renaud Road
Date of Report: August 15, 2024
Date of Site Visit: May 17, 2023
Prepared by: Astrid Nielsen, RPF; astrid.nielsen@dendronforestry.ca
Client: Landric Homes, c/o Eric Danis; ericdanis@constructionlaverendrye.com

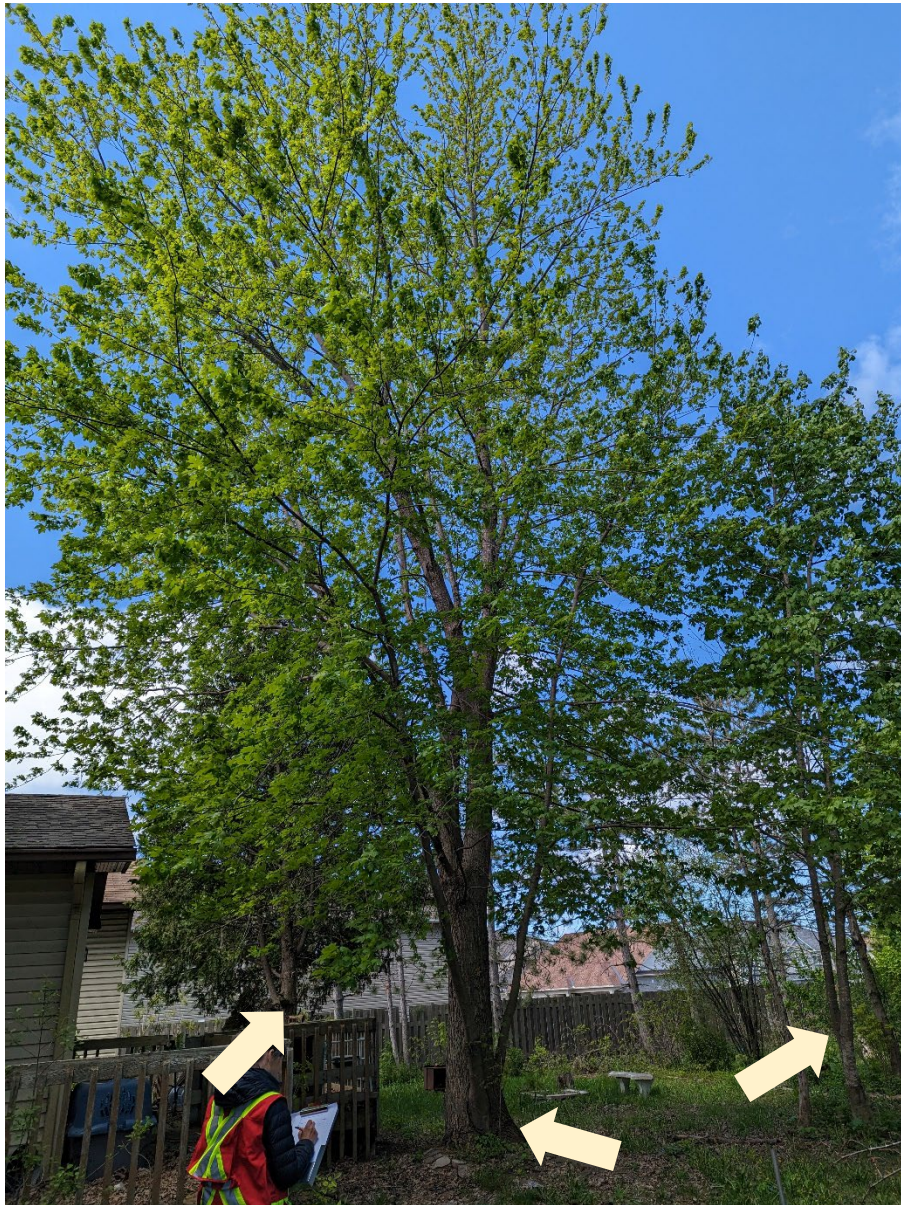
Figure 1 - (Left to Right) Trees 7, 6 & 35

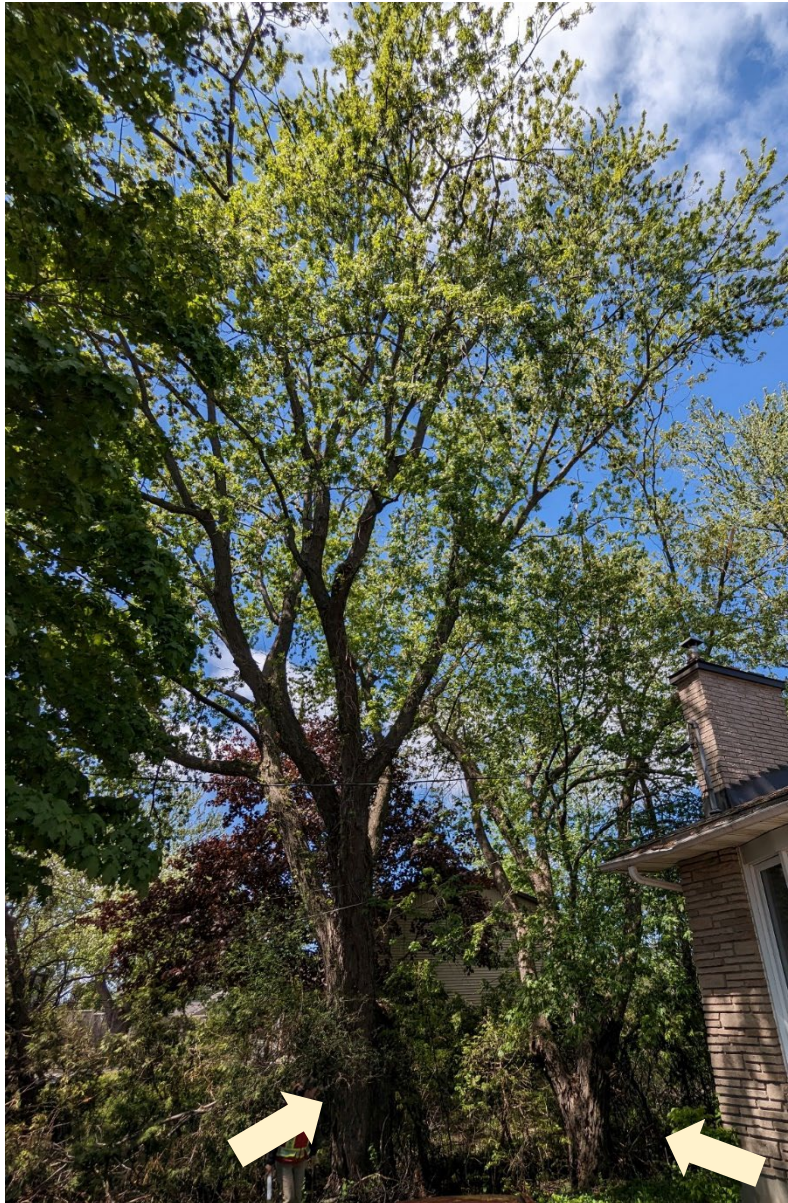
38	Silver maple (<i>A. saccharinum</i>)	110	S.p.	Fair: codominant stems with very large bulge at union; broken branches	Remove.
39	Silver maple (<i>A. saccharinum</i>)	91	S.p.	Fair/Good: tridominant stems; cavities with decay (one >1/4 diameter, one <1/8)	Remove.
40	Silver maple (<i>A. saccharinum</i>)	83	S.p.	Fair: large limb broken and hanging; decay at base where large stem was removed	Remove.
41	Silver maple (<i>A. saccharinum</i>)	27, 57, 60	S.p.	Fair: three stems – smallest fusing with largest; small cavity at base	Remove for staging.
42	Scot's pine (<i>P. sylvestris</i>)	35	S.p.	Fair: suppressed	Remove for staging.
43	Scot's pine (<i>P. sylvestris</i>)	32	S.p.	Fair/Poor: thin crown	Remove for staging.
44	Scot's pine (<i>P. sylvestris</i>)	35	S.p.	Fair/Good	Remove for staging.
45	Red pine (<i>P. resinosa</i>)	33	S.p.	Good/Fair: slight lean with possible girdling root	Remove for staging.
46	Scot's pine (<i>P. sylvestris</i>)	25	S.p.	Good	Remove for staging.

Figure 6 - (Left) Tree 38; (Right) Tree 39

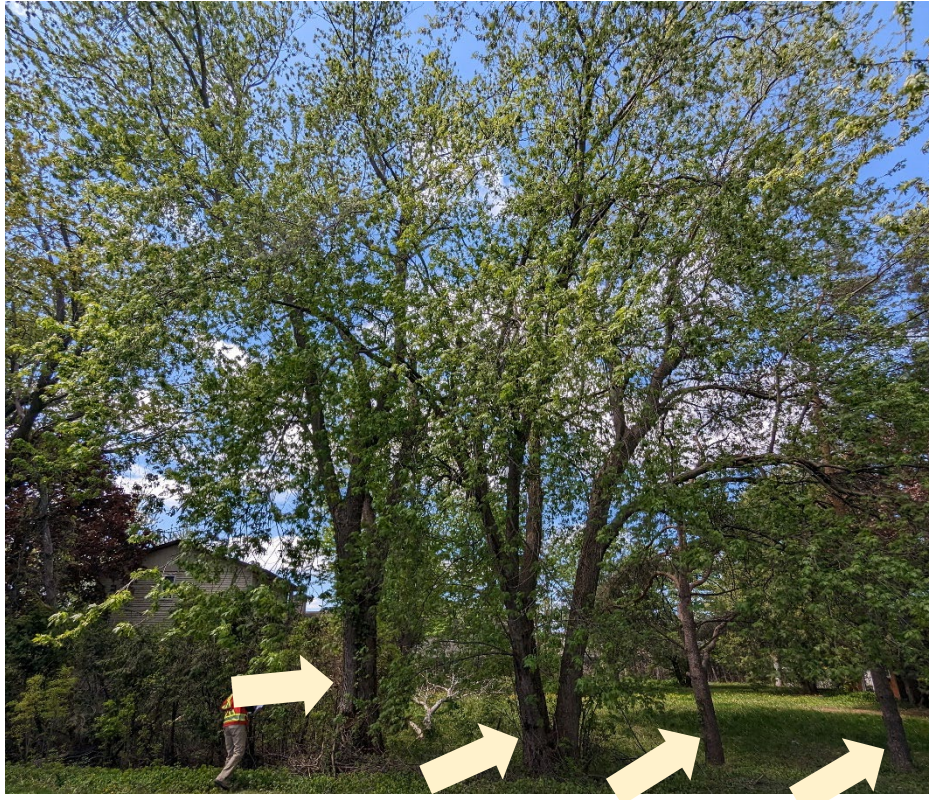
Figure 7 - (Left to Right) Trees 40-43

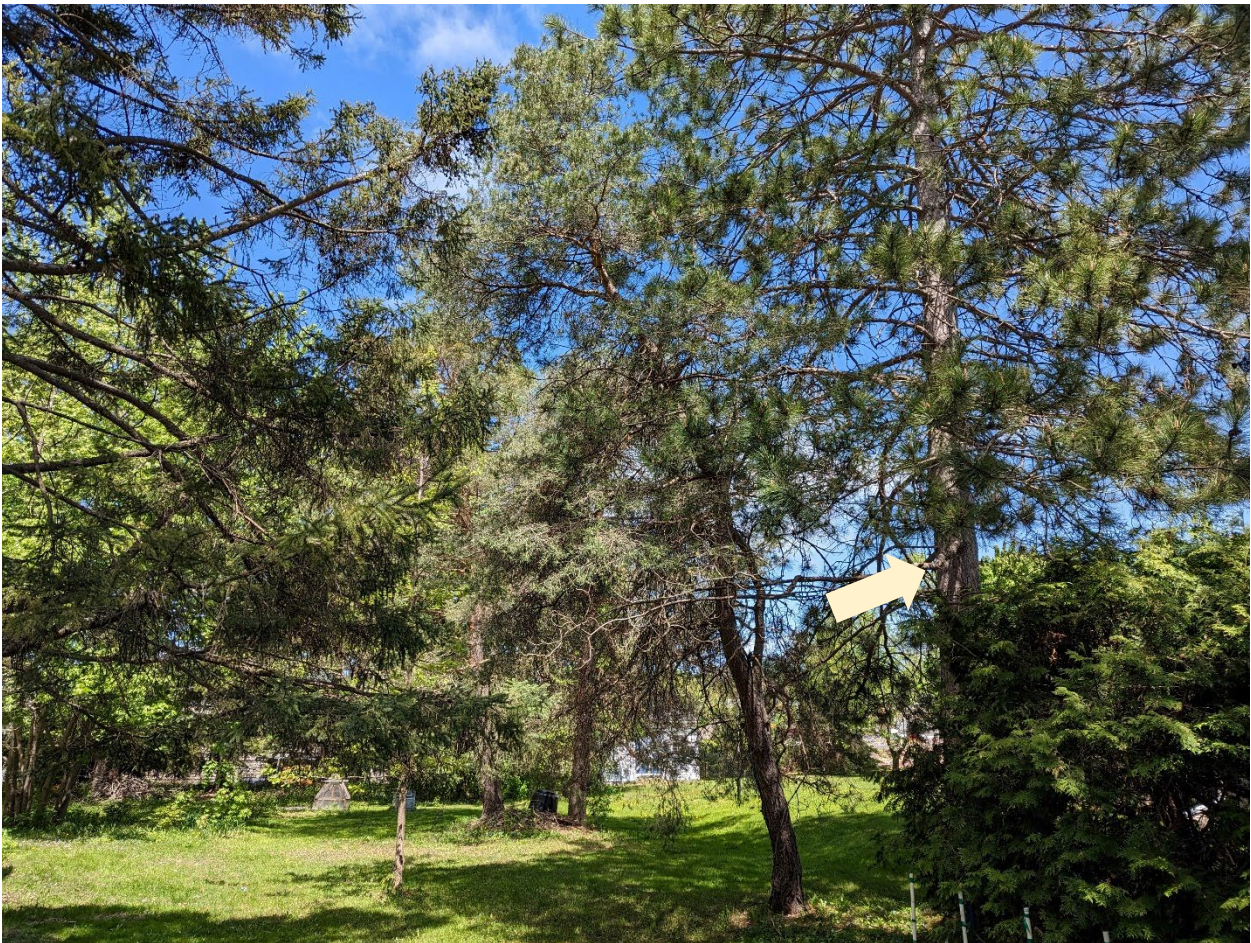
e 40cm			
54	Silver maple (<i>A. saccharinum</i>)	57	S.p.	Fair: heavy lean into subject property	Remove.
55	Manitoba maple (<i>A. negundo</i>)	15	S.p.	Fair: lean	Remove.
56	Manitoba maple (<i>A. negundo</i>)	18	Boundary	Fair: lean	Remove.
57	Manitoba maple (<i>A. negundo</i>)	27	Boundary	Fair: lean	Remove.
58	Manitoba maple (<i>A. negundo</i>)	20	Boundary	Fair: lean	Remove.
59	Scot's pine (<i>P. sylvestris</i>)	22, 30	S.p.	Fair: sapsucker	Remove.
60	Basswood (<i>Tilia americana</i>)	52	S.p.	Fair: hollow trunk with sprouts	Remove.
61	Scot's pine (<i>P. sylvestris</i>)	42	S.p.	Fair/Good	Remove.
62	Scot's pine (<i>P. sylvestris</i>)	33	S.p.	Fair	Remove.
63	Silver maple (<i>A. saccharinum</i>)	8 stems 6-23cm	S.p.	Fair: growing as clump	Remove.
64	Bur oak (<i>Quercus macrocarpa</i>)	9	S.p.	Good	Remove.
65	Scot's pine (<i>P. sylvestris</i>)	26	S.p.	Fair: lean and crooks	Remove.
66	Red pine (<i>P. resinosa</i>)	49	S.p.	Good	Remove.

Figure 9 - Looking along the western property line. Tree 66 indicated with arrow

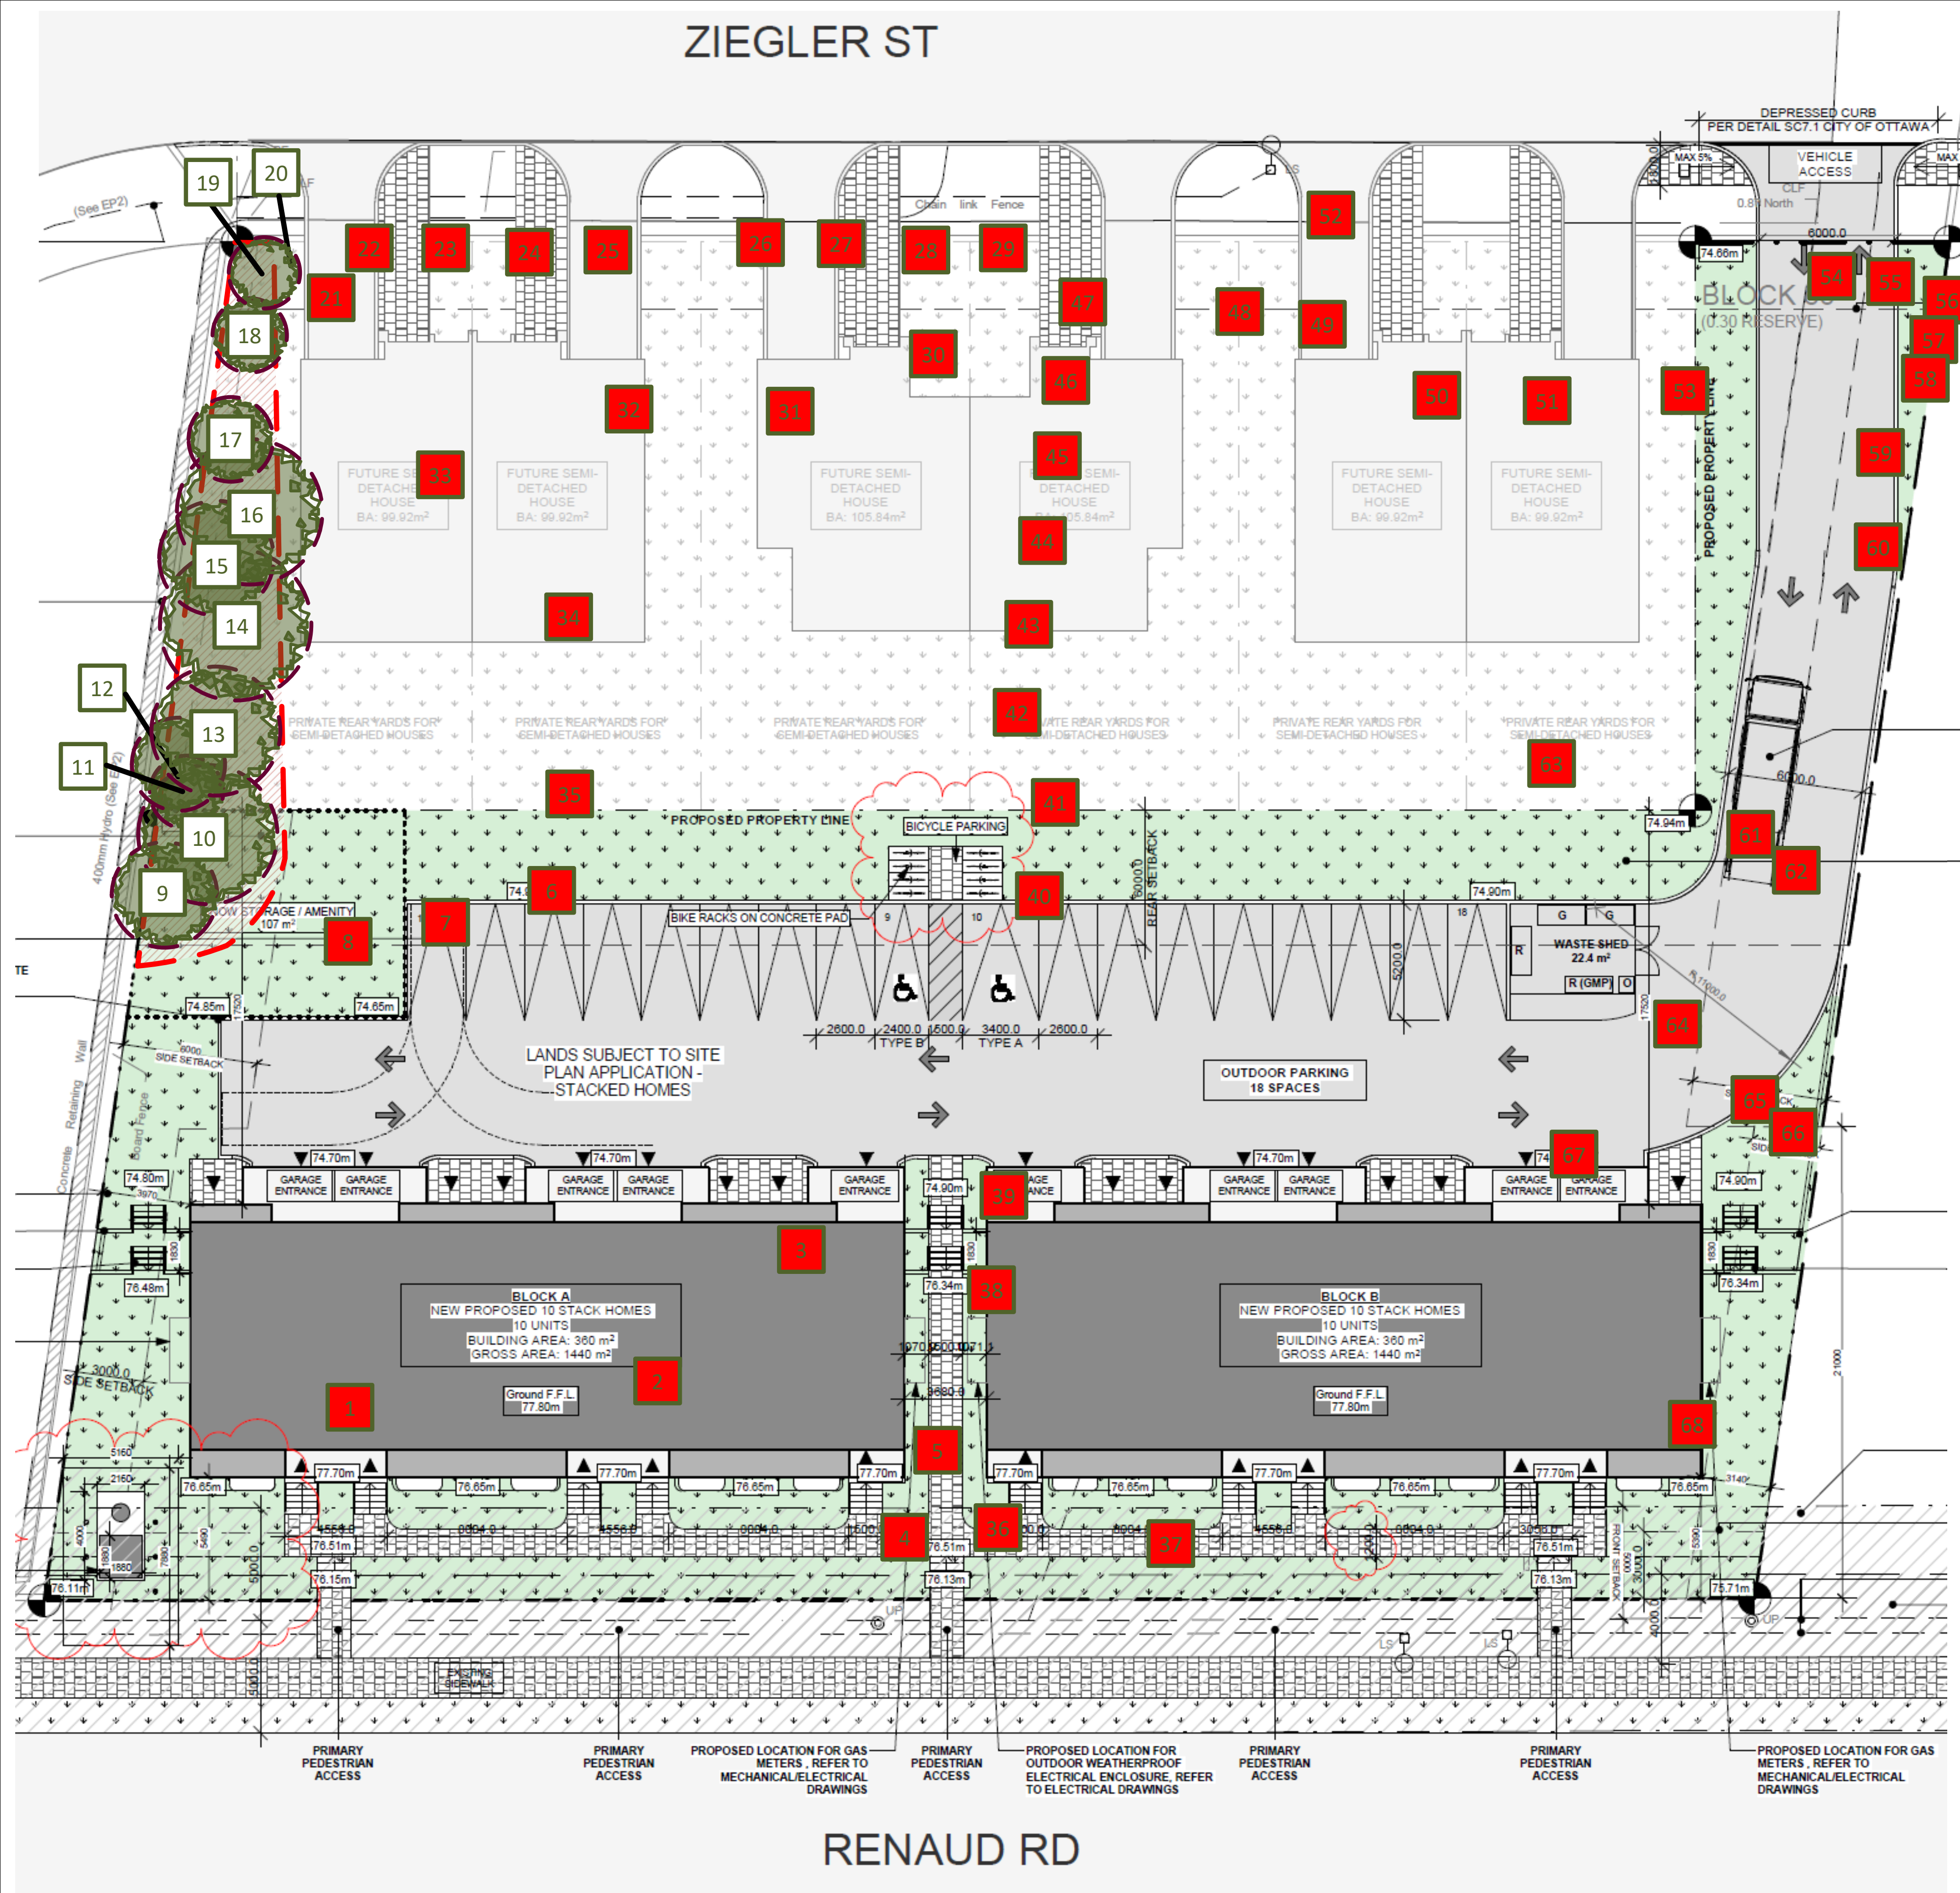
Tree#	Species	DBH (cm)	Condition	Action
1	Silver maple (<i>Acer saccharinum</i>)	80	Fair: epicormic shoots	Remove.
2	Crabapple (<i>Malus spp.</i>)	31	Fair/Good: mechanical injury on trunk; sapsucker holes	Remove.
3	Norway maple (<i>Acer platanoides</i>)	38	Good/Fair: possible canker on trunk	Remove.
4 ⁴	Scot's pine (<i>Pinus sylvestris</i>)	29	Fair/Good: shaded by Tree 38	Remove.
5 ⁴	Scot's pine (<i>Pinus sylvestris</i>)	21	Fair: suppressed	Remove.
6	Silver maple (<i>A. saccharinum</i>)	12, 14, 56	Good/Fair: codominant stems; sprouts from trunk becoming stems	Remove.
7	Eastern white cedar (<i>Thuja occidentalis</i>)	29	Fair	Remove.
8 ³	Silver maple (<i>A. saccharinum</i>)	23	Good/Fair: codominant stems; slight lean	Remove.
9	Red pine (<i>Pinus resinosa</i>)	21	Fair: thin crown	Retain and protect.
10	Red pine (<i>P. resinosa</i>)	28	Fair: thin crown	Retain and protect.
11	Red pine (<i>P. resinosa</i>)	15	Fair: thin crown	Retain and protect.

12	Red pine (<i>P. resinosa</i>)	19	Poor: thin crown; lean	Retain and protect.
13	Red pine (<i>P. resinosa</i>)	26	Fair: thin crown	Retain and protect.
14	Red pine (<i>P. resinosa</i>)	31	Fair: forked leader	Retain and protect.
15	Red pine (<i>P. resinosa</i>)	24	Fair	Retain and protect.
16	Red pine (<i>P. resinosa</i>)	30	Fair	Retain and protect.
17	Red pine (<i>P. resinosa</i>)	17	Fair	Retain and protect.
18	Red pine (<i>P. resinosa</i>)	13	Fair: thin crown; lean	Retain and protect.
19	Red pine (<i>P. resinosa</i>)	14	Fair: suppressed	Retain and protect.
20	Red pine (<i>P. resinosa</i>)	19	Fair	Retain and protect.
21	White pine (<i>Pinus strobus</i>)	37	Good	Remove for staging.
22	White pine (<i>P. strobus</i>)	36	Good/Fair: crooks	Remove for staging.
23	White pine (<i>P. strobus</i>)	31, 33	Fair: codominant stems; included bark	Remove for staging.
24	White pine (<i>P. strobus</i>)	33	Good	Remove for staging.

25	White pine (<i>P. strobus</i>)	42	Good	Remove for staging.
26	White pine (<i>P. strobus</i>)	45	Good	Remove for staging.
27	White pine (<i>P. strobus</i>)	42	Good	Remove for staging.
28	White pine (<i>P. strobus</i>)	24	Fair: suppressed	Remove for staging.
29	White pine (<i>P. strobus</i>)	22, 40, 23, 45	Fair: 4 stems divide at 1.2m	Remove for staging.
30	Norway maple (<i>A. platanoides</i>)	44	Poor: canker on trunk and in crown; lean	Remove for staging.
31	Eastern white cedar (<i>Thuja occidentalis</i>)	29, 11, 16	Fair: tridominant stems; heavy lean on smaller stem	Remove for staging.
32	Eastern white cedar (<i>T. occidentalis</i>)	6 stems 9-26cm	Good/Fair	Remove for staging.
33	Tree lilac (<i>Syringa reticulata</i>)	15, 7, 13, 19, 17	Good/Fair	Remove for staging.
34	Mountain ash (<i>Sorbus spp.</i>)	21, 24	Fair: wound on trunk; sapsucker holes	Remove for staging.
35	Norway maple (<i>A. platanoides</i>)	12, 14	Fair: poor union – included bark	Remove.

36	Scot's pine (<i>P. sylvestris</i>)	24, 20	Poor: LCR <15%	Remove.
37	Sugar maple (<i>Acer saccharum</i>)	55	Fair: central leader is dead	Remove.
38	Silver maple (<i>A. saccharinum</i>)	110	Fair: codominant stems with very large bulge at union; broken branches	Remove.
39	Silver maple (<i>A. saccharinum</i>)	91	Fair/Good: tridominant stems; cavities with decay	Remove.
40	Silver maple (<i>A. saccharinum</i>)	83	Fair: large limb broken and hanging; decay at base	Remove.
41	Silver maple (<i>A. saccharinum</i>)	27, 57, 60	Fair: three stems – smallest fusing with largest; small cavity at base	Remove for staging.
42	Scot's pine (<i>P. sylvestris</i>)	35	Fair: suppressed	Remove for staging.
43	Scot's pine (<i>P. sylvestris</i>)	32	Fair/Poor: thin crown	Remove for staging.
44	Scot's pine (<i>P. sylvestris</i>)	35	Fair/Good	Remove for staging.
45	Red pine (<i>P. resinosa</i>)	33	Good/Fair: slight lean with possible girdling root	Remove for staging.

46	Scot's pine (<i>P. sylvestris</i>)	25	Good	Remove for staging.
47 ³	Scot's pine (<i>P. sylvestris</i>)	23	Fair: suppressed	Remove for staging.
48	Scot's pine (<i>P. sylvestris</i>)	33	Fair: crooks	Remove for staging.
49	Scot's pine (<i>P. sylvestris</i>)	37	Fair: sapsucker	Remove for staging.
50	Silver maple (<i>A. saccharinum</i>)	67, 84	Poor: main union has failed	Remove for staging.
51	Silver maple (<i>A. saccharinum</i>)	94	Fair/Good: decay in large wound in crown	Remove for staging.
52	Trembling aspen (<i>Populus tremuloides</i>)	7 stems 8-14cm	Fair: growing on fence	Remove for staging.
53	Norway spruce (<i>Picea abies</i>)	5 trees average 40cm	Good	Remove for staging.
54	Silver maple (<i>A. saccharinum</i>)	57	Fair: heavy lean into subject property	Remove.
55	Manitoba maple (<i>A. negundo</i>)	15	Fair: lean	Remove.
56	Manitoba maple (<i>A. negundo</i>)	18	Fair: lean	Remove.
57	Manitoba maple (<i>A. negundo</i>)	27	Fair: lean	Remove.

58	Manitoba maple (<i>A. negundo</i>)	20	Fair: lean	Remove.
59	Scot's pine (<i>P. sylvestris</i>)	22, 30	Fair: sapsucker	Remove.
60	Basswood (<i>Tilia americana</i>)	52	Fair: hollow trunk with sprouts	Remove.
61	Scot's pine (<i>P. sylvestris</i>)	42	Fair/Good	Remove.
62	Scot's pine (<i>P. sylvestris</i>)	33	Fair	Remove.
63	Silver maple (<i>A. saccharinum</i>)	8 stems 6-23cm	Fair: growing as clump	Remove.
64	Bur oak (<i>Quercus macrocarpa</i>)	9	Good	Remove.
65	Scot's pine (<i>P. sylvestris</i>)	26	Fair: lean and crooks	Remove.
66	Red pine (<i>P. resinosa</i>)	49	Good	Remove.
67	White spruce (<i>Picea glauca</i>)	31	Fair/Poor: significant dieback in crown	Remove.
68	Silver maple (<i>A. saccharinum</i>)	91	Good	Remove.

Prior to any site works, protective fencing should be installed around the trees as indicated in the attached Tree Information Map and maintained until all construction on site has been completed as per the **City of Ottawa Tree Protection Specifications (March 2021)**. Within the fenced area, the following tree protection guidelines should be applied:

The tree protection fencing must be 1.2 m in height and constructed of a rigid or framed material (e.g. modulus – steel, plywood hoarding, or snow fence on a 2"X4" wood frame) with posts 2.4 m apart such that the fence location cannot be altered. All supports must be placed outside of the CRZ and installation must minimize damage to existing roots.
