Address of Project: 227/229, 231/233, 235/237 St-Patrick, Ottawa, ON

Date of issuance: Oct. 12, 2023

File No.: 23-137

Re: Evaluation of Existing Structures at 227/229, 231/233, 235/237 St-Patrick, Ottawa, ON.

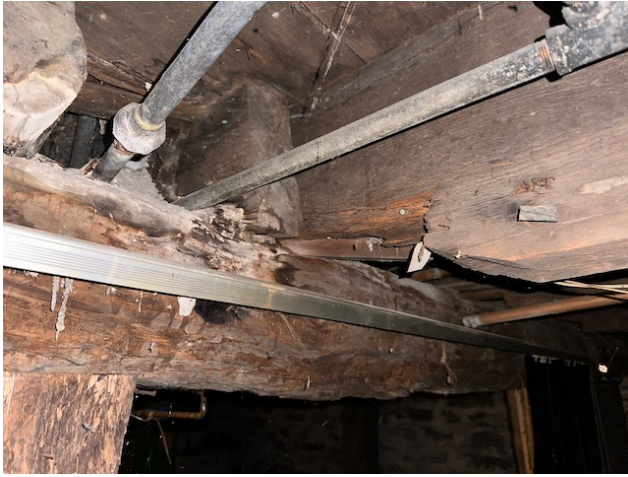
- 2.1.1. Condition of overall framing (main floor supporting) within the basement is very poor. Given the age of the home, and subsequently the age of the lumber, several areas are displaying signs of rot (refer to Photo 1).

Photo 1 – Rotting Basement Joists (227/229)

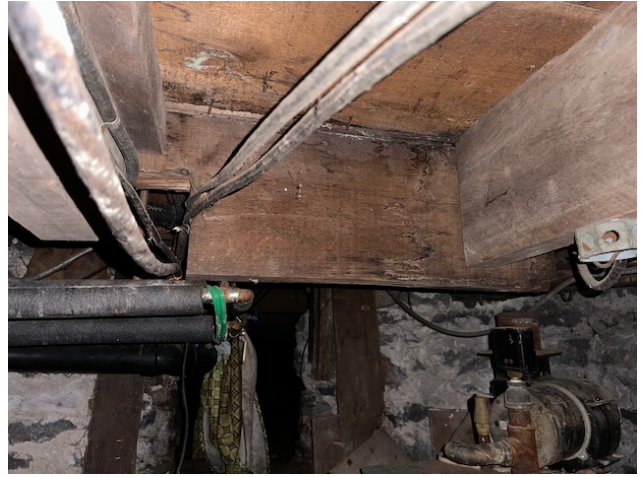
- 2.1.2. Floor joists framing is very inconsistent throughout, with several containing excessive holes and notching for conduits and services added over the years (refer to Photo 2).

- 2.1.3. Modifications to the floor joists have also resulted in some joists being completely unsupported at one end (refer to Photo 2).
- 2.1.4. A single 6" steel I-beam has been added to support a section of the joists.

Photo 2 – Unsupported/Notched Joist (227/229)

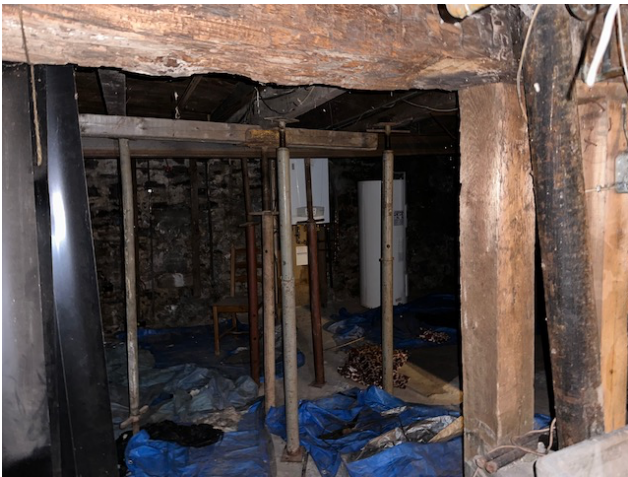
- 2.1.5. Teleposts have been added throughout the basement in order to support the joists that are sagging and that have been cut/notched. Teleposts are bearing on the slab below, and given their placement would have been added by the previous owner without specific engineering (refer to Photo 3).

Photo 3 – Added Teleposts (227/229)

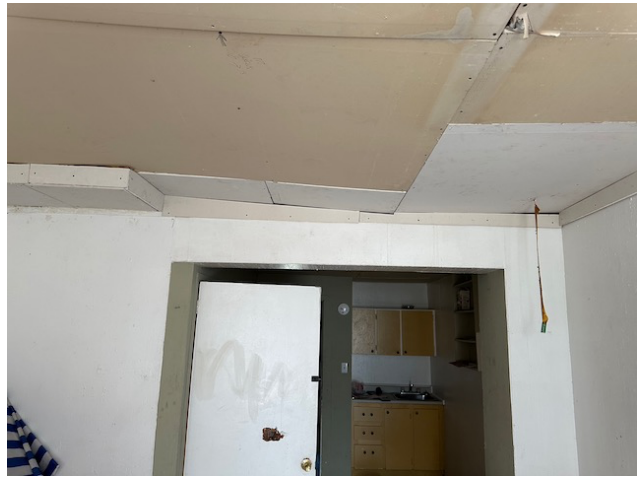
- 2.2.1. Within the main floor the ceiling is sloped in several locations, with certain locations being finished while taking the slope into account (refer to Photo 4). This is an indication of issues with the second floor supporting framing, as well as issues with the overall structural stability of the home. Localised issues may include rot due to water damage, excessively cut or notched joists, rusting of nails connecting members, pulling away of members. Homes from this era were strictly tied together with nailing, as opposed to hangers and more rigid fasteners that are used today. As such, separation of members is not uncommon of homes of this era.
- 2.2.2. Walls within the main floor consists of lathe and plaster, with the plaster clearly degrading in an

Photo 3 – Sagging Floor Joists Above (227/229)

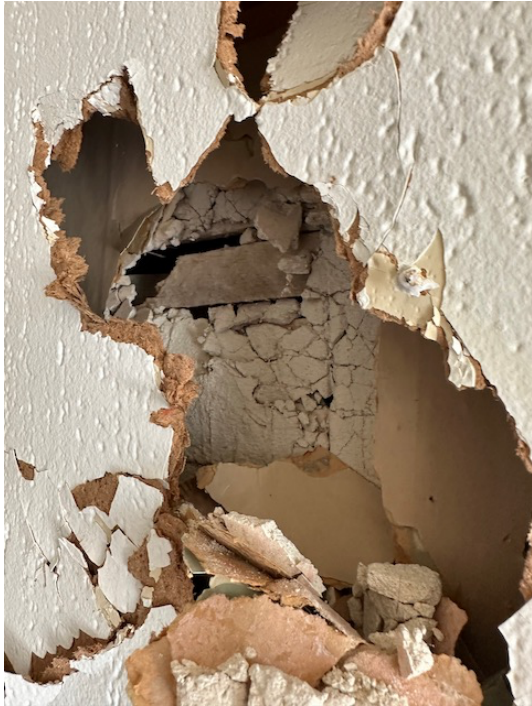
area that was exposed (refer to Photo 5).

Photo 5 – Plaster Degradation (227/229)

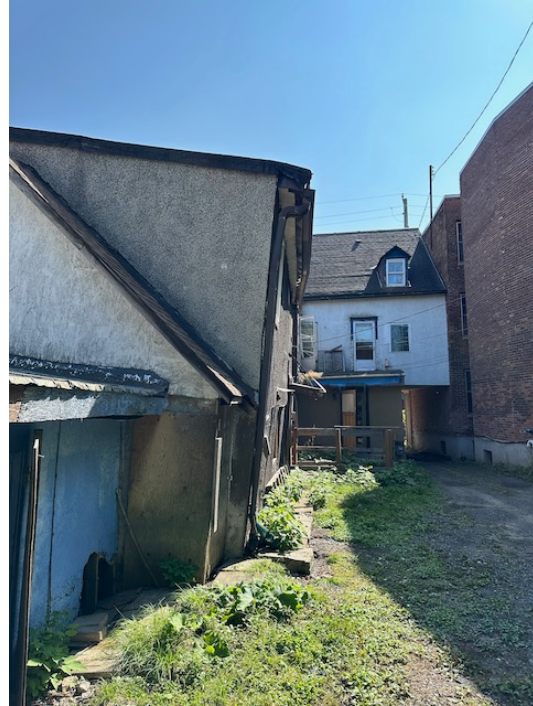
- 2.7.1. A rear addition structure is attached to 229 St-Patrick, and is estimated to be 120 years old.
- 2.7.2. This rear structure is severely degraded with its south-west facing exterior wall leaning by up to 6 degrees (refer to Photo 6). As such, floors within the addition structure are severely sloped.
- 2.7.3. Black mold could also be observed throughout.
- 2.7.4. Currently this structure is unoccupied, and cannot be occupied in its current state as it poses a risk to occupant life-safety.

Photo 6 – Addition Leaning (231/233)

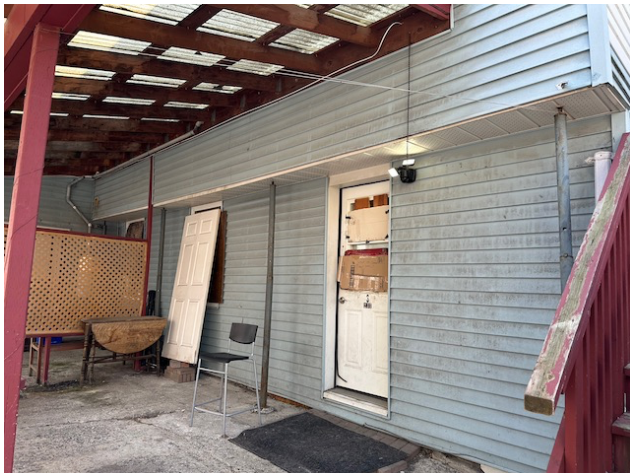
- 3.1.1. At the rear of the building a portion of the second-floor overhangs beyond the main floor wall. Teleposts have been added to support this overhang, which indicates it was likely sagging and required corrective measures. This would be consistent with the condition of the framing observed at 235/237 St-Patrick (refer to Photo 7).

Photo 7 – Added Teleposts @ Overhang (231/233)

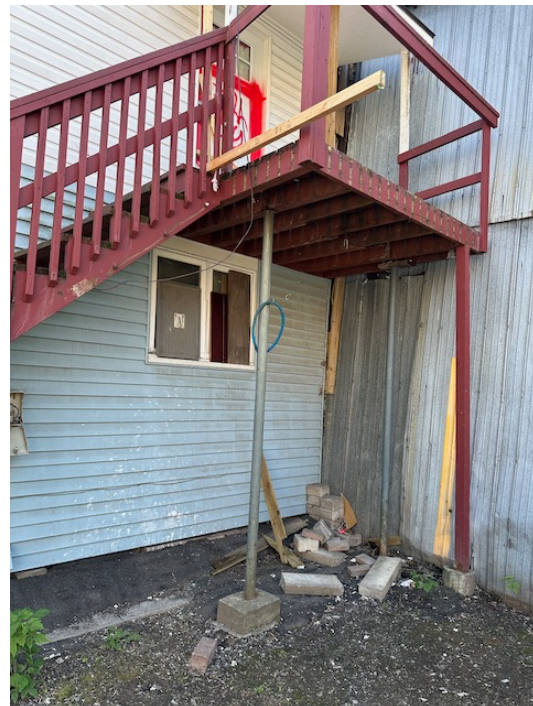
- 3.3.1. At the back of the structure, an elevated deck has been added to the second floor, with an exit stair to the ground. Deck is supported by a single wood column, and an added telepost. This deck is not built to code, and lacks overall structural stability. In its present state the stairs/deck should not be used, and would be required to be re-built (refer to Photo 8).

Photo 8 – Rear Elevated Deck (231/233)

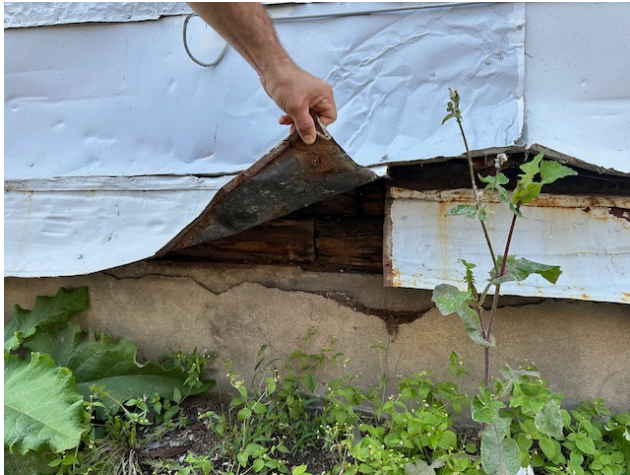
- 3.4.1. Within several locations where siding has been pulled back, rot of the wood framing for the

exterior walls could be observed (refer to Photo 9).

Photo 9 – Rotting of Wall Lumber (231/233)

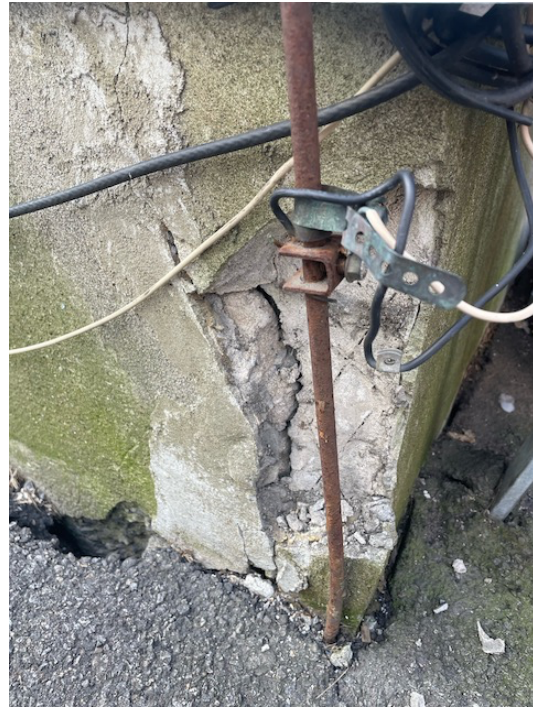
- 3.4.2. Within the foundation wall, severe cracking could be observed in several locations (refer to Photo 10).

Photo 10 – Foundation Wall Cracking (231/233)

- 5.1. Due to the condition of the framing that could be observed through a visual inspection, it is the opinion of the undersigned that as walls and floors are further opened, additional deficiencies will be observed. At this present time, the main floor within both 227/229 & 235/237 St-Patrick would require near complete reframing due to the current state of the floor joists. The rear addition building at 229 St-Patrick is no longer structurally sound and would be required to be demolished and rebuilt. Rear elevated deck/exit at 231 St-Patrick would also be required to be demolished and rebuilt. Given the condition of the sections of exterior walls that could be observed, re-framing of significant portions of the exterior walls would also likely be required. Further, given the observable slope within the roof of 227/229 St-Patrick, this area would also likely need to be reframed, or at minimum repaired. Exterior wall cladding will also require repair or replacement, and foundation walls will require repairs at crack locations.

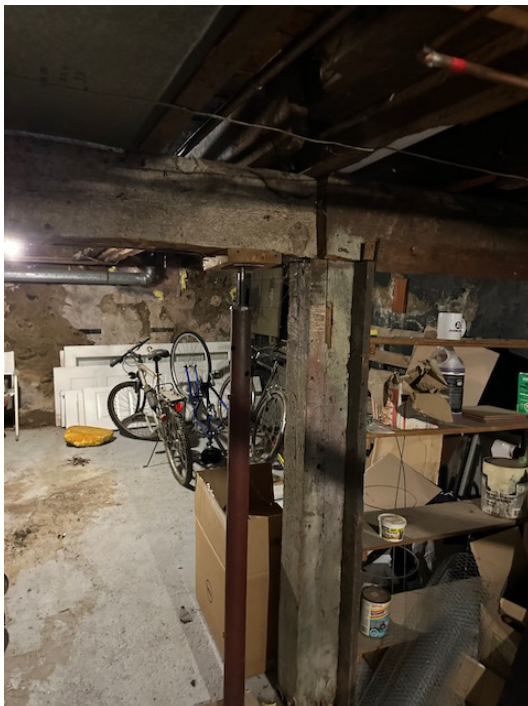
- 4.1.1. Condition of overall framing (main floor supporting) was similar to that observed at 227/229 St-Patrick (refer to Photo 11 & 12).
- 4.1.2. Given the age of the home, and subsequently the age of the lumber, several areas are displaying signs of rot.
- 4.1.3. Floor joists framing is very inconsistent throughout, with several containing excessive holes and notching for conduits and services added over the years (refer to Photo).
- 4.1.4. Modifications to the floor joists have also resulted in some joists being completely unsupported at one end.
- 4.1.5. Teleposts have been added throughout the basement in order to support the joists that are sagging and that have been cut/notched. Teleposts are bearing on the slab below, and given their placement would have been added by the previous owner without specific engineering.

Photo 11 - Basement Framing Reinforcing (235/237)

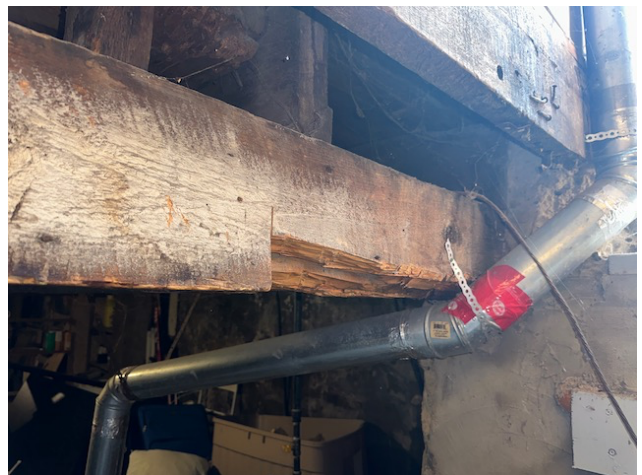
Photo 12 – Notched Joists (235/237)
