CAPACITY ENGINEERING LTD.

Condition Assessment

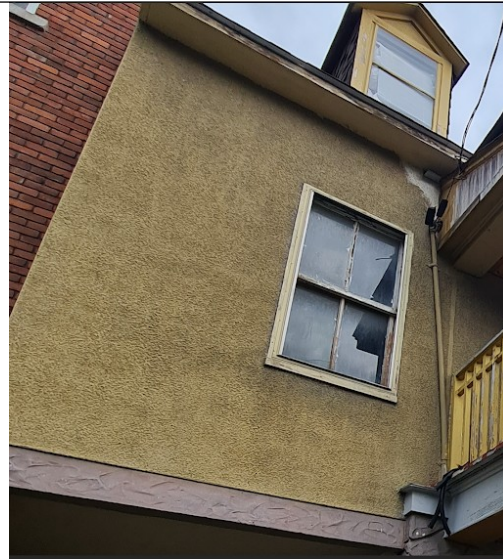
Photo 2: Front Stucco weathering & staining.

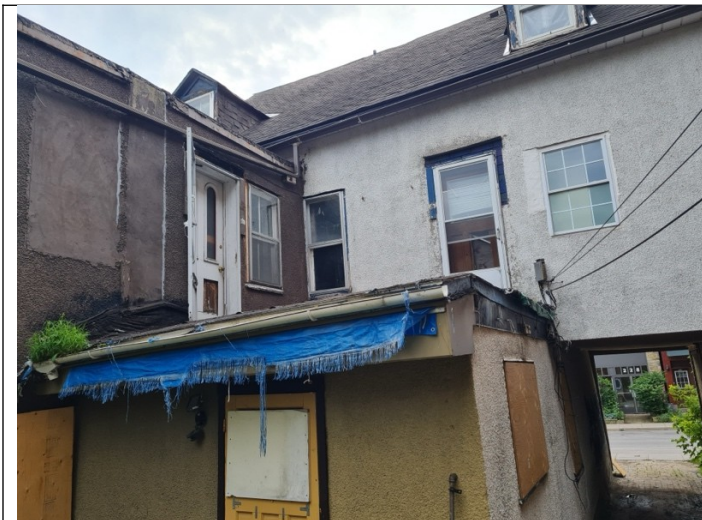
Photo 3: Rear view of home, one-storey addition, and stucco deterioration.

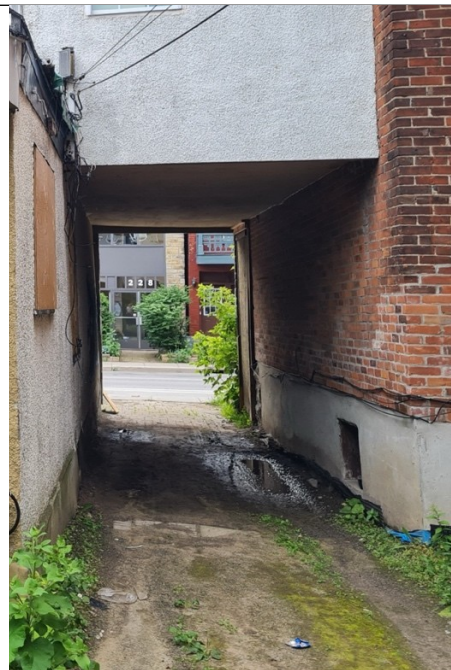
Photo 4: Laneway covering is slanted.

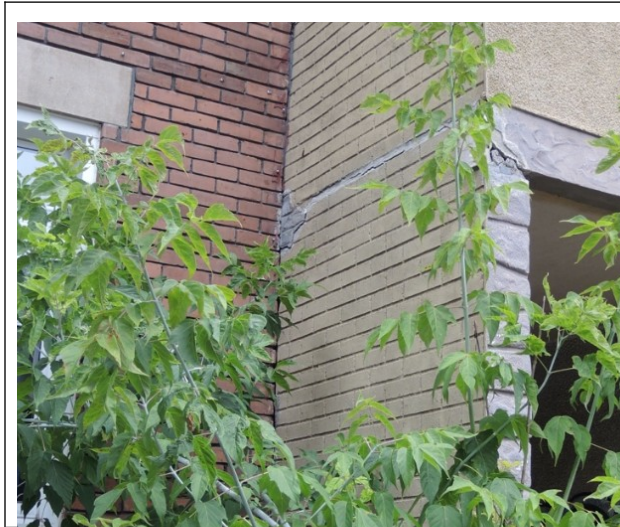
Photo 5: Horizontal cracking can be observed across the mortar in addition to cracking across the face of the bricks attached to the adjacent property. Cracking can also be observed at the corner above the laneway.

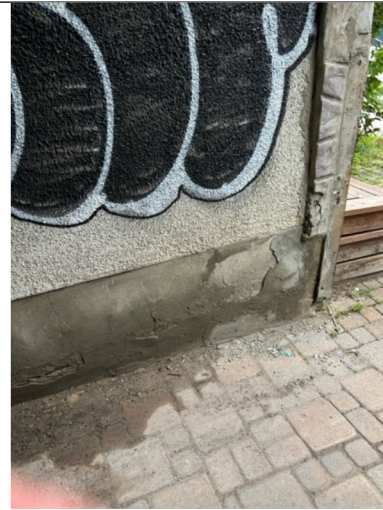
Photo 6: Cracking in back of veneer.

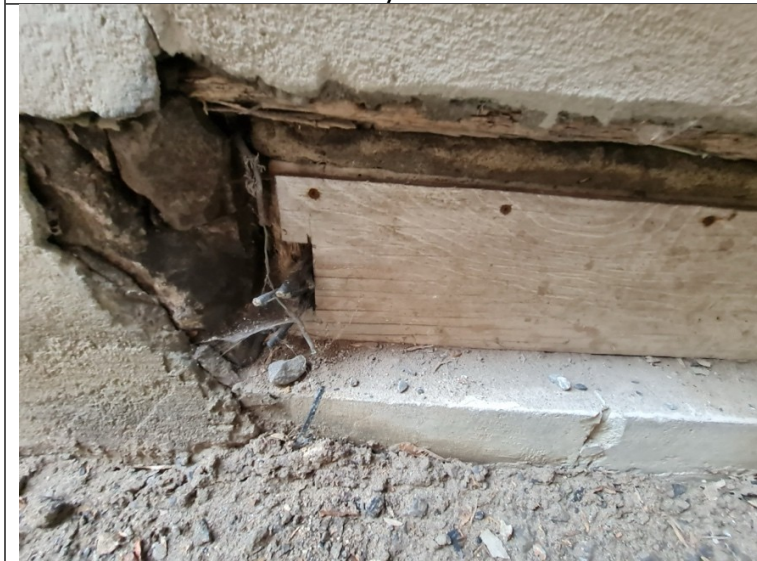
Photo 7: Foundation wall deterioration.

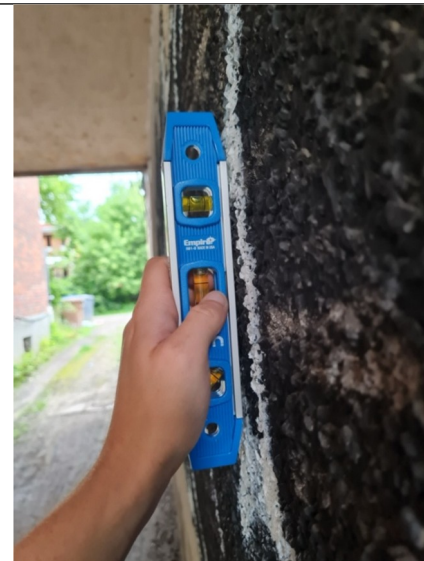
Photo 8: Laneway wall plumbness.

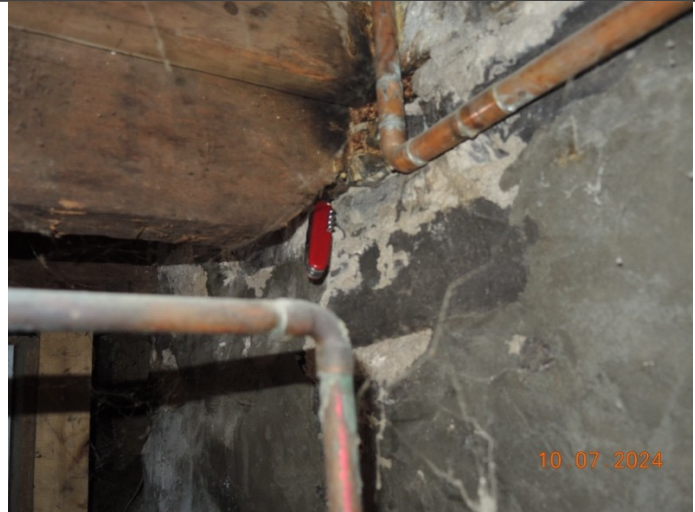
Photo 11: Joists going directly into moist foundation wall, decay observed.

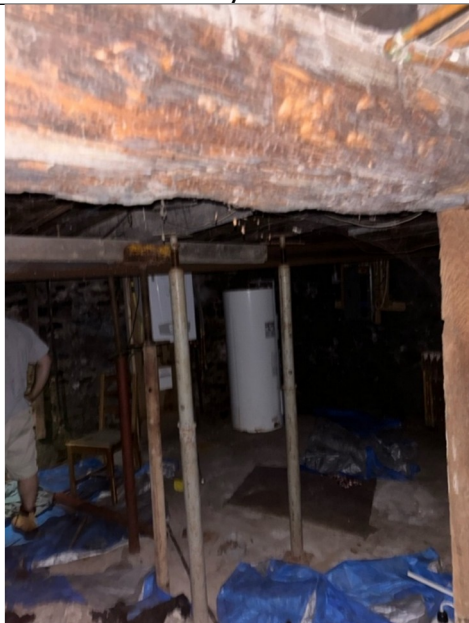
Photo 12: Temporary jackposts installed to support sagging floors.

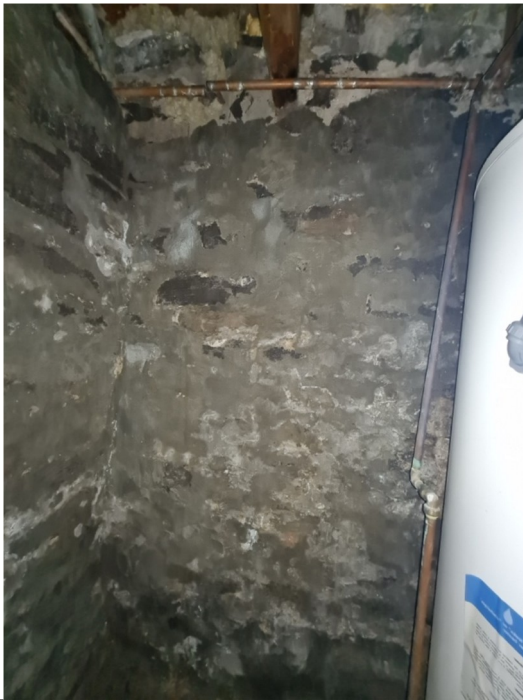
Photo 14: Previous Portland cement-based mortar application to interior surface.

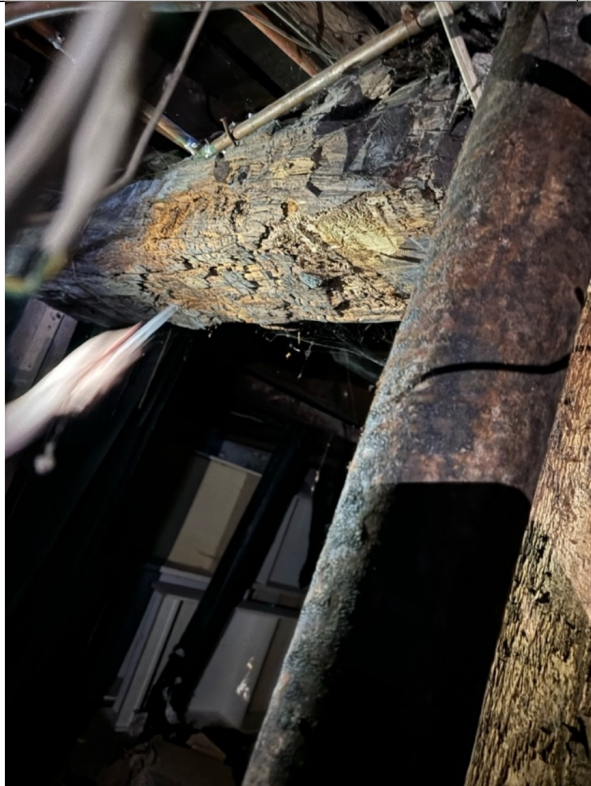
Photo 16: Severe deterioration of beam due to rot.

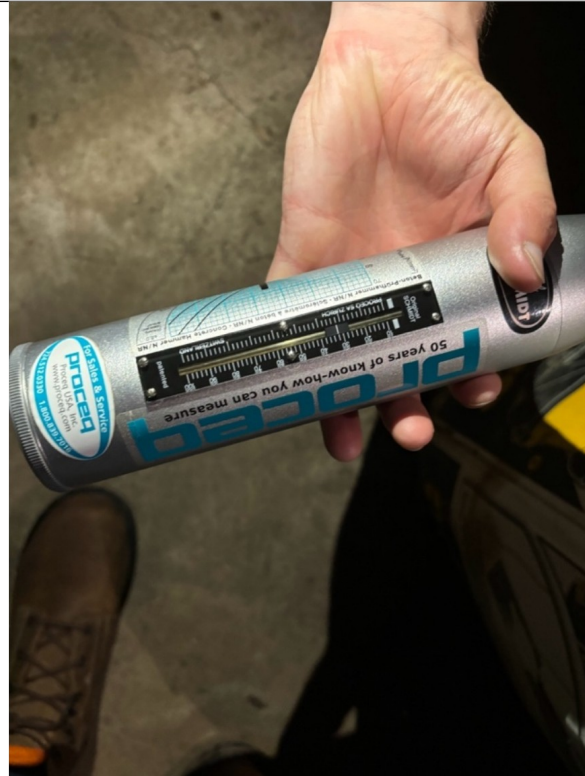
Photo 17: Schmidt hammer test result for foundation wall.

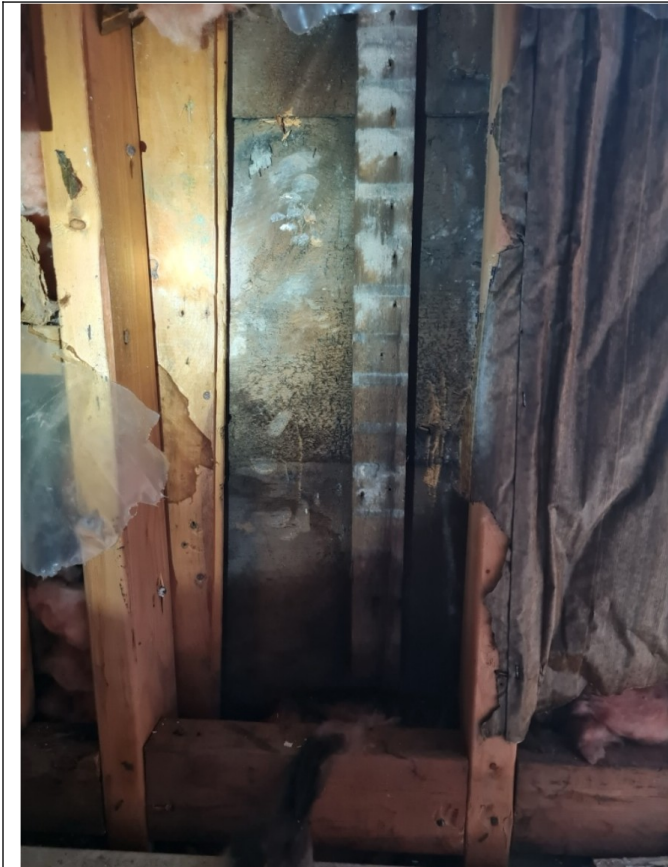
Photo 18: Exposed exterior wall showing signs of water damage on first floor at the front (South) wall of the building.

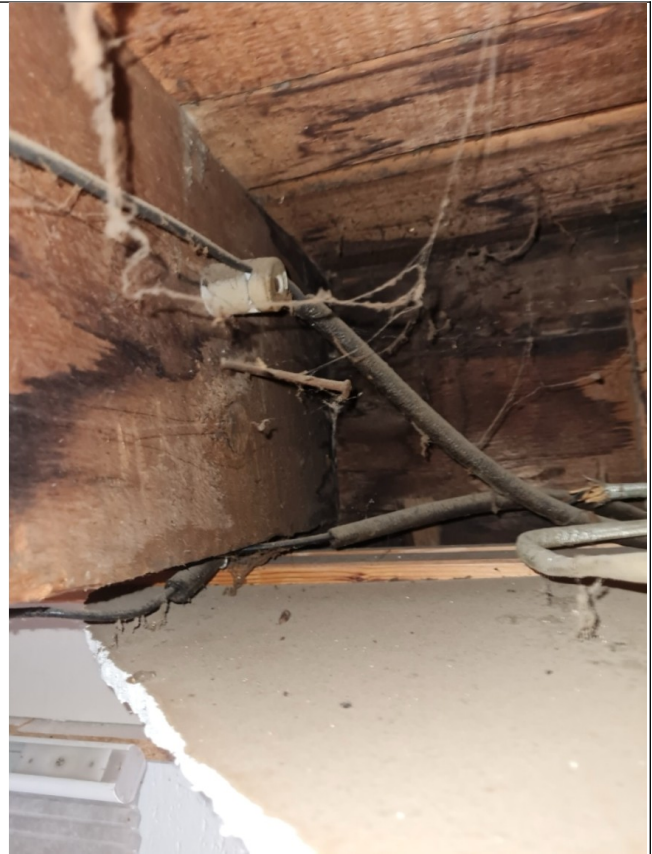
Photo 19: Dark stained joists and rim board in the second floor plenum at the front (South) wall of the building.

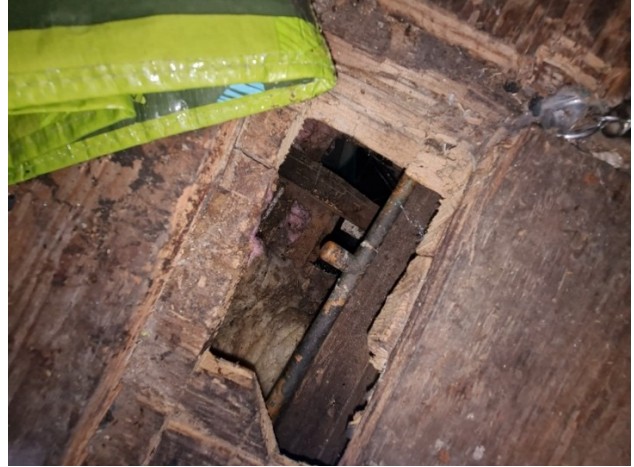
Photo 21: Hole in floor displaying signs of rot.

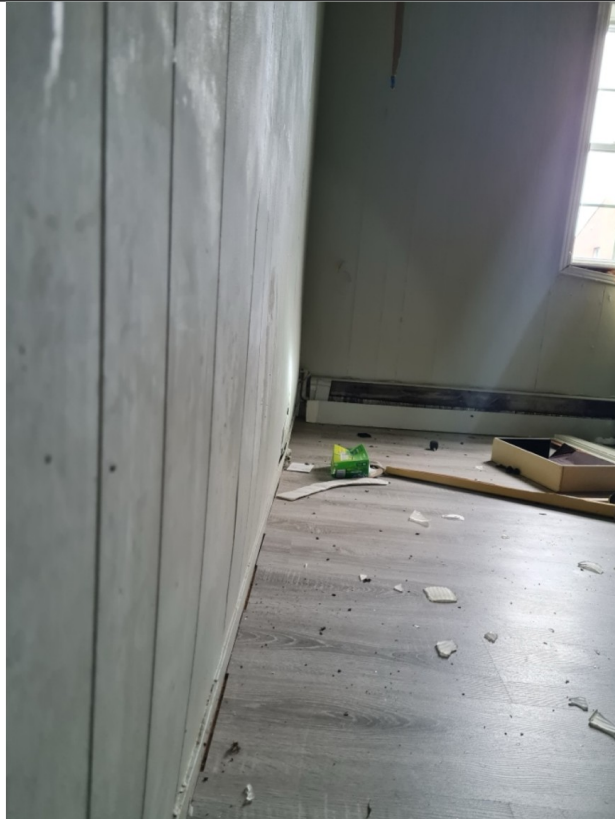
Photo 22: Interior wall bulge and sloped floor above laneway below.

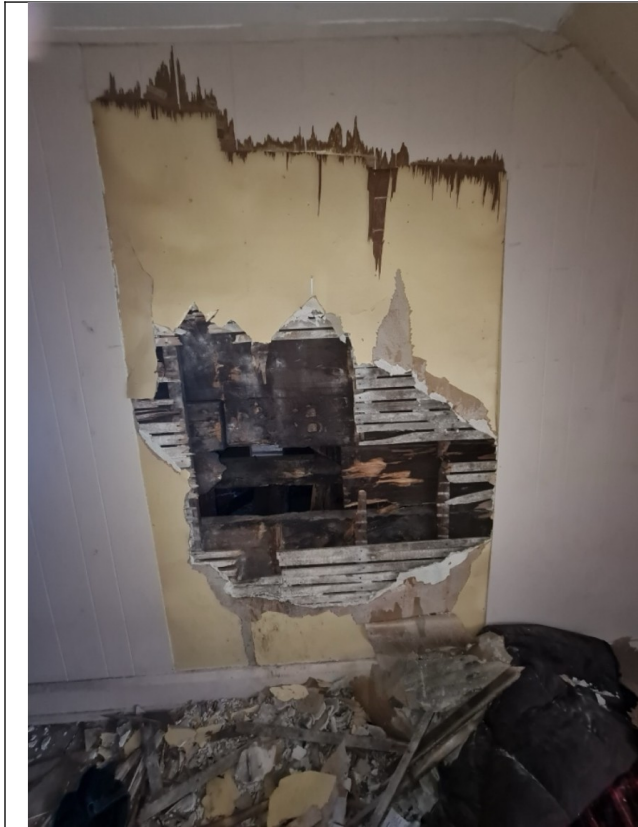
Photo 24: Hole in wall connecting to adjacent attic in 231/233 St-Patrick. Decay noted in plank-on-edge structure.

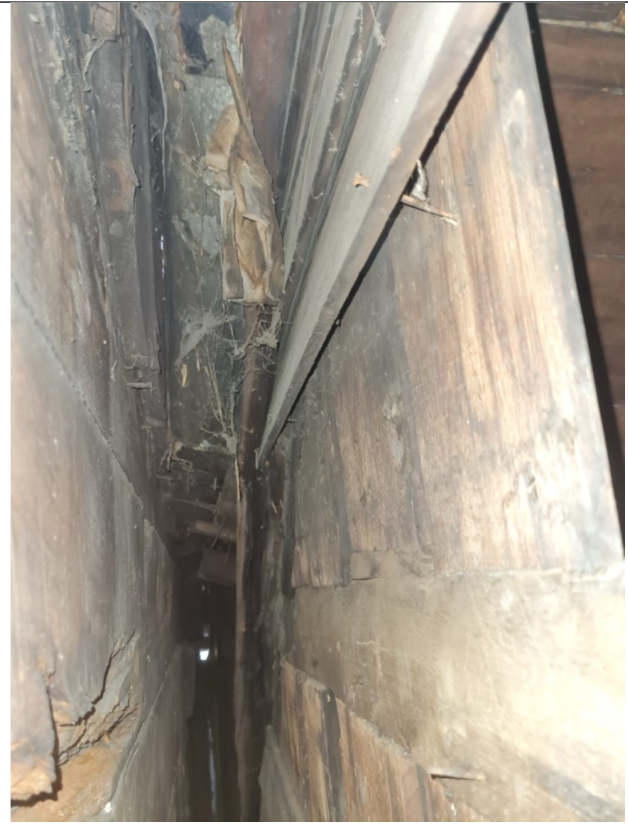
Photo 25: Inside of wall showing signs of decay along both structures. Daylight observed on all sides.

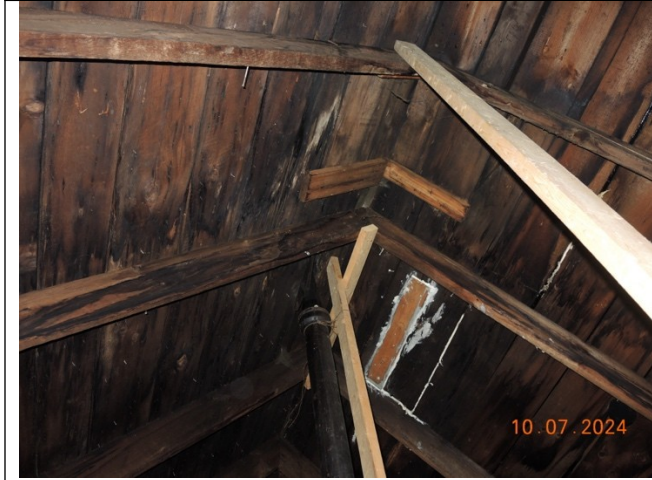
Photo 26: Dark staining in roof by plumbing stack. Prior local repair noted.

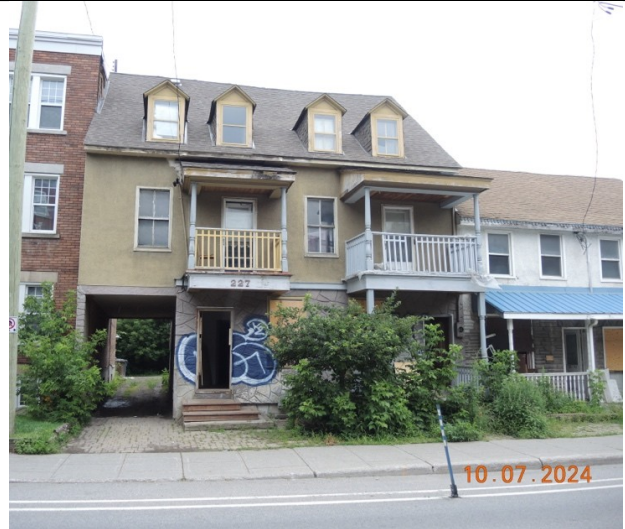
Photo 27: Roof line shows signs of sagging near the middle of the roof.

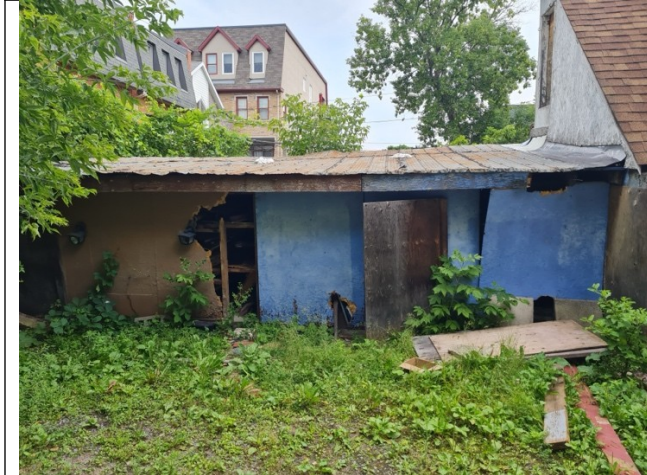
Photo 30: Certain pieces of wooden wall are broken/missing. Shed is leaning, roof slope is curved.

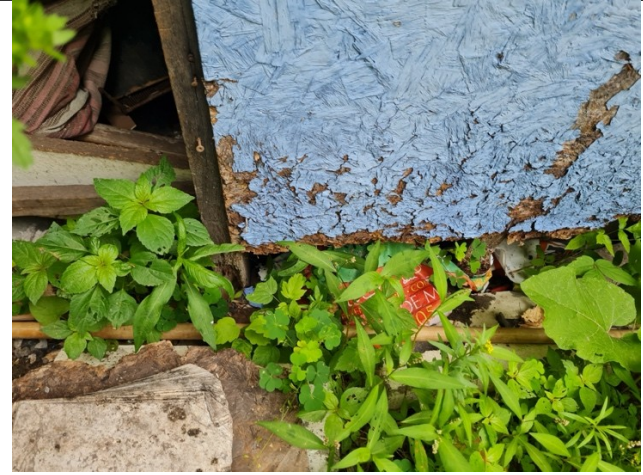
Photo 31: Shed lacks a foundation, bearing on water damaged areas. The paint is peeling, indicative of weathering of the wood.

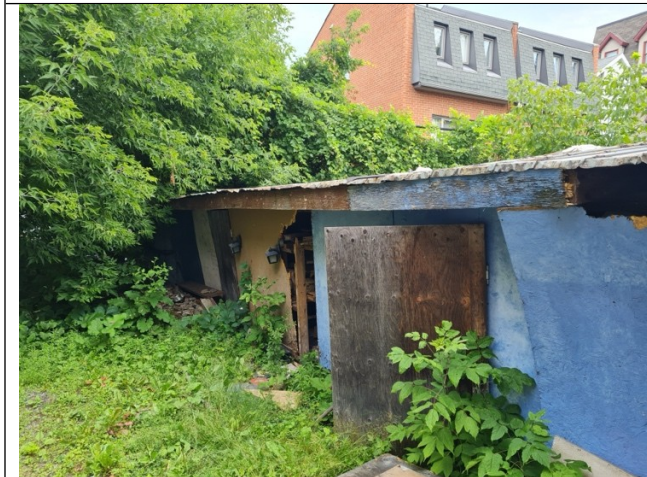
Photo 32: Shed is visibly settling and leaning.

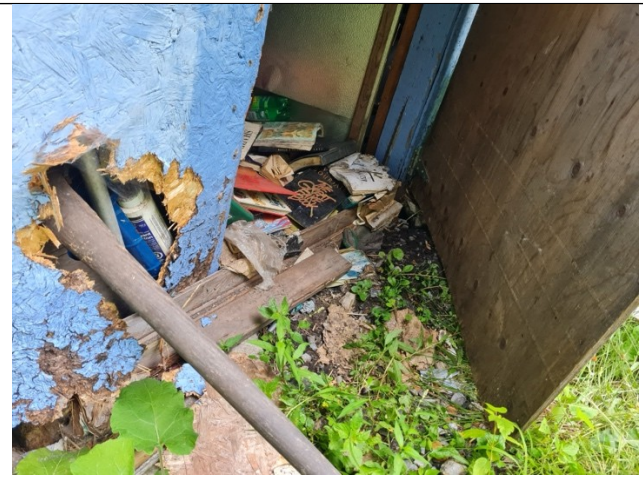
Photo 33: Visible damage to exterior walls of the shed.

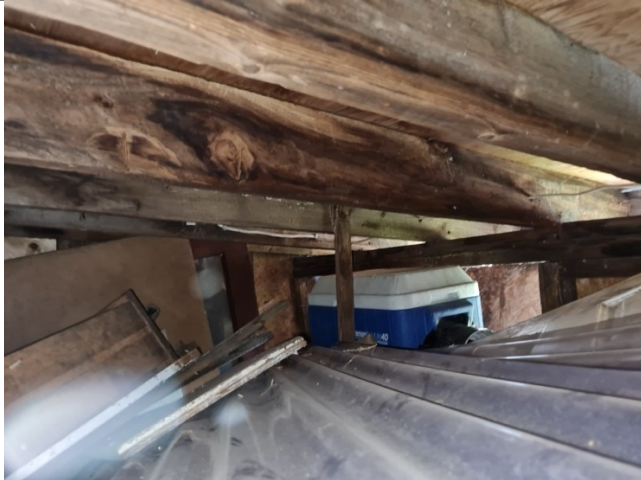
Photo 34: Dark wet staining on roof joists, indicative of rot.

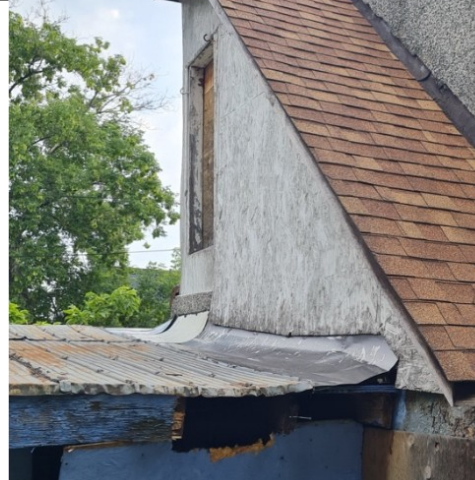
Photo 35: Corrosion of roof sheathing.

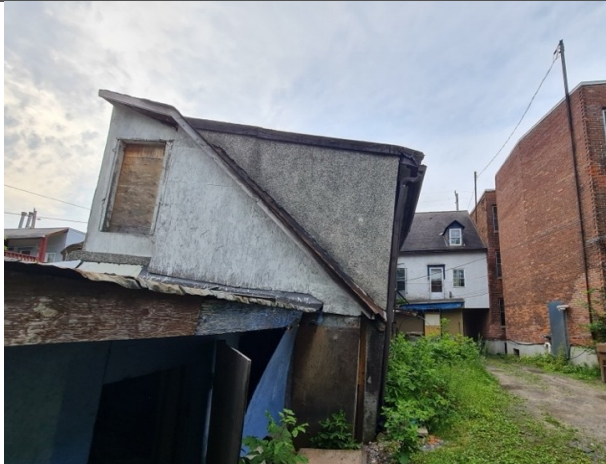
Photo 36: Addition wall leaning dramatically. Unstable structure in state of active collapse.

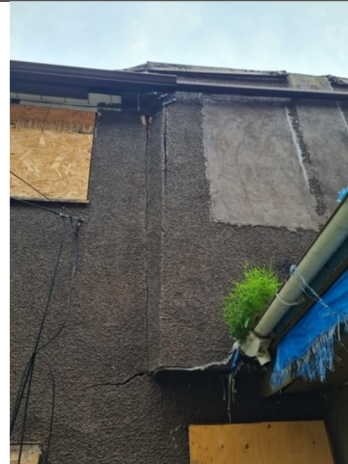
Photo 37: Stucco cracking and shifting visible on addition.

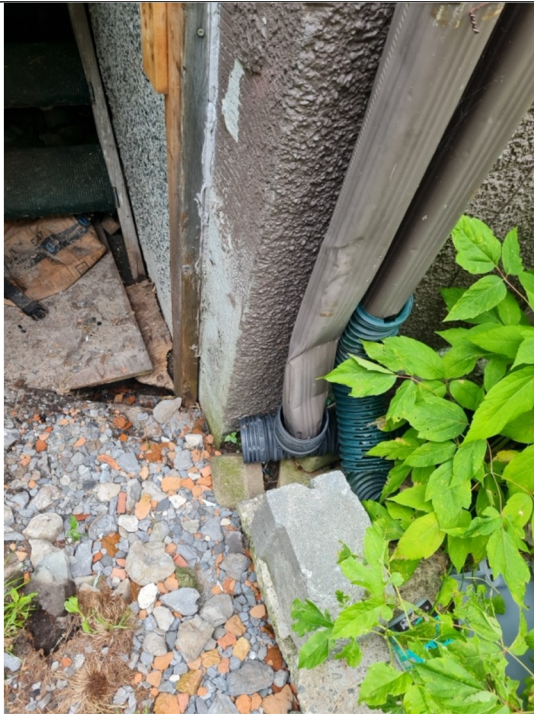
Photo 38: Downspouts coming down in localised area, washing away soil beside/beneath foundation wall.

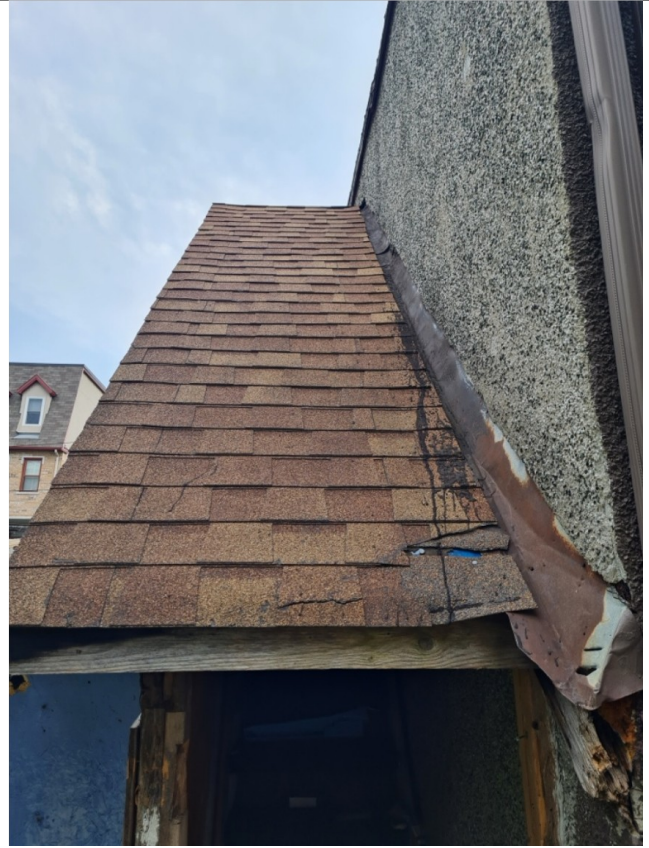
Photo 43: Poor flashing detail, corroding
away.

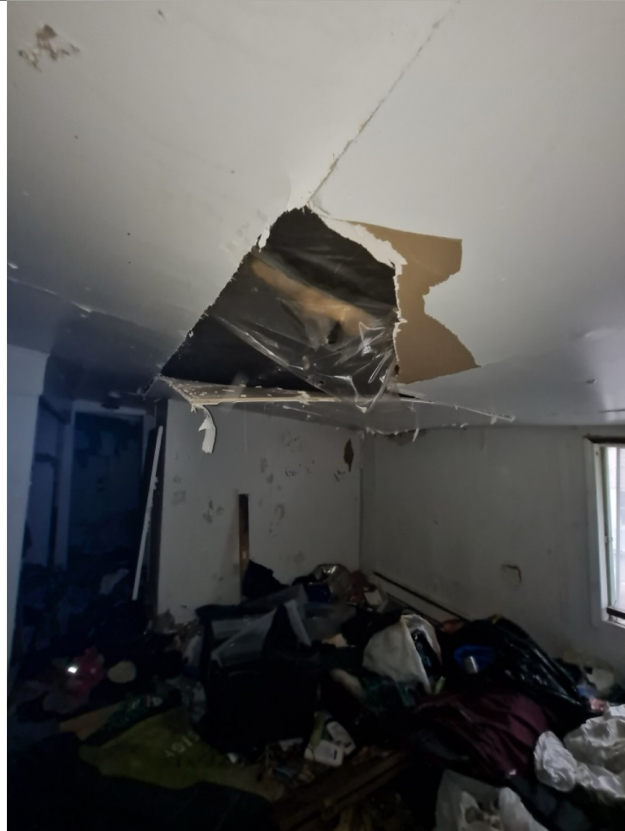
Photo 44: Ceiling is damaged and appears to be sagging.

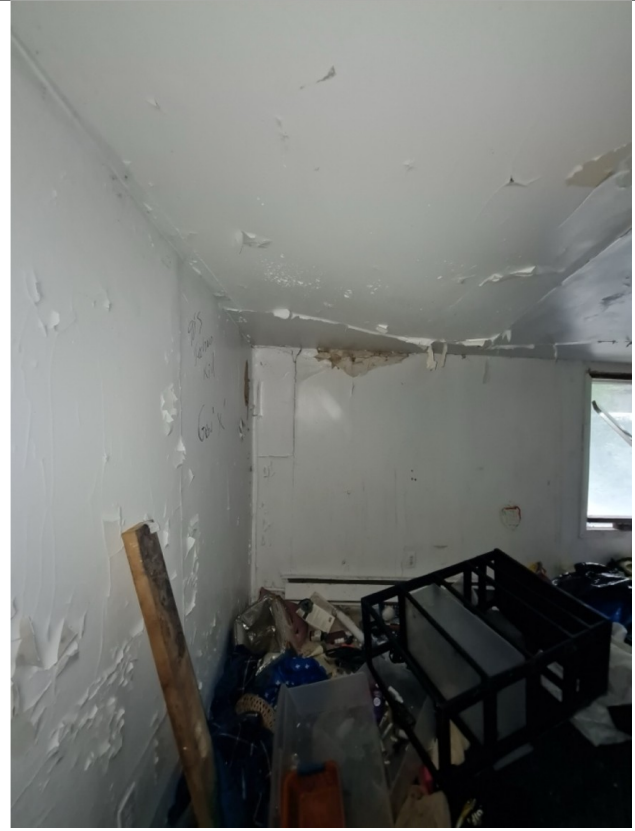
Photo 45: Ceiling appears to be sagging and interior walls are damaged.

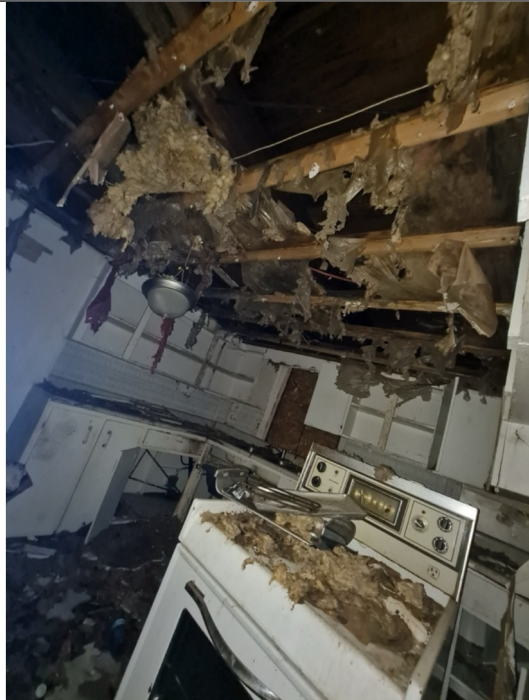
Photo 46: Ceiling and insulation have been

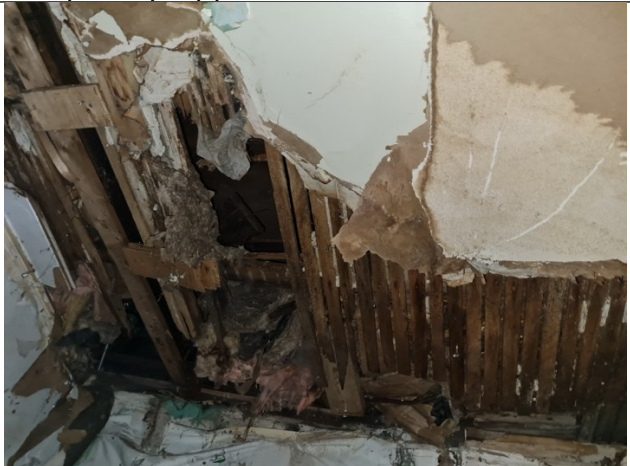
Photo 48: Water damage to exposed wood.	This square is intentionally left blank.
