CAPACITY ENGINEERING LTD.

# Condition Assessment

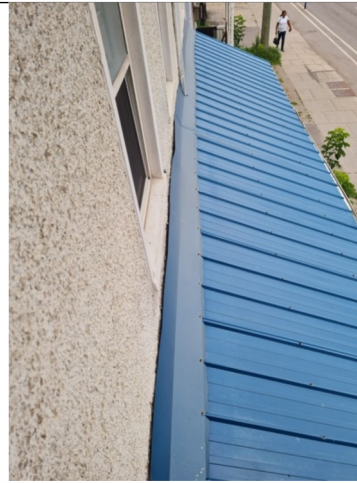
Photo 2: Flashing is not tied into stucco cladding and stucco is cracked along the interface.

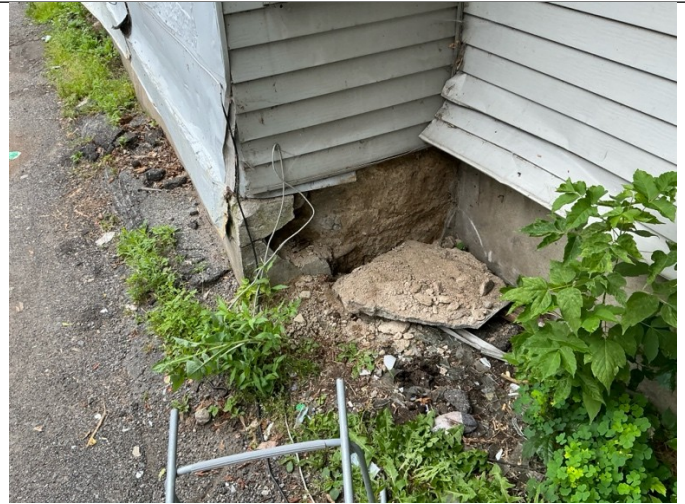
Photo 5: Exterior concrete spalling of foundation wall exposed above grade.

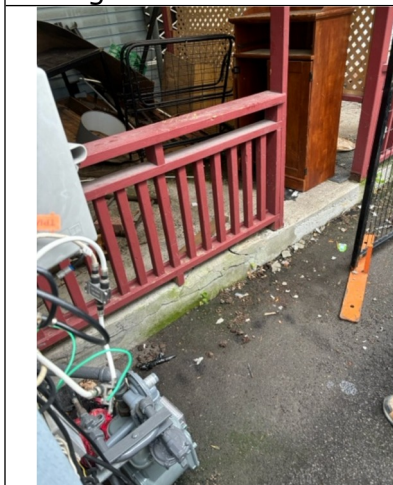
Photo 6: Cracking of the rear porch slab.

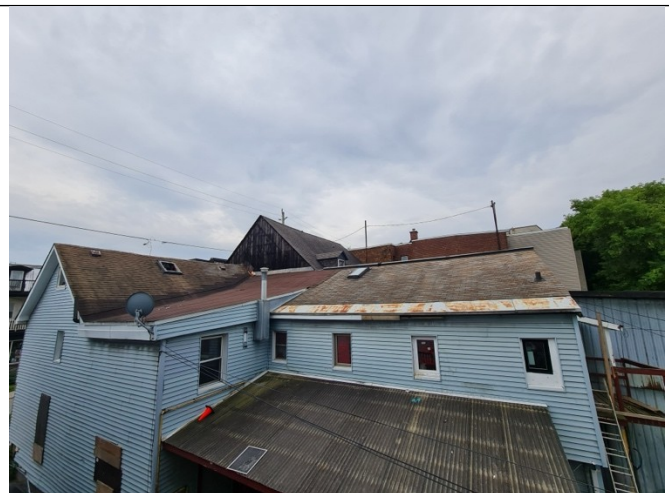
Photo 7: 231/233 St. Patrick St roof condition.

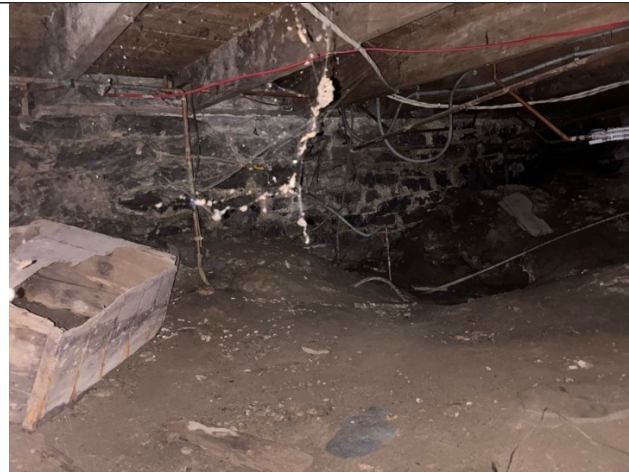
Photo 8: Water staining on joists and wet foundation wall.

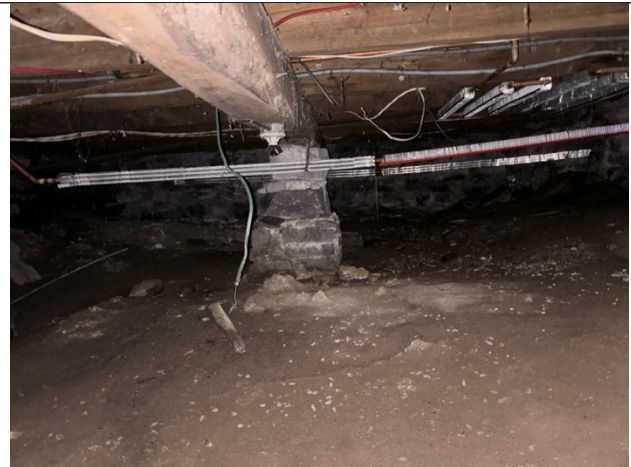
Photo 9: Deterioration of masonry pier.

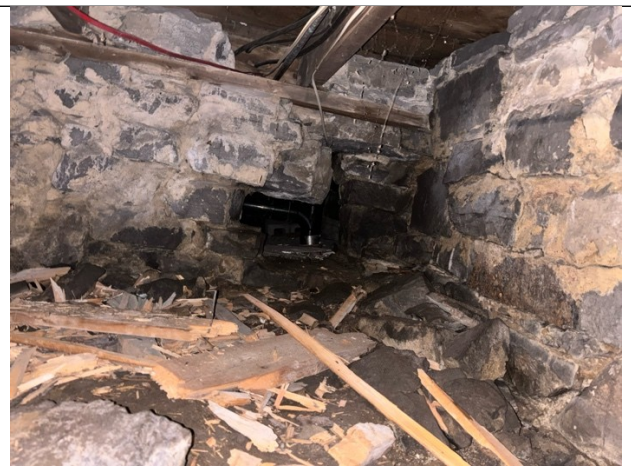
Photo 11: Opening at the corner of the foundation wall.

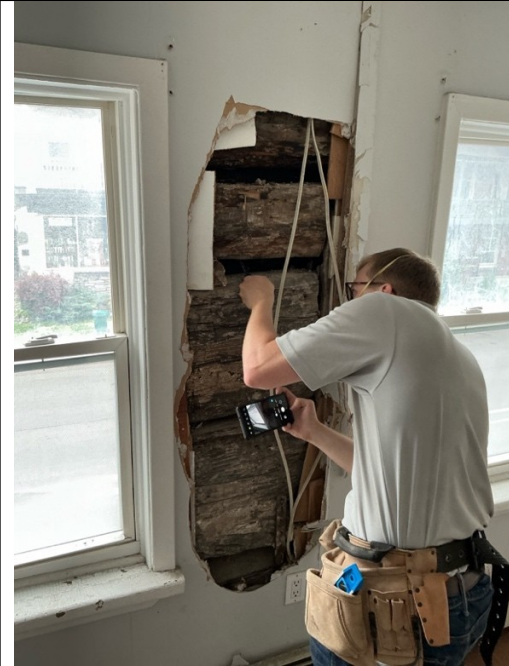
Photo 12: Rot in exterior South wall on second storey.

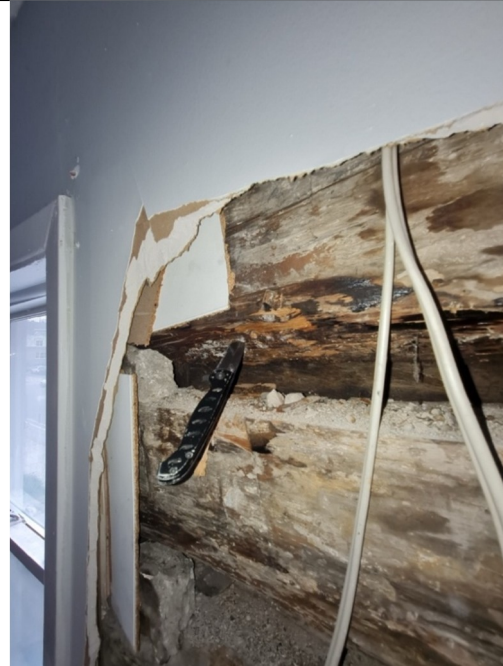
Photo 13: Field knife probe easily entered deep into exterior wall elements.

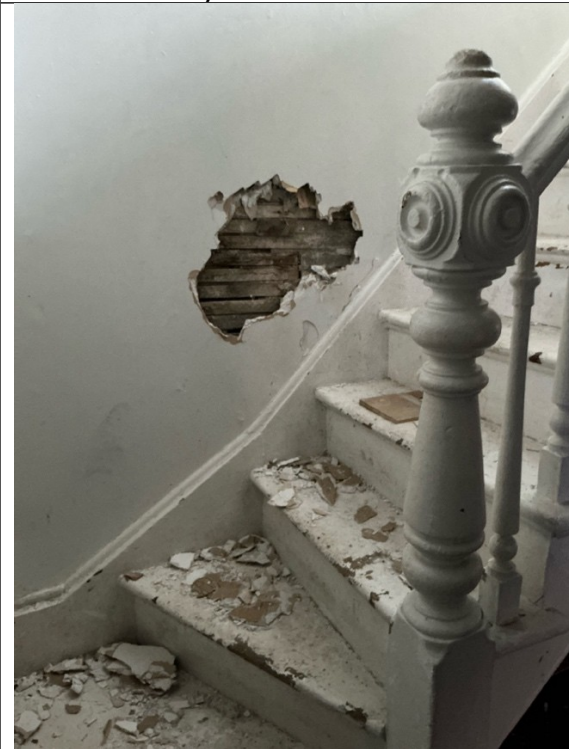
Photo 14: Exposed Lath showing signs of moisture damage.

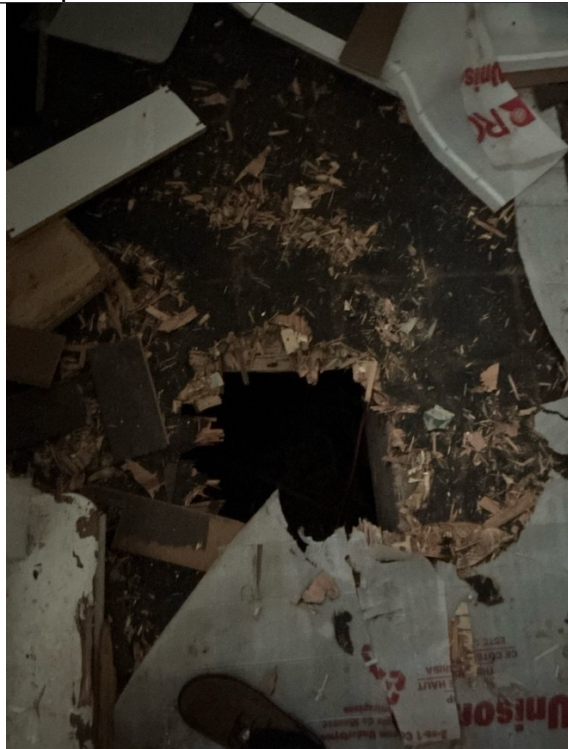
Photo 15: Hole in floor down to crawlspace. Rot is present.

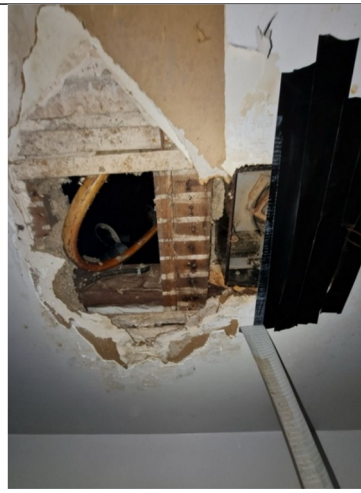
Photo 17: Hole in ceiling. Showing signs of water damage.

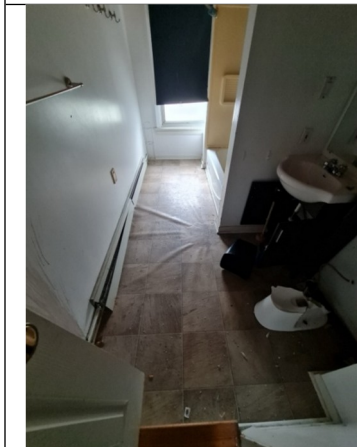
Photo 20: Flood caused water damage to floors, likely underlying damage.

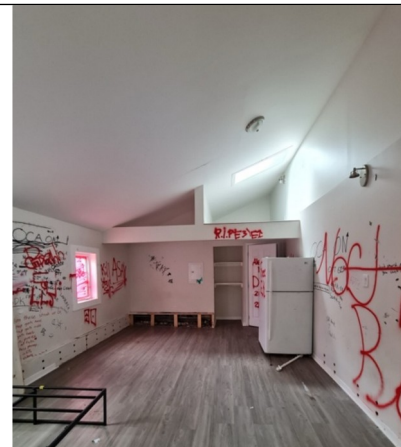
Photo 21: Small bulge in drywall.

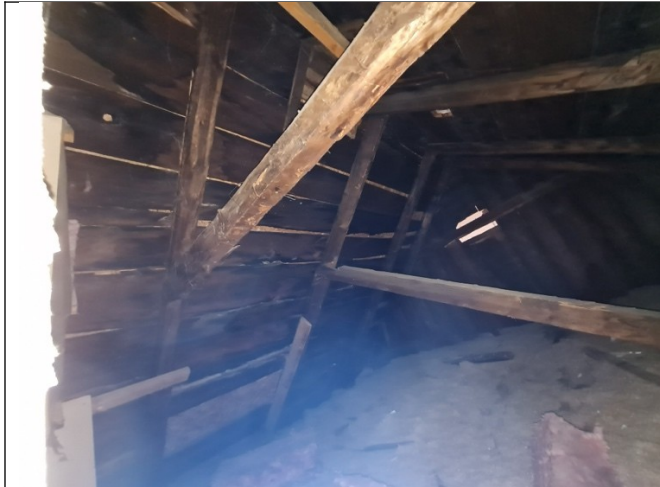
Photo 22: Roof structural elements showing signs of decay and moisture. Daylight observed from inside the attic.

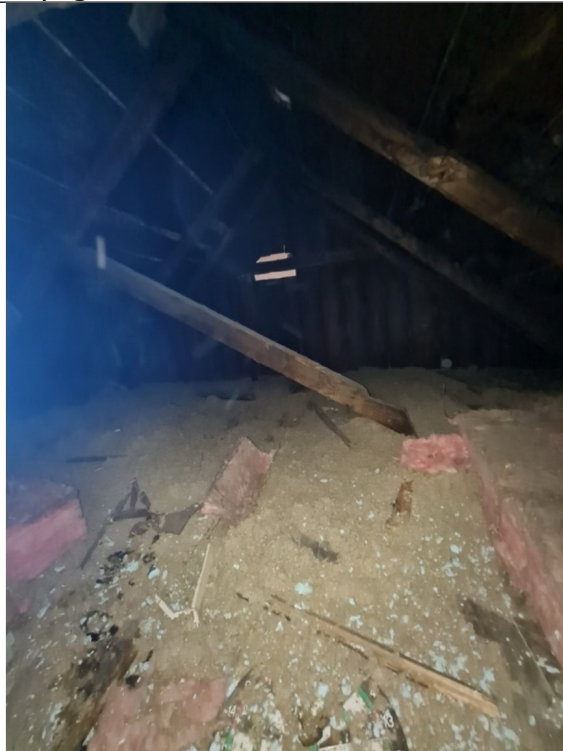
Photo 24: Rafter-tie is disconnected from rafter. End where previously connected has dark staining.

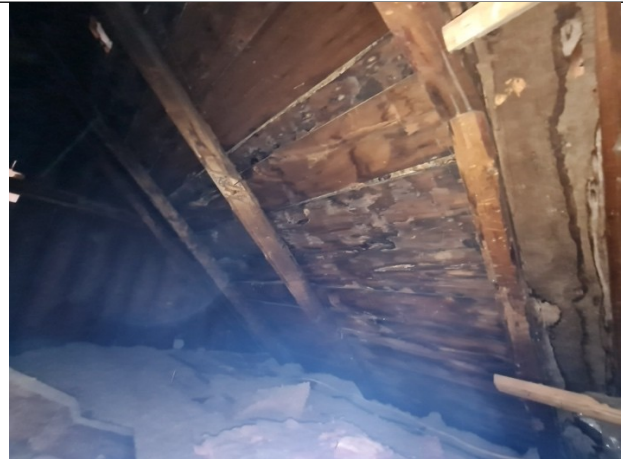
Photo 25: Staining of roof rafters and plank decking. Contemporary roof sheathing has been installed on top.

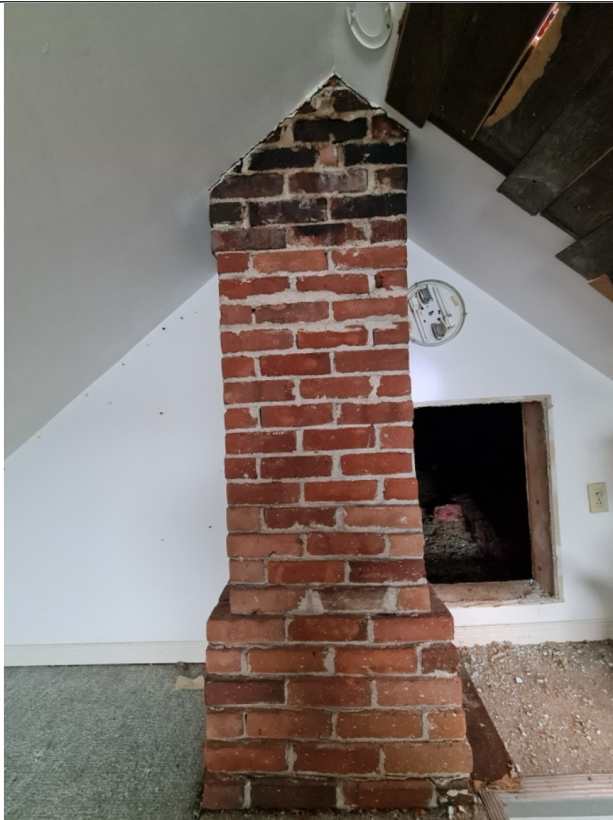
Photo 26: Chimney, with upper portion showing decay and moisture damage.
