Tree Conservation Report Addendum Update

Submitted as part of Site Plan Control Application

Address: 253, 255 and 257 York Street and 78 and 80 Nelson Street
Date of Report: May 15th, 2024
Date of Site Visit: Jan 30, February 8 and February 14, 2024
Prepared by: Astrid Nielsen, RPF, ISA Certified Arborist®
Client: Corey Kou, Associate, Development
Smart Living Properties
226 Argyle Avenue, Ottawa, ON
C: 613-325-2153
T: 613-244-1551 ext. 628
corey@smartlivingproperties.ca

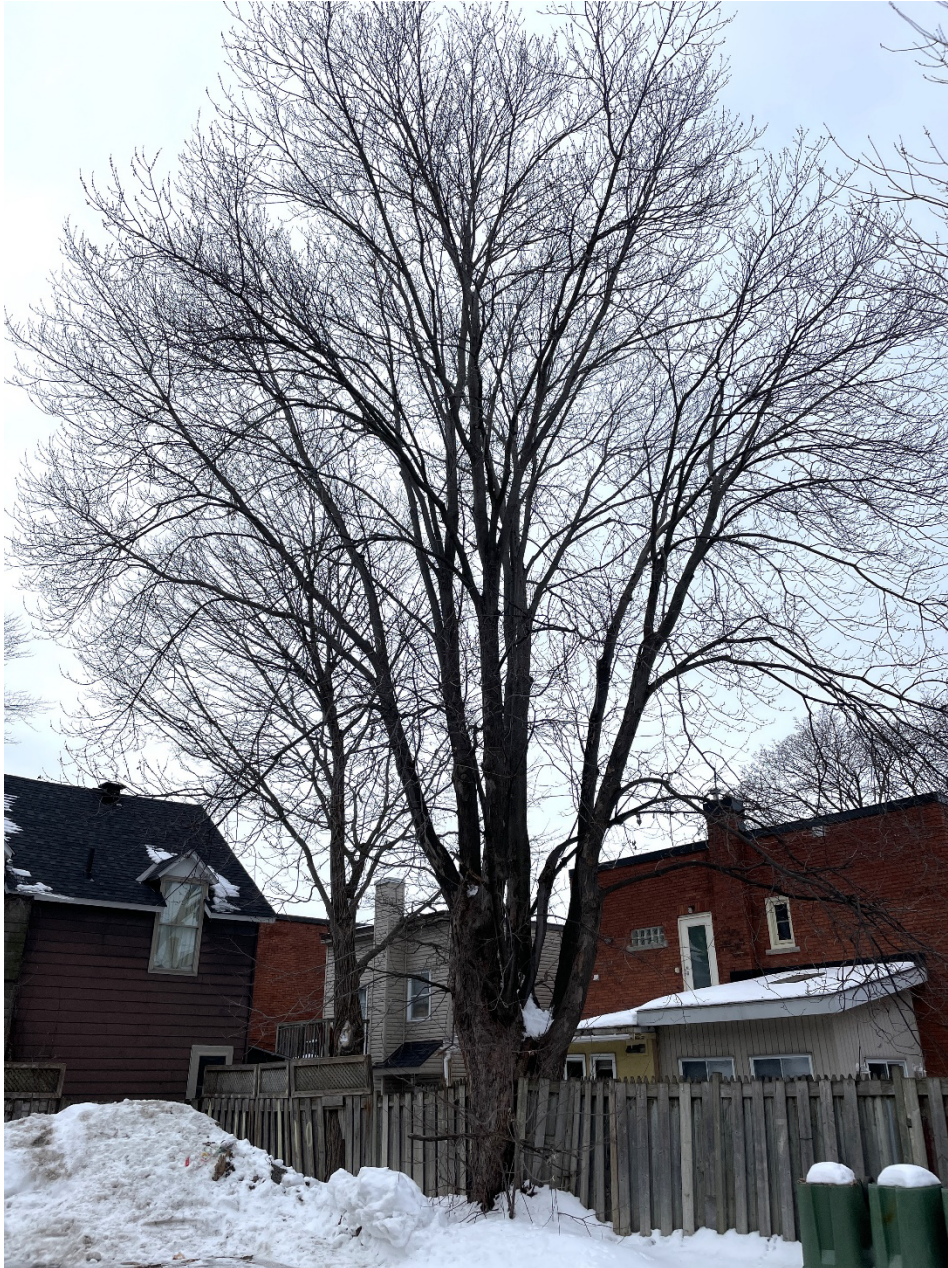
Figure 1: Large silver maple, note the location relative to the fence

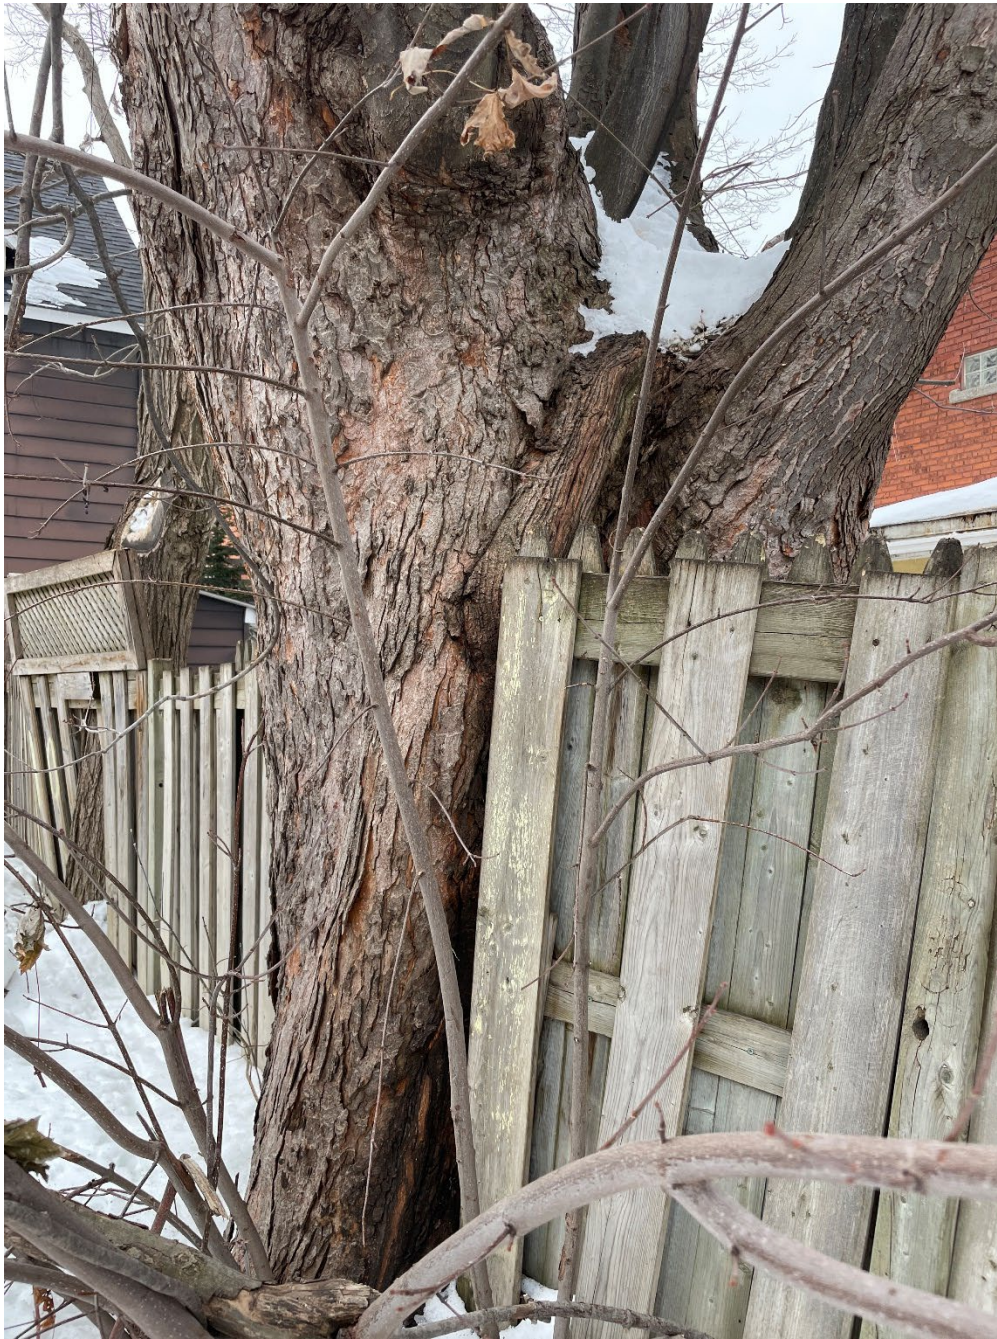
The site visit on Feb 14th included a consultation with David Buttivant, a Certified Arborist from Eastern Ontario Arborists regarding tree health. Mr. Buttivant was able to view the junction with the main concern around decay and structural weakness (photos provided). He confirmed that there is significant decay at the junction of the main stems that are leaning over the subject property that extends through the trunk of the tree. However, in his professional opinion, the tree could be retainable, and risk of failure of the larger stems could be reduced through a *crown reduction* prune. This type of pruning would reduce the crown of the *entire* tree, and thus, reduce the weight and stress on the tree branch unions lower down. As part of this procedure, clearance pruning could be achieved to remove those

Figure 2: Large seam extending from the main junction to the base of the tree

branches that are in conflict with the proposed new building and construction activities required to build it. Note that this reduction pruning is a recommended practice regardless of what construction activities occur on the site. Regular maintenance of larger, mature silver maples is required in urban settings to lower the risk of impacts through failures, especially during inclement weather. Furthermore, maintenance of private trees is the responsibility of all the owners of the tree.

In addition to the reduction prune, installing a structural support system in the tree is also recommended and would reduce the risk of significant branch failures. A formal tree risk assessment was not completed; however, it is the opinion of the undersigned (Astrid Nielsen), that the tree will not become hazardous as a result of the construction on the site if these risk reduction activities are followed.

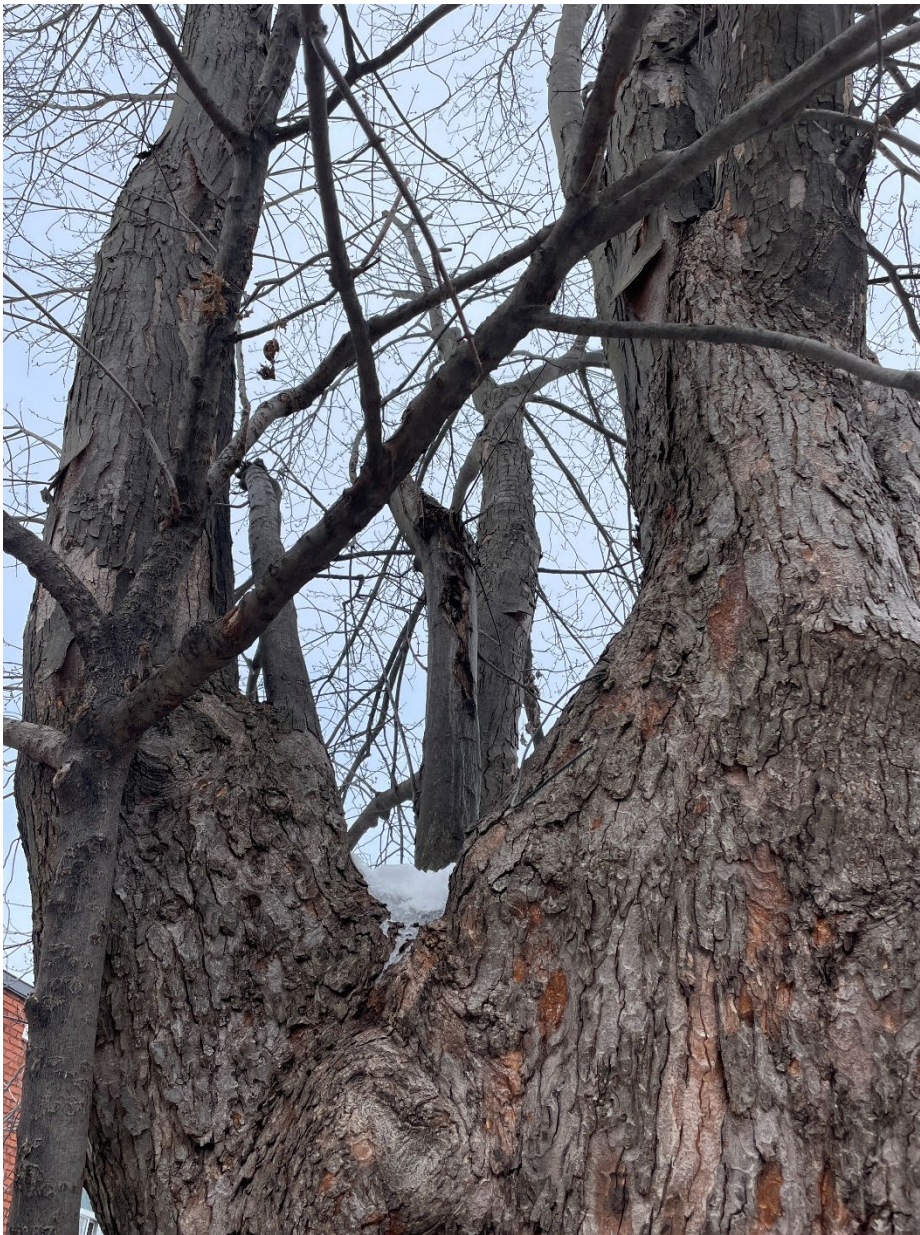
Figure 3: branches growing from centre of tree that have decayed

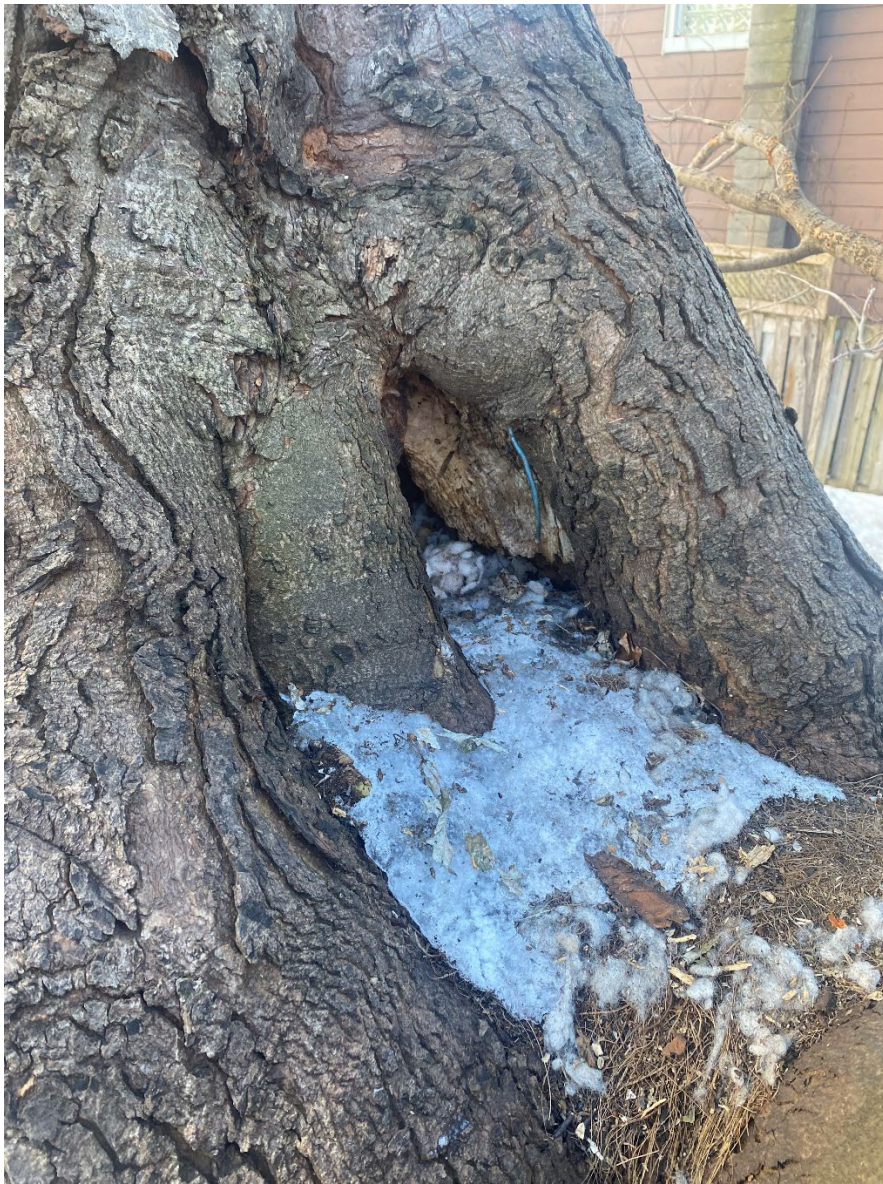
Figure 4: Decay in the main junction of the large branch leaning over the subject property

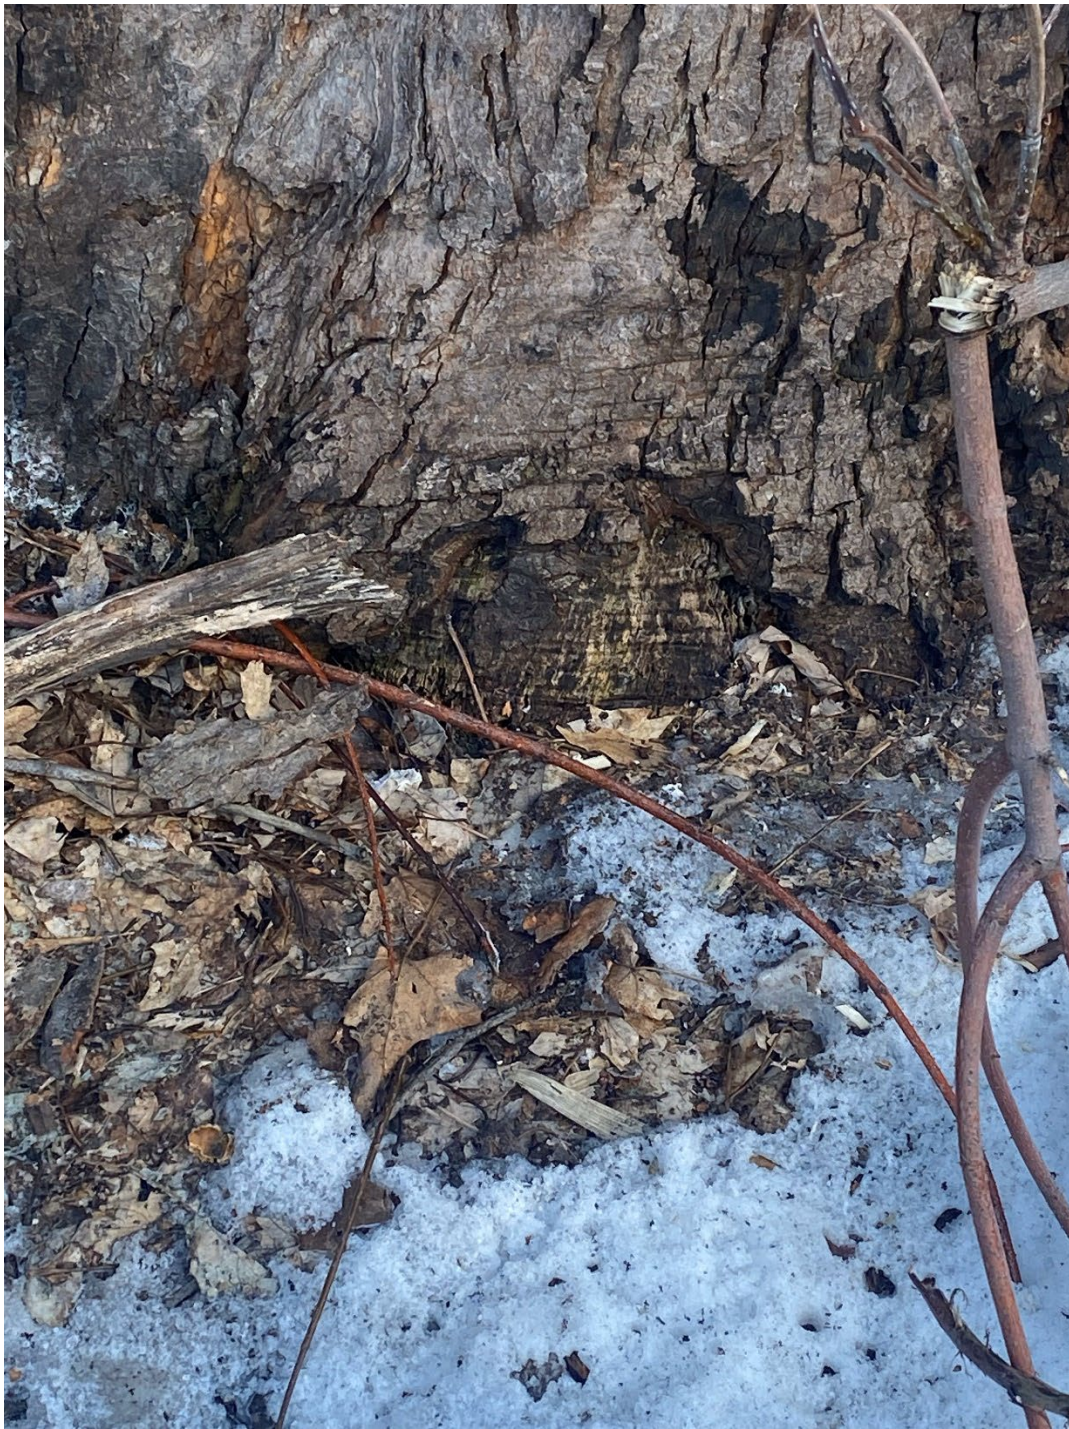
Note: during the second site visit on February 14th, the snow cover had melted somewhat, and more of the trunk was visible than the previous site visit. Some damage to the base of the trunk was noted (see picture) and this should be further explored once the ground has thawed to ensure that there is no visible evidence of significant decay in the roots and base of the tree.

Figure 5: Damage to trunk visible on Feb 14, 2024
