Dendron Forestry Services

Tree Information Report v2.0

Date of Report:	July 25, 2024
Property Address:	451 Roosevelt Avenue
Prepared for:	Jordan Tannis; jt@concorde-properties.ca
Prepared by:	Kevin Myers, ISA Certified Arborist [®] ; <u>kevin.myers@dendronforestry.ca</u>
Date of Site Visit:	May 1, 2024

451 Roosevelt Avenue

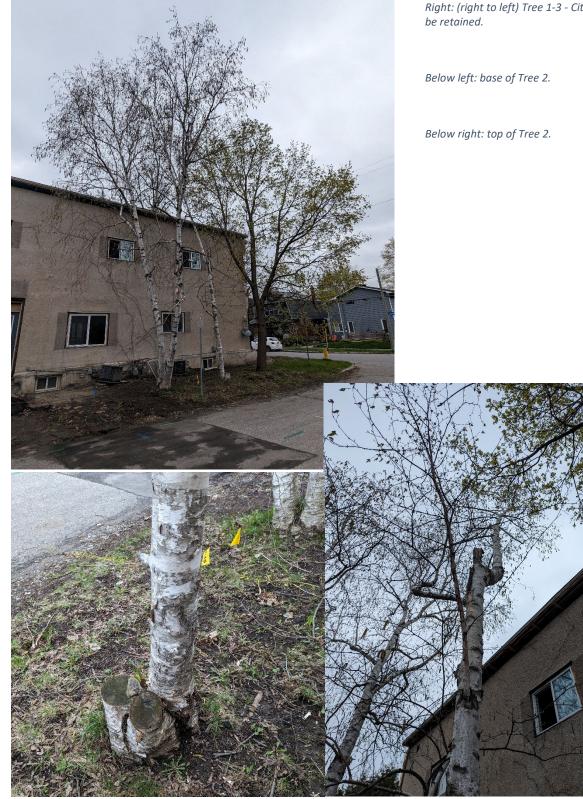
The proposed development at this site includes demolishing and rebuilding the existing dwelling on the same foundation. This should allow for the retention of **Trees 1-3**, as less root zone disruption is expected. Foot and machine traffic near the trees is to be kept to a minimum, and fencing as described below and shown in the map is to be erected only far enough from the wall to allow construction access. Most major branches from these trees are not close to the existing wall, but if any clearance pruning is required it is to be completed by a certified arborist.

Right: (right to left) Tree 1-3 - City trees to be retained.

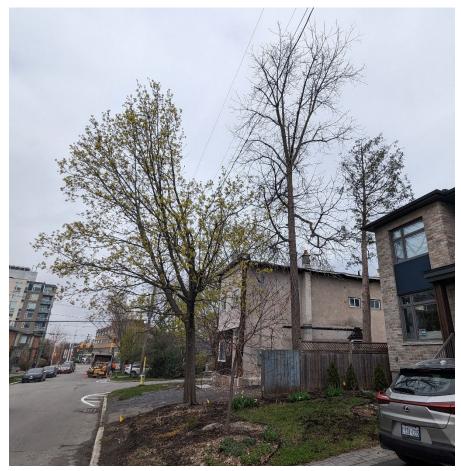
The proposed walkway is 1.3m from **Tree 6**. This is 3.7x the DBH, which is generally within best practices for retaining stability. What is more, where the walkway is proposed is currently an asphalt parking area and it is unclear how many roots the tree may have developed under the hard surface. As the tree has rooting space on the adjacent property, it may be able to withstand impacts from construction, and is therefore recommended for retention in an effort to retain streetscape canopy. When removing Tree 5, the stump is to be ground or the roots around the stump are to be severed so as not to disturb any roots of Tree 6 which may be entangled with those of Tree 5.

4	Eastern white cedar (<i>Thuja</i> occidentalis)	42	Subject property	Poor: Live-crown ratio of 25% - much has been removed, defoliation ~70% of remainder	0	Remove	Remove based on plans. Tree permit required for removal.
5	Black walnut (<i>Juglans</i> <i>nigra</i>)	41	Subject property	Fair/Good: pruned – epicormic shoots growing at cut; growing beside asphalt parking area; small wound on root flare	0	Remove	Remove based on plans. Tree permit required for removal.
6	Norway maple (<i>Acer platanoides</i>)	35	City	Fair: pruned around wires – asymmetrical crown; lean to west; large root will girdle the tree in years to come	Walkway: 1.3	Retain	Retain and protect as per the City of Ottawa Tree Protection Specifications (March 2021). Care is to be taken to not tear roots during removal of the asphalt parking area.
H1	Eastern white cedar (Thuja occidentalis)	~20 stems 7-24cm	City	Fair: several stems are dead; asymmetrical growth	Driveway: 0	Remove	Remove based on plans. Tree permit required for removal.

Above: (right to left) Trees 4 & 5 - private trees to be removed. Tree 6 - City Norway maple to be retained.

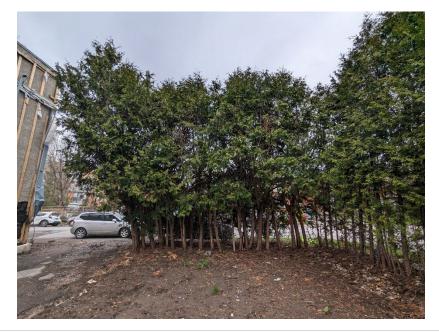
H1 is a cedar hedge at the northeast property boundary. This hedge appears to fall right on the property line between city and private property. There are approximately 20 stems between 7 and 24cm DBH. Most of the hedge seems pruned and maintained, but the stem closest to the existing building has not been pruned and grown a large canopy. While some stems could be retained based on the proposed plans, it is likely the level of activity on site as well as the removal of the majority of the hedge for the proposed driveways will cause decline in any stems retained. It is therefore recommended that the entire hedge be removed.

Below: cedar hedge on city property to be removed.
