Dendron Forestry Services

Tree Information Report

Property Address: 251 Columbus Avenue

November 27, 2024

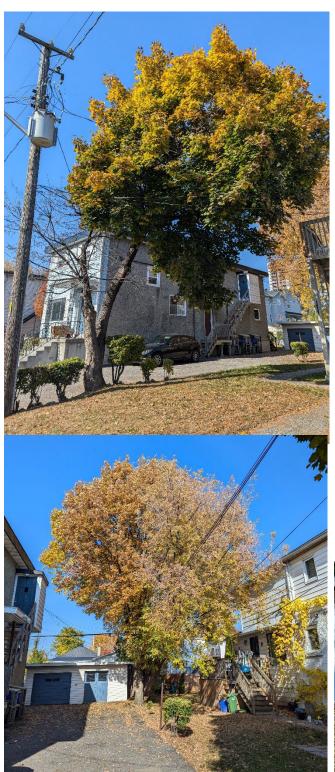
Tree 1 is not in good condition; only the northern stem is living, and it is leaning towards the proposed building. The building as drawn is approximately 4m from the tree, which would likely necessitate the removal of approximately 20-30% of the crown to facilitate construction. The combination of this canopy loss with the tree's poor growing location (beside the existing driveway) and poor condition, mean it is unlikely to endure construction.

Clockwise from left:

Tree 1 - boundary maple to be removed.

Base and stems of Tree 1.

Base and stems of Trees 2-5 - private trees to be removed.

Position of Trees 2-5

The intensification on this site will make tree preservation very difficult. **Trees 2-5** will be within the excavation footprint of the new building, and are recommended for removal.

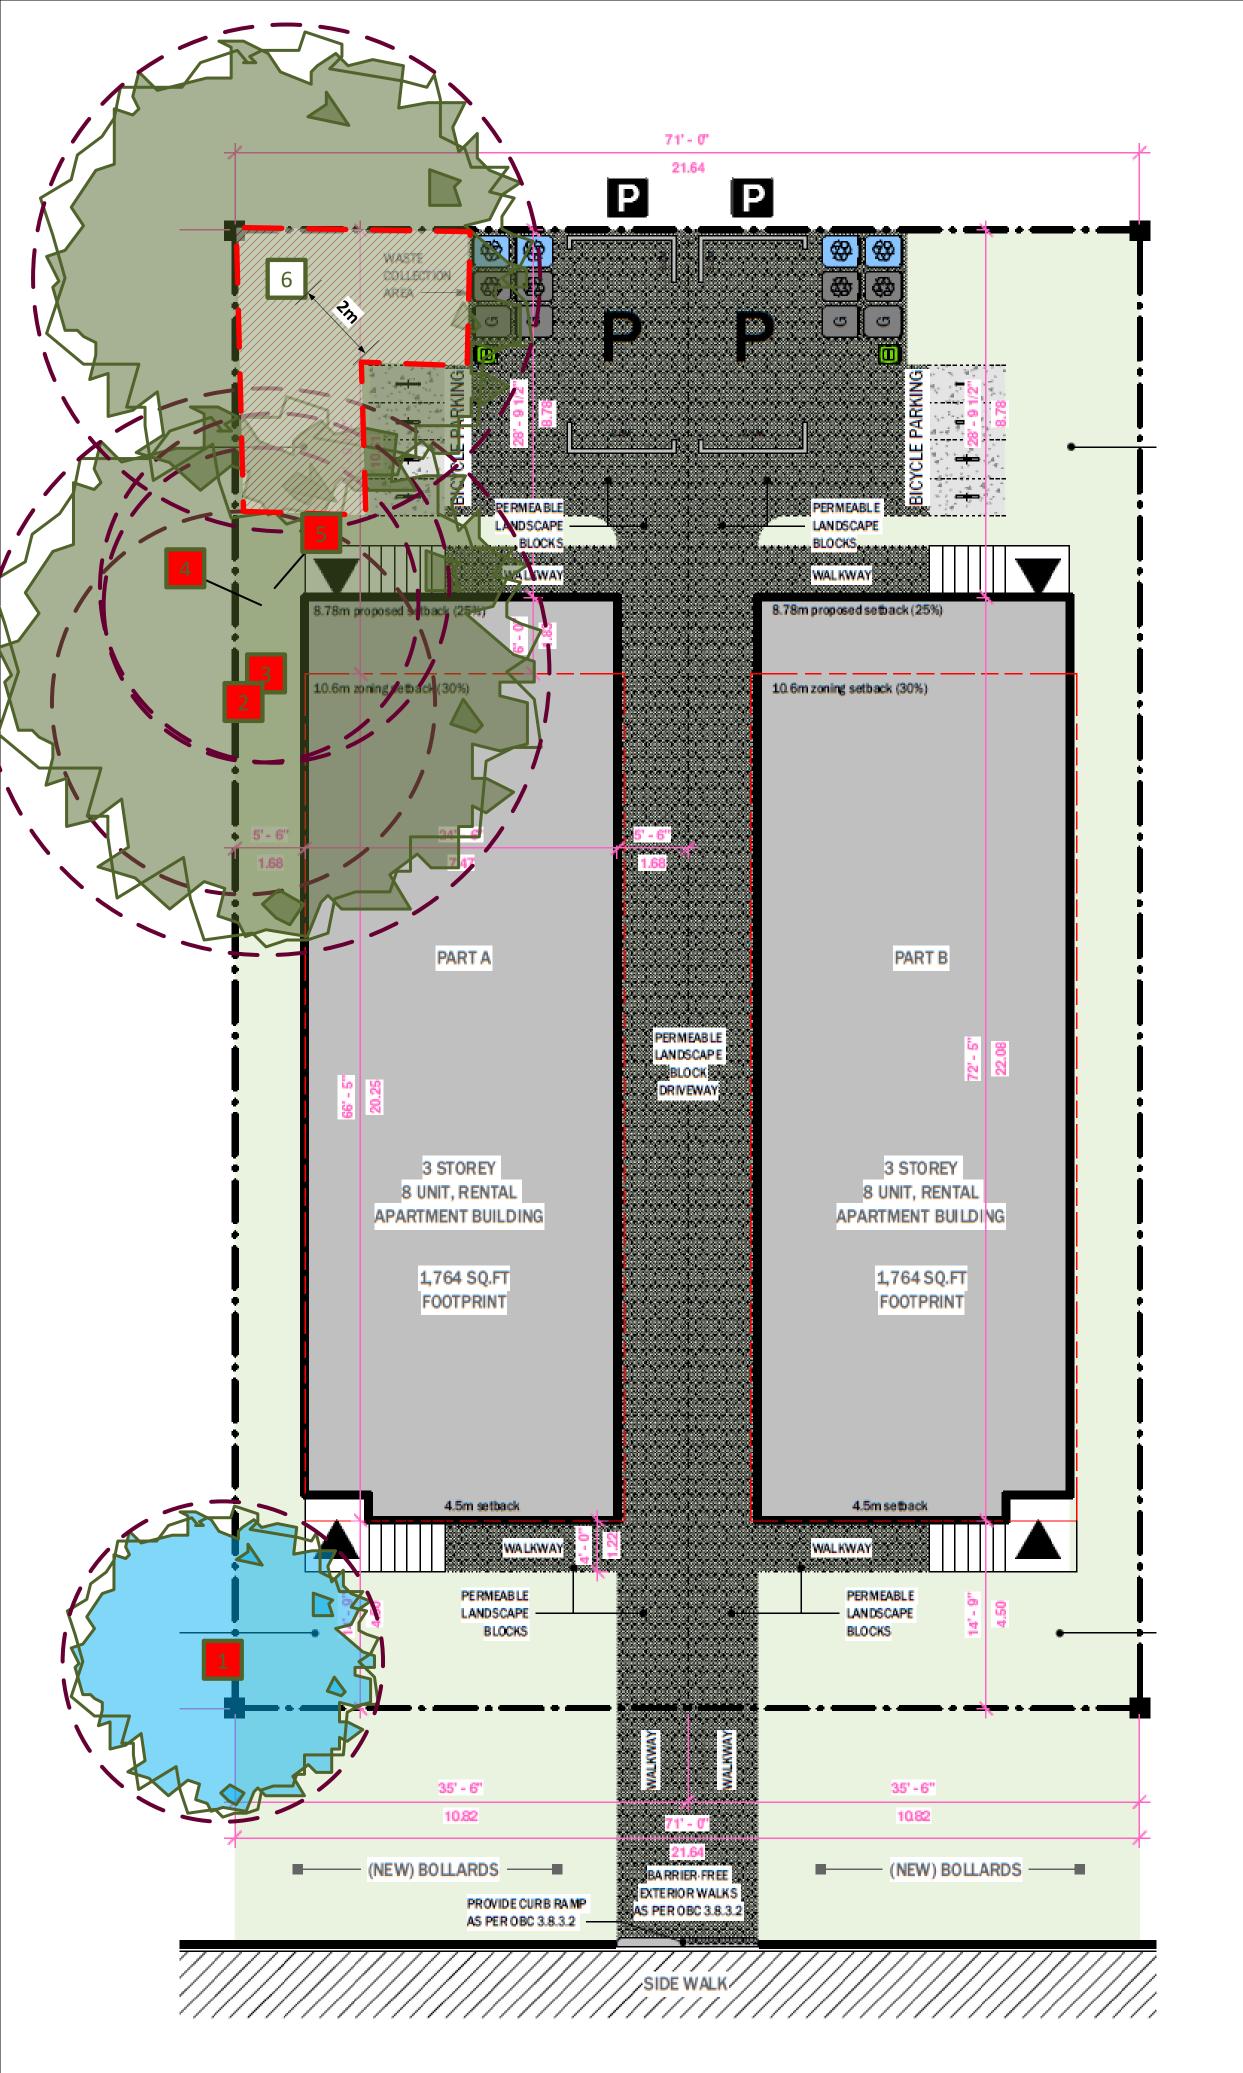
TIR Map – 251 Columbus Avenue							
Date	Revision	Prepared By					
27/11/2024	Version 1	KM

Tree ¹	Species	DBH (cm)	Tree condition	sForester recommendation
1	Norway maple (Acer platanoides)	34, 36	Poor: 34cm stem is dead. In remaining stem: heavily asymmetric crown over subject property; branch stub with decay beginning to seal over	Remove due to expected loss of canopy, poor condition, and growing location. Tree permit and permission from neighbour required for removal.
2	Bur oak (Quercus macrocarpa)	43	Fair/Good: asymmetric crown due to shading; growing next to driveway	Remove: in excavation footprint. Tree permit required for removal.
3	Manitoba maple (<i>Acer</i> negundo)	38, 34, 26, 28	Poor: multiple stems with heavy leans; fungal bodies where stems removed at base; wounds and cavities with decay	Remove: in excavation footprint. Tree permit required for removal.
4	Manitoba maple (<i>Acer</i> negundo)	35	Fair/Poor: poor form at base - growing around base of Tree 5; heavy lean to the Northeast	Remove: in excavation footprint. Tree permit required for removal.

5	American elm (<i>Ulmus</i> americana)	39	Fair: slightly asymmetric crown; slight lean North; rooting zone covered by existing garage and driveway	Remove: in excavation footprint. Tree permit required for removal.
6	American elm (<i>Ulmus</i> americana)	57	Good/Fair: small dead internal branches; rooting adjacent construction	Retain and protect as per the City of Ottawa Tree Protection Specifications (March 2021).

Prior to any site works, protective fencing should be installed around the Tree Protection Area as indicated in the attached Tree Information Map and maintained until all construction on site has been completed as per the City of Ottawa Tree Protection Specifications (March 2021).
