Dendron Forestry Services

Tree Information Report

Date of Report: January 31, 2025

Property Address: 135 Marlborough Avenue

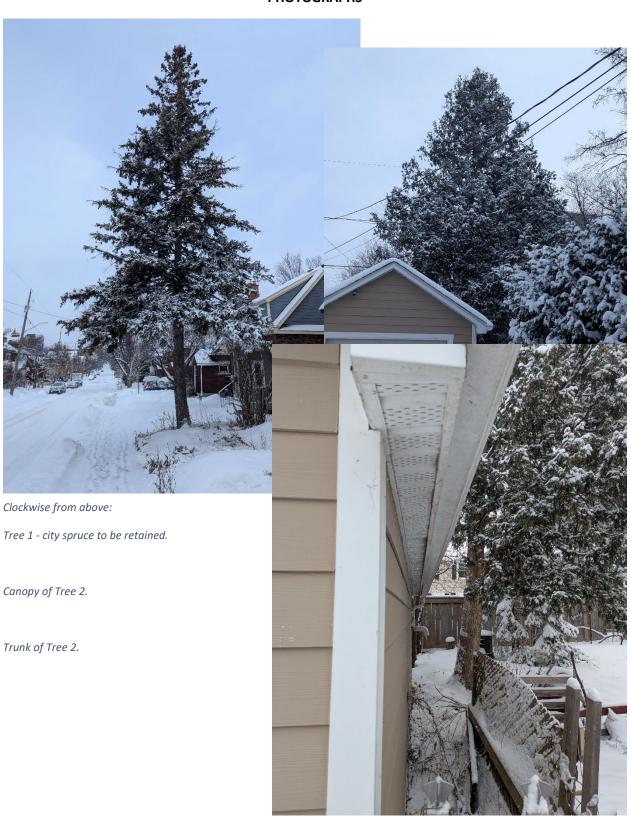
PHOTOGRAPHS

Tree 1 is a spruce in fair condition. The tree is currently growing in a raised garden bed at approximately a 10cm higher grade than the existing driveway. Due to the grade change, along with the presence of the small retaining wall and existing driveway, it is unclear how many roots the tree may have developed on the subject property. As the driveway is proposed in approximately the same location as the existing one, the impacts to the tree are expected to be minimal.

Similarly, **Tree 2** is growing close to the existing garage. As the proposed workshop is proposed in the same location as the existing garage, impacts to the root system are difficult to determine – the tree may not have developed many roots under the existing garage. Approximately 10% of the tree's canopy may need to be removed to accommodate the building. Any required pruning is to be completed by a certified arborist.

For both trees, care is to be taken not to tear roots during removal of the existing infrastructure. If roots >2" in diameter are discovered under the driveway or garage and need to be removed to facilitate construction, an arborist is to be on site to make a determination about the tree's stability and possibility for retention going forward.
