Tree Information Report v2.0

Submitted as part of Committee of Adjustment Application to the City of Ottawa

Date of Report: March 4, 2025

Property Address: 1686 Ortona Avenue

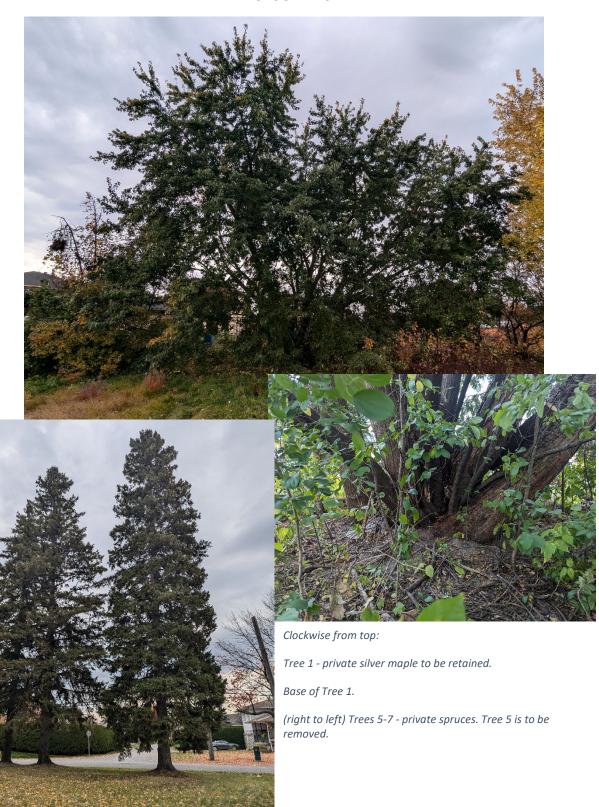
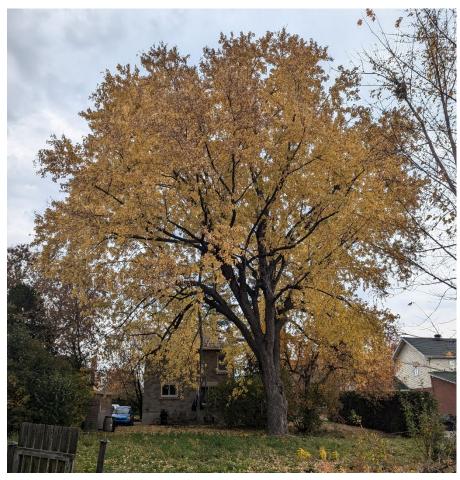
The client has informed Dendron that **Tree 4** has been removed.

Tree 4 - private silver maple which has been removed.
