## TREE CONSERVATION REPORT

2506 Innes Road

**Dendron Forestry Services**

May 2, 2024

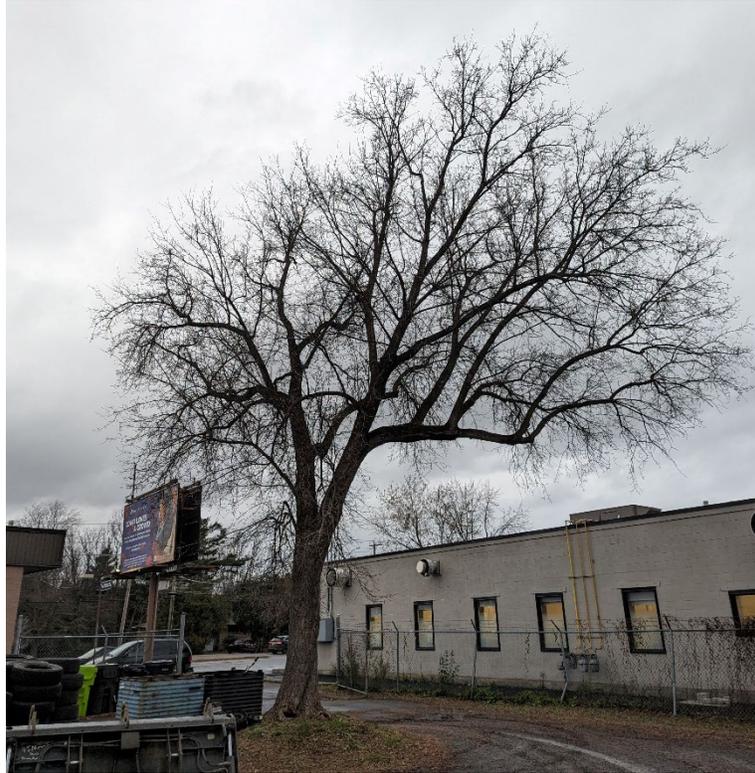
Above: Tree 1 - private manitoba maple to be removed.

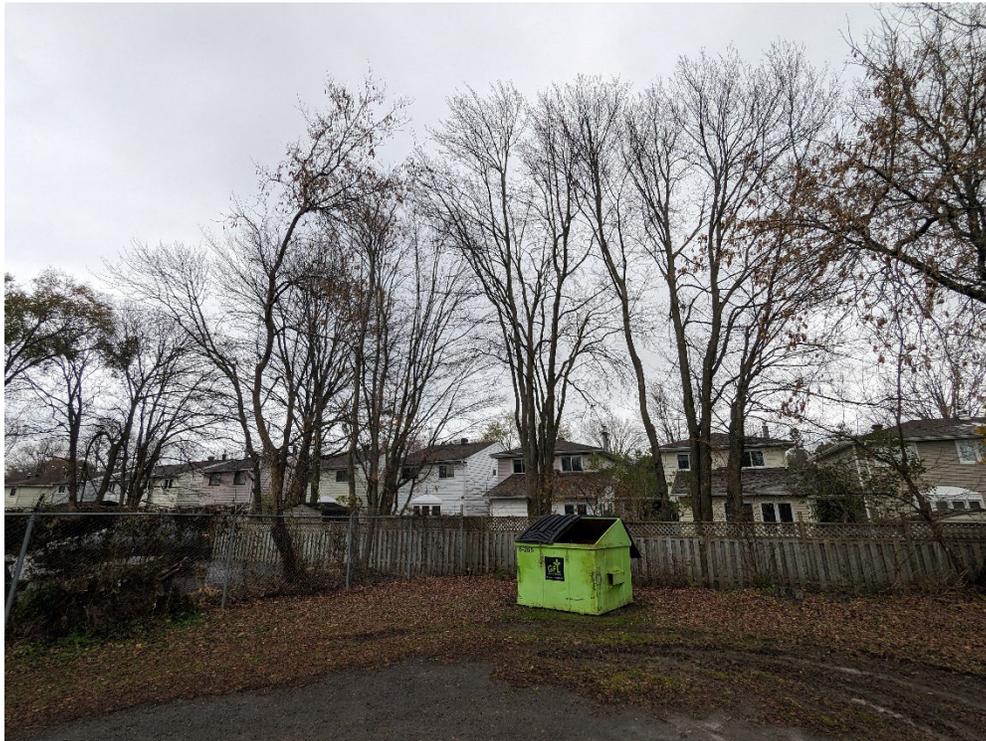
Below: East corner of the property, including Trees 2-6

**Trees 4-6** are adjacent maples of varying health and distance from the property line. Due to excavation for the proposed retaining wall and the 75cm grade change, some of these trees are expected to decline quickly and are therefore recommended for removal. However there may be a possibility to retain some stems from the groupings. To accomplish this, the following steps are recommended: that the proposed retaining wall be marked out along the ground, the DBH of each trunk be measured (they were estimated during the site visit) as well as the distance between each trunk and the line for the retaining wall; those that are further than 3x their diameter from the wall can be marked for retention. Then, when it comes time for excavation, the roots can be revealed along the line of excavation and a certified arborist can be on site to ensure that roots are properly severed and no stability concerns remain.

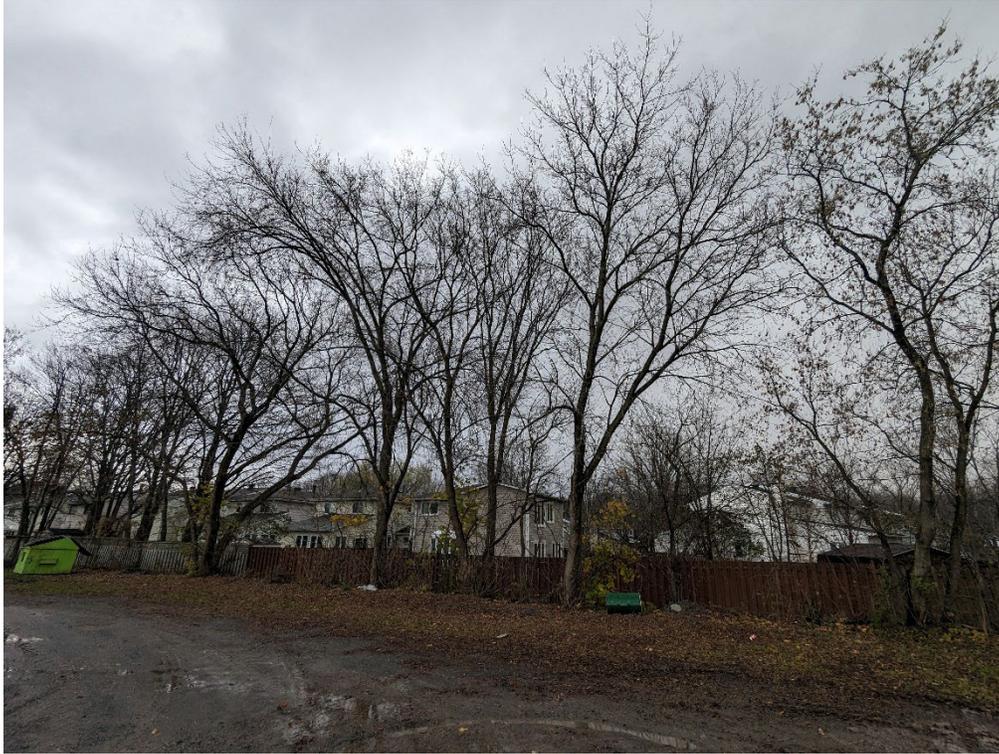
Above: Trees 4-21 along the south property line.

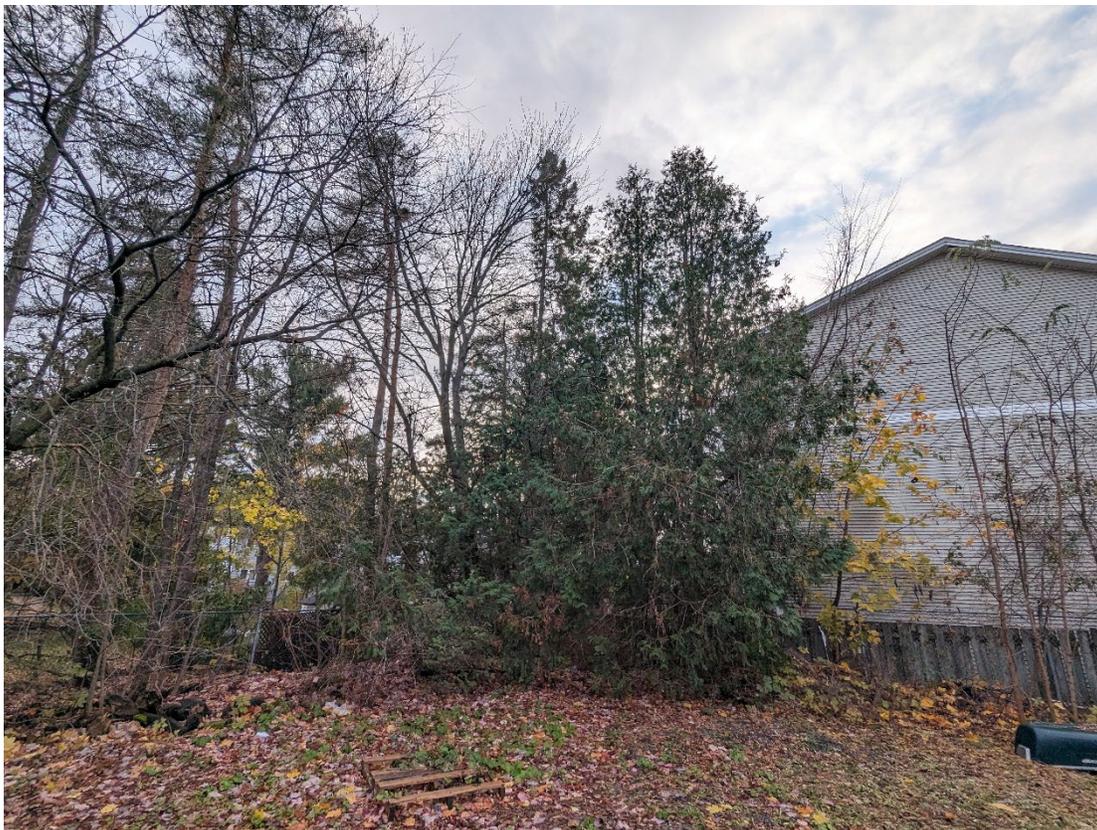
Below: southwest corner of the property, including Trees 23-33

The southwest corner (**Trees 25-32**) has a high percent canopy cover due to large trees on the adjacent properties. These trees are at a lower grade from most of the subject property (approximately 10-30cm). Fencing should be erected at the edge of the proposed retaining wall, and any roots that are encountered during excavation are to be cleanly severed by hand to promote faster sealing after construction. **Tree 25** is a young Manitoba maple approximately 80cm from the proposed retaining wall. This is 4.9x its DBH, which is within best management practices for maintaining stability. What is more, Manitoba maples are known to be able to withstand construction. This tree is recommended for retention, as it could grow into a large-canopy tree in the future. **Tree 31** is a large Freeman maple on the adjacent property. The retaining wall is proposed to come approximately 4.75m from the base of the tree and remove approximately 4% of its CRZ.

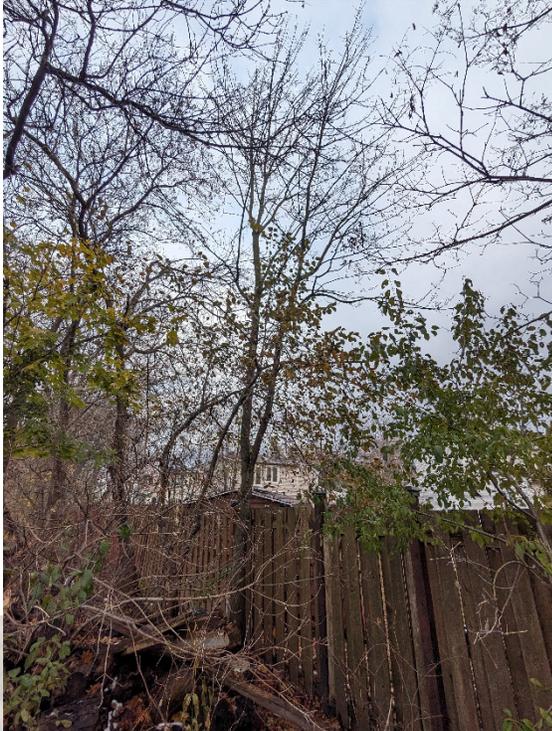
Left: Tree 22 – private maple to be removed.

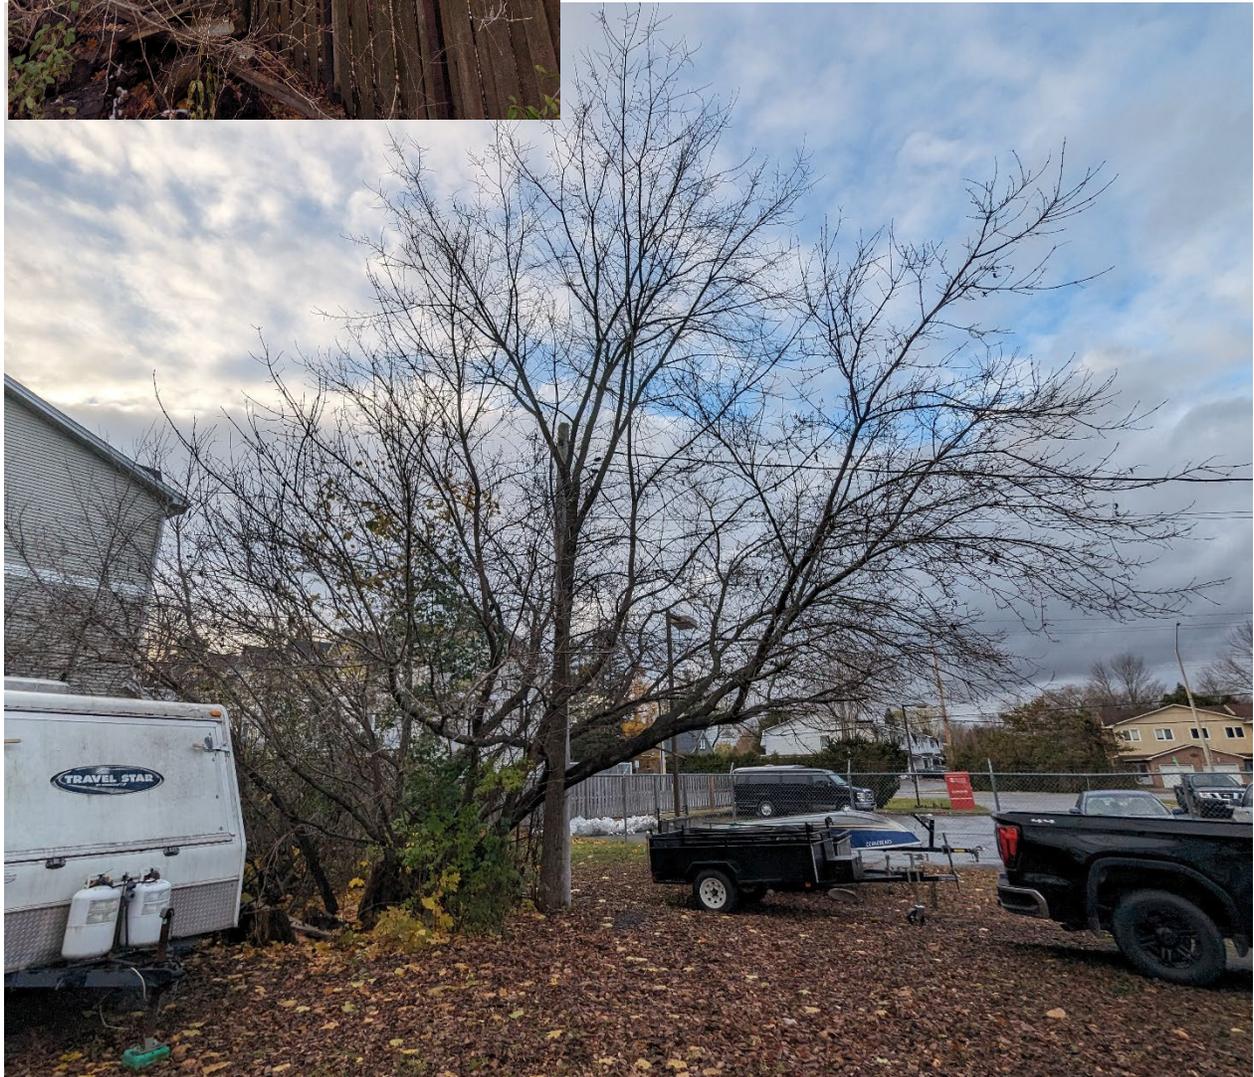
Below: Trees 34-36 - to be removed
