TREE CONSERVATION REPORT V2.0

1098 Ogilvie and 1178 Cummings

Tree Conservation Report submitted as
Partial Requirements for a Site Plan Control
Application, August 24, 2021

Prepared for 6770967 Canada inc by
Dendron Forestry Services

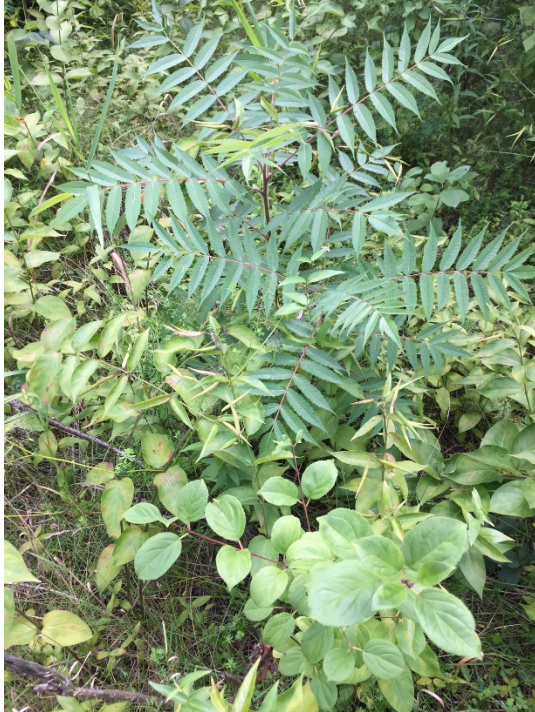
Other invasive plant species identified include dog strangling vine, Japanese knotweed, among others. The general health of the trees in the forest is fair to poor. Those older trees that are located sporadically through the forest, such as cottonwood and willow, are multi-stemmed and in poor health.

Figure 1: Example of invasive dog-strangling vine competing with a native sumac

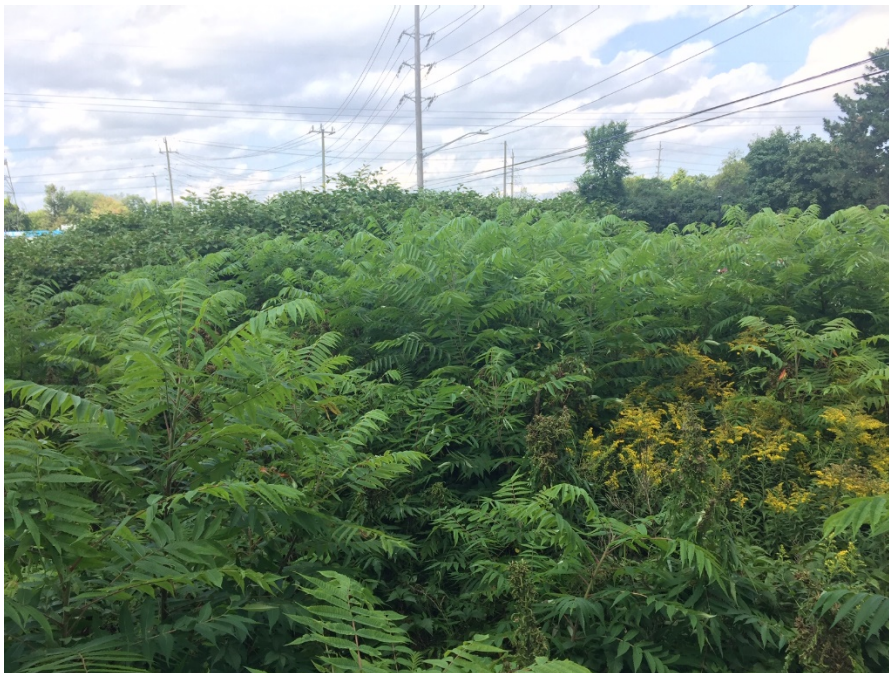
Figure 2: Open area in the northeast section (facing north) - with a patch of Japanese knotweed in the distance

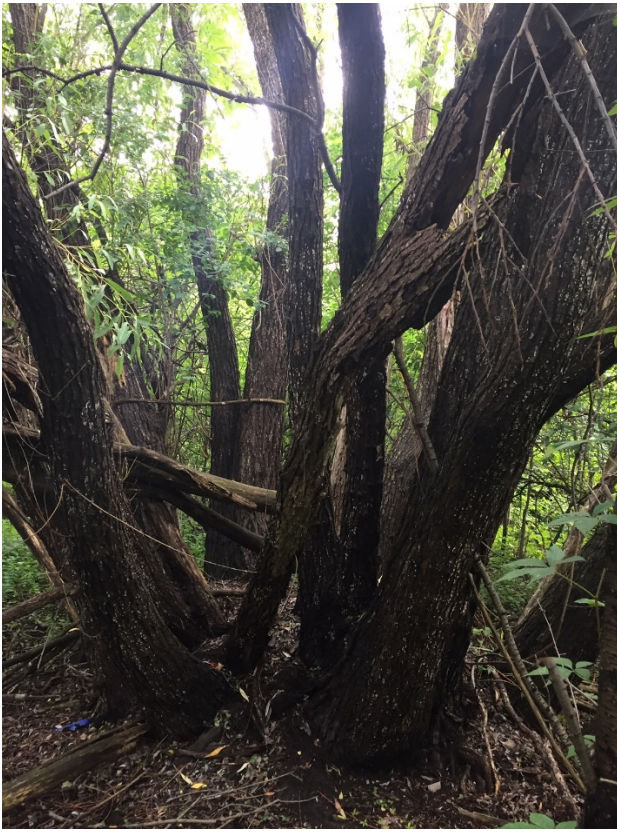
Figure 3: Large multi-stemmed willow in poor health

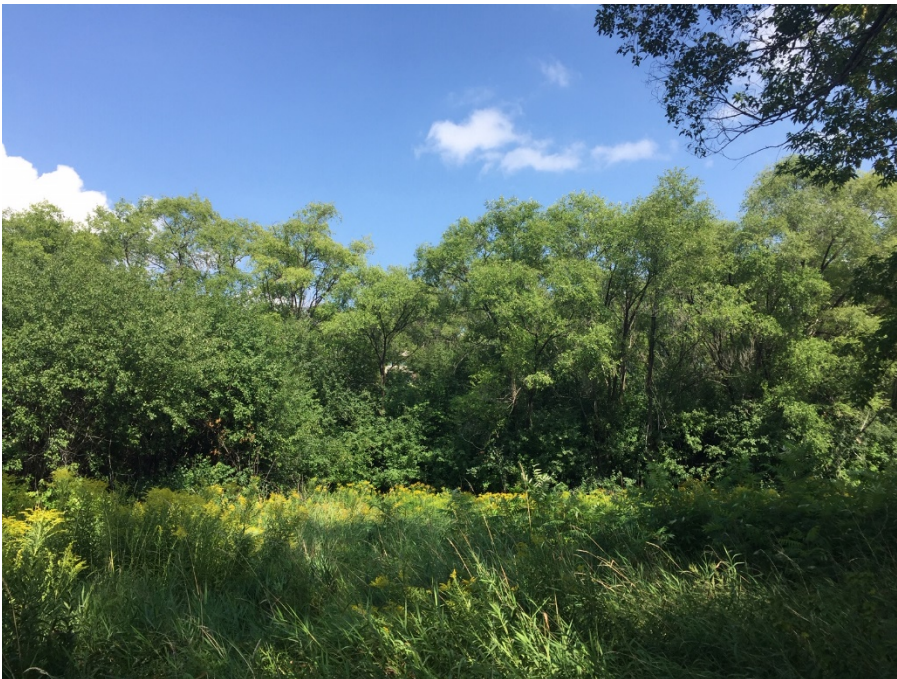
Figure 4: The Siberian elm forest in the south with open field in front - facing east

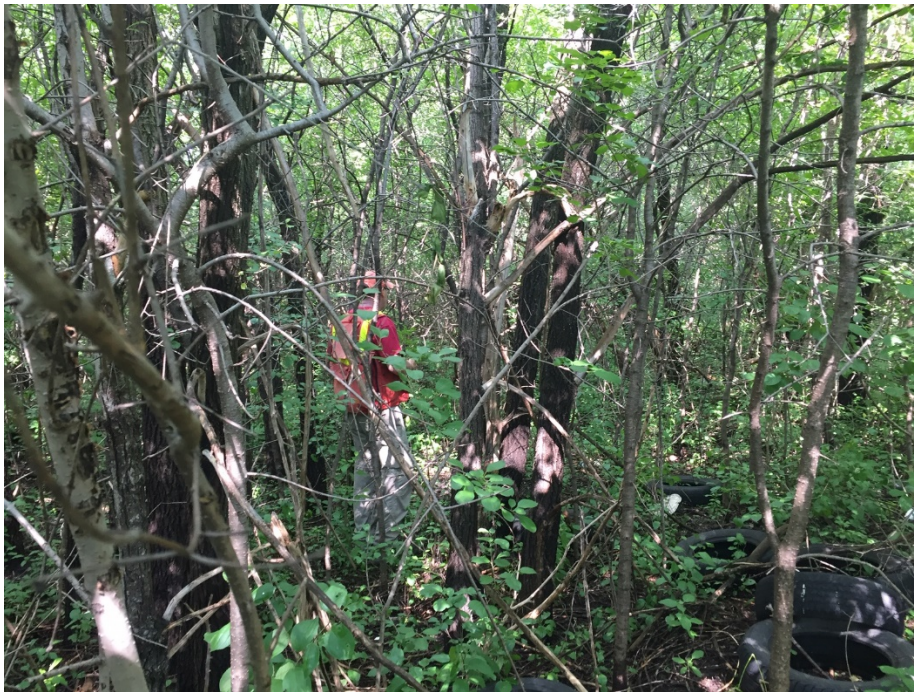
Note that the buckthorn was not included in the inventory as most of the stems are under 10 cm in diameter. However, it makes up a significant portion of the forest and the density varies from medium

to heavy throughout both stands. The only areas where buckthorn is not present is in the open areas. There were no species at risk observed on the site.

Figure 5: The dense understory of buckthorn in the Siberian elm stand

Based on the site plan provided by the client, 0.0772 ha of the southern section will be retained for parkland contribution. This area is made of the Siberian elm forest with a slight area of field along the west side. The Siberian elm forest is in fair health and has a significant amount of buckthorn in the understory, both of which are undesirable, non-native, invasive species. There will be a significant grade change (50-70 cm) in the surrounding development which would most likely increase the water flow to this area. The area is already relatively wet, and more moisture would likely impact tree health negatively. Furthermore, there is a significant amount of park infrastructure proposed at this site (see Landscape and Grading Plans) that includes walking paths and a possible play area. Based on these factors, removal of the existing trees in this section is the most practical option with the intention of replacing them with a high number of native trees and shrubs.

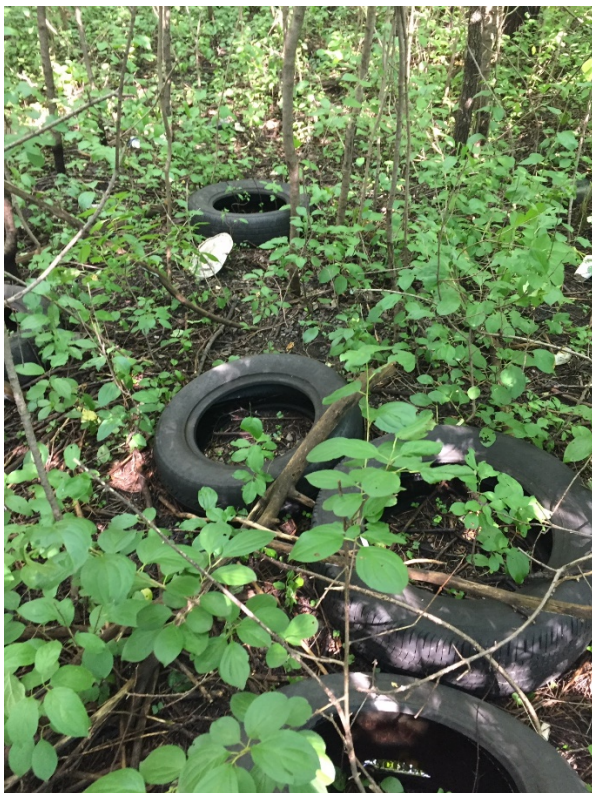
Figure 6: Example of garbage scattered throughout the entire forested area
