254 ARGYLE AVENUE

Church Relocation Scenarios Analysis

Project Number: 2023-049-2

August 23, 2024

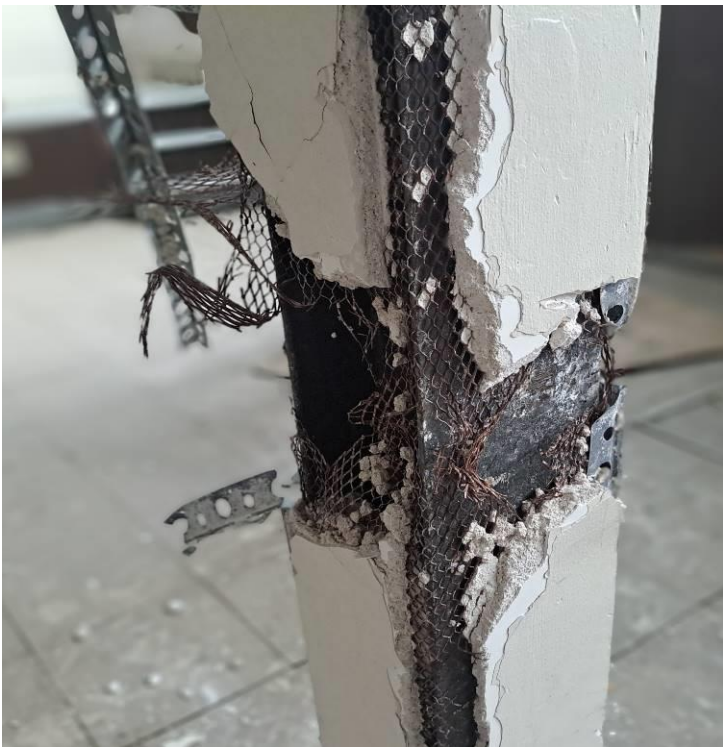
Figure 5: Steel Column in Basement

- The steel columns are size W150x22, (d x b = 152mm x 152mm, see Figure 5).
- The steel beams are size W460x68 (d x b = 459mm x 154mm, see Figure 6).
- Total wall thickness was measured as 360mm (14 inches).
- The height from the basement floor to the left-hand basement windows is approximately 175 cm (70 inches).
- The height from the basement floor to the right-hand basement windows is approximately 137 cm (54 inches).

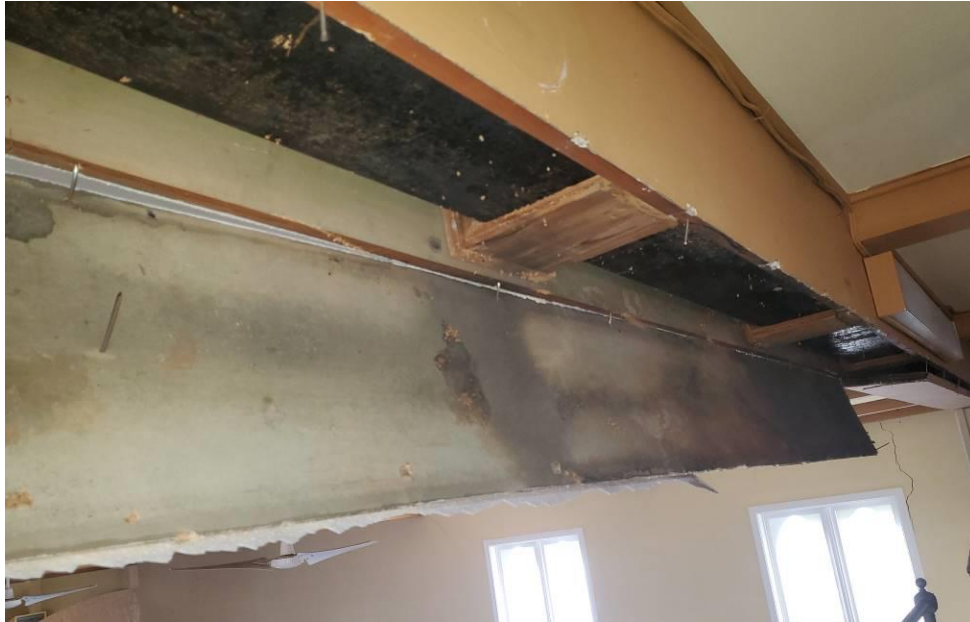
Figure 7: Steel Beam Supporting Roof

- The steel beams are size W460x60 (see Figure 7).
- The total wall thickness is approximately 360 mm (14 inches).

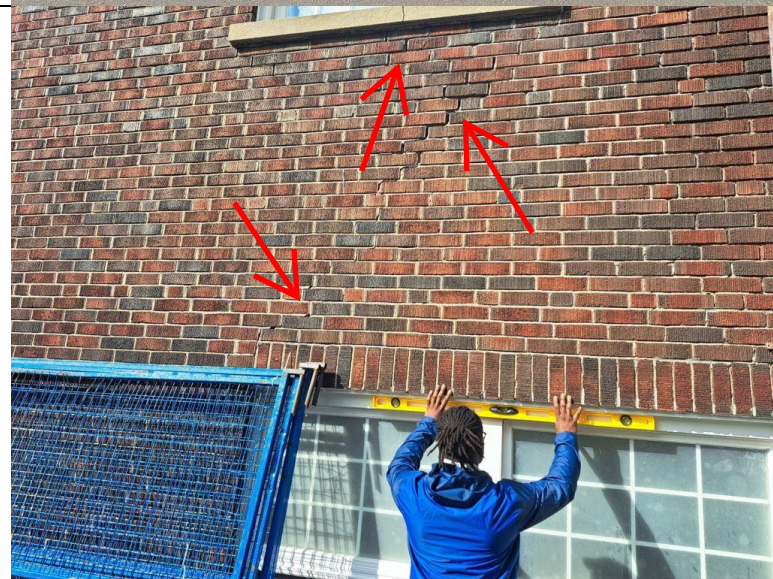
Photo 5
Stepped wide cracks noted along the South wall

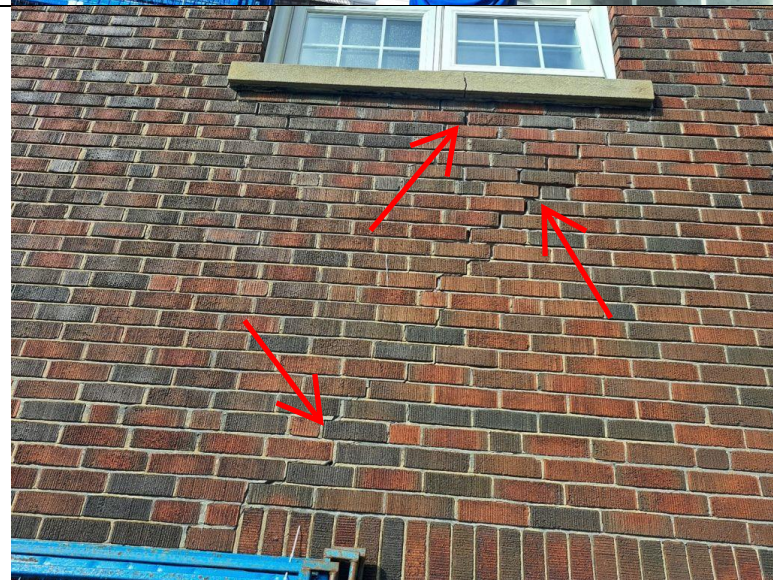
Photo 6
Stepped wide cracks noted along the South wall

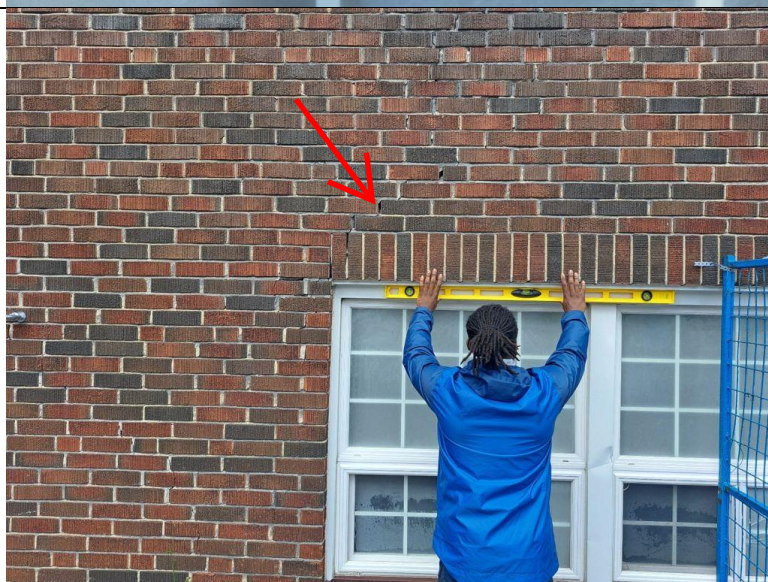
Photo 9

Stepped wide cracks noted along the South wall

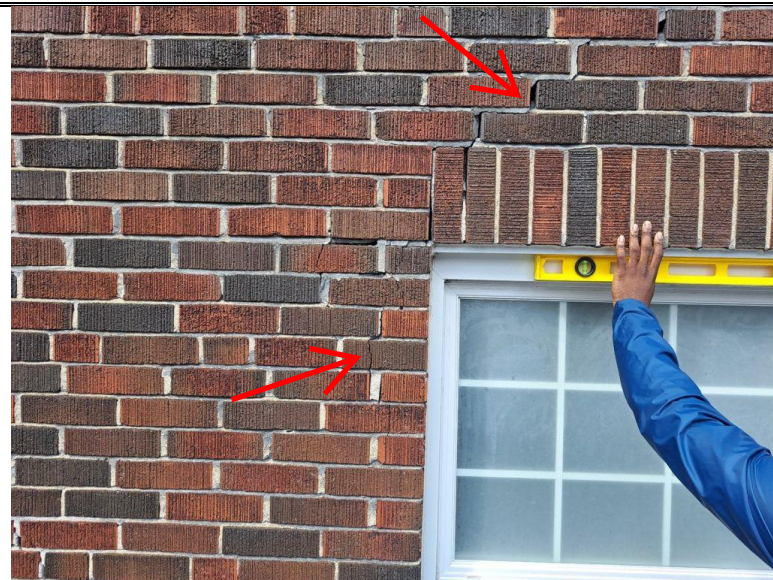
Photo 10
Stepped wide cracks noted along the South wall

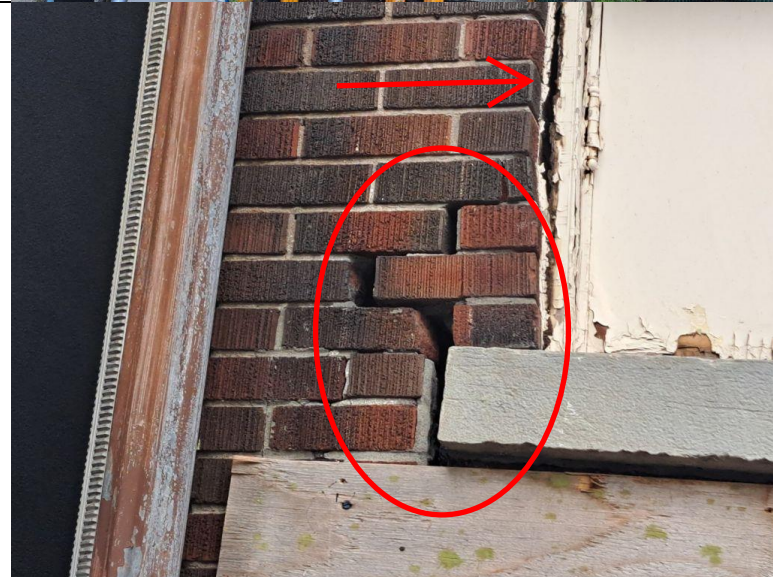
Photo 14

Huge cracks noticed at the Southeast corner

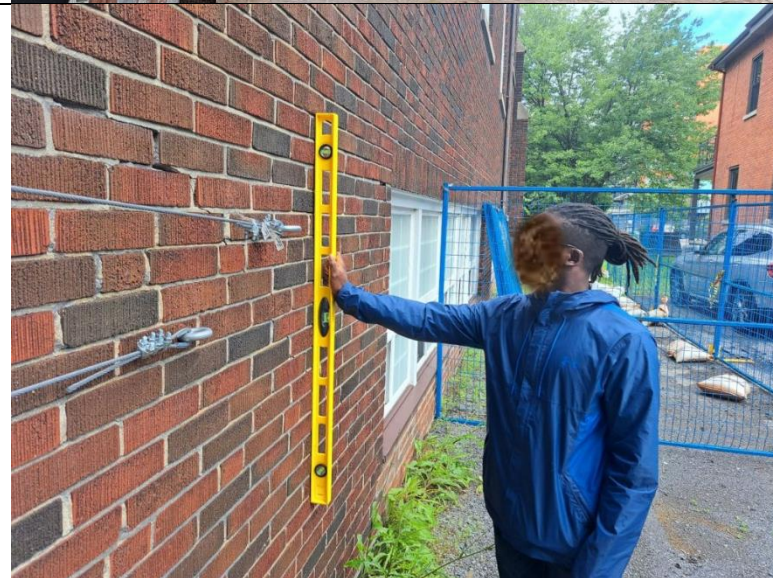
Photo 15

The South wall is leaning to the outside by 1cm for every meter

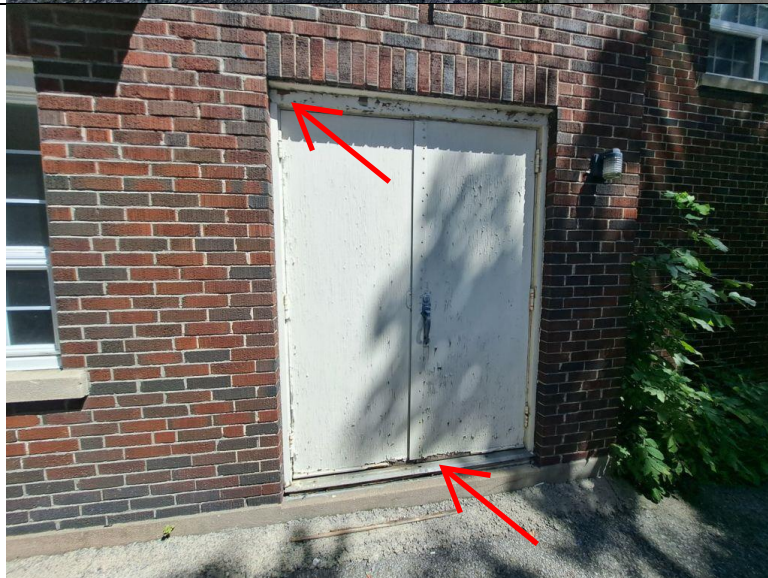
Photo 18
The side door is in a poor condition

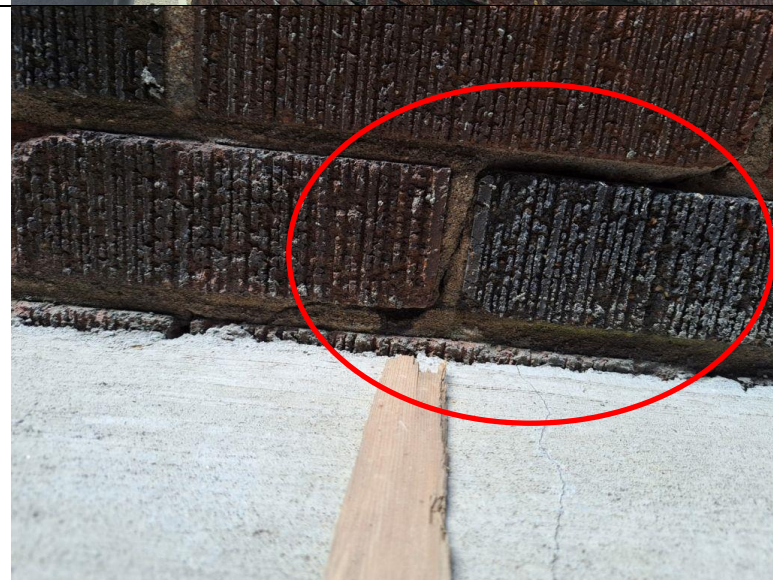
Photo 21

One step crack in the middle of the East wall

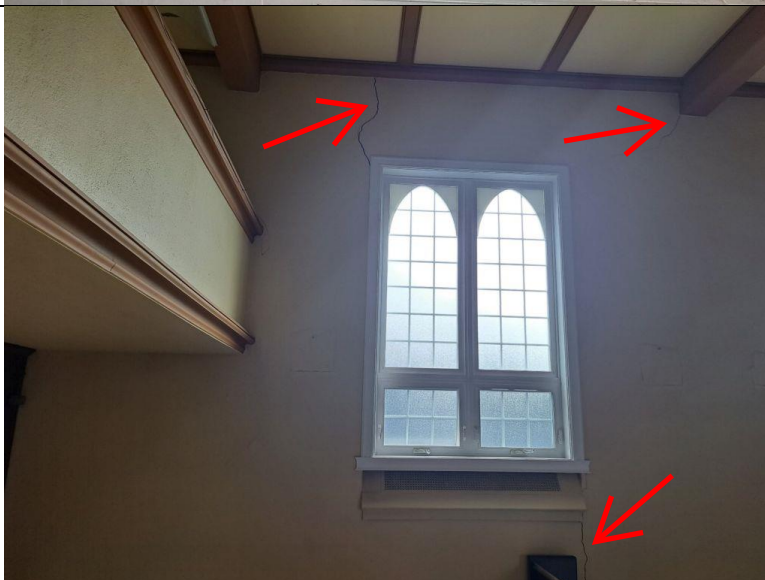
Photo 24
Cracks are noted along the left side (South) wall

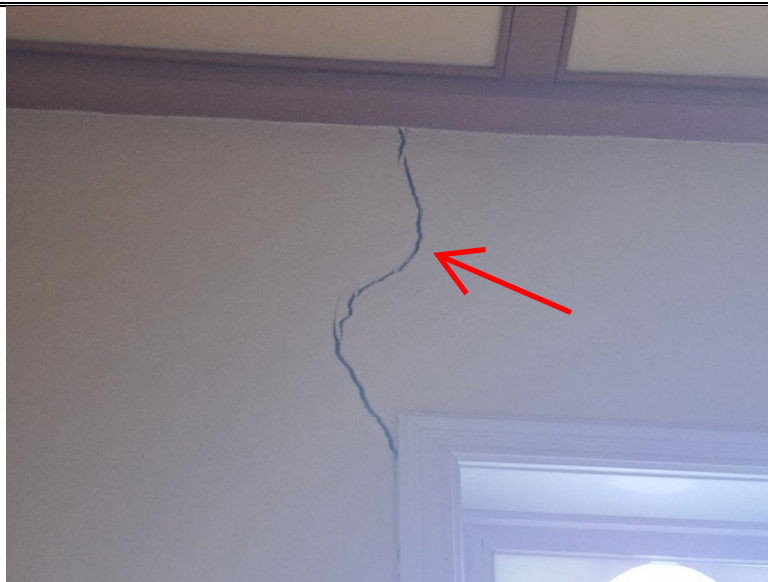
Photo 25
Cracks are noted along the left side (South) wall

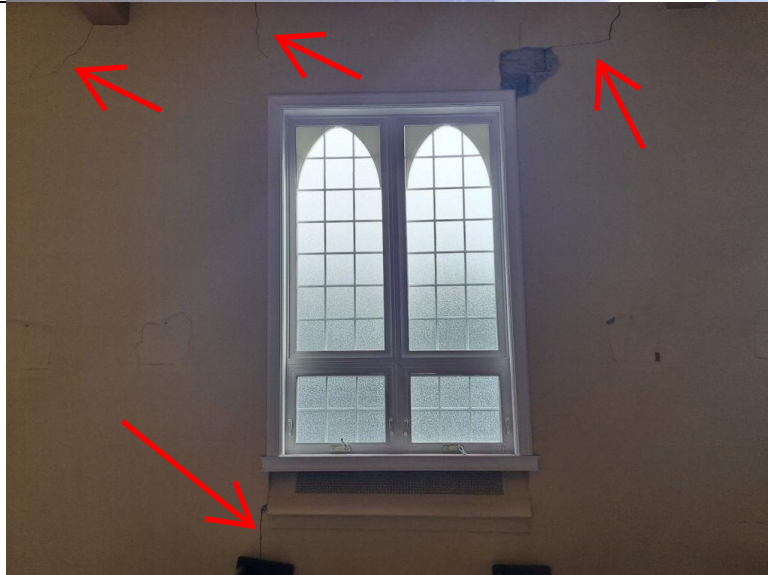
Photo 26
Cracks are noted along the left side (South) wall

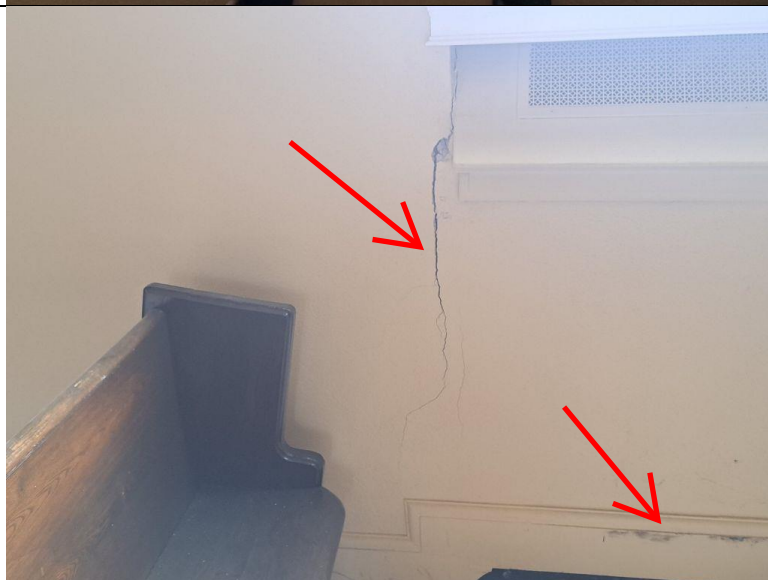
Photo 27
Cracks are noted along the left side (South) wall

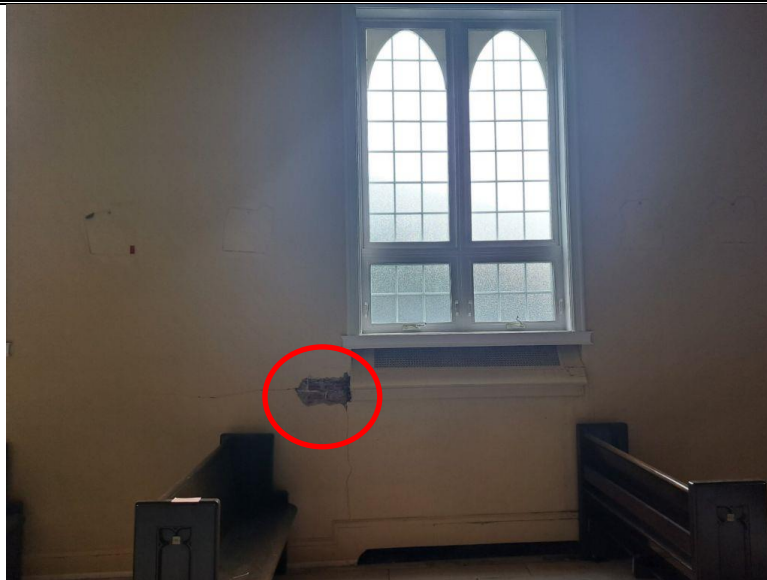
Photo 28
Cracks are noted along the left side (South) wall

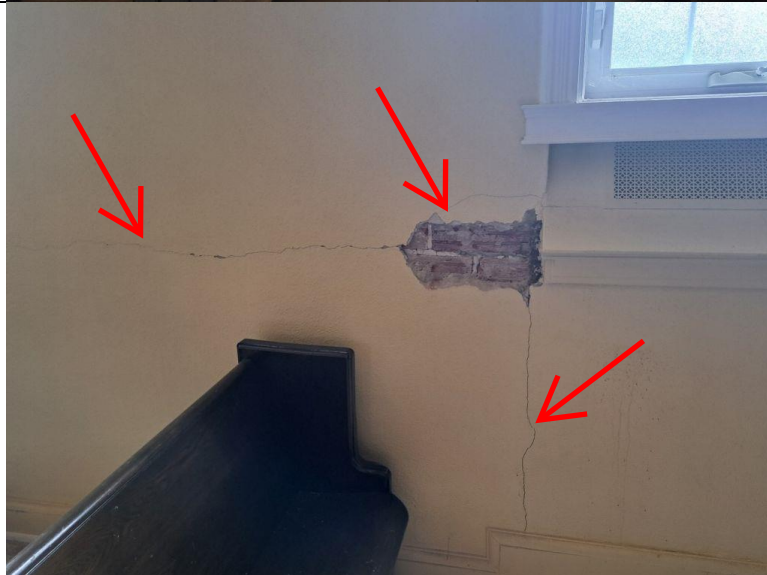
Photo 29
Cracks are noted along the left side (South) wall

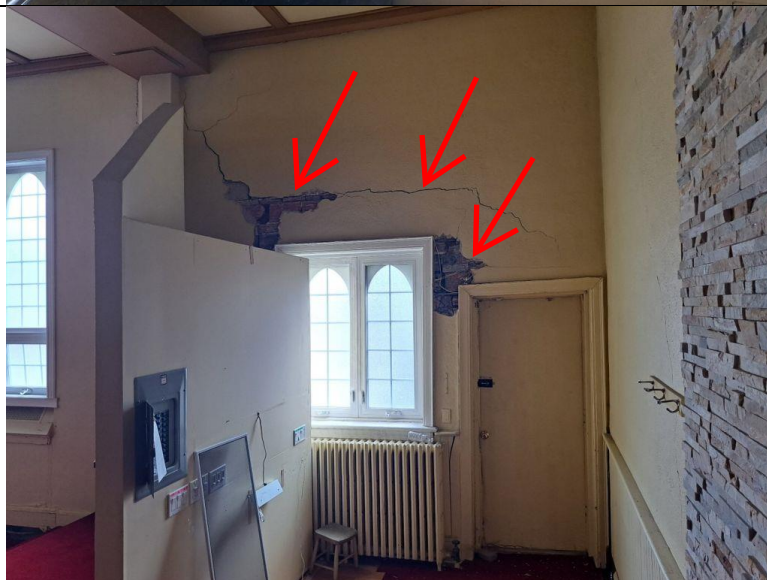
Photo 30
Cracks are noted along the left side (South) wall

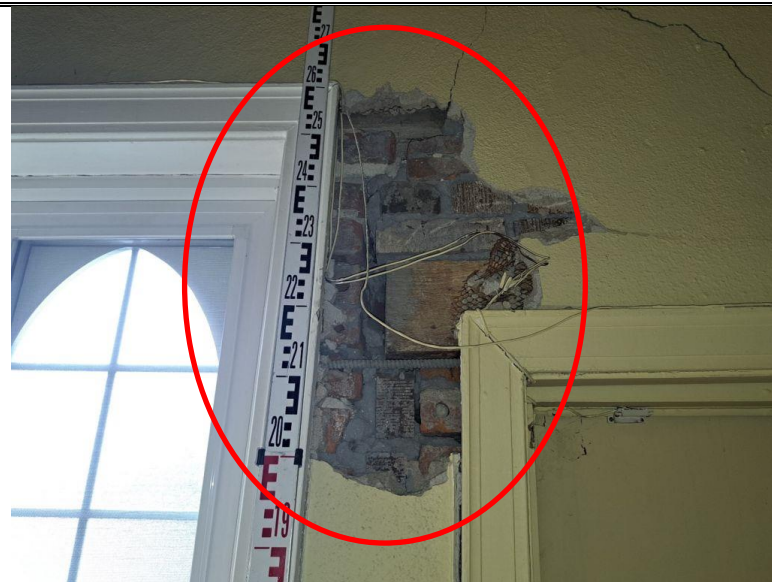
Photo 31

Plaster has spalled exposing the terracotta hollow core blocks and the wood lintel

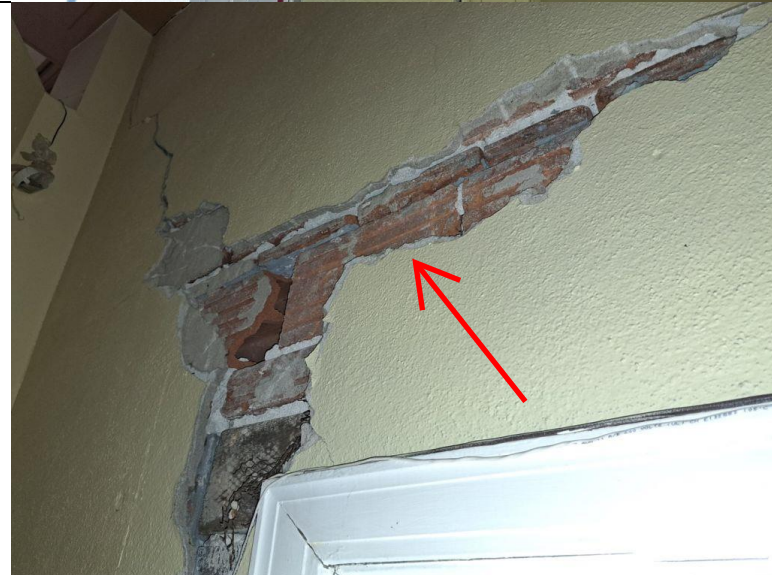
Photo 32

Plaster has spalled exposing the terracotta hollow core blocks and the wood lintel

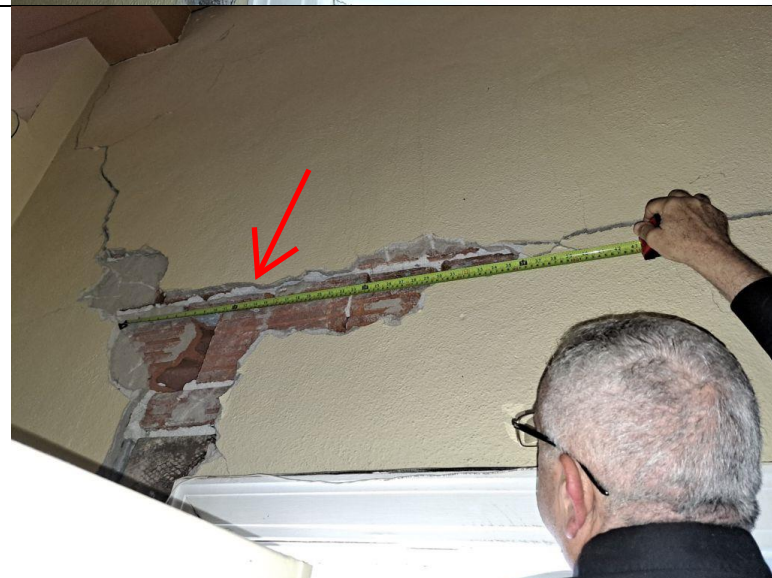
Photo 33

Plaster has spalled exposing the terracotta hollow core blocks and the wood lintel

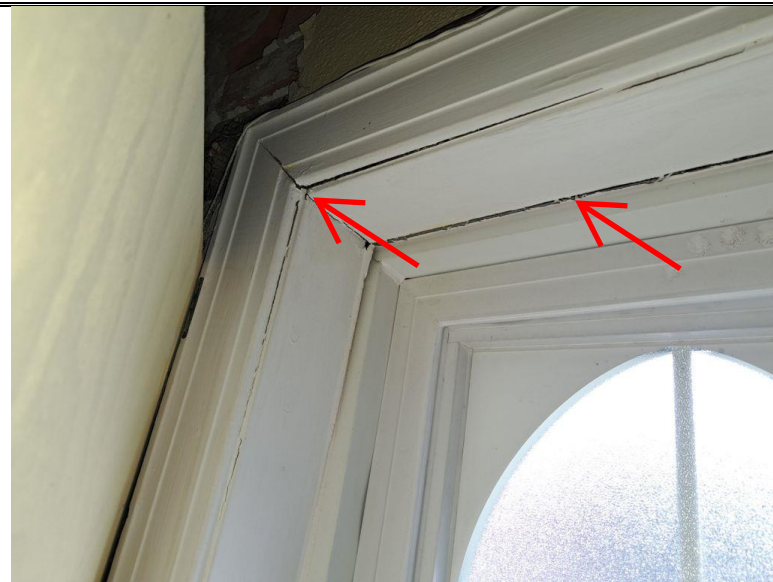
Photo 34

Sever damage and cracks to the fire exit door at the Southeast corner

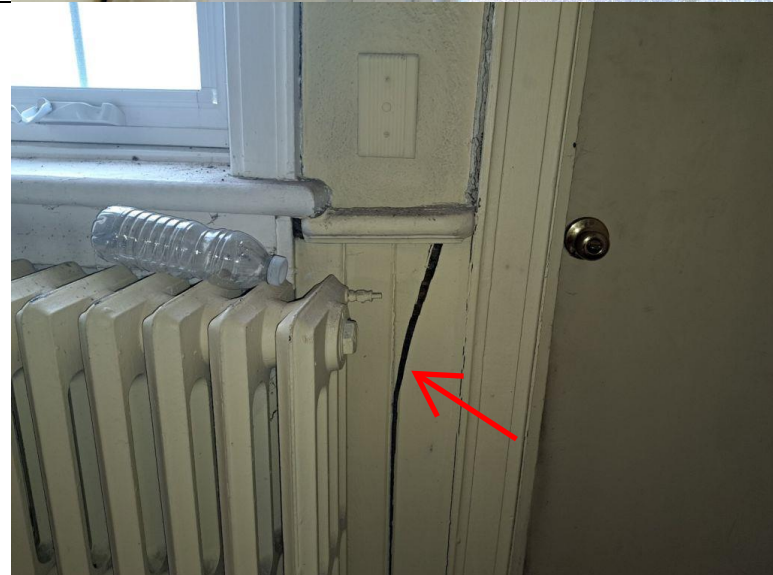
Photo 35

Sever damage and cracks to the fire exit door at the Southeast corner

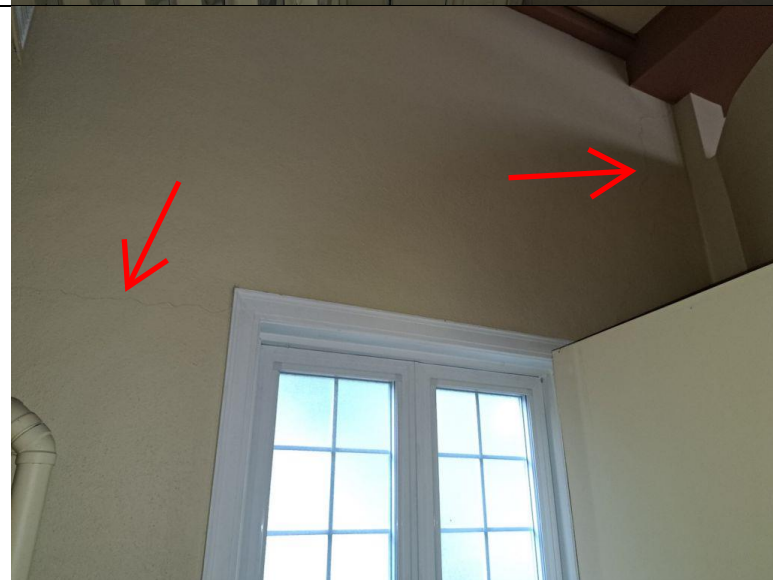
Photo 36

Several hair cracks at the top and the bottom of the windows and door lintel, and painted plaster with average quality

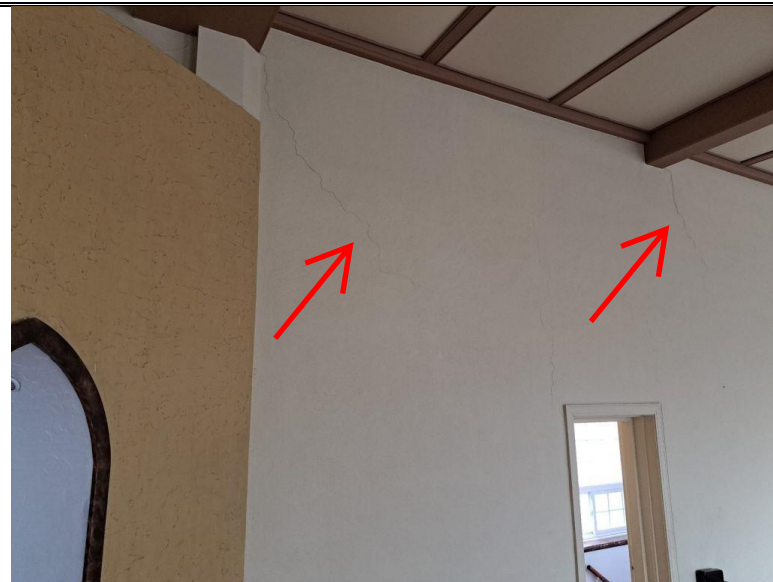
Photo 37

Several hair cracks at the top and the bottom of the windows and door lintel, and painted plaster with average quality

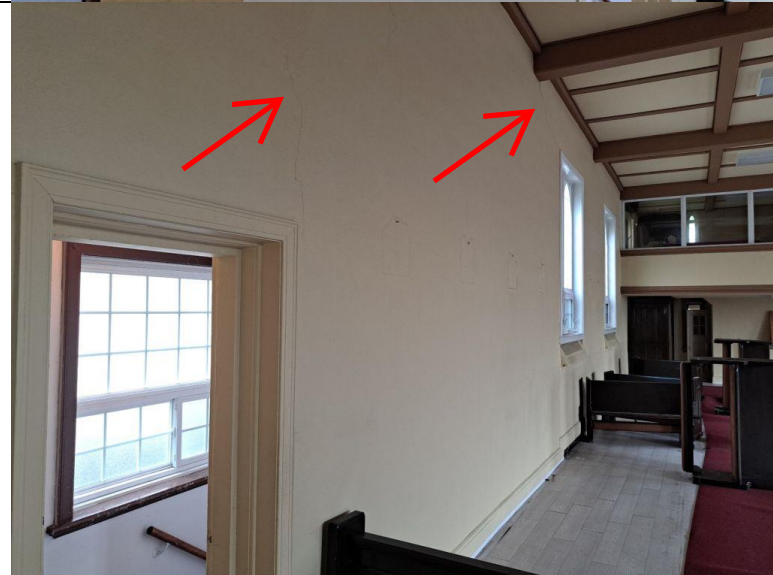
Photo 38

Several hair cracks at the top and the bottom of the windows and door lintel, and painted plaster with average quality

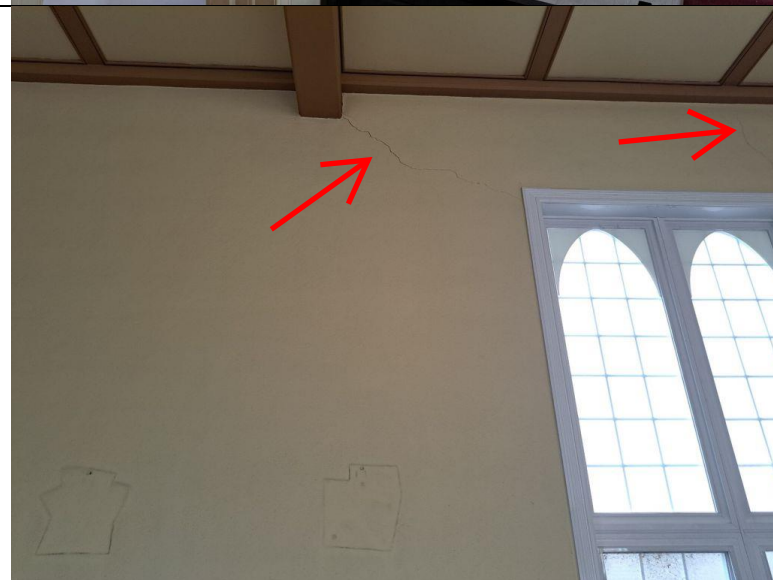
Photo 39

Several hair cracks at the top and the bottom of the windows and door lintel, and painted plaster with average quality

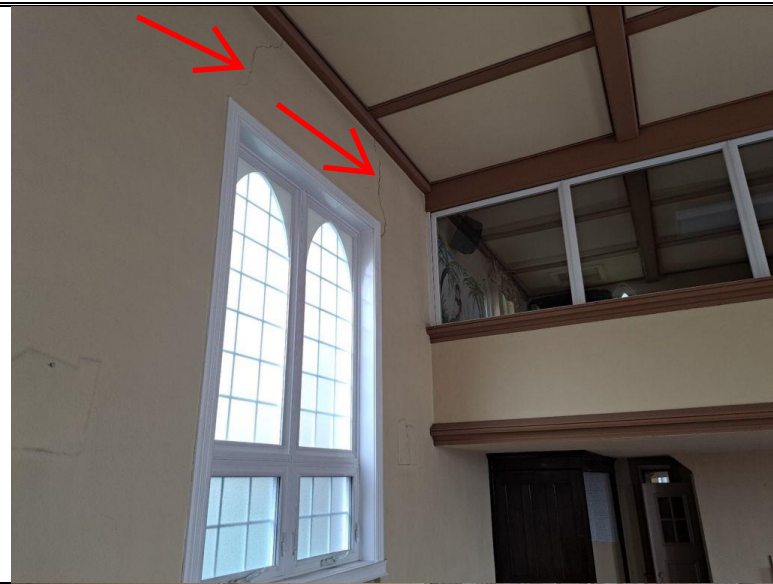
Photo 40

Several hair cracks at the top and the bottom of the windows and door lintel, and painted plaster with average quality

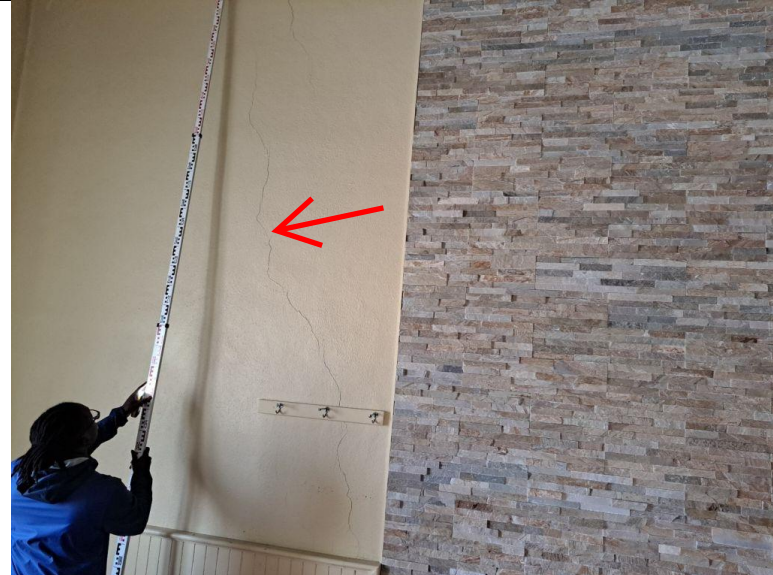
Photo 41

A vertical crack of 1mm width is noted from the top to the bottom of the rear wall (East side)

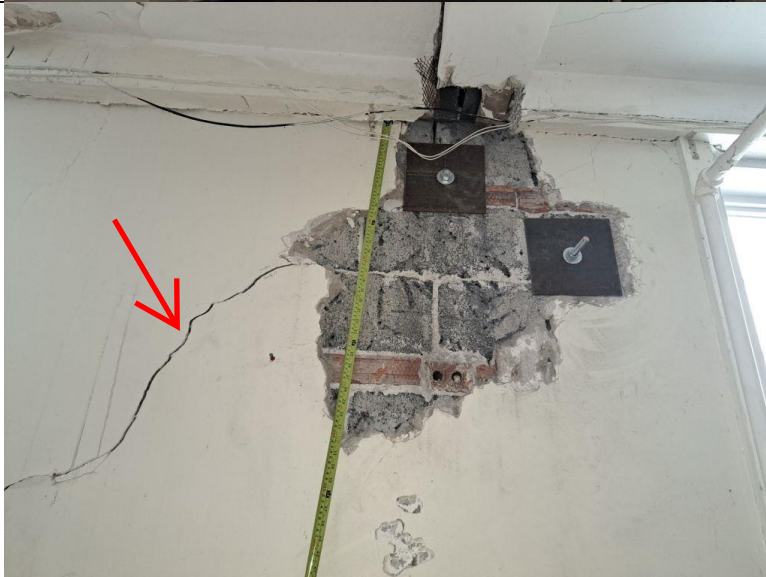
Photo 50
Diagonal cracks of 4mm width

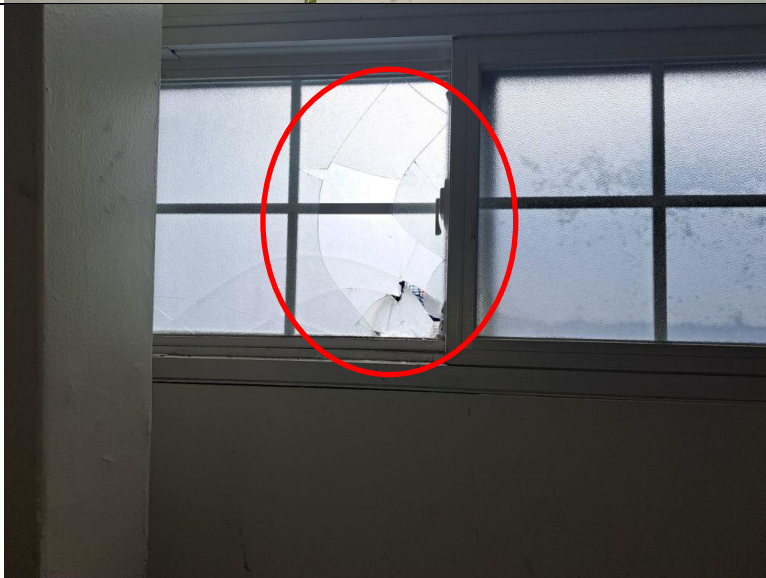
Photo 51
Windows with broken glass

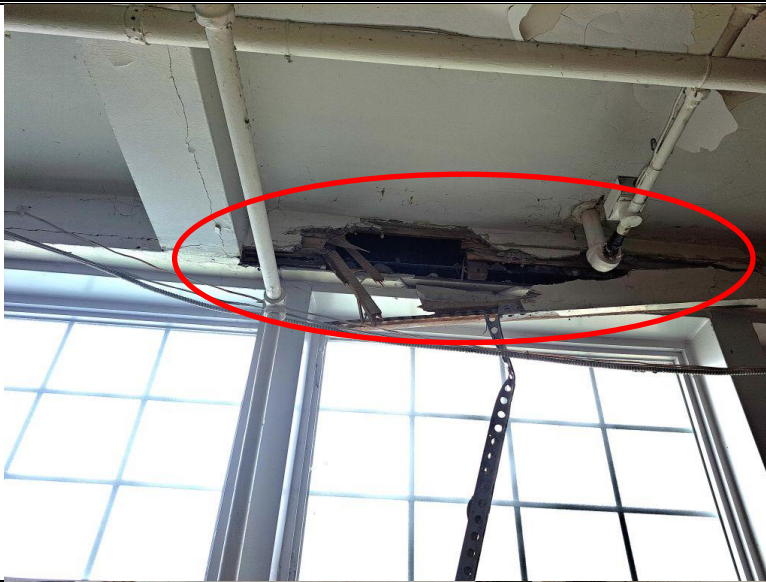
Photo 52
Sever damages at the Southeast corner

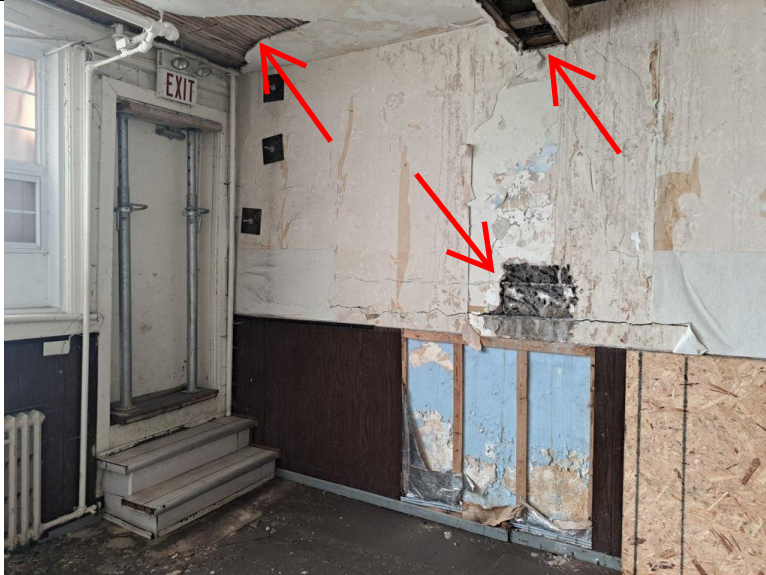
Photo 53
Sever damages at the Southeast corner

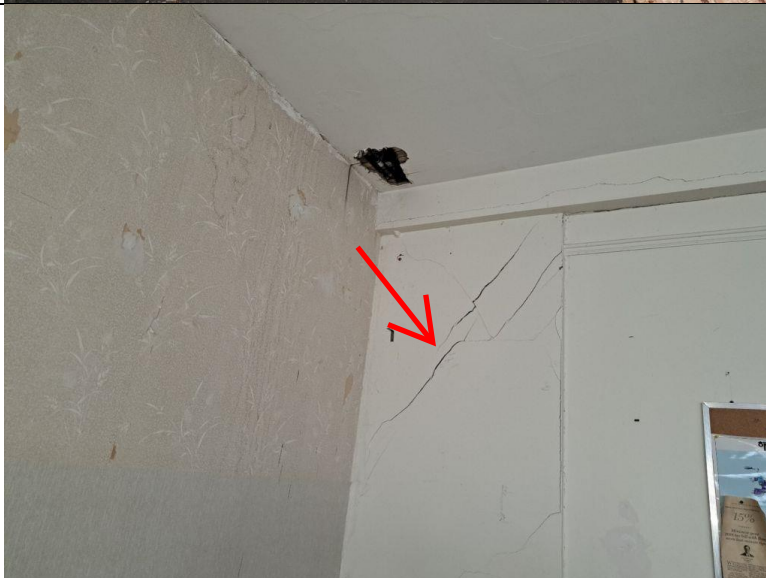
Photo 54
Diagonal cracks of the right (North side) wall

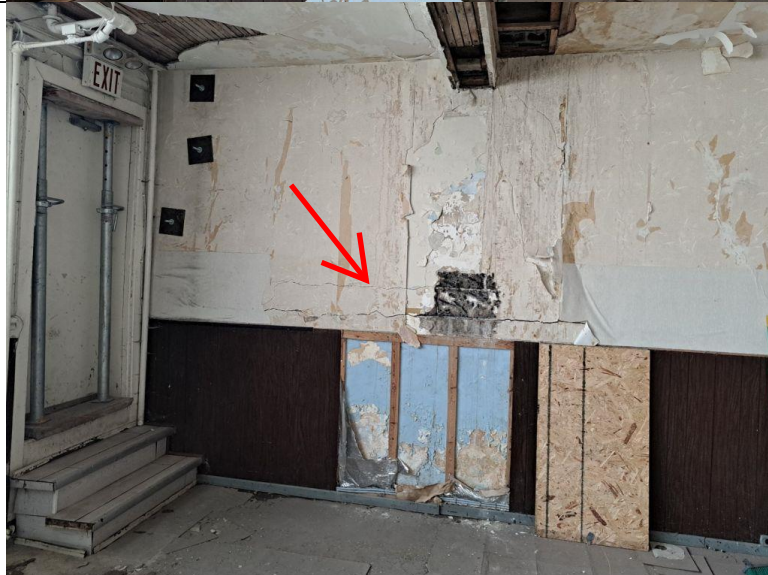
Photo 56
Horizontal crack of at least 5mm width at the
rear side wall (East side) at the basement level

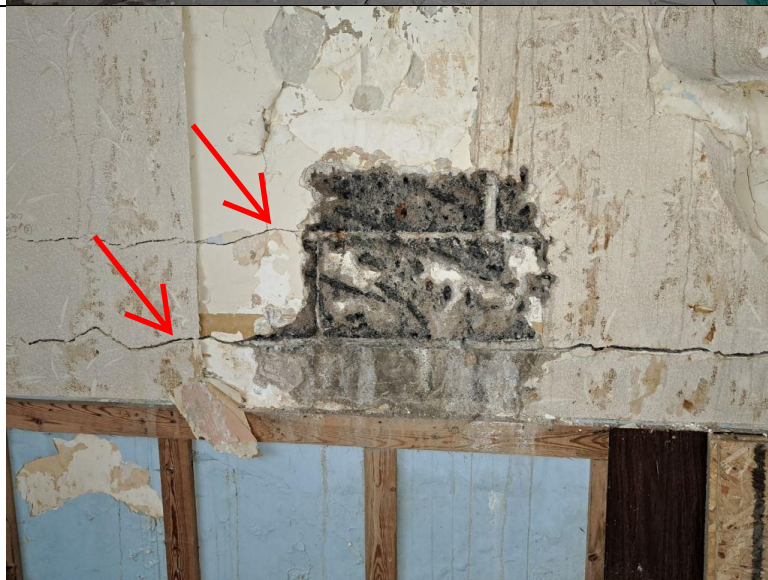
Photo 57
Horizontal crack of at least 5mm width at the
rear side wall (East side) at the basement level

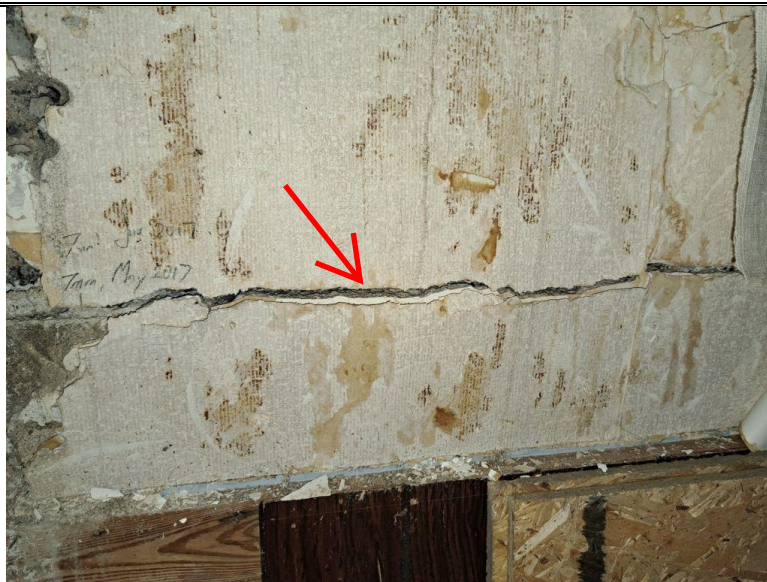
Photo 58
Horizontal crack of at least 5mm width at the rear side wall (East side) at the basement level

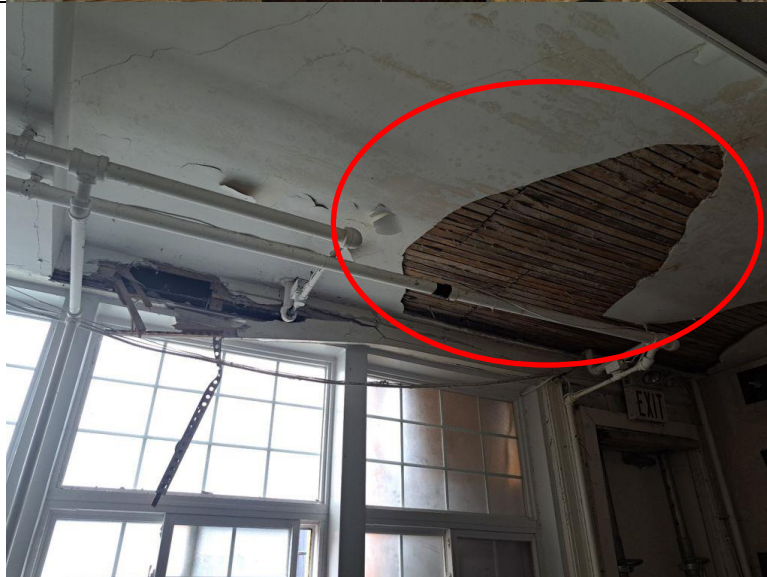
Photo 59
Exposed ceiling due to plaster that fell down, and damaged wood frame by water, wood has started to rot

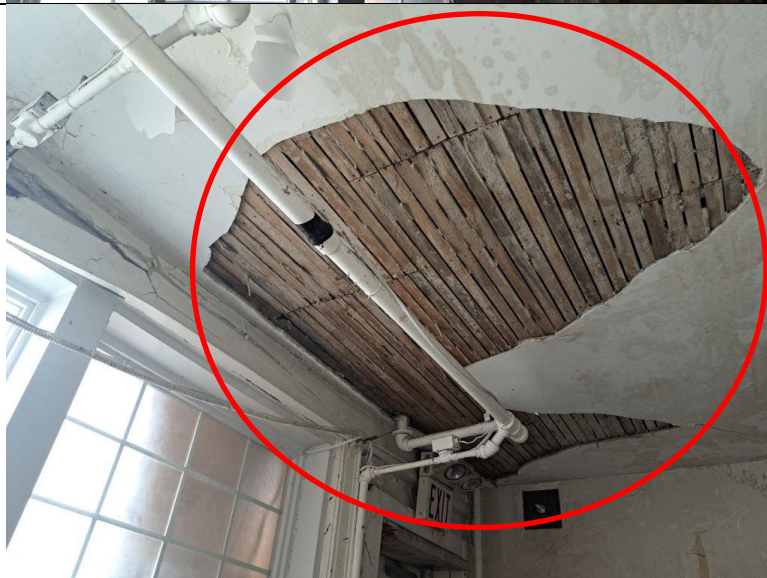
Photo 60
Exposed ceiling due to Gyproc that fell down, and damaged wood frame by water, wood has started to rot

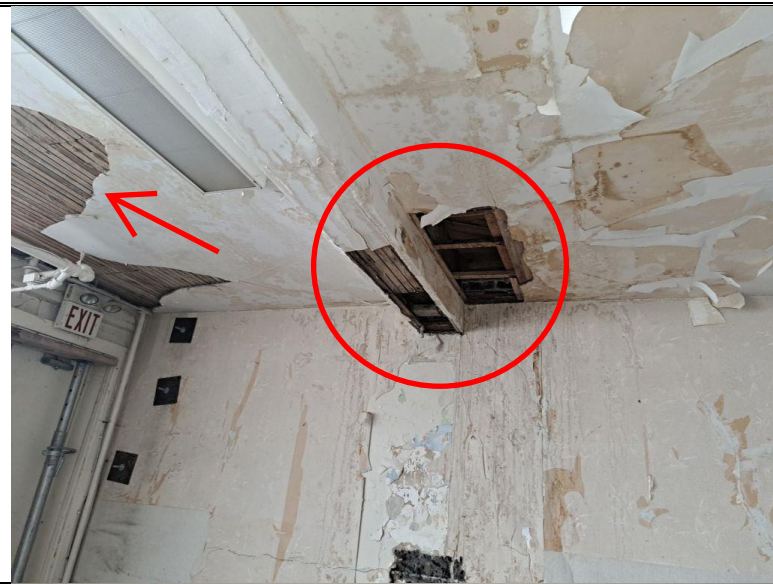
Photo 61

Exposed ceiling due to plaster that fell, and damaged wood frame by water, wood has started to rot

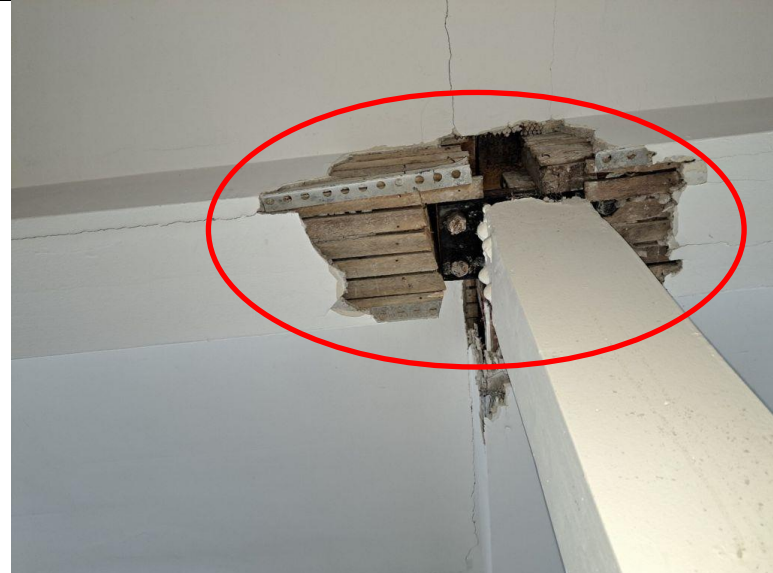
Photo 62

Exposed ceiling due to plaster that fell down, and damaged wood frame by water, wood has started to rot

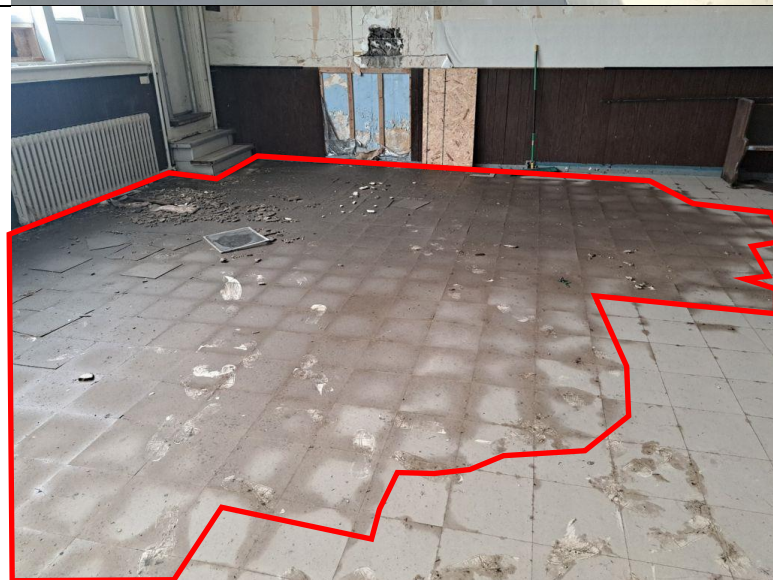
Photo 63

Wet floor due to water leakage

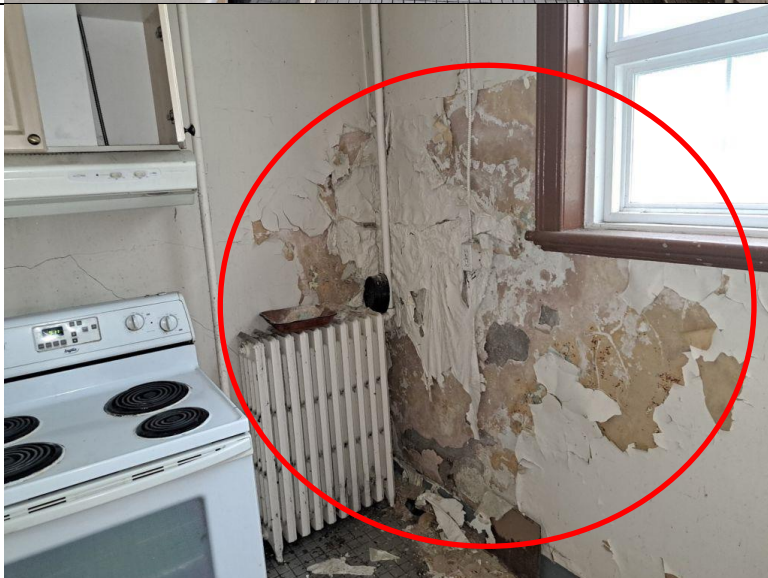
Photo 66

Moisture intrusion, paint peeling off, and water leakage on the floor

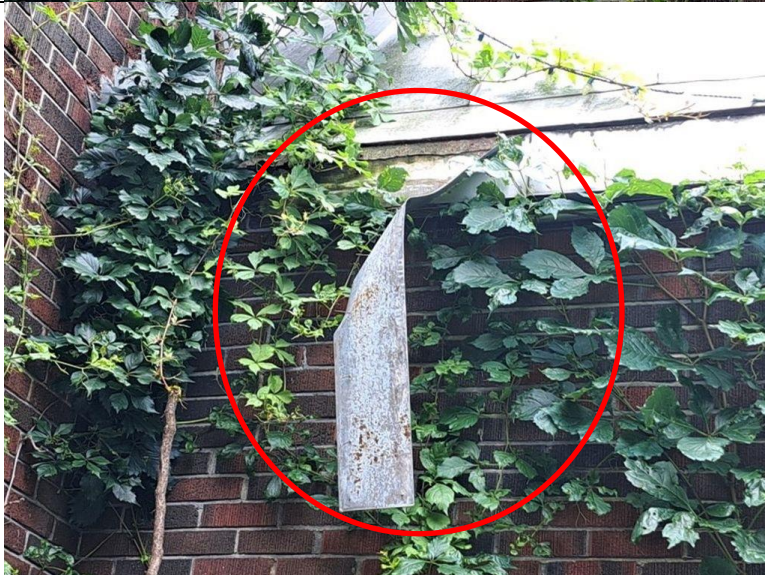
Photo 68
Flashing damage is noted

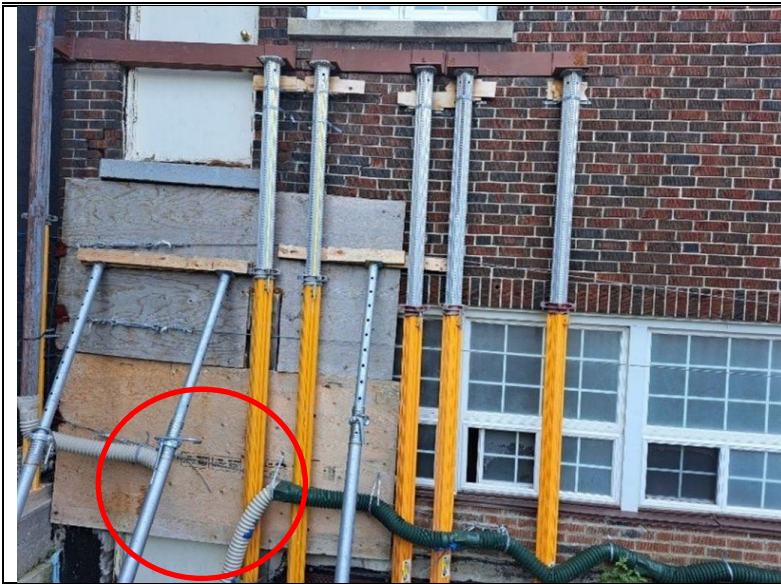
Photo 70

- Downspouts empty too close to the building, concentrating water against the foundation, a very likely source of basement water entry.
- The staircase to the doorway on the main floor was removed.

All down spouts are discharging the rainwater adjacent to building, which leads to moisture penetration to the basement and settlement of the foundation
