CONSERVATION PLAN

254 ARGYLE AVE, OTTAWA, ON
L'ÉGLISE CHRIST-ROI (CHRIST THE KING CHAPEL)

PREPARED BY: Emily B. Leonoff, MAC, CAHP

DATE: September 27, 2024

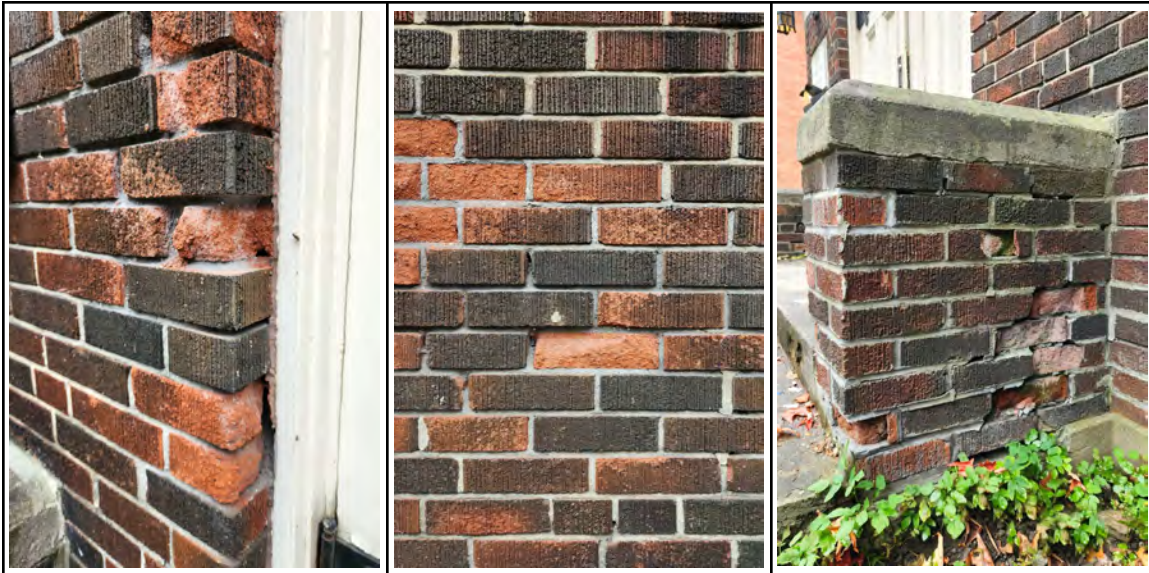
Condition of Masonry Components: The majority of the bricks appear to be in good condition. The lighter-coloured orange bricks have deteriorated more quickly than the darker brown bricks. This is because the darker bricks were exposed to higher temperatures when fired in the kiln, giving them a more durable fire-skin. There will be a higher proportion of salvaged darker bricks than lighter bricks and this should be a consideration for the heritage consultant.

Fig. 5: Three views showing typical brick damages observed. Those situated adjacent to window and door openings show greater damages due to additional surface area exposed to the elements, as well as bricks closer to the base of the building which would have been exposed to snowdrifts held against the clay surface (also considering freeze / thaw cycles). Bricks that are closer to orange than brown show greater damages due to the lower temperature of the kiln used in their creation (brown coloured bricks were subject to higher firing temperatures and are therefore more durable).

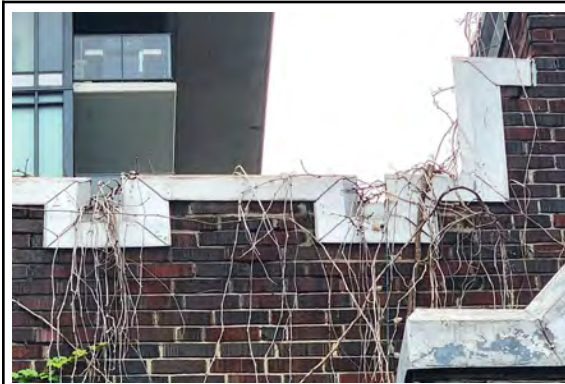
The existing paint layers are failing but the flashing seems in overall good condition despite a small number of lifting sections.

Fig 9: A partial view of the painted metal flashing that follows the perimeter of the front face roofline. The metal is folded and riveted in place.

Conservation Work: Microabrasion to remove existing paint layers, surface repairs if necessary, recoating and repainting, fastener replacement if necessary.

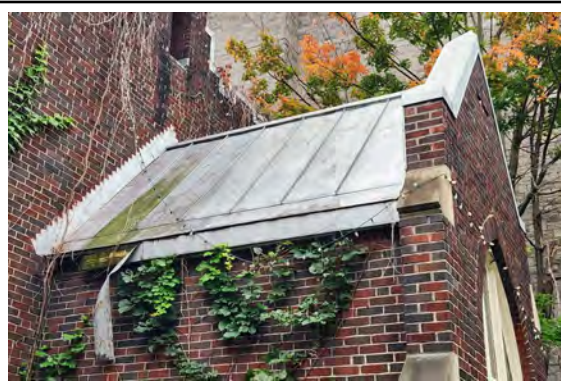
Fig 10: A view of the metal sheeting on the gabled roof over the front, main entrance vestibule. The metal shows soiling and some lifted sections but is overall in good condition.

Conservation Issues: A preliminary investigation from the ground level showed minimal issues such as paint layers failing and lifting sections.

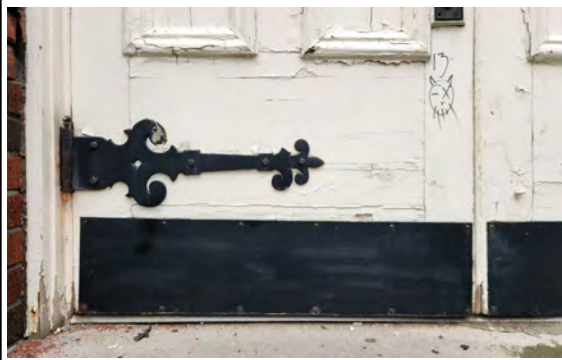
Conservation Issues: A preliminary investigation showed issues with paint layers failing, loose joinery, loose mouldings, small areas of rot at the base of the door frame jambs, mismatched glazed panels, inappropriate contemporary lockset hardware, split panels, obsolete fastener holes, and some breakages/missing elements on the decorative metal hinges.

Fig. 12: The bottom of the left door leaf showing existing heavy paint layers failing and corrosion around the metal decorative hinges.

Conservation Work: Though looking weathered, the door and transom assembly are in fairly good condition and should likely not require any major interventions. Conservation work should include paint stripping, joinery repair, Dutchman repairs, possible reglazing, and new hardware.

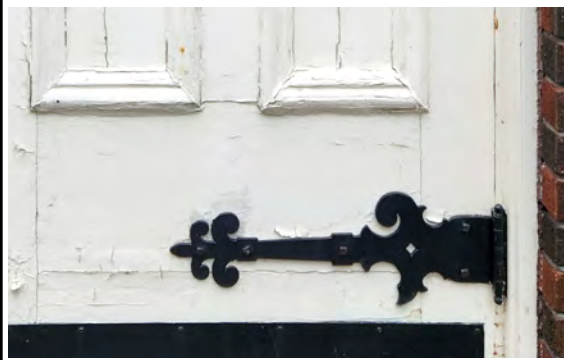
One of the four decorative metal hinges has a missing section and will require repairs or replacement (see Fig. 13).

Fig. 13: The bottom of the right door leaf showing a missing section of the metal decorative door hinge, and panel cracks.

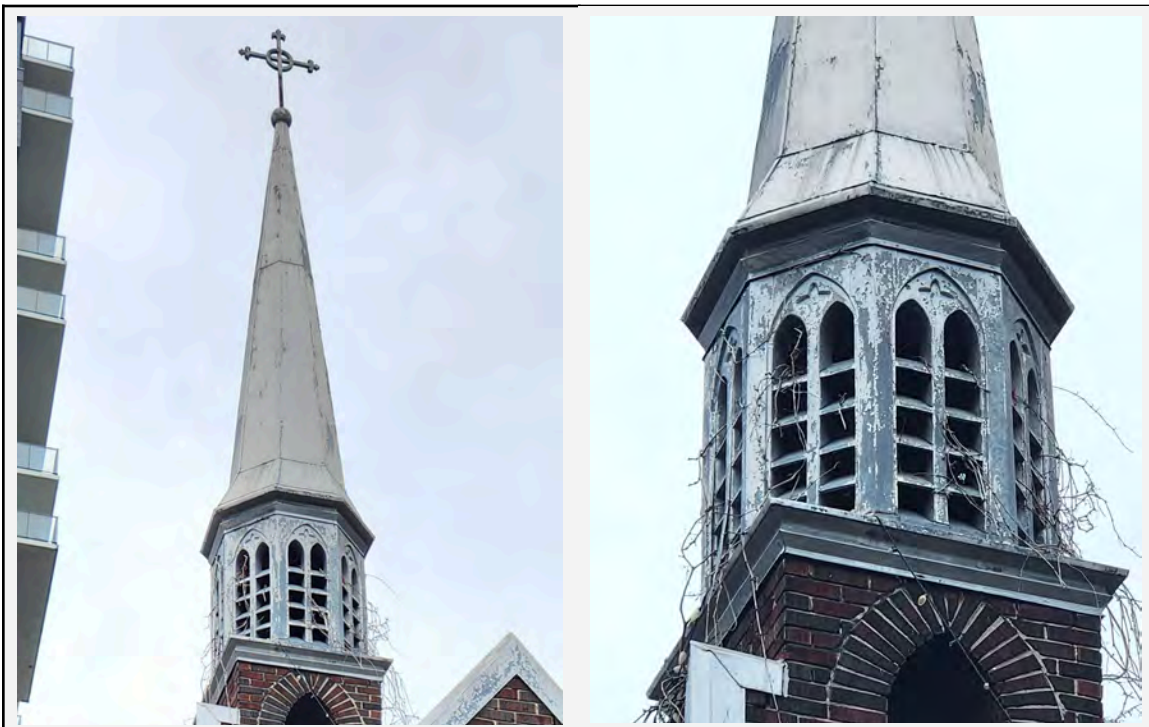
Conservation Issues: Only a best guess description of conservation issues can be given until a detailed investigation can take place. There is likely a degraded wood core beneath the sheet metal that will require repairs. The existing paint layers have failed. Possible corrosion issues.

Fig. 23: An overall view of the painted metal spire. **Fig. 24:** A view of the spire's painted octagonal base. Its construction details are currently unknown.

Conservation Work: Conservation work will likely require disassembly, paint stripping, structural and sheet metal repairs, repainting, and reassembly. Care will have to be taken in the hoisting of the conserved spire back into place during the reinstallation phase.

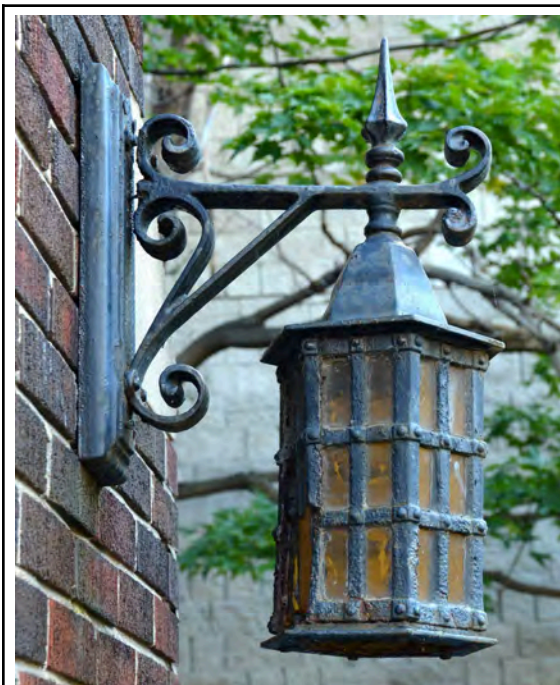
Conservation Issues: The brackets are pulling away from the wall plates and will need to be affixed into place. The paint layers on the assemblies have failed. Heavy corrosion is present, as well as corrosion jacking (also known as rust burst).

Fig. 26: One of the two lanterns that flank the main doors to the chapel.

Conservation Work: The lanterns will require complete disassembly and paint stripping. Missing components will require fabrication. All fasteners will require replacements. New stainless steel threaded connections will need to be made. Assume all new glazing will be necessary as the individual yellow glass panes will likely not survive the disassembly phase.

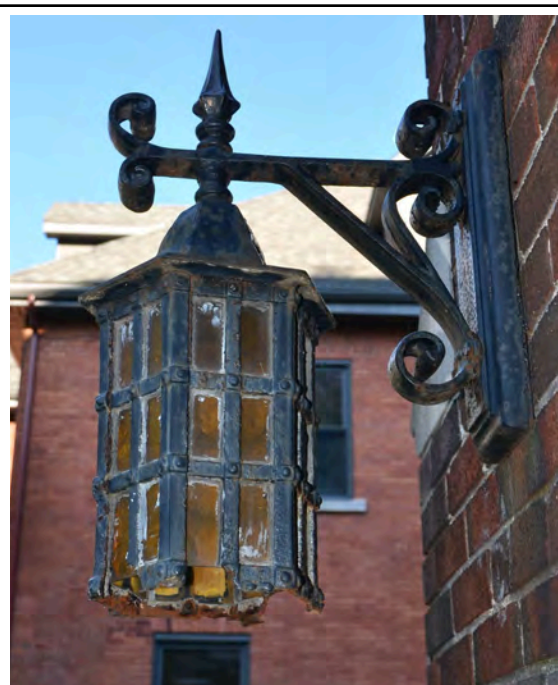
Fig. 27: One of the two lanterns that flank the main doors to the chapel.

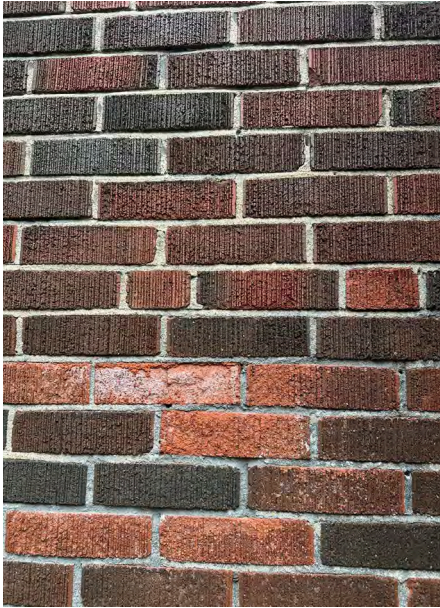
Typical brick condition, with lighter-coloured bricks proving less durable.

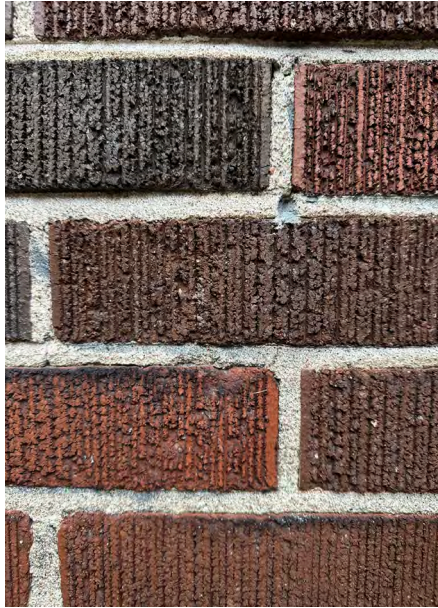
Brick mortar scraped back with steel tool to reveal grey pigmented original mortar.

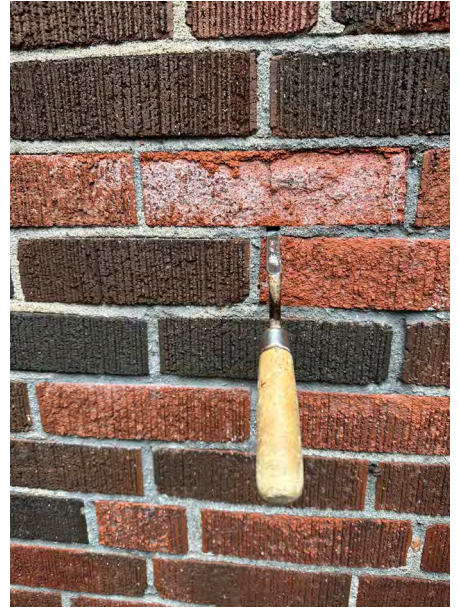
Example of brick not suitable for salvage.

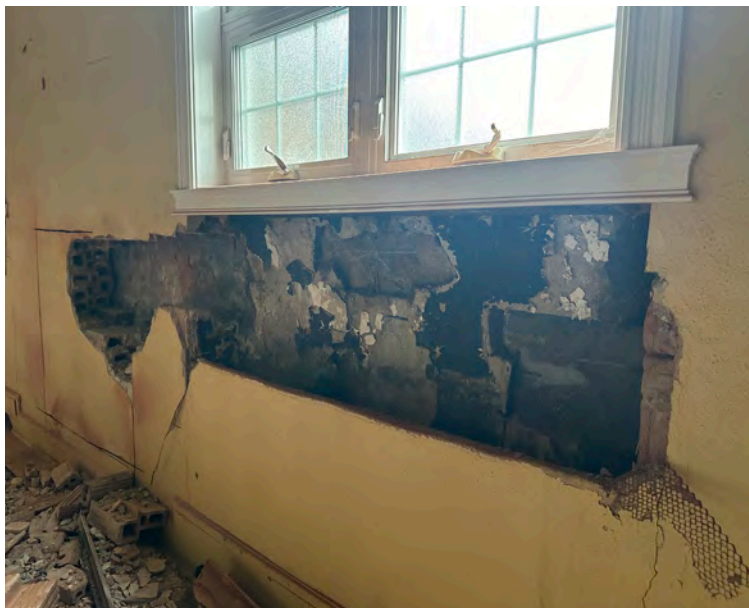
Exploratory opening on the interior, showing wall composition.
