HERITAGE IMPACT ASSESSMENT & CONSERVATION PLAN*

168 -174 MURRAY STREET, OTTAWA

Owner: David Yoo
Address: 168 – 174 Murray Street, Ottawa, Ontario

Revised March 2025

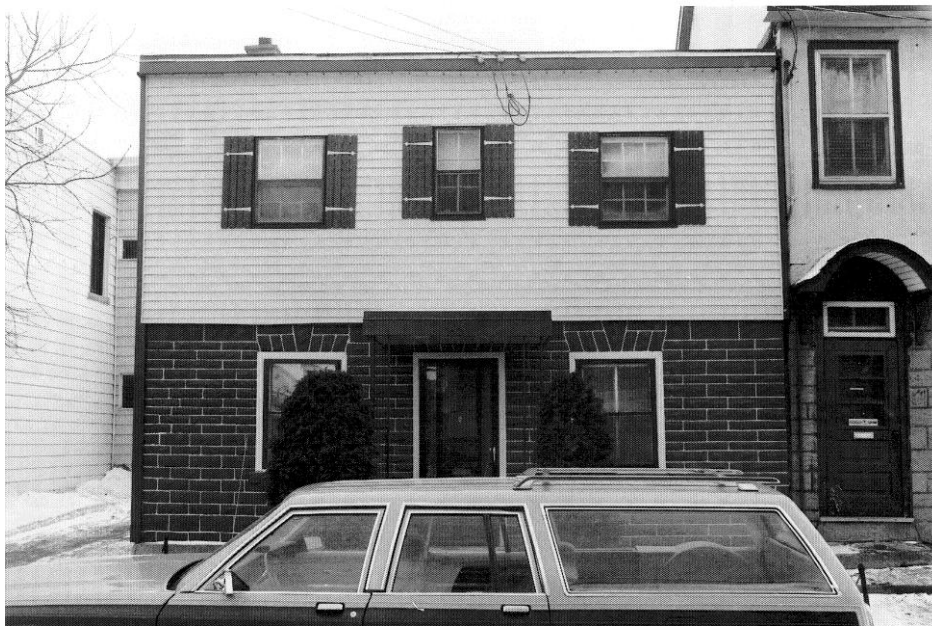
Figure 13: A view of 168 Murray Street as altered circa 1965. The house has been remodelled with a flat roof, second floor added, and three windows replacing the dormers. The exterior was reclad in an angel stone on the ground floor and aluminum siding on the upper floor. A canopy over the front door has been added. Source: City of Ottawa Heritage Survey Forms 1991.

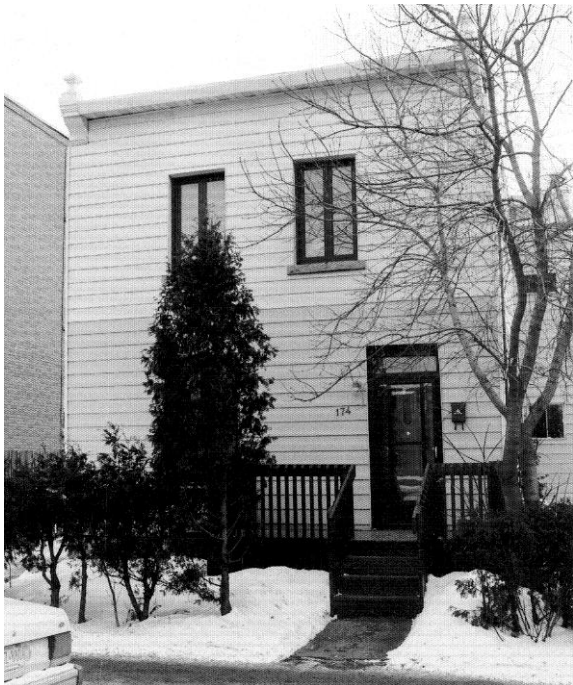
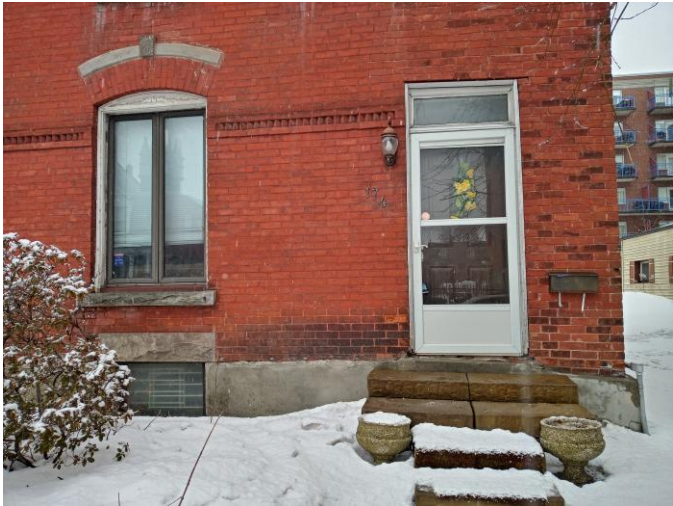
Figure 15 and 16: This collage of pictures documents the extensive alterations. Two views 1992 and 2022. 174 Murray (left) before the vinyl siding being removed and rehabilitated front. Note the different brick at the corner (both size and colour consistency) and the lack of corbelled banding and the transom treatment.

The house appears in a c.1949 photo, which highlights its attributes (Figure 14). The 1992 view of the building retains its form, with the exterior re-clad with a vinyl siding. The finials and a portion of the cornice detail are retained. The offset door is evident in the 1949 picture, but the distinctive hood has been covered or altered. In the 2022 view, the front door’s arched brickwork (voussoir), masonry hood and band of corbelled brickwork at the transom, were not incorporated into the replaced brick at the corner.

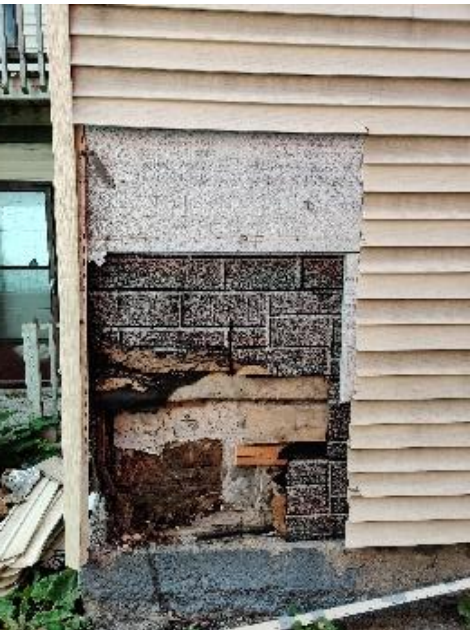
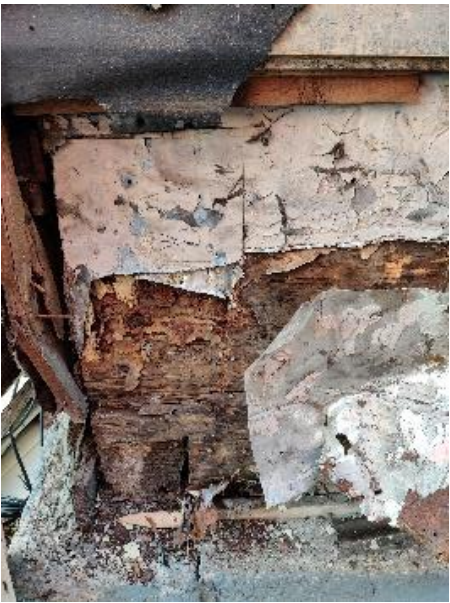
Figures 39 and 40 : The two views illustrate the multiple layers of finishes covering the squared timber, (tin panels insul-brick, ridged insulation, and vinyl siding.) Source David Yoo 2022.

1. As part of demolition of the rear additions, remove the second floor addition and the exterior siding on the front and east facades to expose the squared timber. The west façade butts directly against the neighbouring house and will be exposed from the interior to determine its condition and stability.

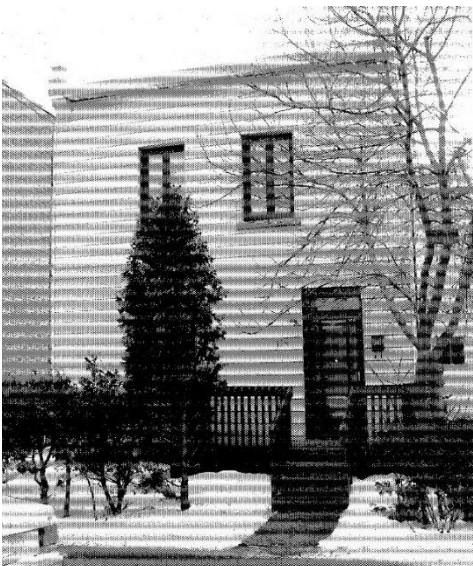
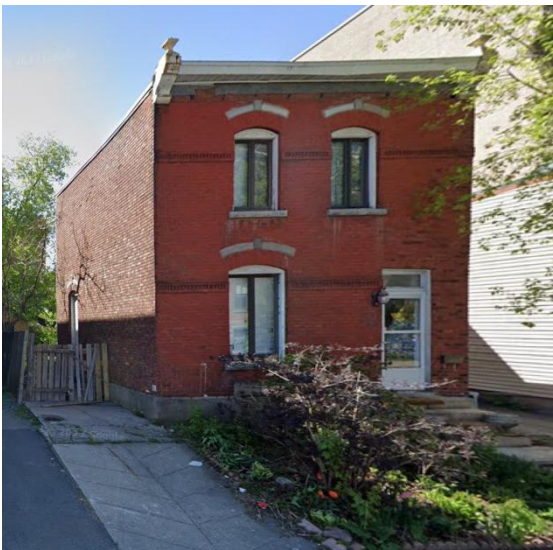
Figure 42 and 43: Two views 1992 and 2021 174 Murray (left) prior to the vinyl siding being removed and rehabilitated front. Note: A section of the cornice will need to be replicated. There is bulging of the brick along the 2nd floor between the windows. Also noted is the different brick at the corner (both size and colour consistency) and the lack of corbelled banding and the transom treatment. Earlier photos document a decorative hood over the door has been removed.

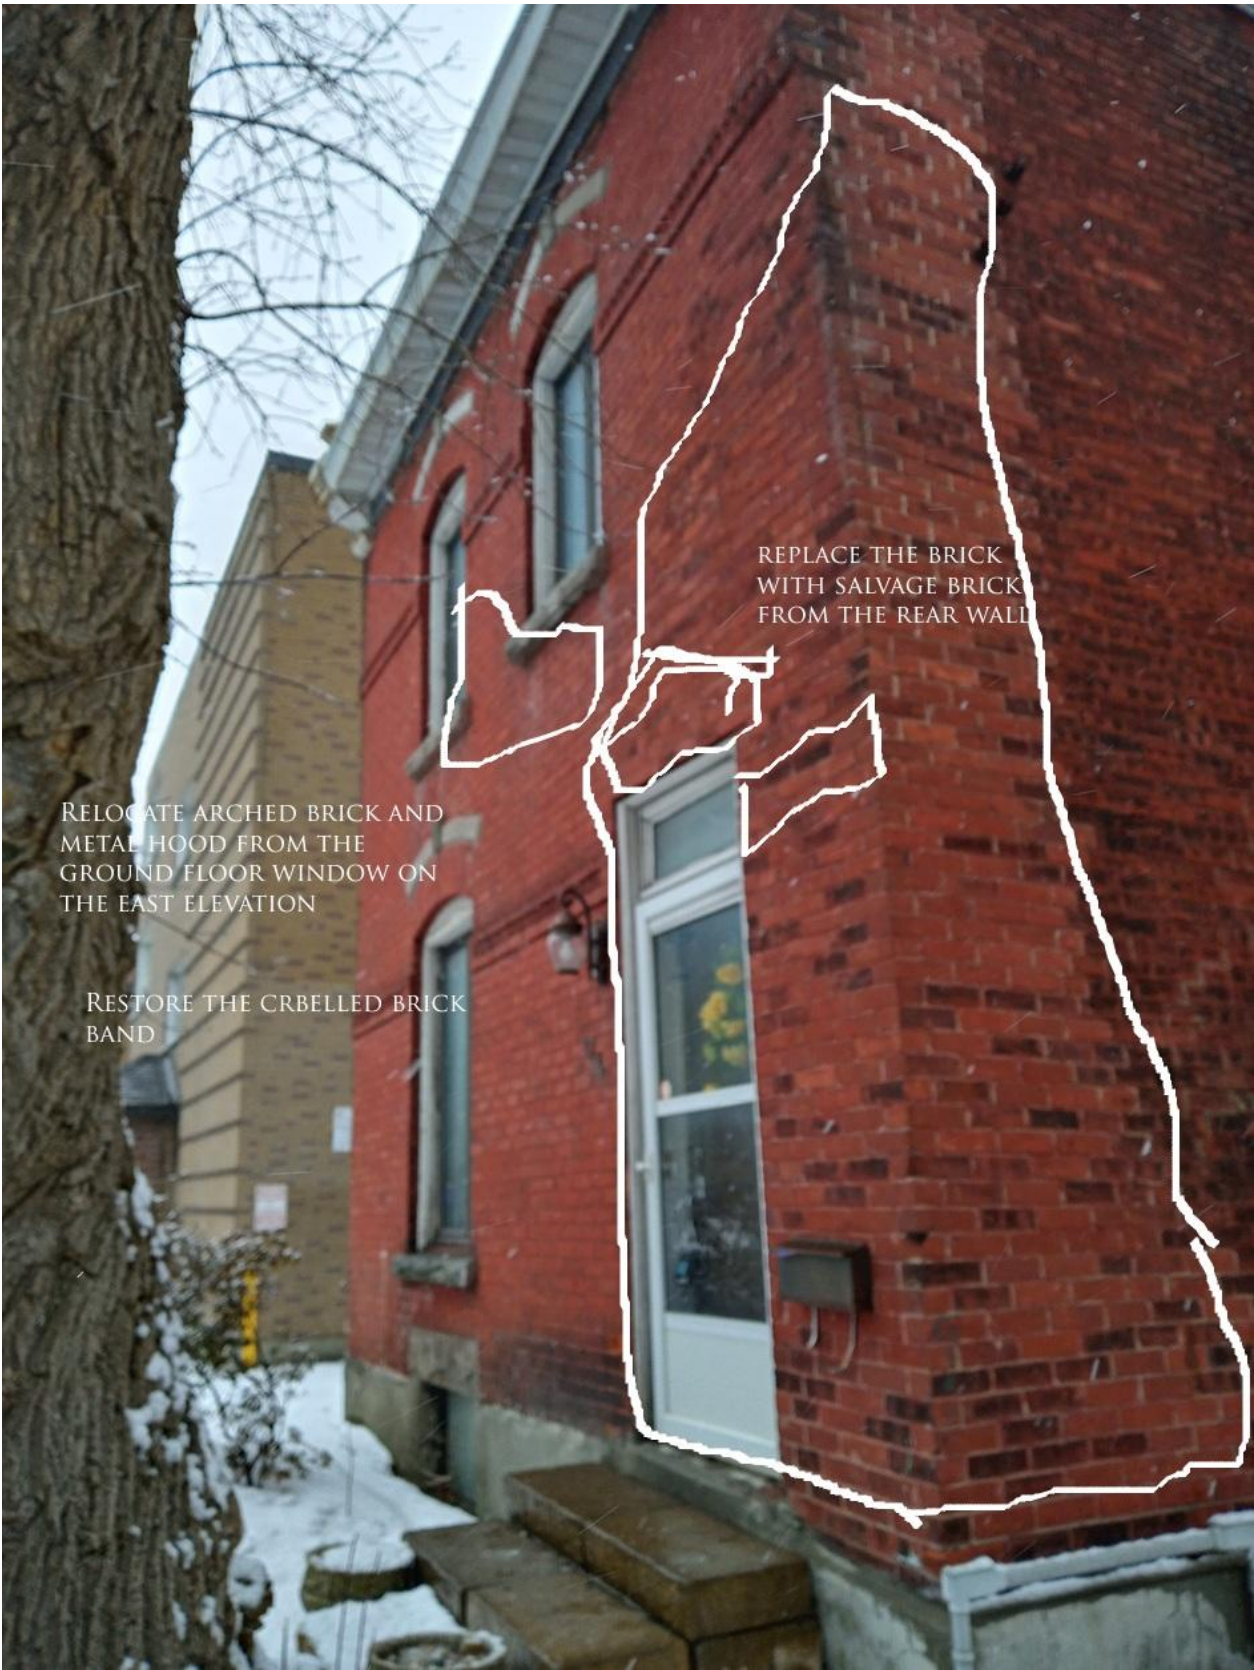
Figure 45: As -found image with areas requiring repair and restoration highlighted in white.

- 4. The arched segmented brick and metal hood from the east side window of 174 can be reclaimed and used to restore the front entry.
- 5. repair the cornice and, where badly deteriorated, replicate the section.
