Tree Information Report v2.0

Date of Report: April 22, 2025
Property Address: 15 Deerfox Drive
Prepared for: Antilia Homes c/o Ravi Shanghavi; ravi@antiliahomes.com
Prepared by: Kevin Myers, ISA Certified Arborist®; kevin.myers@dendronforestry.ca
Date of Site Visit: March 20, 2024

TIR Map – 15 Deerfox Drive
Tree layer prepared by
Dendron Forestry Services
Version 2.0, April 22, 2025
For more information, please contact: info@dendronforestry.ca

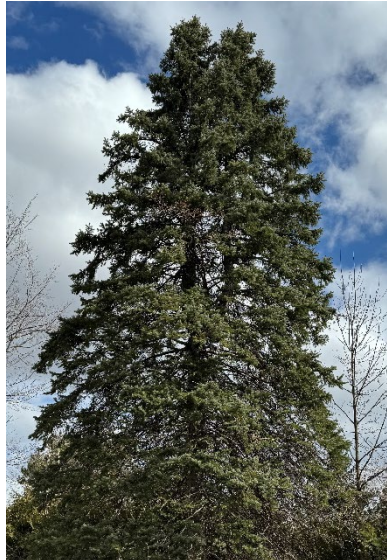
Right: Tree 5 – private spruce to be removed.

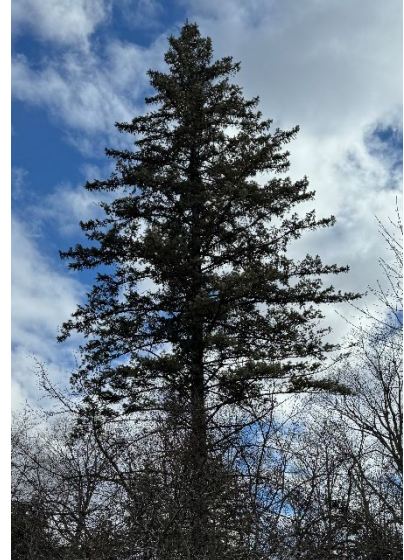
Far right: Tree 4 – private spruce to be removed.

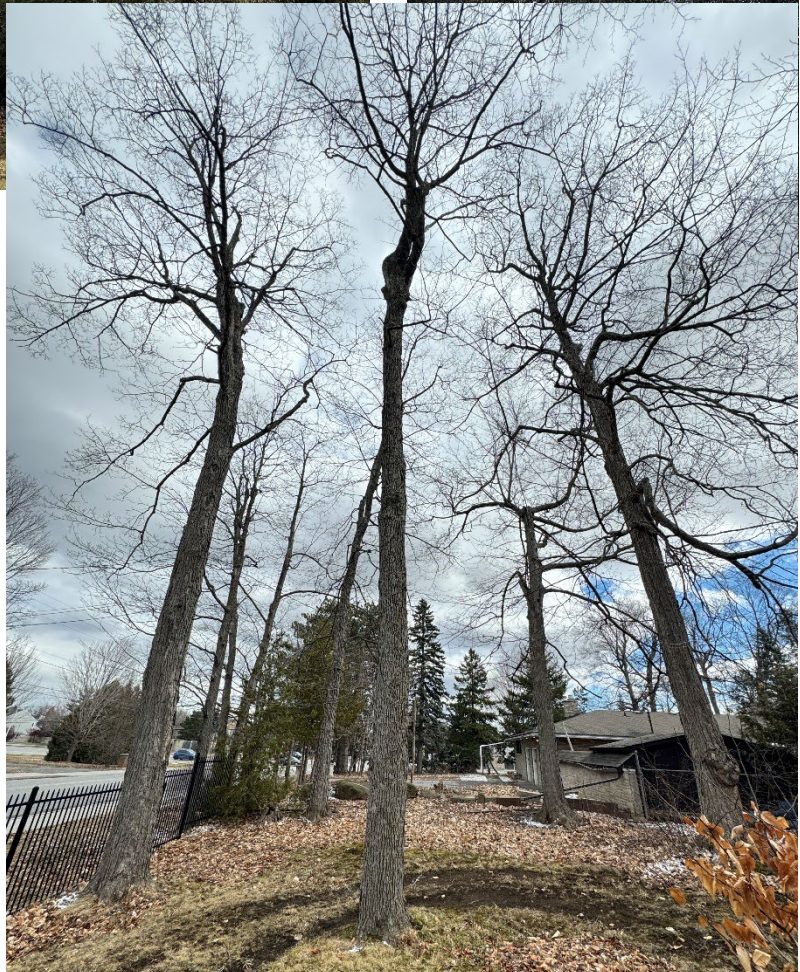
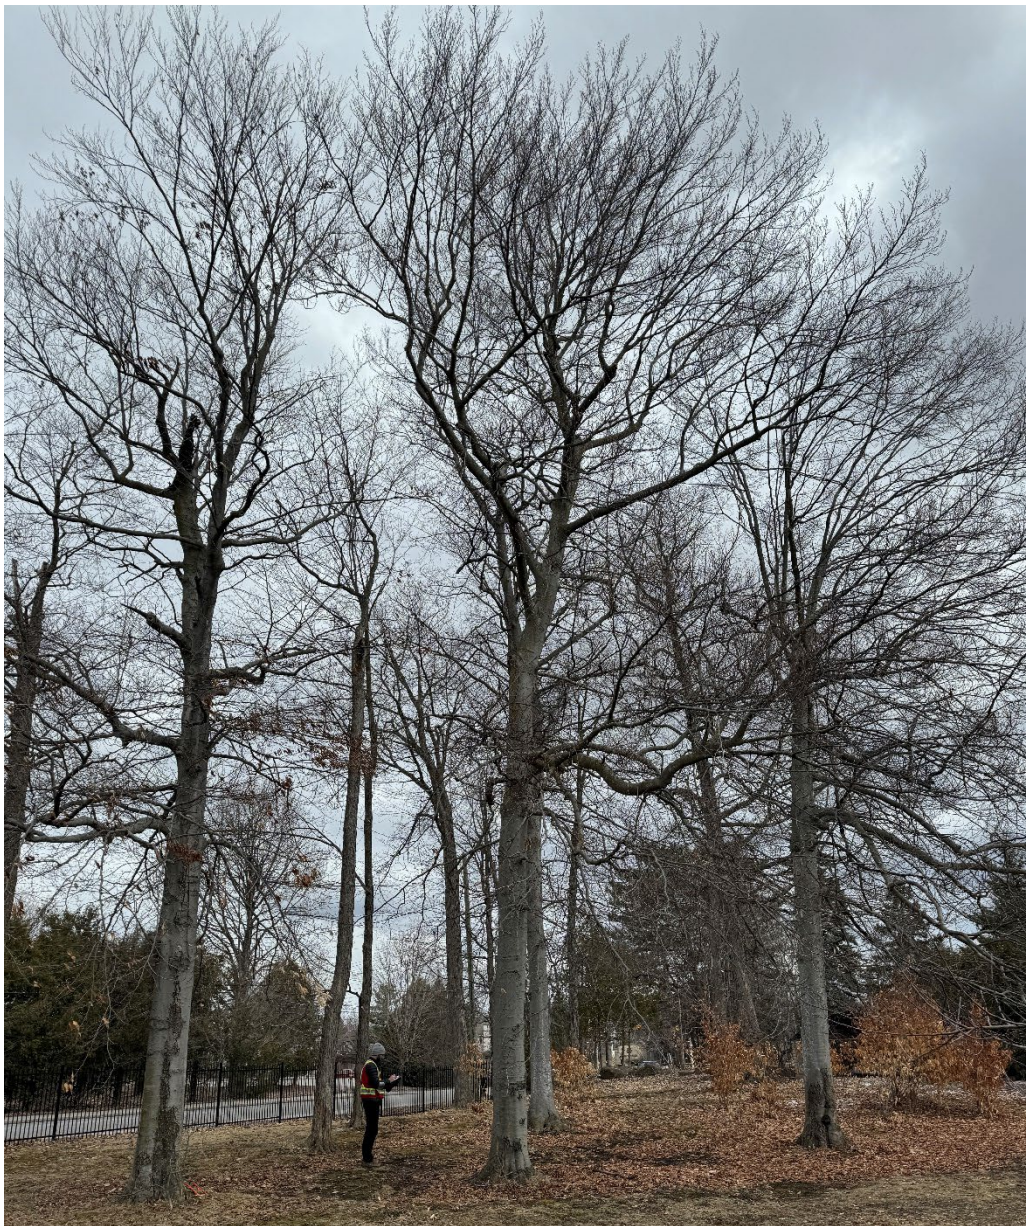
9	Sugar maple (<i>Acer saccharum</i>)	63	Subject property	Fair/Poor: decay probable – woodpecker activity; top has poor form	Driveway: 0	Remove	Remove: in line with driveway. Tree permit required for removal.
10	Sugar maple (<i>Acer saccharum</i>)	49.5	Subject property	Fair: large crook at top – likely broken off years ago	Driveway: 0	Remove	Remove: in line with driveway. Tree permit required for removal.
11	Sugar maple (<i>Acer saccharum</i>)	35, 36	City	Fair/Poor: cavities with decay in canopy; codominant stems with included bark at base	Driveway: 2	Retain	Retain. Roots to be revealed along the line of excavation and cleanly severed by hand prior to excavation with heavy equipment.
12	Beech (<i>Fagus grandifolia</i>)	43	Subject property	Good/Fair: crooks; scale insect	0	Remove	Remove: within area of excavation. Tree permit required for removal.
13	Beech (<i>Fagus grandifolia</i>)	49.3	Subject property	Poor: scale insect; top broken; large cavity at top; fungal bodies at base	0	Remove	Remove: within area of excavation. Tree permit required for removal.

Below right: (right to left) Tree 6, 7, 10, 8, 11, 9 – Sugar and black maples. All are to be removed except Tree 11.

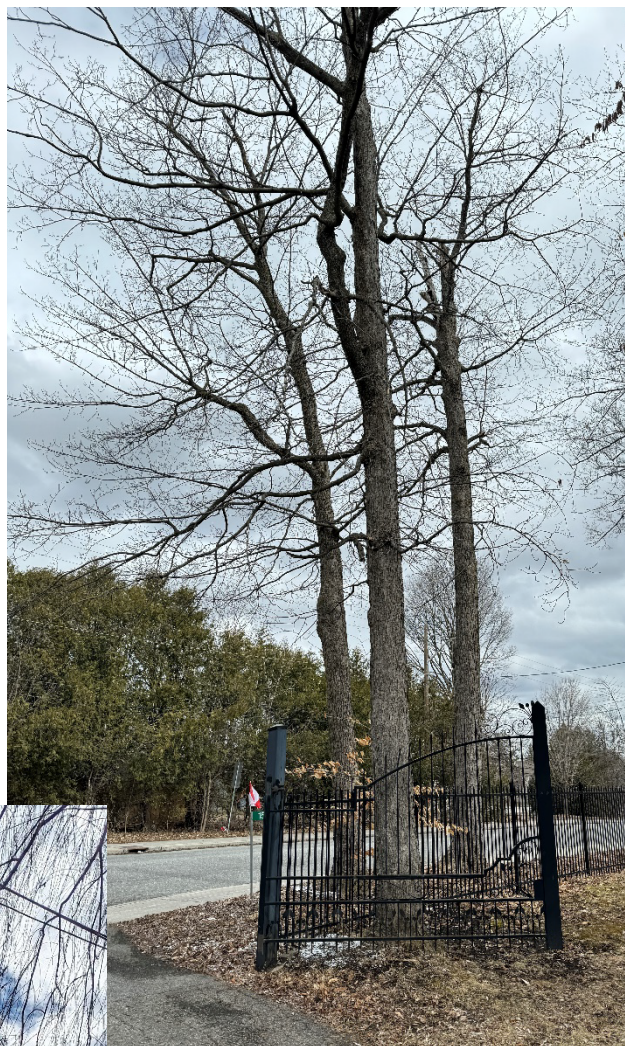
14	Beech (<i>Fagus grandifolia</i>)	52	Subject property	Good: Slight lean; epicormic shoots	0	Remove	Remove: within area of excavation. Tree permit required for removal.
15	Black maple (<i>Acer nigrum</i>)	33	Subject property	Poor: large cavity at top; debarking at base – low vigor	0	Remove	Remove: within area of excavation. Tree permit required for removal.
16	Beech (<i>Fagus grandifolia</i>)	54	Subject property	Poor: large cavity at top; bark disease	0	Remove	Remove: within area of excavation. Tree permit required for removal.

17	Sugar maple (<i>Acer saccharum</i>)	44	Subject property	Fair/Poor: decay in large wound at top	< 1	Remove	Remove due to proximity of excavation. Tree permit required for removal.
18	Sugar maple (<i>Acer saccharum</i>)	46	City	Fair: epicormics turning into	Walkway: 0	Remove	Remove: in line with proposed walkway. Tree permit required for removal.
19	Sugar maple (<i>Acer saccharum</i>)	54	City	Fair/Poor: top dead	Walkway: < 1 House: 3.5	Remove	Remove due to proximity of excavation. Tree permit required for removal.
20 ⁴	Sugar maple (<i>Acer saccharum</i>)	7	City	Good	3	Retain	Retain and protect as per the City of Ottawa Tree Protection Specifications (March 2021).
21	Cedar hedge (<i>Thuja occidentalis</i>)	7 stems 14-22	City	Fair: 15' tall	3.5	Retain	Retain and protect as per the City of Ottawa Tree Protection Specifications (March 2021).
22	Willow (<i>Salix spp.</i>)	119	City	Fair: large cavity at base – approx. 1/3 diameter deep; decay and woodpecker activity on trunk (small area); large branches pruned off – epicormic shoots at wounds and on trunk	House: 4 Porch: 3 Walkway: < 1	Remove	Remove due to impacts from previous construction, combined with proposed walkway and site works. Tree permit required for removal.

(right to left): Tree 14, 13, 15, 16, 17 - private beeches and maples to be removed.

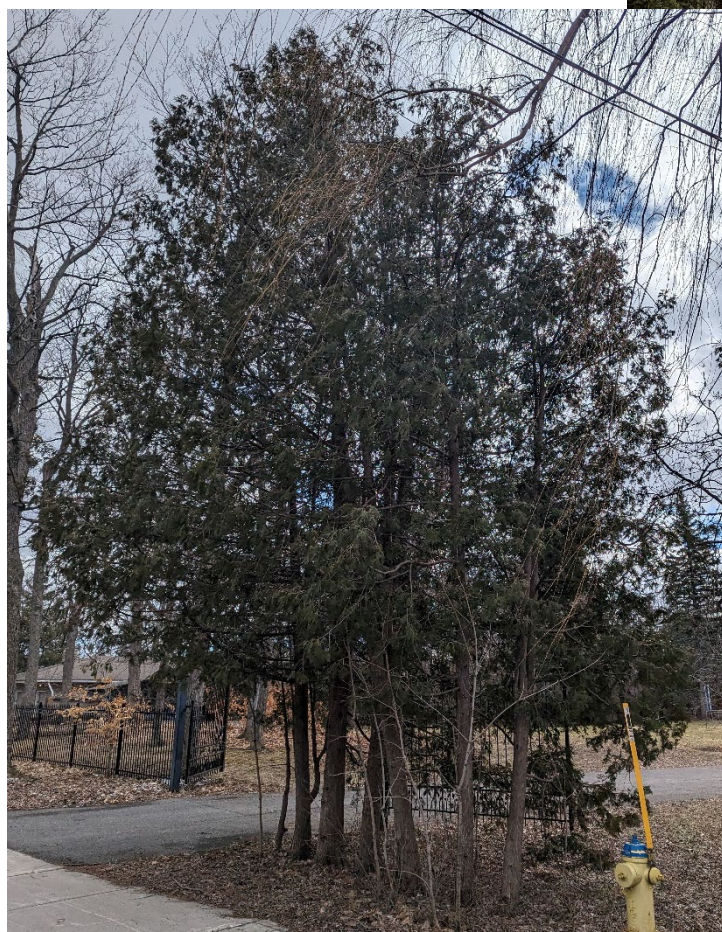
Tree 20 is a small sugar maple. The TPA around this tree should be as large as is feasible and should be implemented before removal of the existing fence.

Above: (right to left) Tree 20, 18, 19 - City and private sugar maples to be removed.

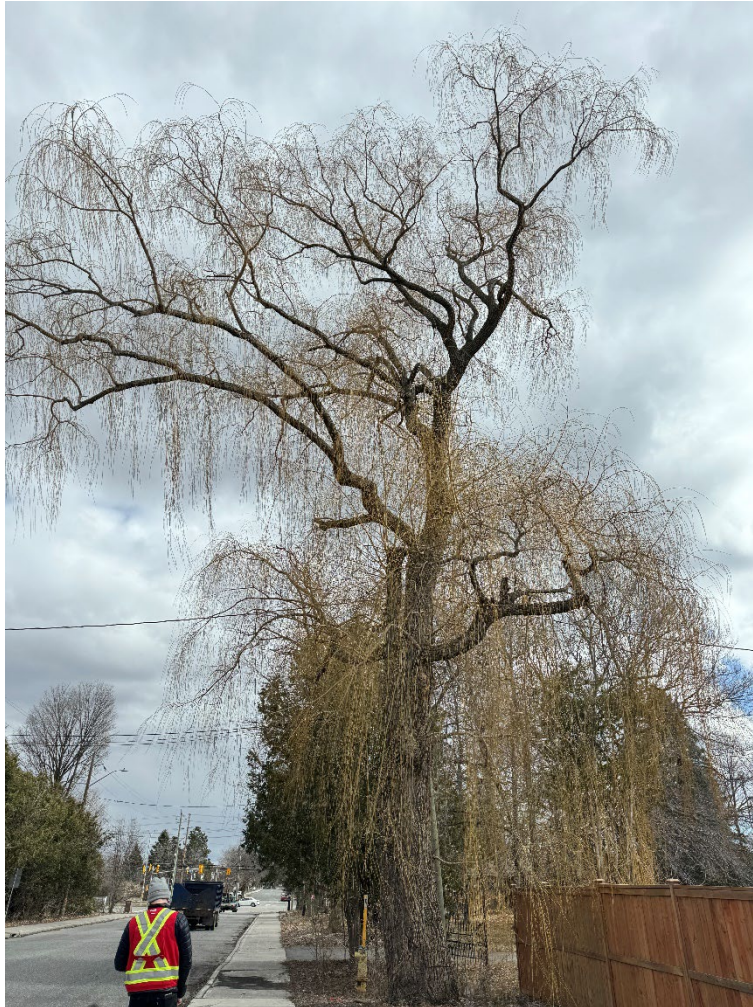
Left: Cedar hedge listed as Tree 21 - to be retained.

21	Cedar hedge (<i>Thuja occidentalis</i>)	7 stems 14-22	Fair: 15' tall	3.5	Retain and protect as per the City of Ottawa Tree Protection Specifications (March 2021).
22	Willow (<i>Salix spp.</i>)	119	Fair: large cavity at base – approx. 1/3 diameter deep; decay and woodpecker activity on trunk (small area); large branches pruned off – epicormic shoots at wounds and on trunk	House: 4 Porch: 3 Walkway: < 1	Remove due to impacts from previous construction, combined with proposed walkway and site works. Tree permit required for removal.

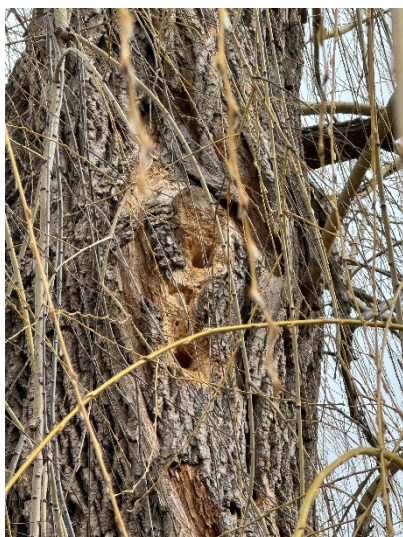
Tree 22 is a large weeping willow nearing its pinnacle of expected growth. A large portion of the root system was likely disturbed by construction on Ryland street – specifically the rear yard of 138: it appears the grade has been raised beyond the recommended 10cm, and it is possible some roots were cut during construction. Combined with its position beside a road, the tree is left with little rooting space even before construction. A path is proposed to run approximately 84cm from the tree's trunk. The required excavation for this path, combined with the stress of site works, could lead to the tree's becoming unstable and rapid decline. For these reasons, it is recommended the tree be removed.

Above: Tree 22 - City willow to be removed.

Below left: decay and woodpecker activity in the trunk of Tree 22.

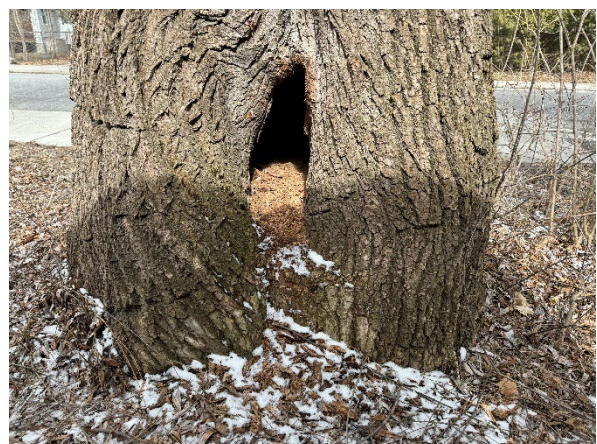
Below right: cavity at the base of Tree 22.
