Our File: 31115-2123

Re: **Structural Assessment of Residential Fire Damage**

Claim Number: R2878122
Date of Loss: March 26, 2025
Insured: 5897 Fernbank Inc.
Loss Location: 5897 Fernbank Road, Stittsville, ON

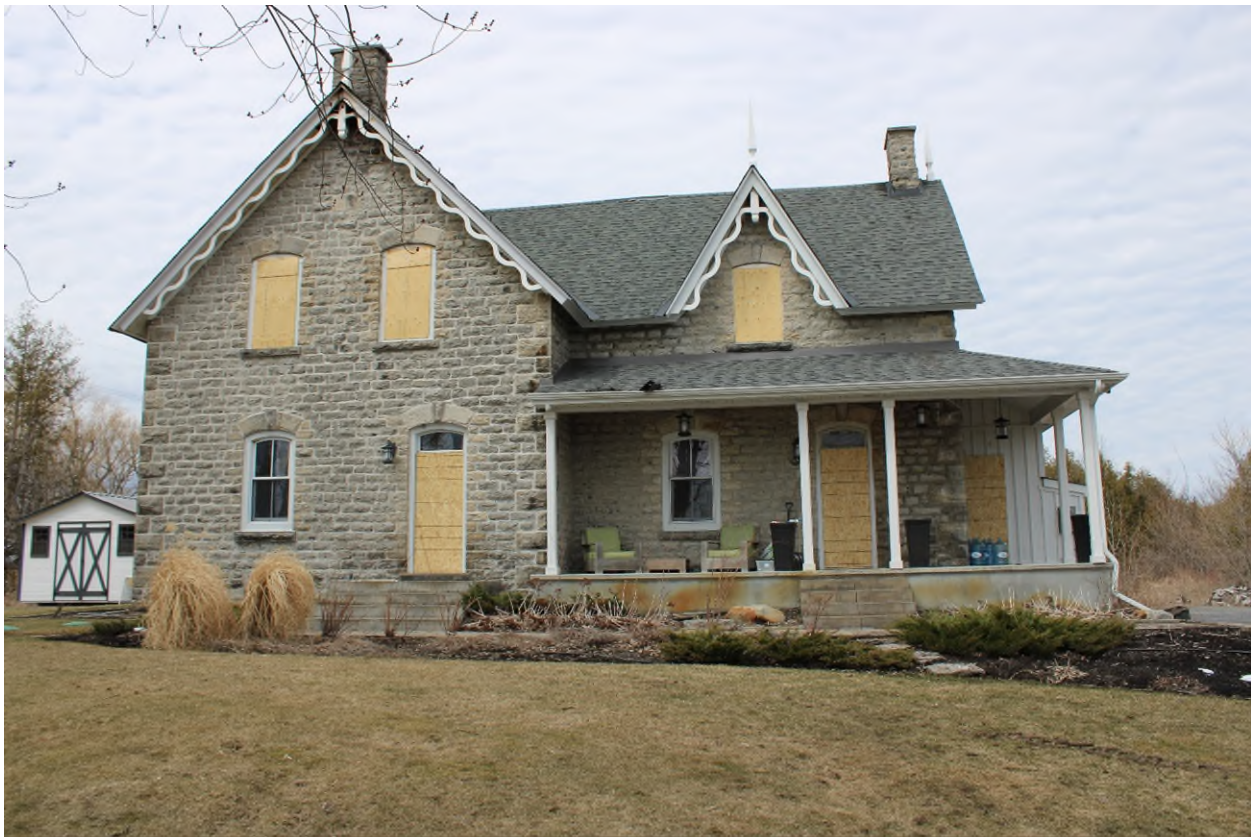
Photograph 01 – South (Front) Elevation – Taken by Pario on April 14, 2025.

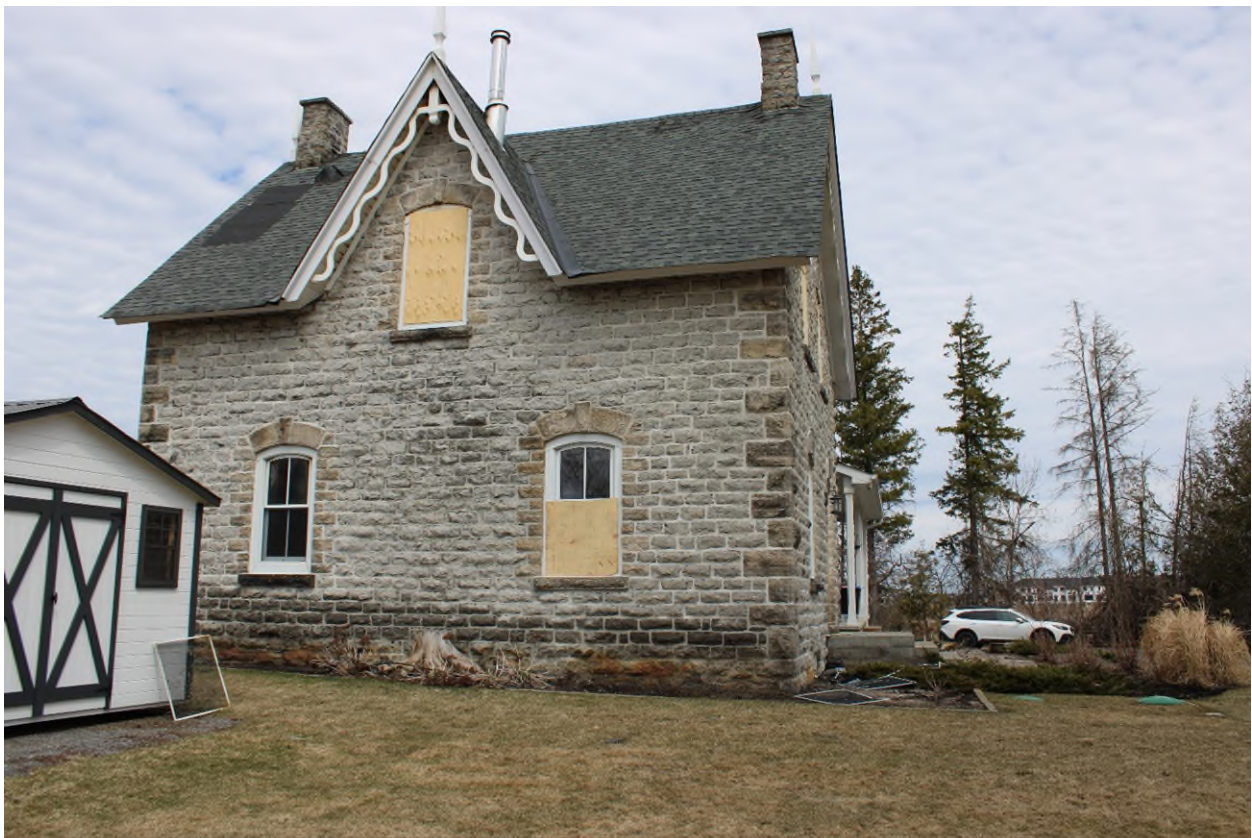
Photograph 02 – West (Side) Elevation – Taken by Pario on April 14, 2025.

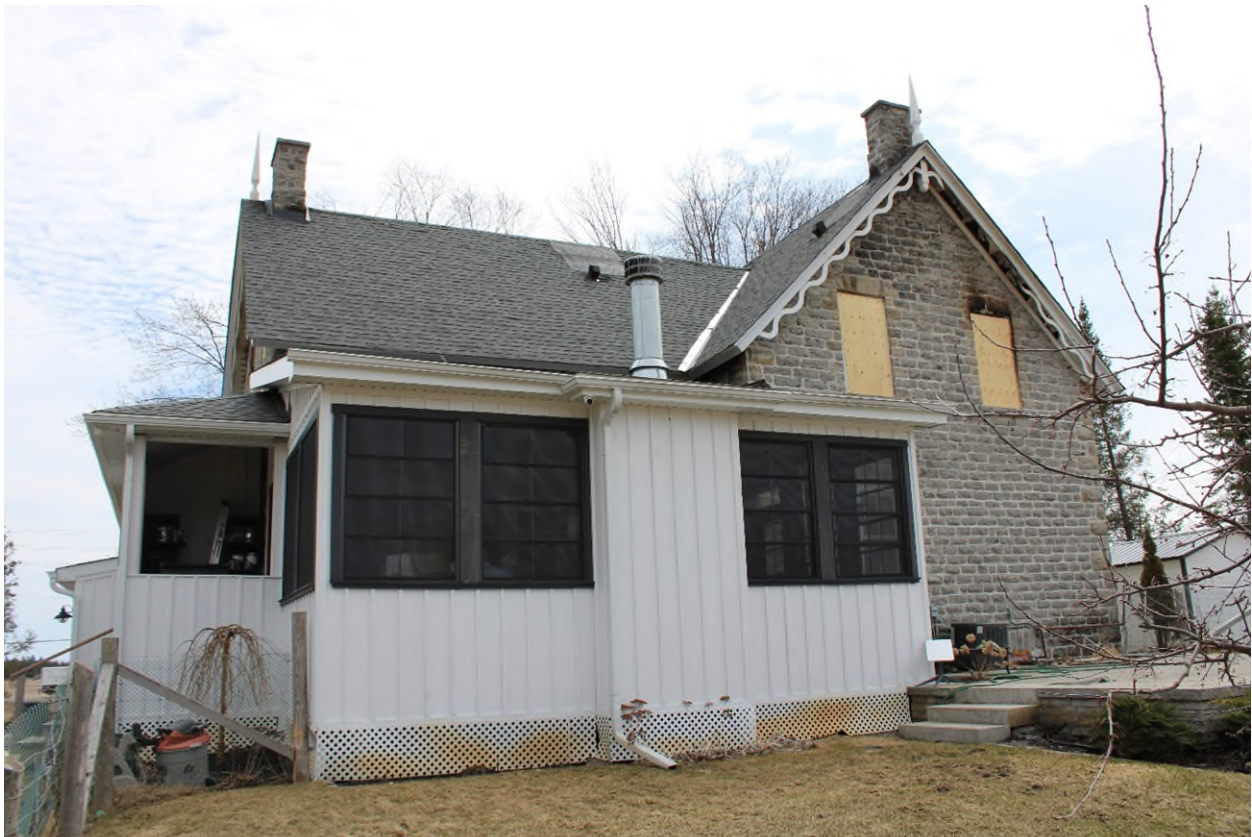
Photograph 03 –North (Rear) Elevation – Taken by Pario on April 14, 2025.

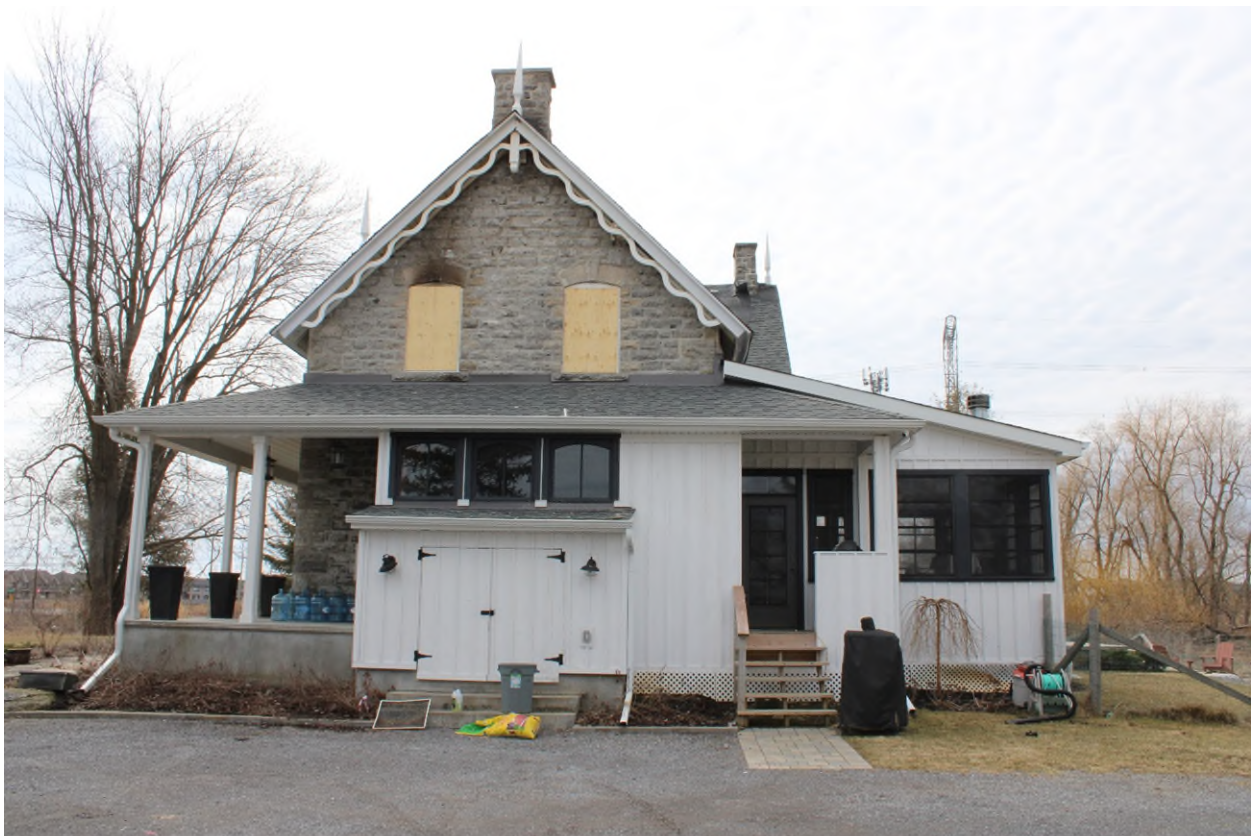
Photograph 04 –East (Side) Elevation – Taken by Pario on April 14, 2025.

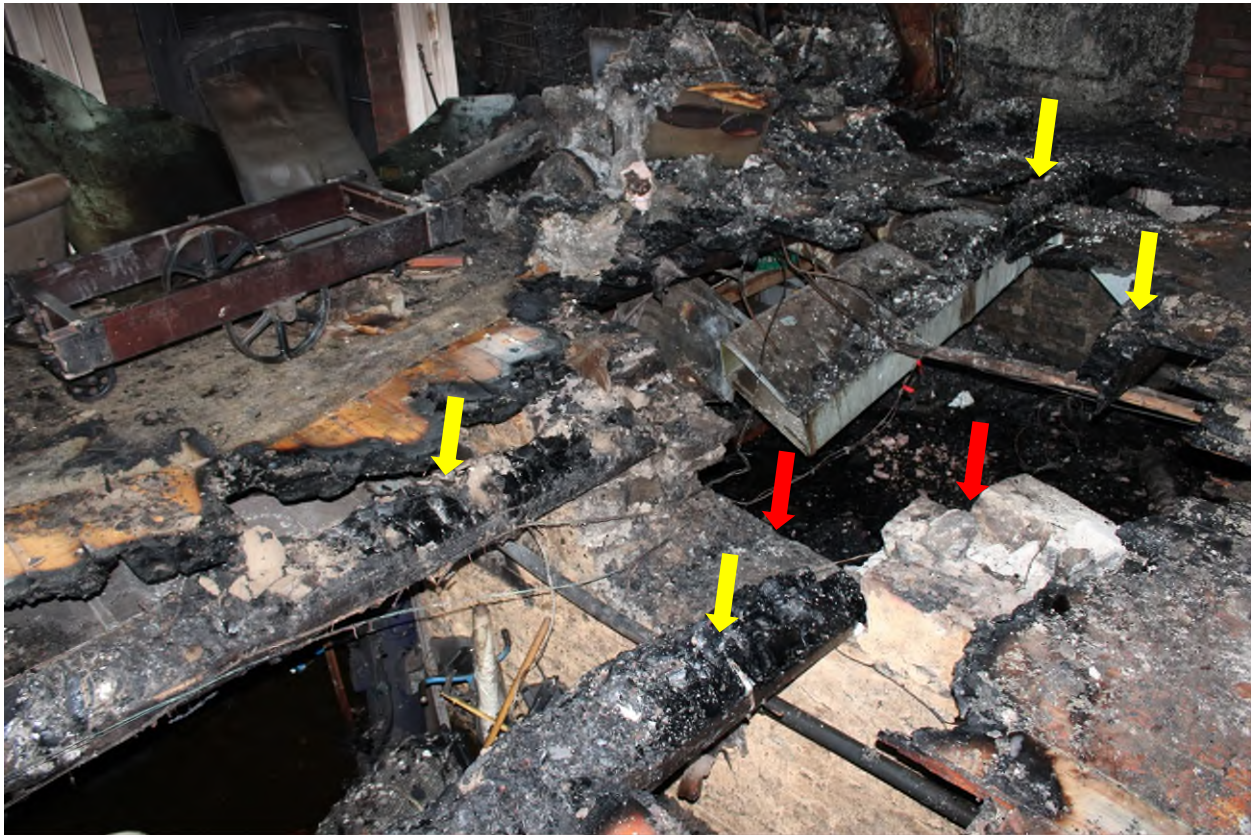
1. The foundation was constructed of stone & mortar with unknown footings. There was a central foundation in the west portion of the structure which ran east to west. This foundation was in very poor condition with missing/damaged stones. There were several areas noted with degraded lime mortar and compromised stones. The exterior of the stone & mortar foundation and exterior stone cladding appeared to have been repointed at some time; the condition of the foundation wall below grade was unknown (refer to Photographs 05 to 07).

2. The rough-cut timber main floor, floor beams on the west portion of the structure were heavily fire damaged rendering the floor assembly unsafe (refer to Photograph 05).

Photograph 05 – Main Floor West Side – Taken by Pario on April 14, 2025. – Damaged Stone & Mortar Foundation (Red Arrows) – Damaged Timber Floor Beams (Yellow Arrows).

Furthermore, with the extent of observed rough-cut floor beam, second-floor exterior & interior wall, and roof fire damage, combined with the extensive heat/smoke/soot damages, Pario recommends the complete demolition of the structure, including the foundation.

The structure is deemed to be unsafe due to the floor and roof damage and should remain unoccupied.

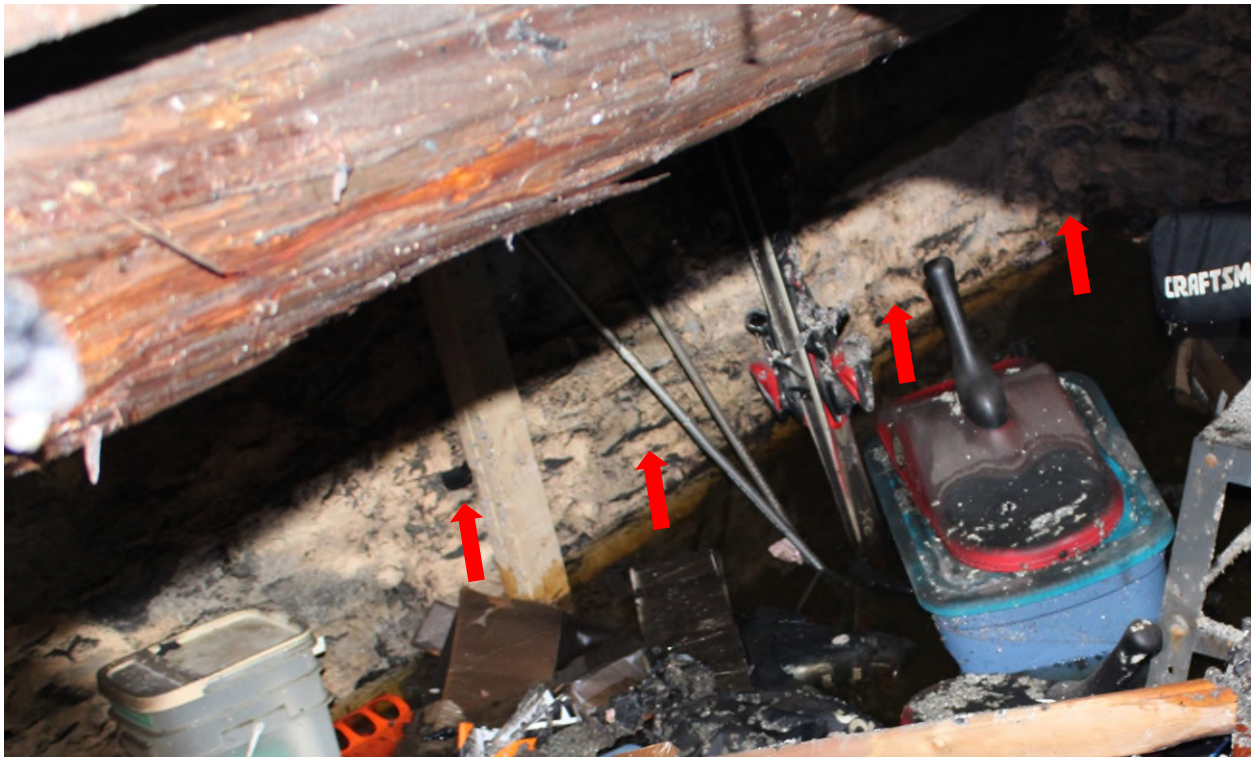
The stone & mortar foundation displayed signs of mortar degradation and damaged areas throughout. As noted above, the exterior stone & mortar foundation and exterior stone cladding appeared to have been repointed at some time. The repointing appeared to be of a modern cement-based mortar.

Photograph 06 – South Foundation Wall – Taken by Pario on April 14, 2025. – Degraded Lime Mortar (Red Arrows).

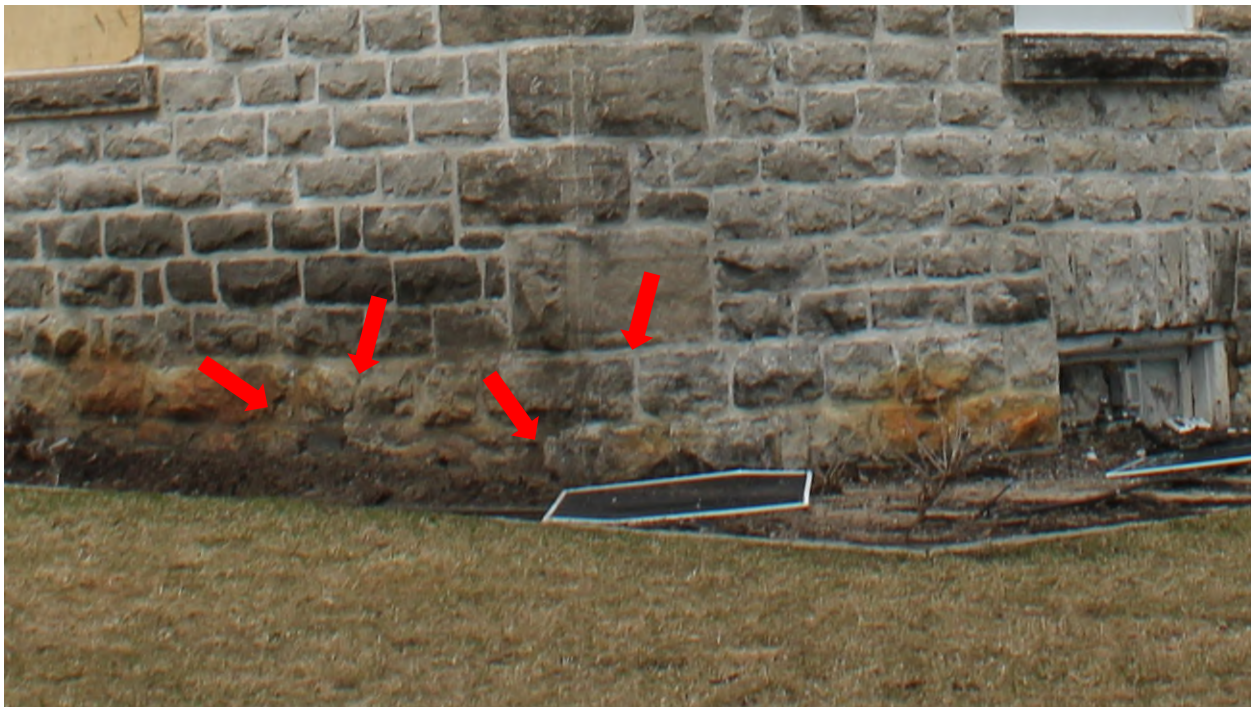
With cement mortar in place, it would be expected that moisture would build up within the wall over a period of time. This buildup of moisture would then be expelled through the next-most relatively permeable material – the masonry. Over extended periods of time this will prematurely degrade the material composition of the masonry. Further to this, freeze/thaw cycles during the winter months will cause expansion of the moisture within masonry units and cause visible spalling.

Photograph 07 – Southwest Corner – Taken by Pario on April 14, 2025. – Repointed Mortar and Potential Mortar Degradation (Red Arrows).

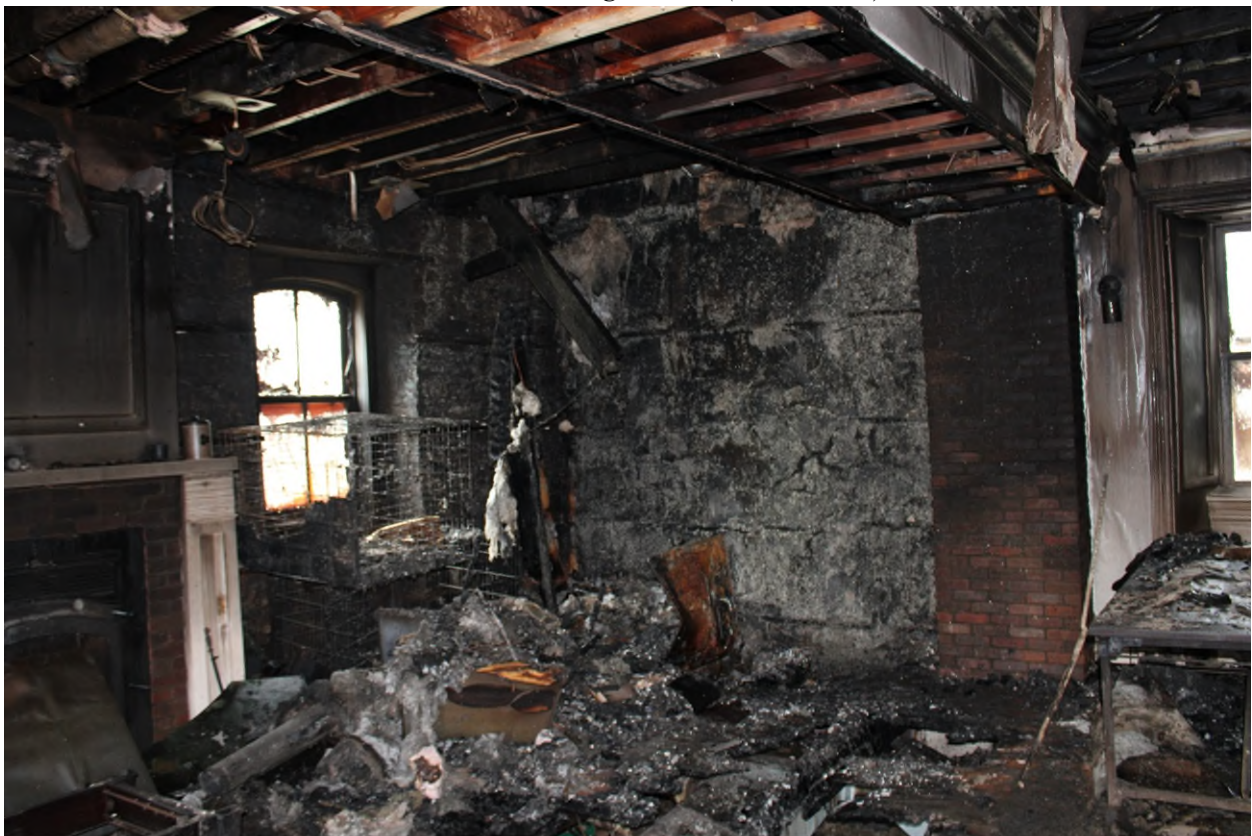
3. There was extensive fire/heat/smoke/soot damage noted throughout the structure (refer to Photographs 08 to 11).
4. The entire second-floor roof assembly was heavily fire damaged and was at risk of collapse (refer to Photographs 10 and 12).

Photograph 08 – View Looking Northwest at Fire Damages (Main Floor) – Taken by Pario on April 14, 2025.

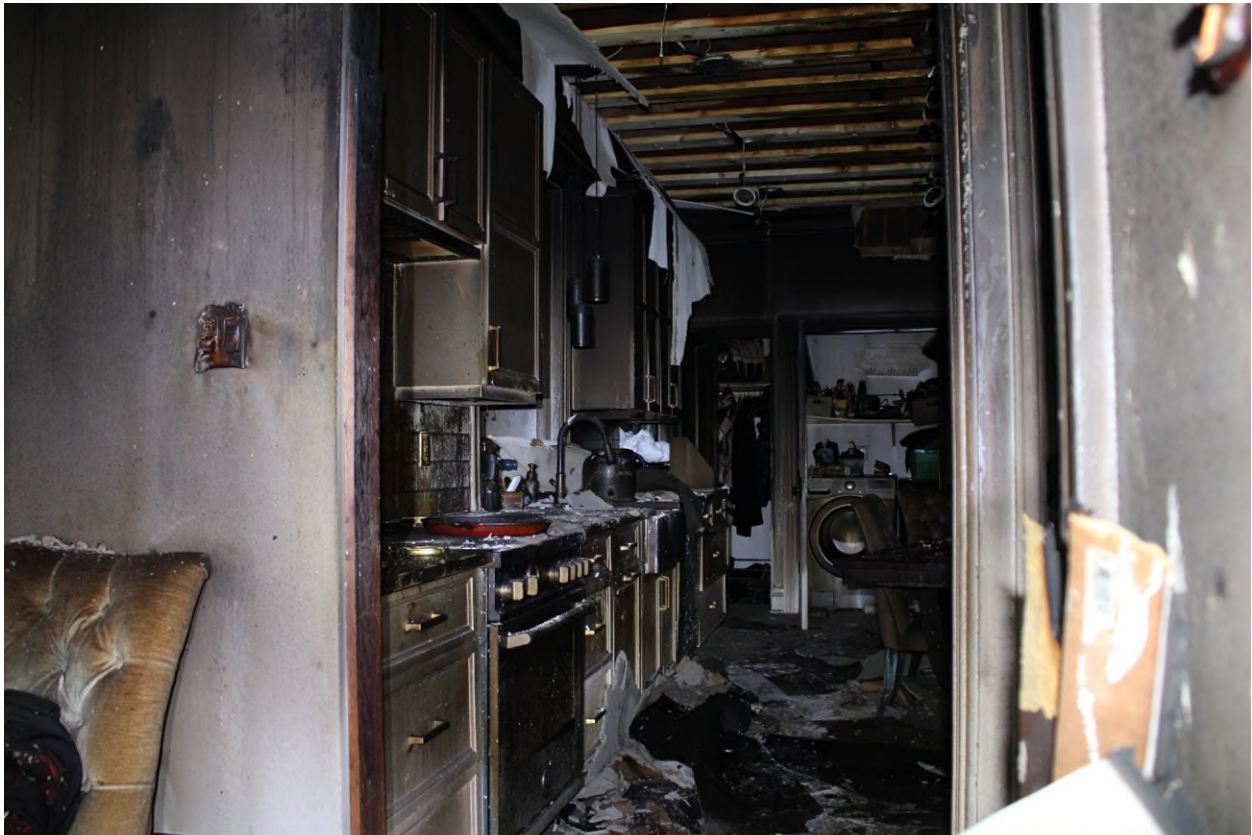
Photograph 09 - View Looking East at Fire Damages (Main Floor) – Taken by Pario on April 14, 2025.

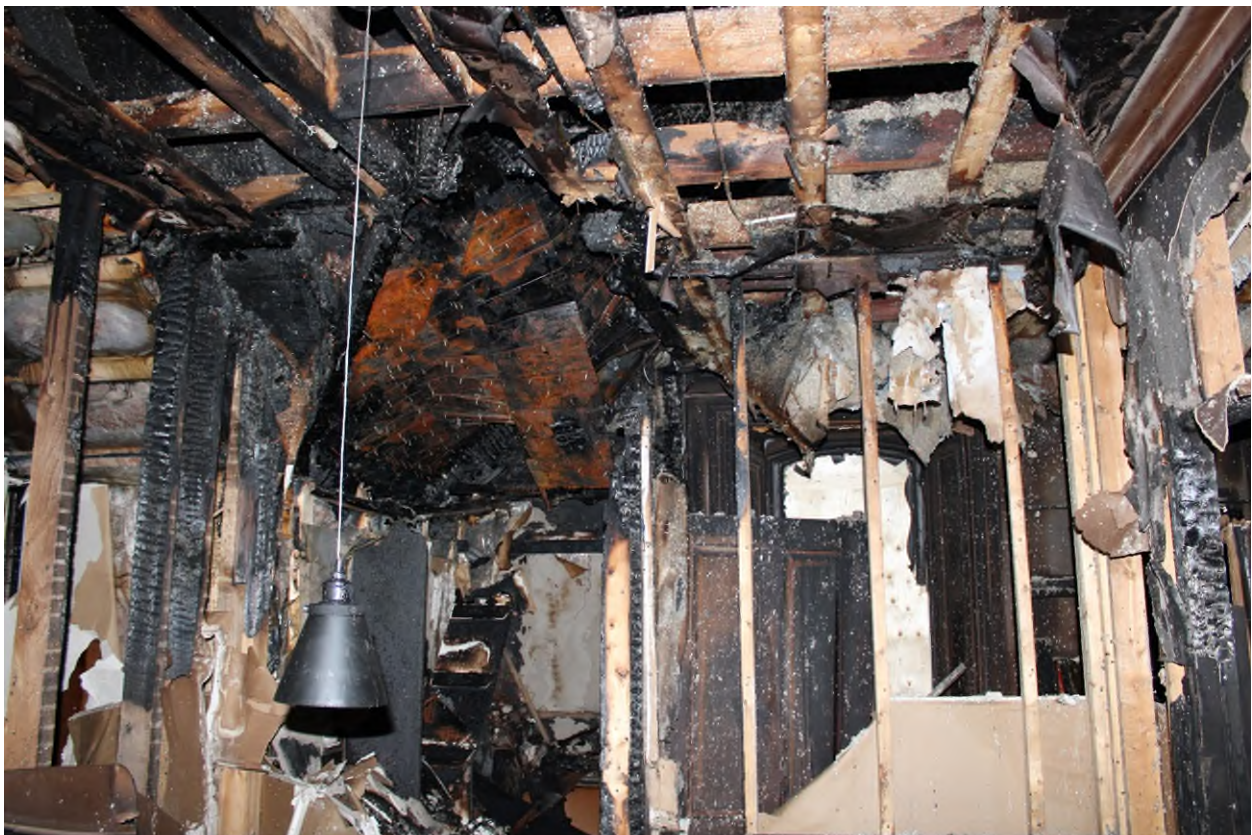
Photograph 10 - View Looking at Fire Damages (Second Floor) – Taken by Pario on April 14, 2025.

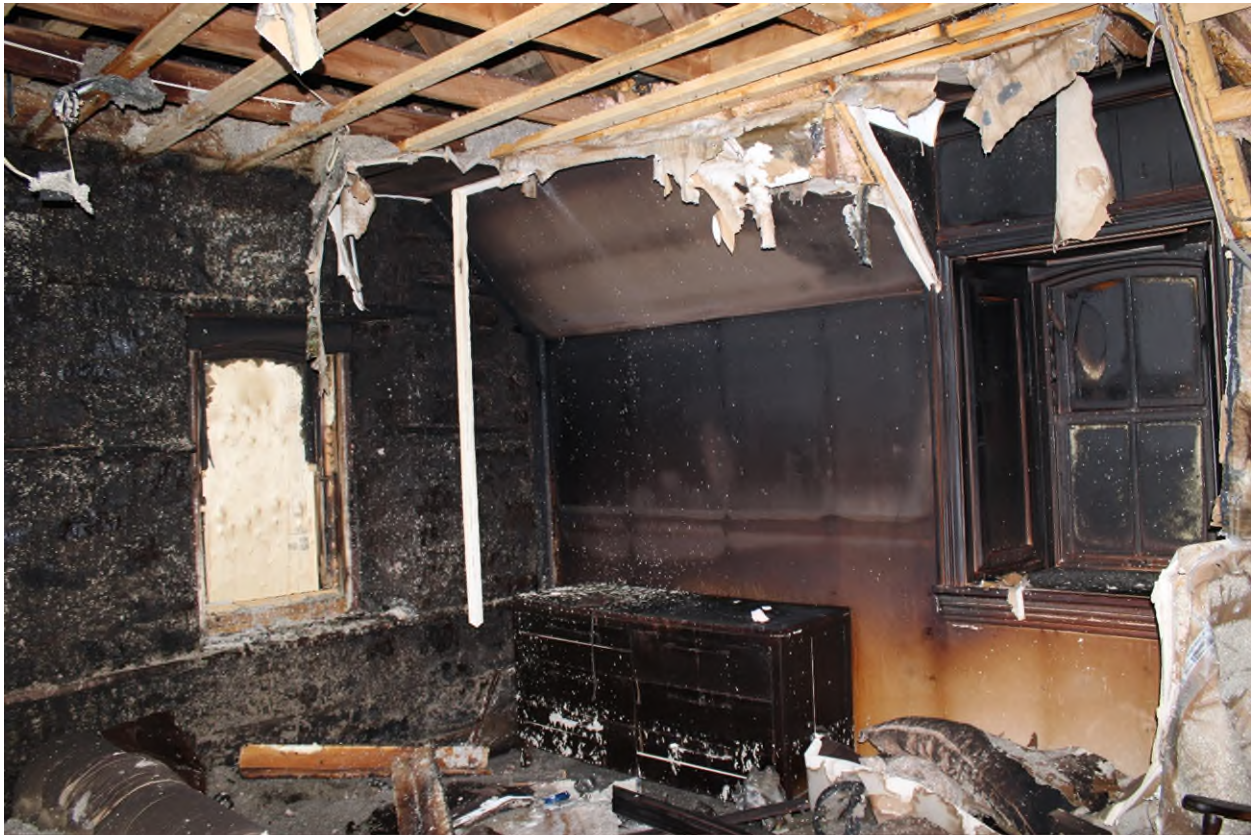
Photograph 11 – View Looking at Fire Damages (Second Floor) – Taken by Pario on April 14, 2025.

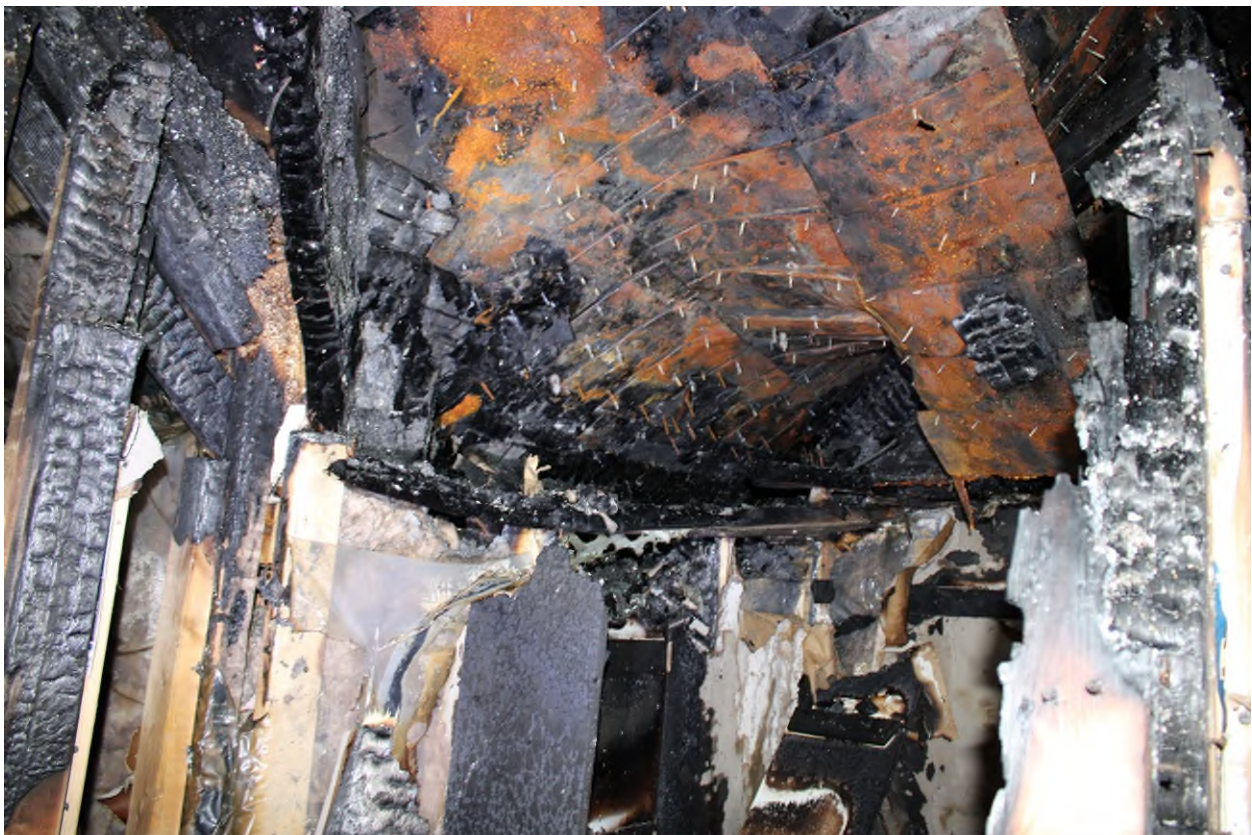
Photograph 12 – View Looking at Fire Damaged Roof Assembly (Second Floor) – Taken by Pario on April 14, 2025.

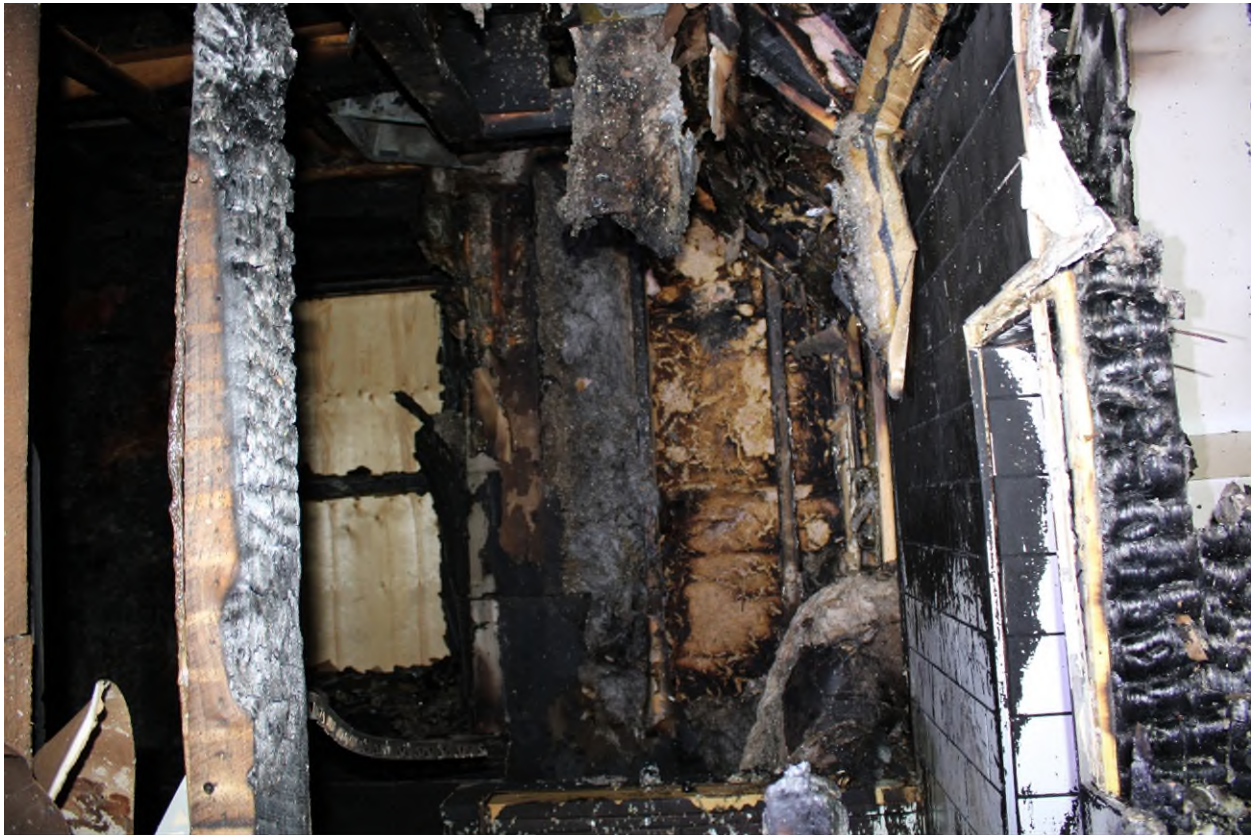
5. The second-floor level exterior and interior walls were extensively fire damaged (refer to Photographs 13 and 14).

Photograph 13 – View Looking at Fire Damaged Wall Assemblies (Second Floor) – Taken by Pario on April 14, 2025.

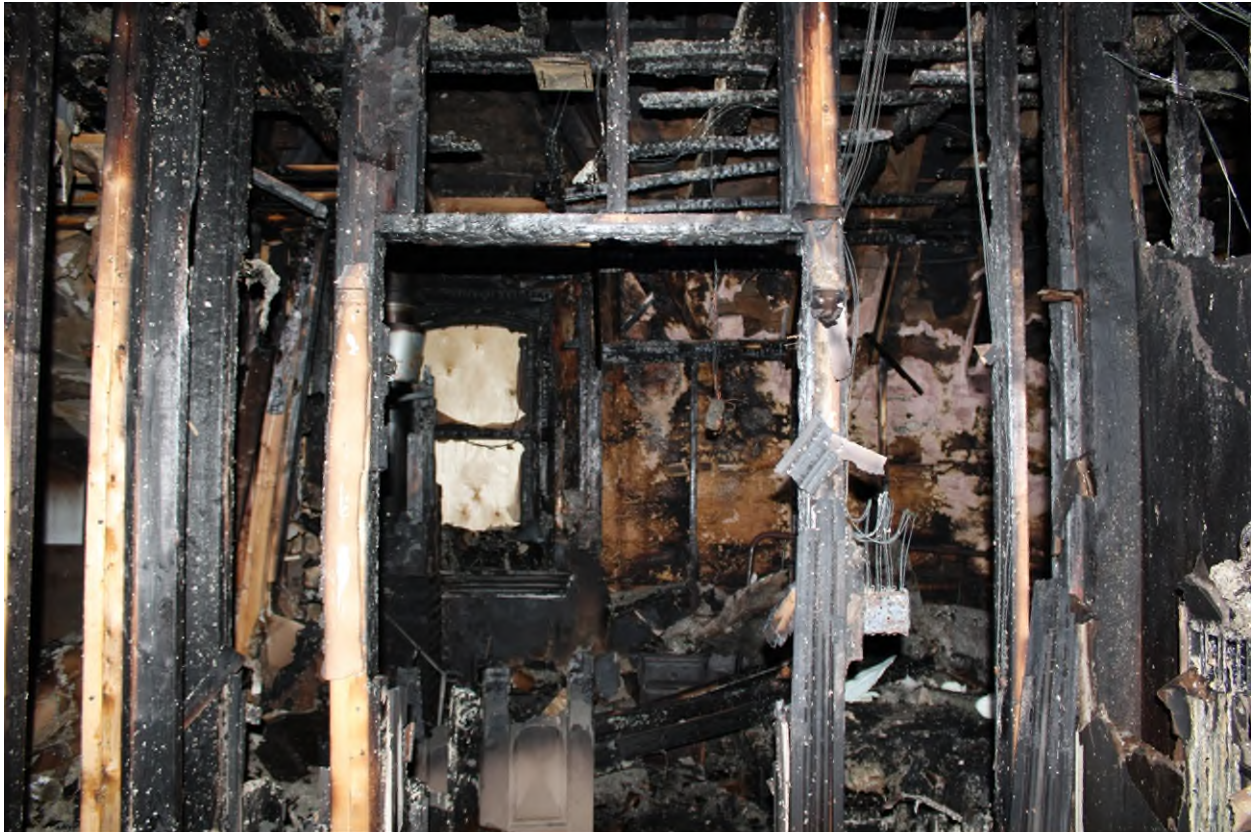
Photograph 14 – View Looking at Fire Damaged Wall Assemblies (Second Floor) – Taken by Pario on April 14, 2025
