Tree Information Report Version 3.0

Submitted as part of Building Permit Application for the City of Ottawa

Address: 844 Connaught

Date: December 21, 2023

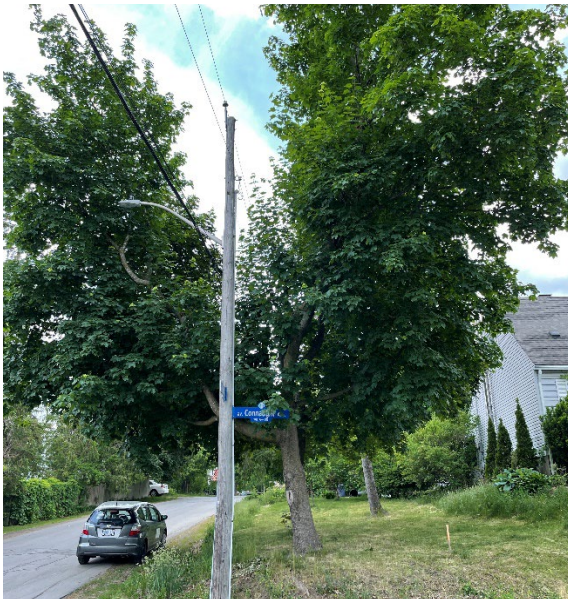
Tree ¹	Species	Diameter at breast height (cm)	Ownership ^{2,3}	Condition	Action	Recommendations
1	Norway maple (<i>Acer platanoides</i>)	41 cm	City	Fair/poor; large canker (35X50) at base of tree, leaning in opposite direction, pruned by hydro	Retain and protect	Retain and protect with fencing as per specifications in report, City should monitor regularly for stability
2	Norway maple (<i>Acer platanoides</i>)	36 cm	City	Fair/good; 2 from hydro lines, significant hydro pruning but has adapted well	Retain and protect	Retain and protect with fencing as per specifications in report
3	White spruce (<i>Picea</i>)	35 cm	City	Good/fair; sweep at base, some hydro pruning, possible	Retain and protect	Retain and protect with fencing as per specifications in report

Figure 1: Tree 1, city owned Norway maple to be retained

Trees 1,2, and especially 5, are city trees in fair to poor health. It is recommended that the forestry inspector visit the site and assess these trees for potential removal by the city. The proposed driveway on Sackville Street is well within the critical root zone of tree 6, but it will be in the same location as the existing garage and driveway, so there should be limited root damage to this tree, if any.

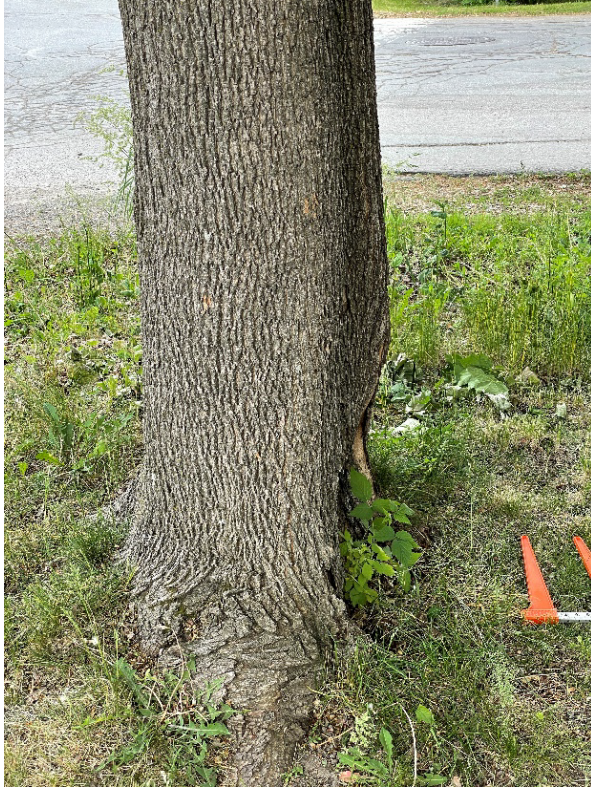
Figure 2: Canker at base of tree 1

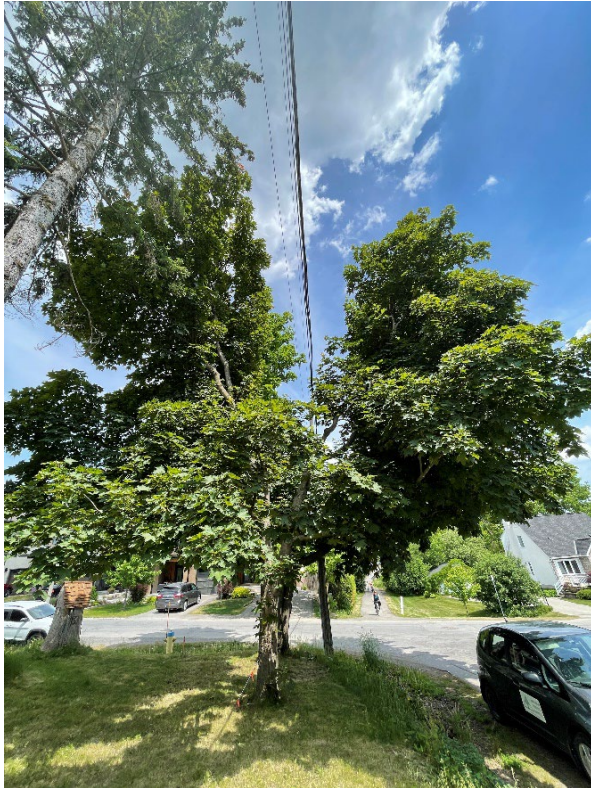
Figure 3: Tree 2, city owned Norway maple to be retained

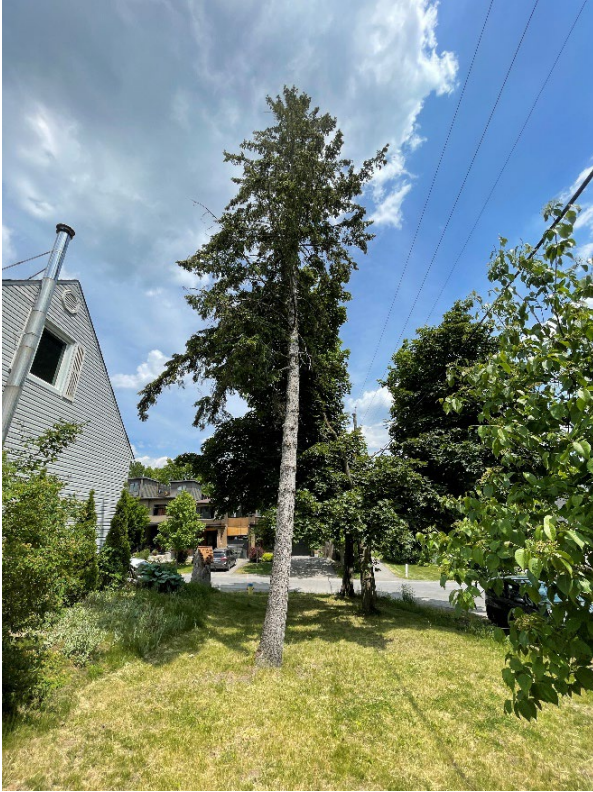
Figure 4: Tree 3, city owned white spruce to be retained

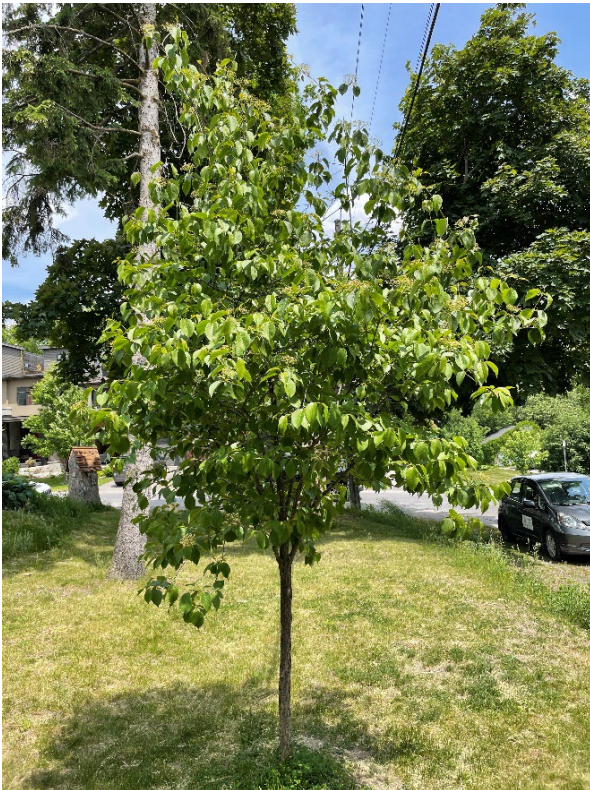
Figure 5: Tree 4, city owned Viburnum

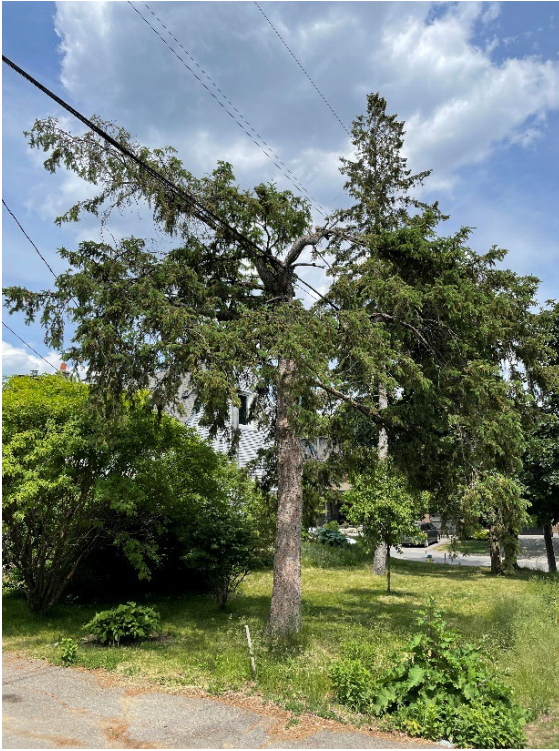
<i>glauca</i>)			root girdling on underside of lean		
4	Viburnum (<i>Viburnum lentago</i>)	5 cm	City	Good	Retain	Retain and protect with fencing as per specifications in report
5	White spruce (<i>Picea glauca</i>)	39 cm	City	Poor; topped by hydro	Retain and protect OR City should consider removing this tree based on poor health	Remove based on health and potential impact of construction; better option is to replace with a new tree post construction
6	Norway maple (<i>Acer platanoides</i>)	25, 35 cm (rough estimate)	Adjacent property at 839 Tavistock; possibly on the property line	Good (tree not very visible through fence)	Retain and protect	Avoid exposing any roots during construction of new driveway and garage

Figure 6: Tree 5, city owned white spruce in poor condition

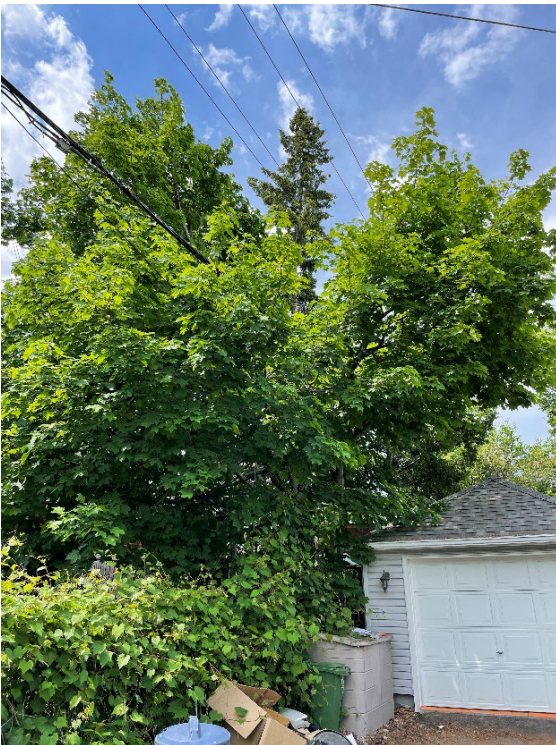
Figure 7: Tree 6, Norway maple on adjacent property at 836 Tavistock

6	Norway maple (<i>Acer platanoides</i>)	25, 35 cm (rough estimate)	Good (tree not very visible through fence)	Avoid exposing any roots during construction of new driveway and garage
