**re: Preliminary Slope Stability Assessment
Proposed Residential Development**
Lots 1 to 4, Bonnie Lane / Linda Loop, Kinburn, ON

date: November 19, 2025

file: PG7794-MEMO.01

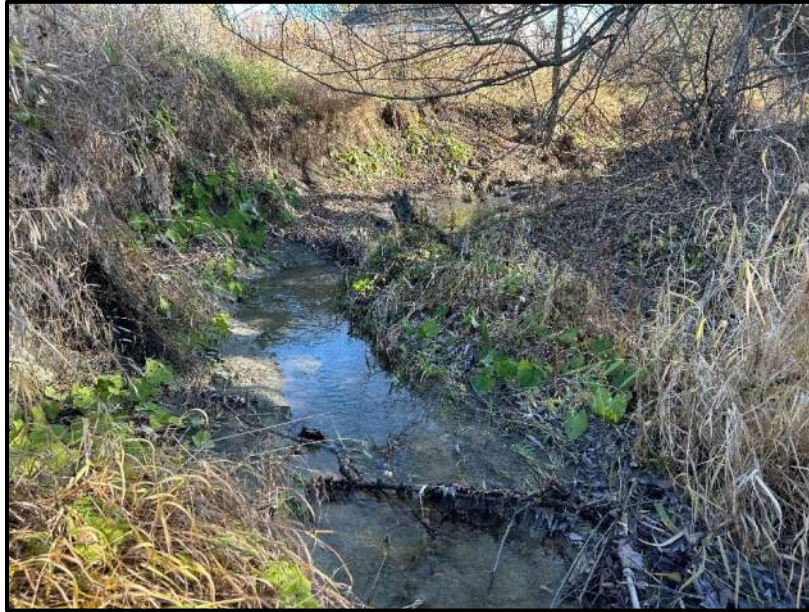
The slope face was observed to be covered with grass and shrubs, with one dead tree also noted along the slope. The slope appeared to be in stable condition with continuous vegetative cover. No evidence of erosion, instability, or surficial movement was observed along the slope face or at the toe of the slope. Reference should be made to photographs captured during our site visit, attached to the current report.

Photo 1: Photograph of Creek, facing northwest, illustrating slopes covered with grass and shrubs.

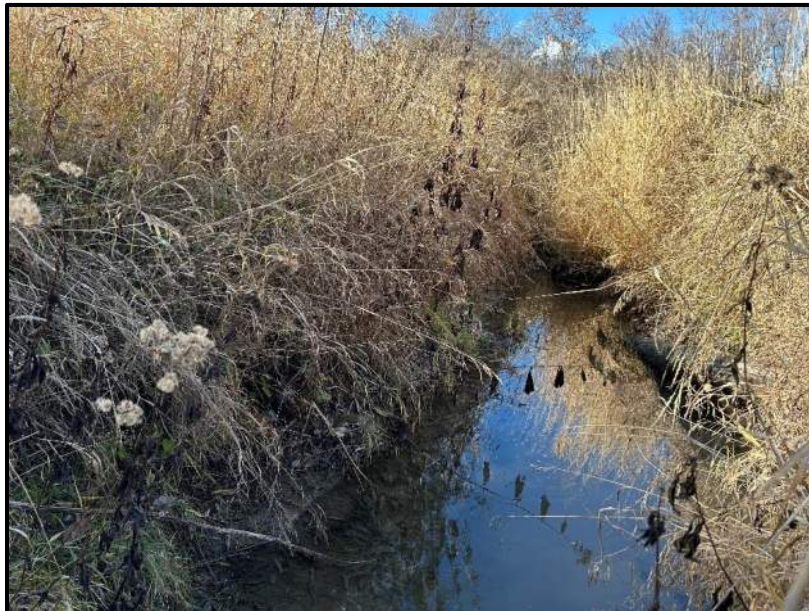
Photo 2: Photograph of Creek at cross section B-B', facing northeast, illustrating slopes covered with grass and shrubs.

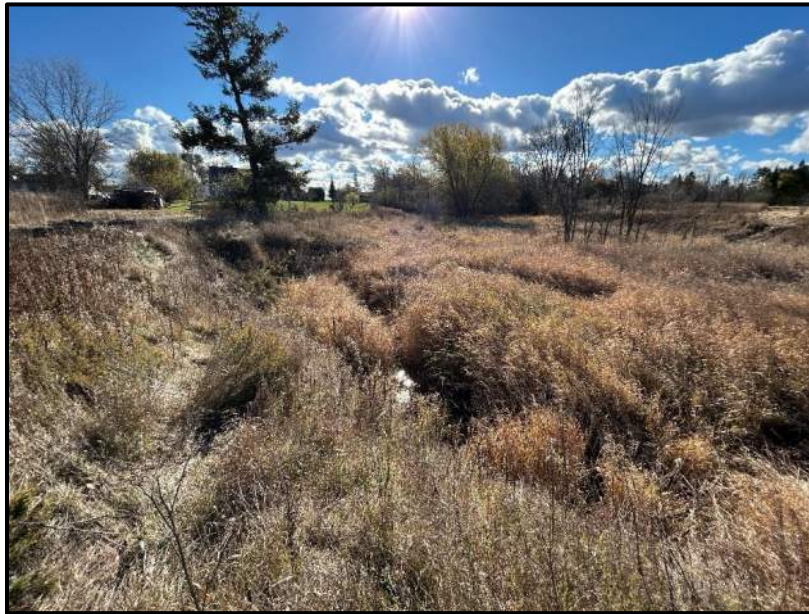
Photo 3: Photograph of sloped area, facing north, illustrating slopes covered with grass and shrubs.

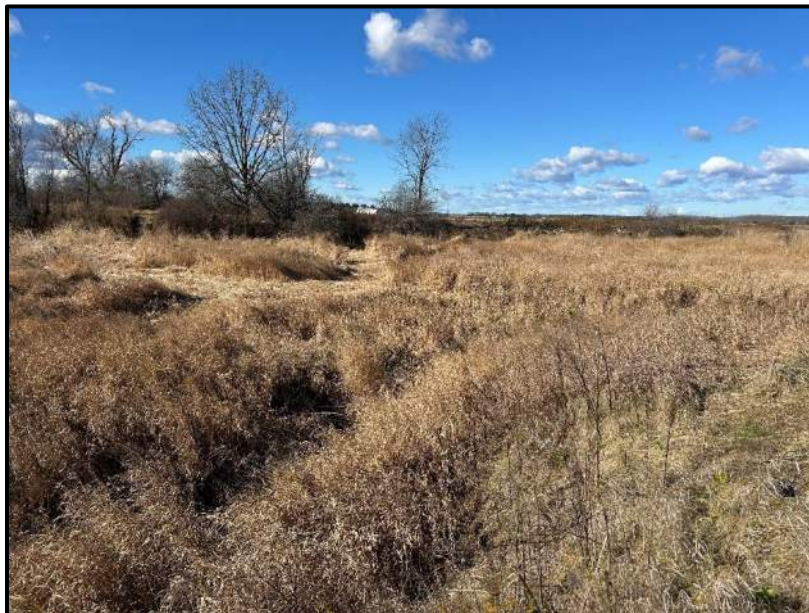
Photo 4: Photograph from the central portion of the site, facing northeast, illustrating ground cover consisting of grass and shrubs.

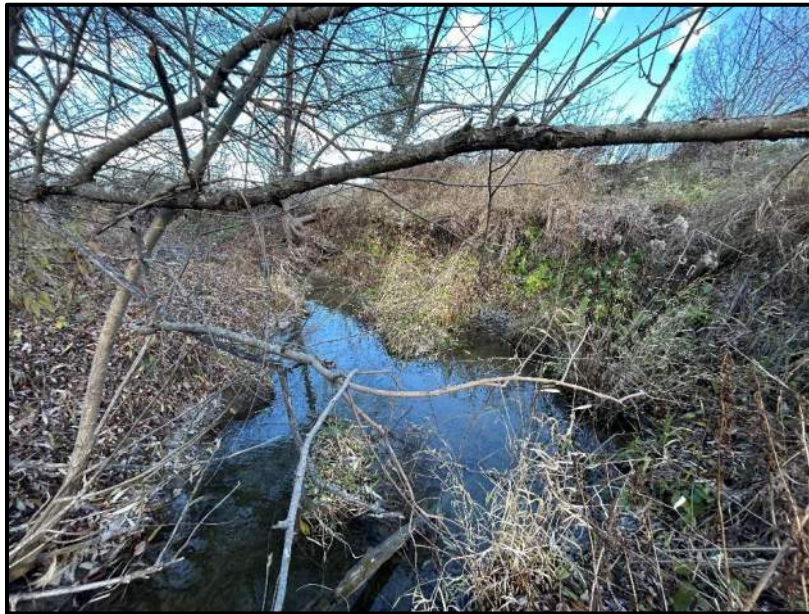
Photo 5: Photograph of Creek, facing northwest illustrating slopes covered with grass and shrubs.

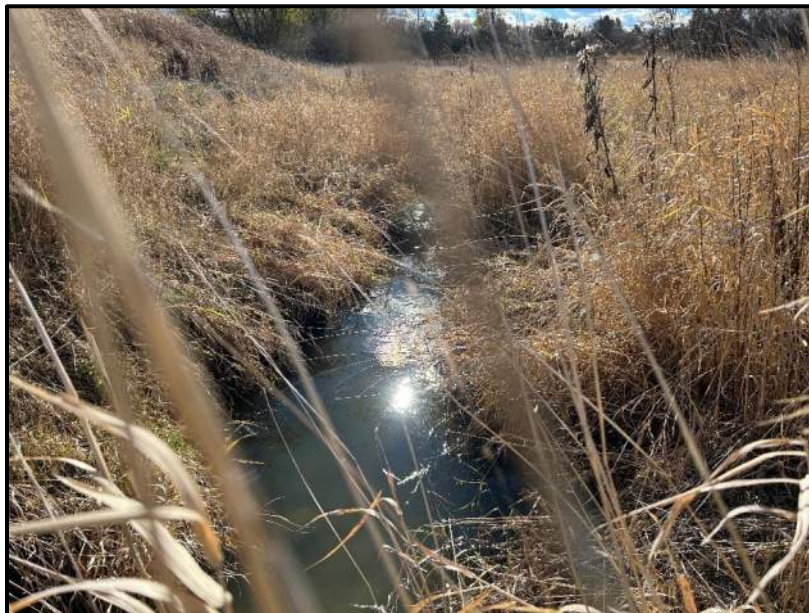
Photo 6: Photograph of Creek, facing northwest, illustrating slopes covered with grass and shrubs.

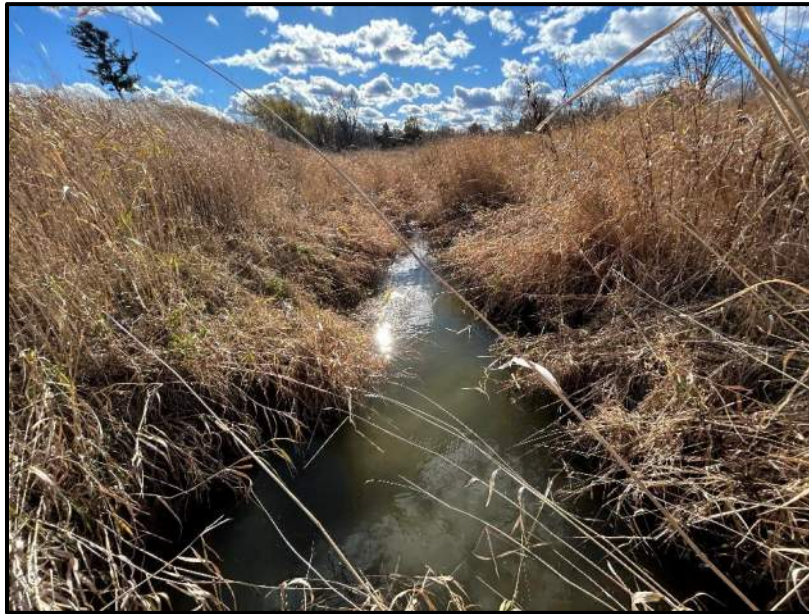
Photo 7: Photograph of Creek, facing southeast illustrating slopes covered with grass and shrubs.

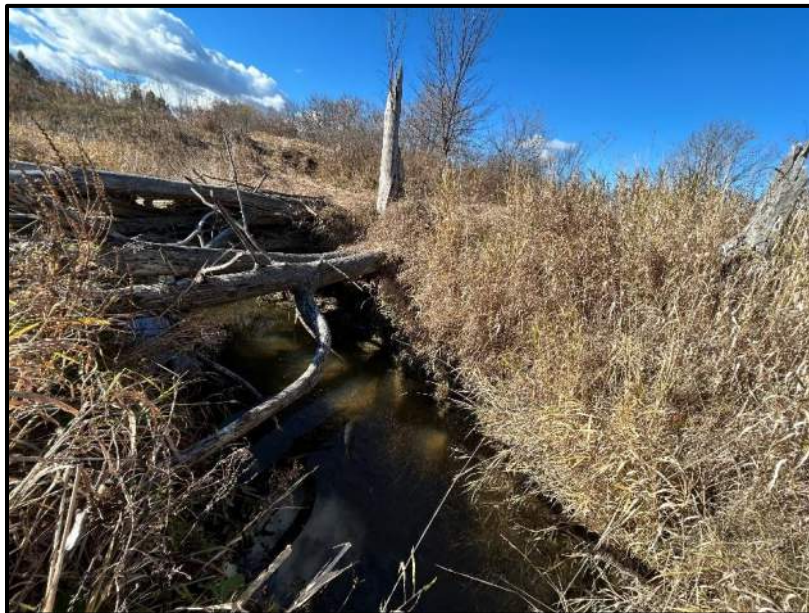
Photo 8: Photograph of the creek near cross-section A–A', facing northeast, illustrating slopes covered with grass, shrubs, and a dead tree.

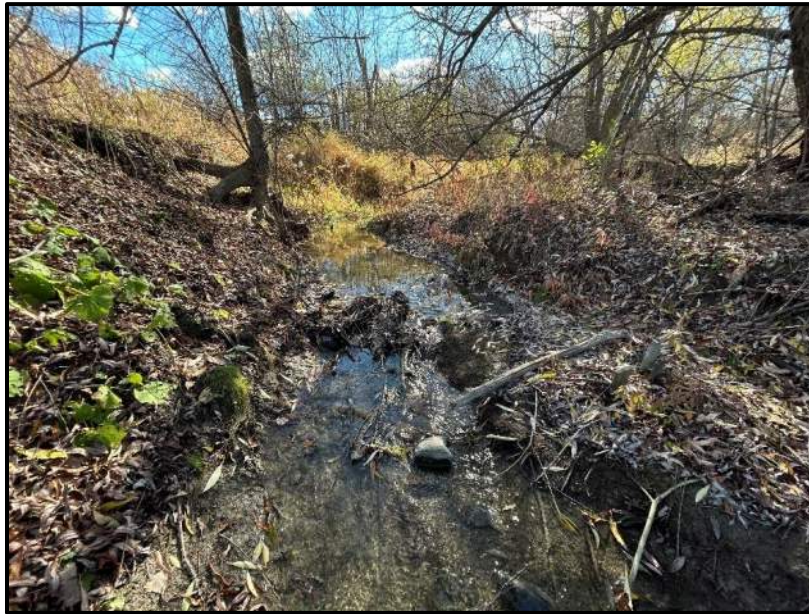
Photo 9: Photograph of the creek to the south of cross-section A–A', facing northwest, illustrating slopes covered with grass, shrubs, and trees.

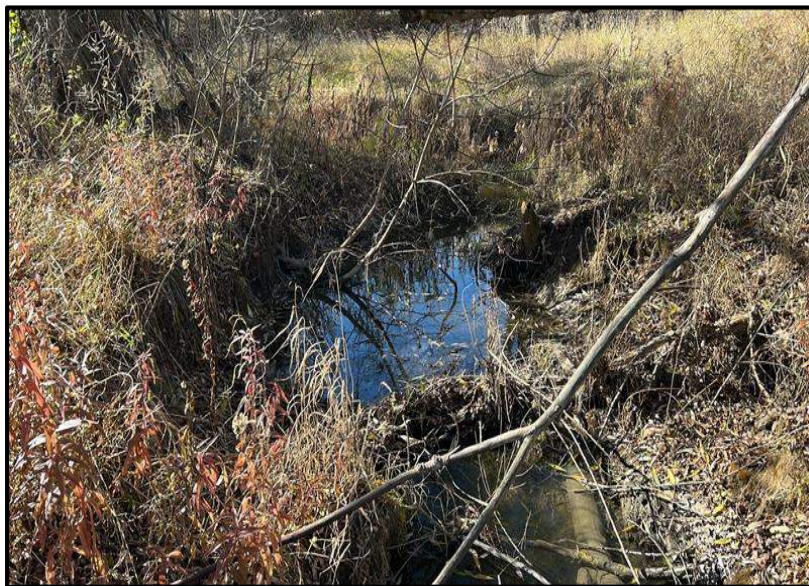
Photo 10: Photograph of the creek to the south of cross-section A–A', facing south, illustrating slopes covered with grass, and shrubs.

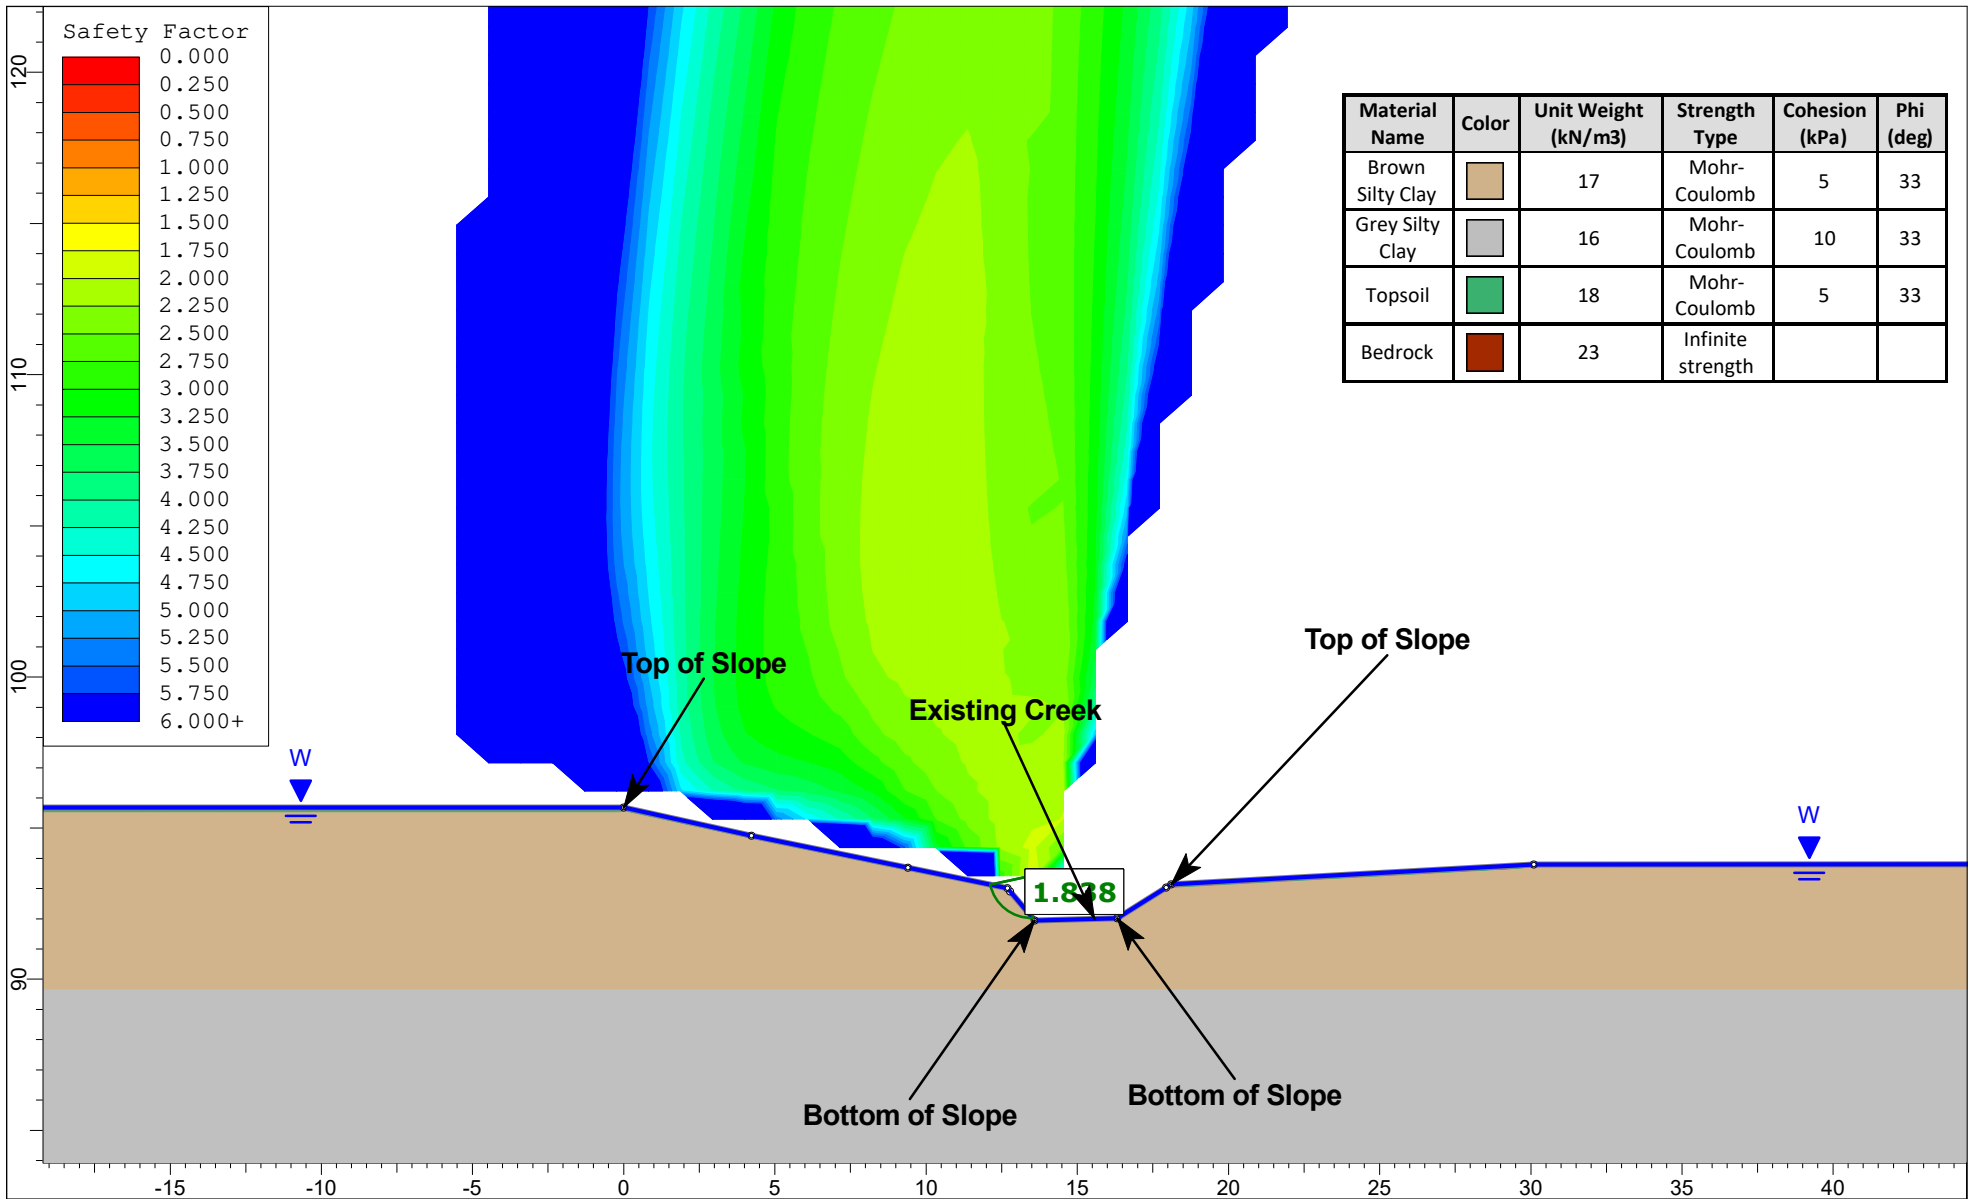
<i>Project No.:</i> PG7794 - Lots 1 to 4, Bonnie Lane/Linda Loop, Kinburn, ON - Slope Stability - Existing Conditions		
	<i>Drawing No.:</i> Section A-A - Figure 2A - Left to right - Static Loading		
	<i>Prepared By:</i> YZ	<i>Approved By:</i> DP	<i>Date:</i> 2025-11-13

The results for the existing static conditions are shown in Figures 2A, 2C, 3A, and 3C, attached to the current memorandum. The results indicate that the factor of safety for all the sections was found to be greater than 1.5.

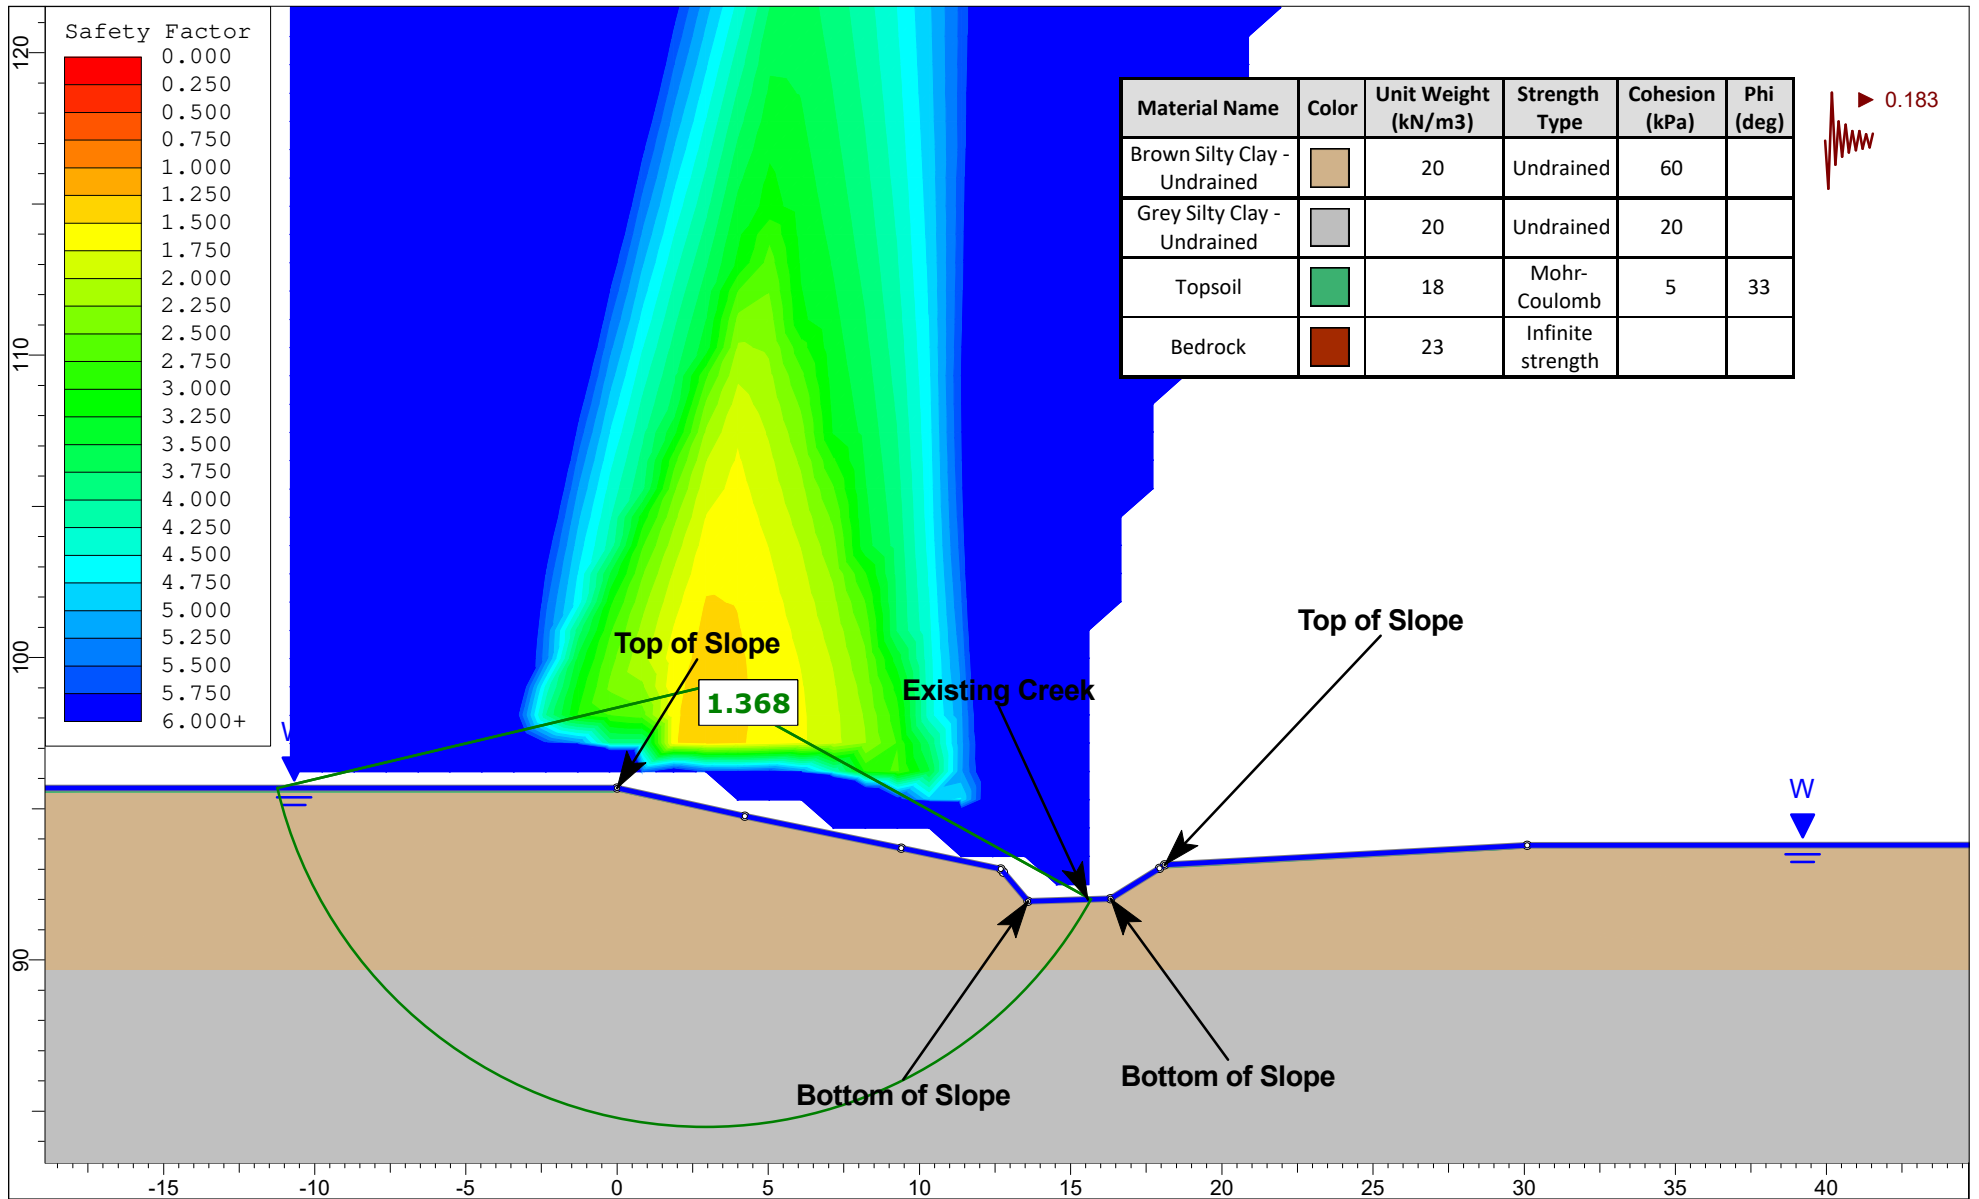
<i>Project No.:</i> PG7794 - Lots 1 to 4, Bonnie Lane/Linda Loop, Kinburn, ON - Slope Stability - Existing Conditions		
	<i>Drawing No.:</i> Section A-A - Figure 2B - Left to right - Seismic Loading		
	<i>Prepared By:</i> YZ	<i>Approved By:</i> DP	<i>Date:</i> 2025-11-13

An analysis considering seismic loading and the groundwater at the ground surface was also completed. A horizontal acceleration of 0.183g was considered for all slopes. A factor of safety of 1.1 is considered to be satisfactory for stability analyses, including seismic loading.

The results of the analyses, including seismic loading, are shown in Figures 2B, 2D, 3B, and 3D, attached to the current memorandum. The results indicate a slope with a factor of safety greater than 1.1 at all sections. Based on these results, the slopes are considered to be stable under seismic loading.

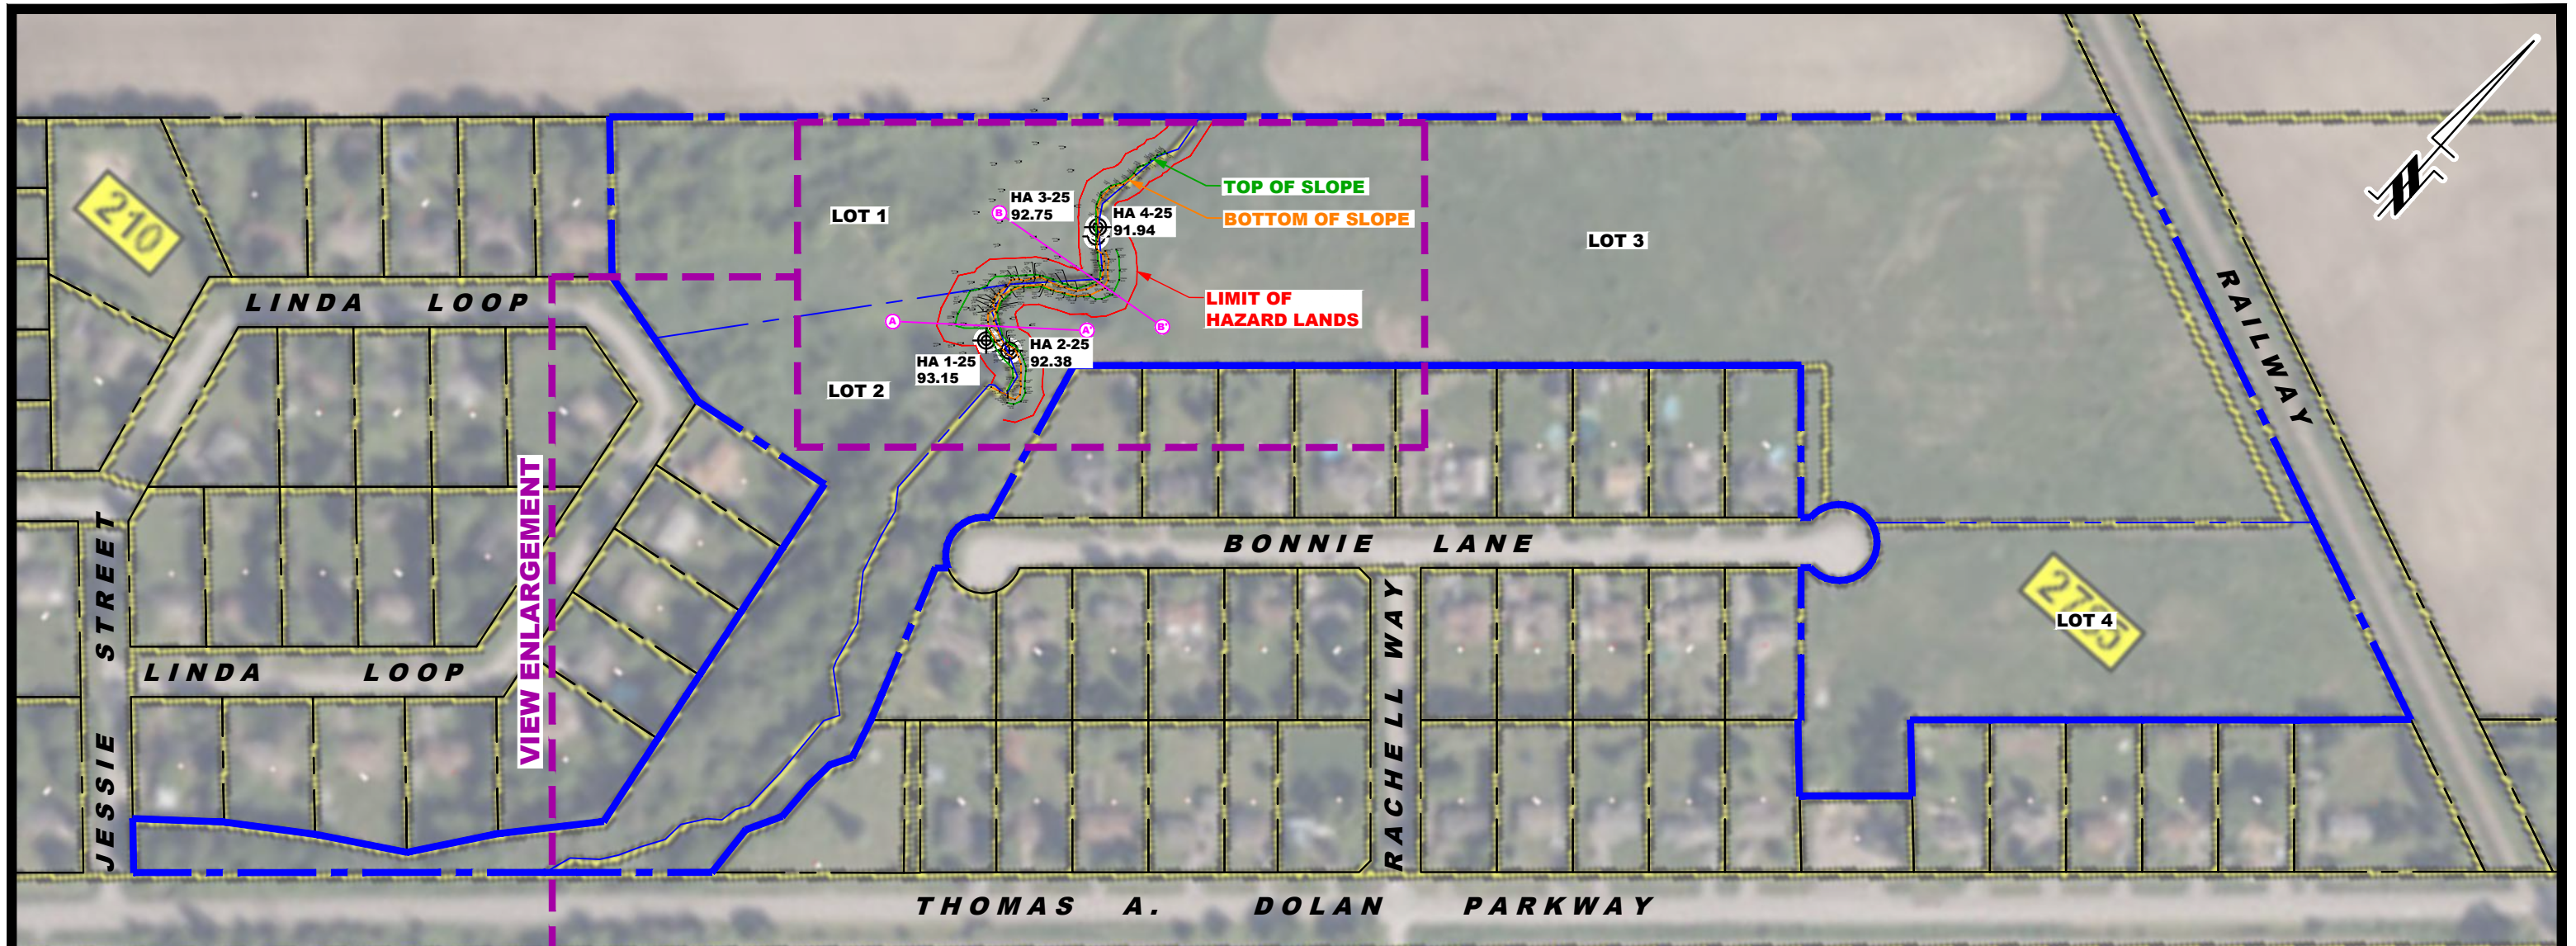
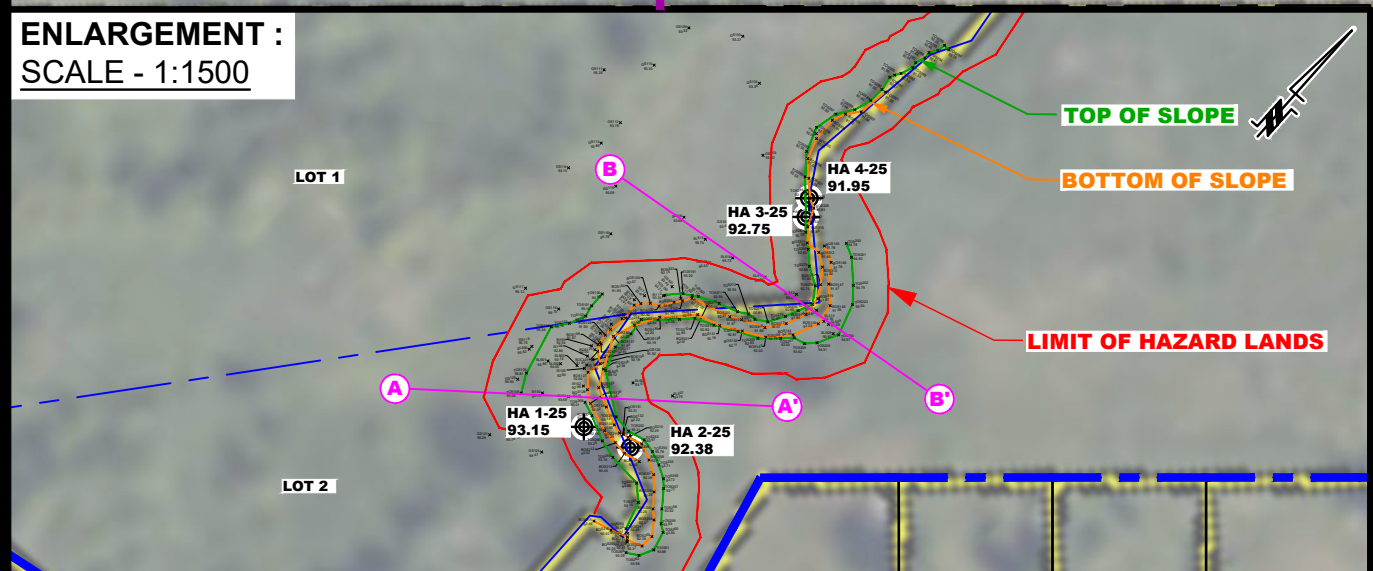
TEST HOLE LOCATION PLAN

Based on our analysis and the above-noted results, the limit of hazard lands designation line for the subject site is indicated on Drawing PG7794-1 – Test Hole Location Plan attached to the end of this report.

Based on the anticipated soils and due to no evidence of active erosion at the toe of the existing slope, a toe erosion allowance of 1 m should be applied from the watercourse edge, and an access allowance of 6 m is required from the top of the slope or geotechnical setback (where applicable).

Typically, the limit of hazard lands setback is comprised of a stable slope allowance, a toe erosion allowance, and an erosion access allowance, and would comprise a combination of an erosion access allowance (6 m) and a toe erosion setback (1 m) taken from the top of the stable slope. Since the observed slopes are considered stable based on analysis and visual review, there is no applicable stable setback to be considered for the subject slopes at this time, such that the setback may be taken from the top of slope alignment identified in the field by Paterson field personnel.
