## TREE CONSERVATION REPORT

65 and 85 Gemini Way

Tree Conservation Report submitted as Partial  
Requirements for a Site Plan Control  
Application, November 28, 2024 and Application  
for Severance for 65 Gemini Way

**Date of Report:** November 28, 2024

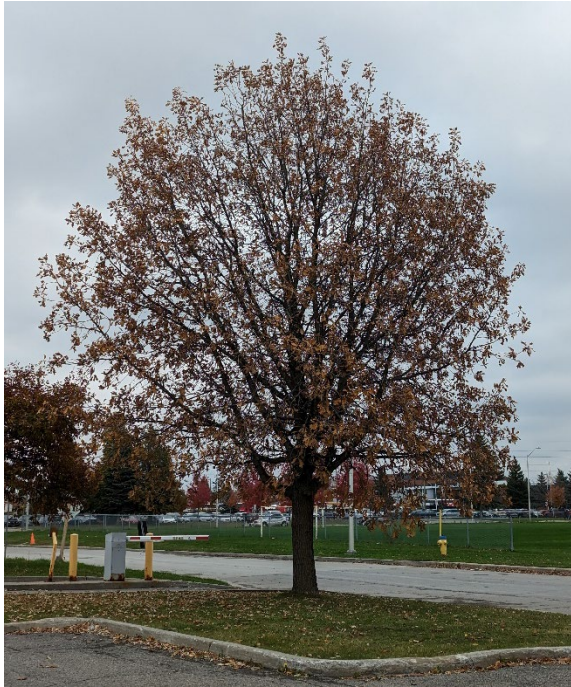
Tree 2 - private oak to be removed.

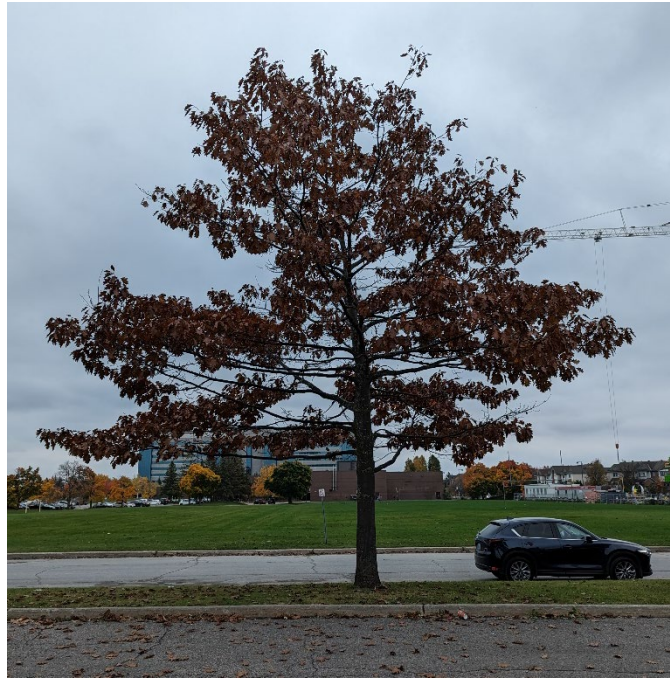
**Tree 3** is an oak in good condition. A Tree Protection Area should be installed to ensure that the tree's rooting space is protected to the greatest extent possible.

Tree 3 - private oak to be retained.

**Prior to any site works**, protective fencing should be installed around the Tree Protection Area as indicated in the attached Tree Information Map and maintained until all construction on site has been completed as per the City of Ottawa Tree Protection Specifications (March 2021).

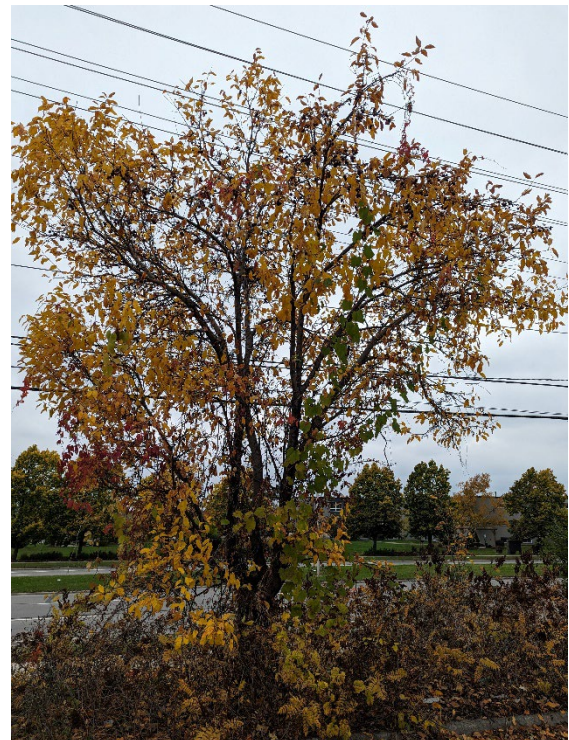
Tree 29 – private crab apple to be removed.

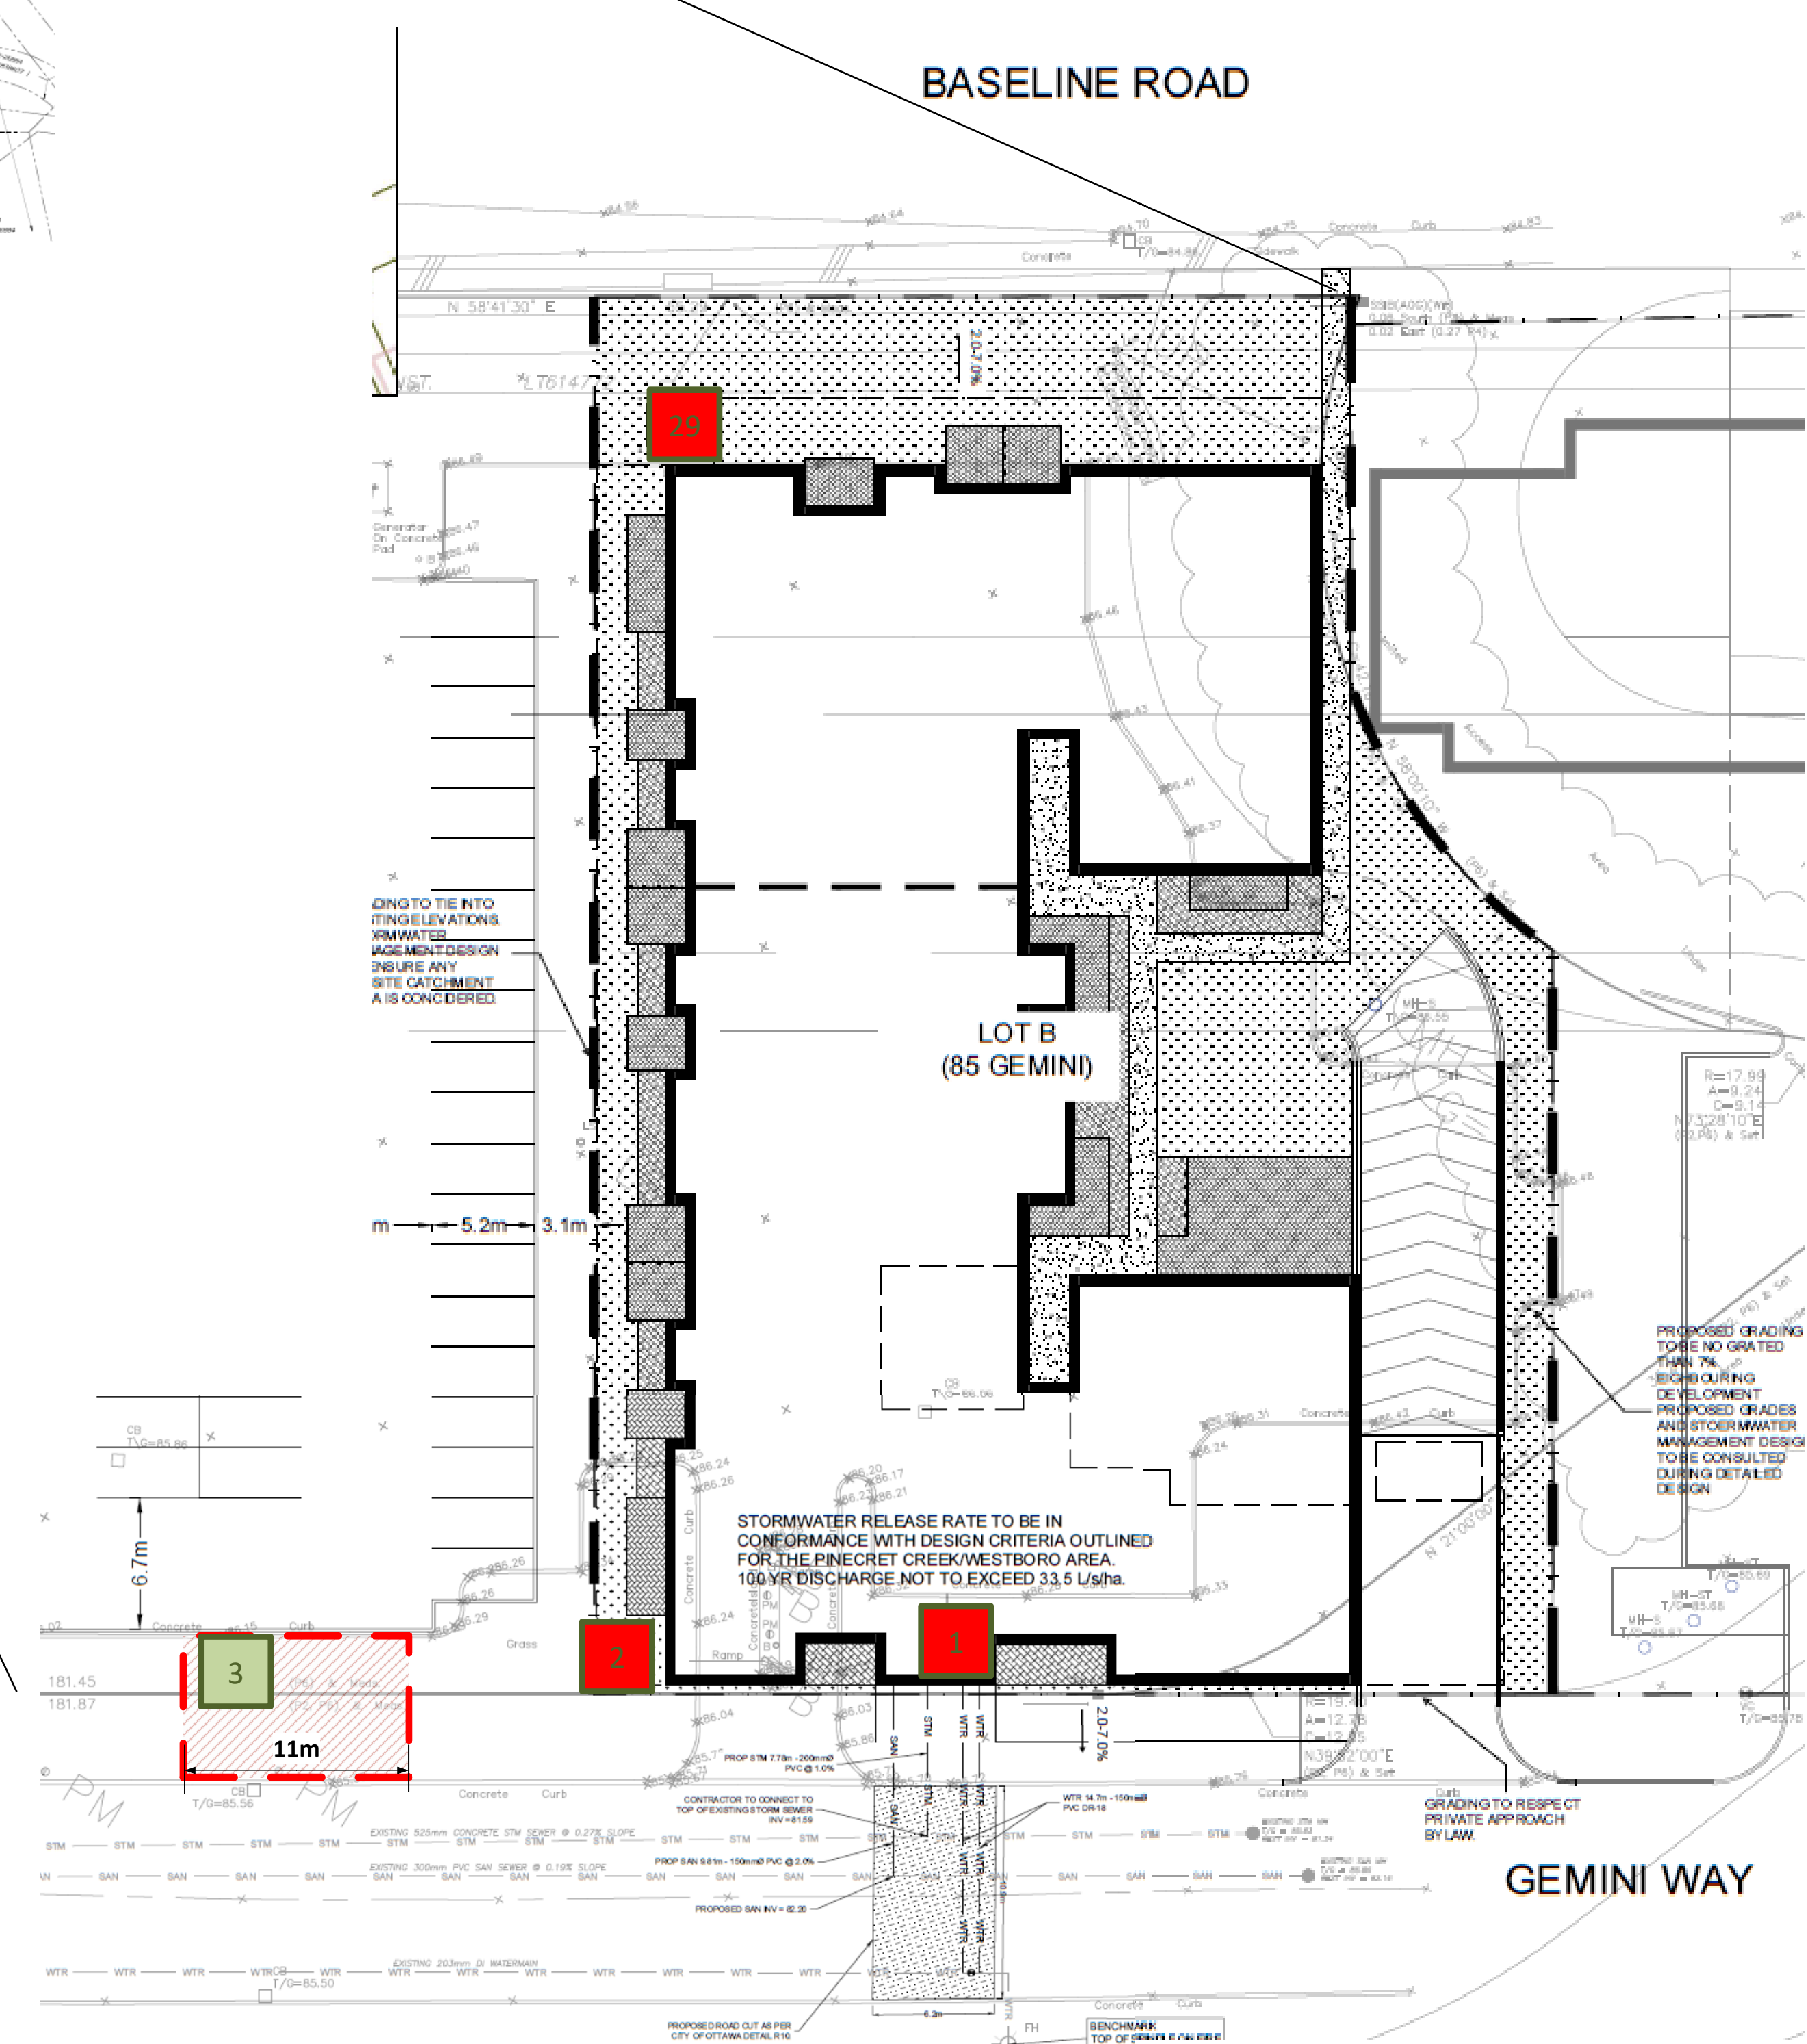
Tree Conservation Reprt – 85 Gemini Way  
 Map #2 – Proposed Development  
 Version 1.0, November 28, 2024  
 For more information, please contact [info@dendronforestry.ca](mailto:info@dendronforestry.ca)

The proposed building will include underground parking. The three protected trees in this area of the 1 Centrepointe property are recommended for removal based on the intensity of excavation required to install the parking and build the tower.
