May 30, 2013

OEI File: N009-002

RE: Heritage Structural Review of 197 and 201 Wilbrod Street, Ottawa

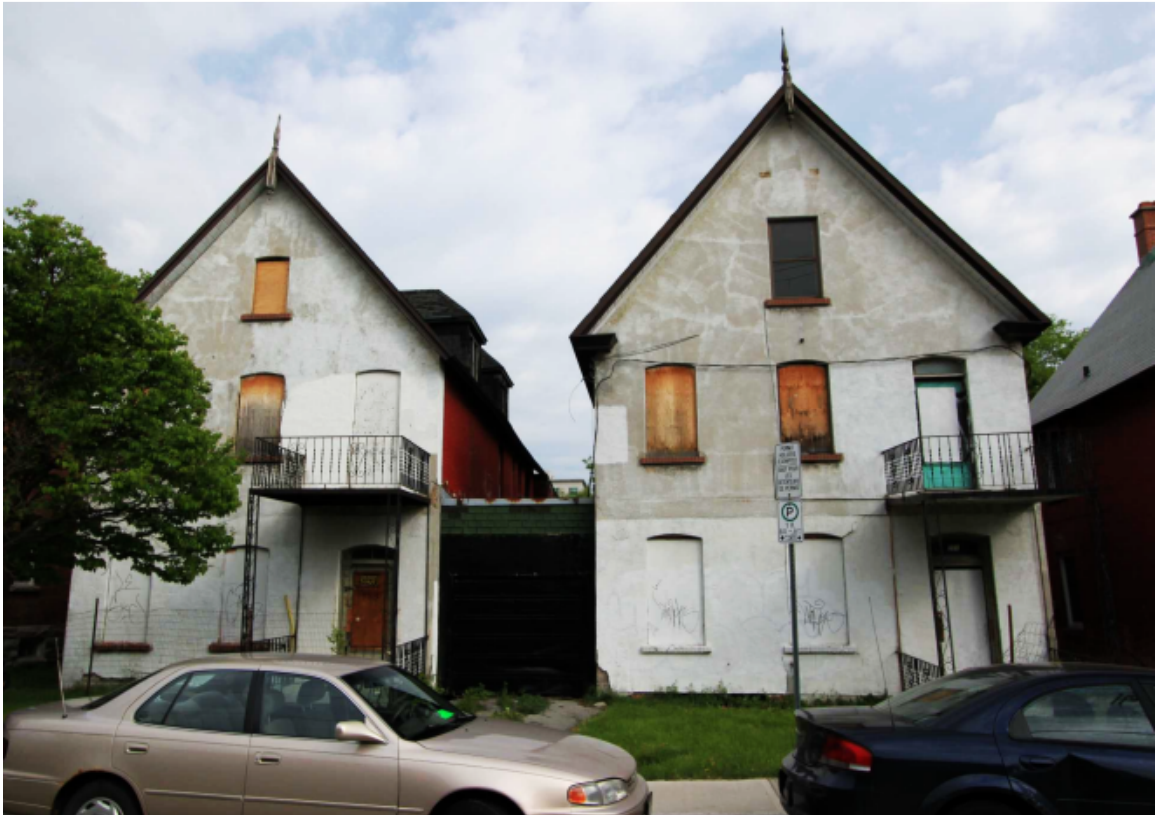
The buildings are located on an approximately 7,000 square foot lot (Figure 1). The rear additions were made to both buildings at a later date, and a garage was inserted between them. Partial basements exist at the rear ends of both buildings. The original buildings appear to have only crawl spaces. Interior modifications happened throughout the history of the buildings.

Figure 1. Wilbrod Street View

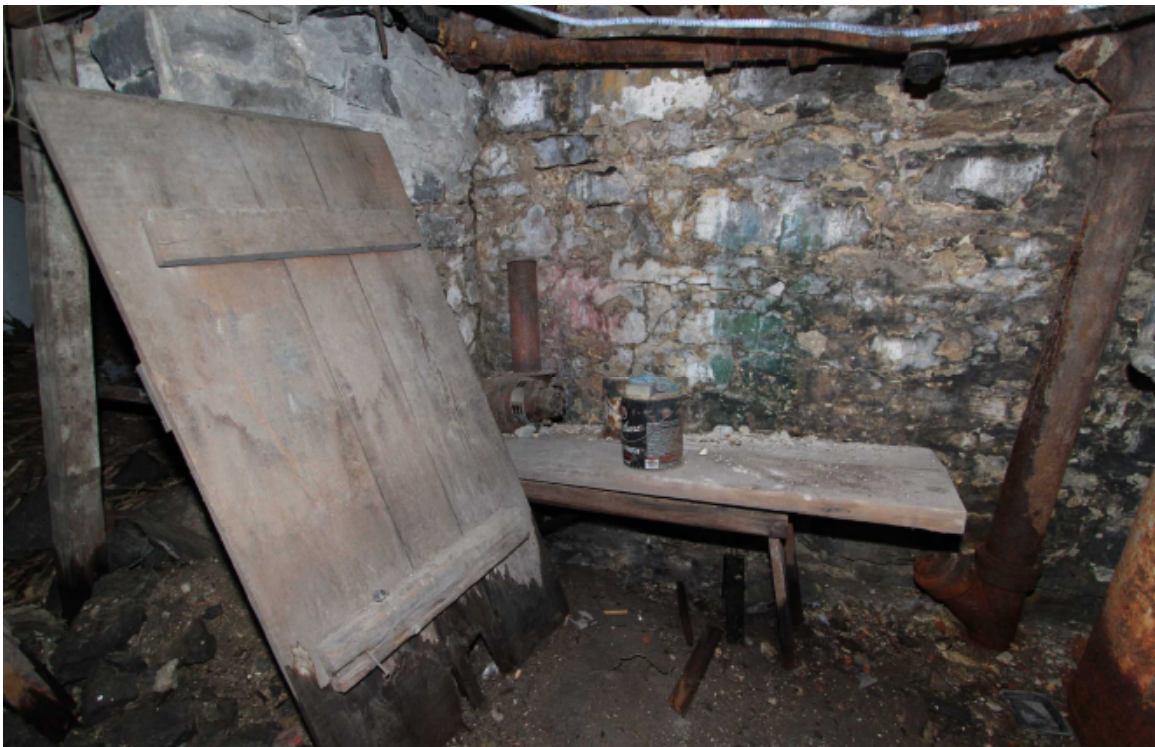
FOUNDATION WALLS. The basement rubble stone foundation walls are approximately 24 inches thick. Parts of the walls have failed and parts appear to be weathered but sound. Figure 3 shows one of the walls. It was not possible to closely inspect the condition of the foundation walls in areas with crawl space.

Figure 3. Foundation Walls

The slabs on grade in both basements have failed (Figure 4). The basements are not high enough, and in one of them it was necessary to dig out the middle in order to install the furnace. If the decision is made to restore the buildings, a detailed survey of the walls with recommendation for repairs would have to be performed. If the use of the basements is required, an underpinning of the walls must be designed.

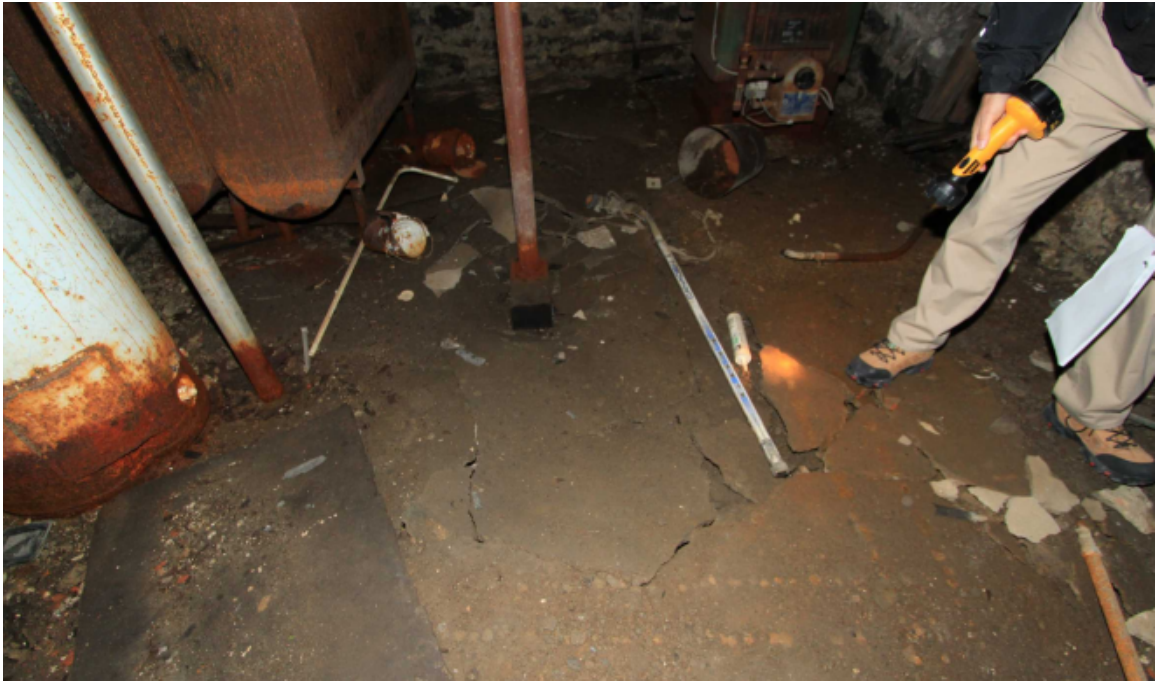
Figure 4. Basement Slab on Grade

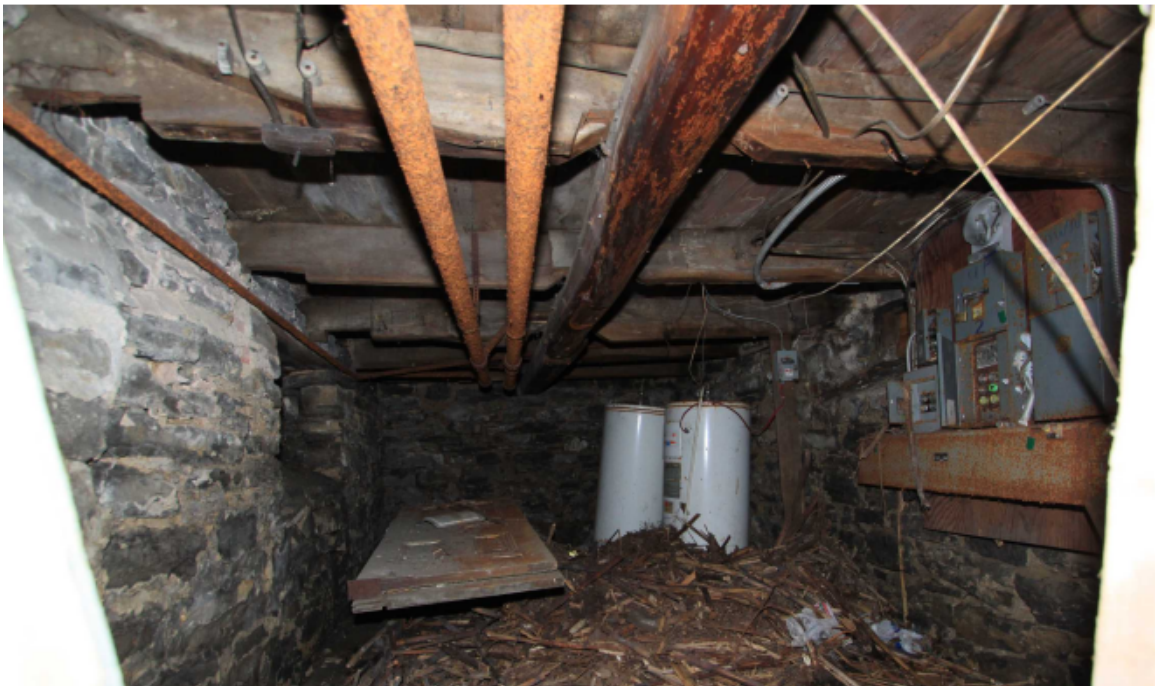
Exposure to weather and water has caused deterioration of several of the viewed ground floor joists. A lot of joists have been notched at the walls. Some of them have been randomly notched to allow passage of utilities. Most of the joists rest directly on rubble stone foundation walls instead on wood plates (Figure 5).

Figure 5. Ground Floor Joists

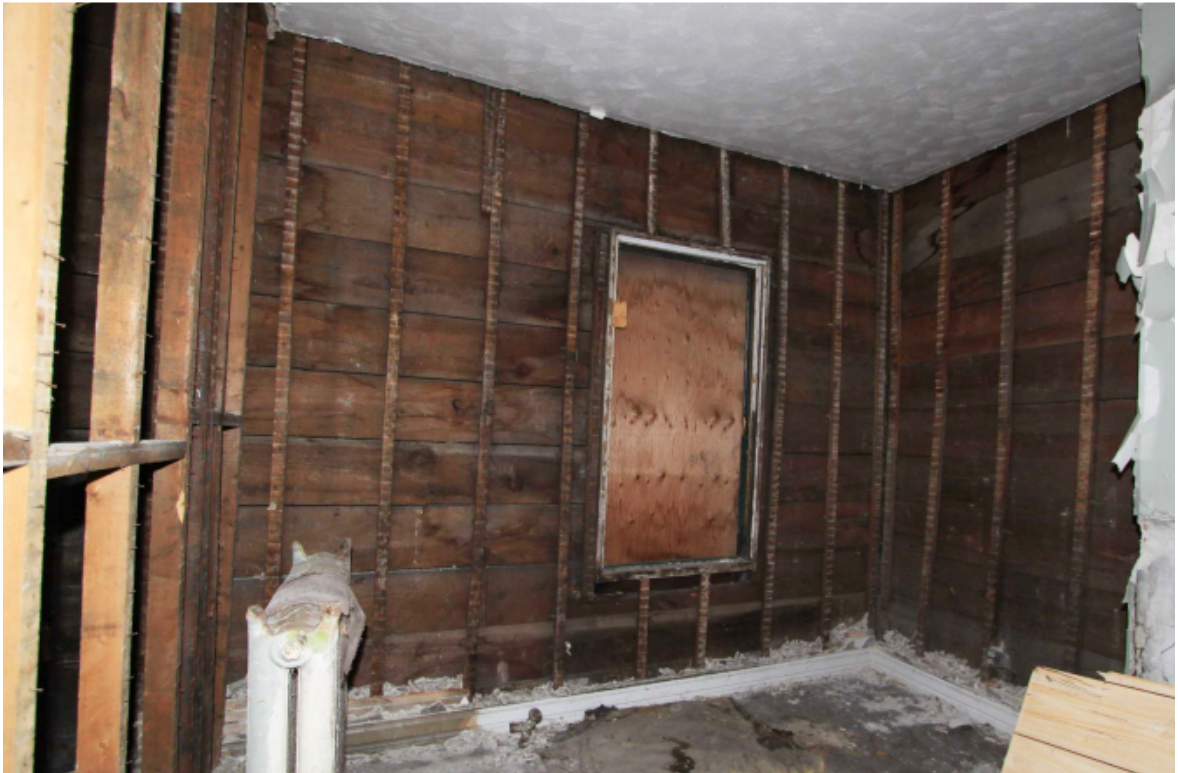
WOOD FRAMING. Three inch thick planks, stacked on top of each other, form the main structural frame of the building (Figure 6). Please note the regularly spaced vertical strapping. It provides much needed lateral stability for the planks. Please note the absence of a corner post. The planks in the corners are overlapped. It was not possible to verify nailing in corners (Figure 7). In a few locations, it was possible to verify that there are no connectors along the horizontal joints between the two planks. The only lateral support appears to be vertical straps. The contact between the planks is discontinuous. The planks are often separated by a fraction of an inch for a few feet, measured horizontally.

Figure 6. Plank Framing System

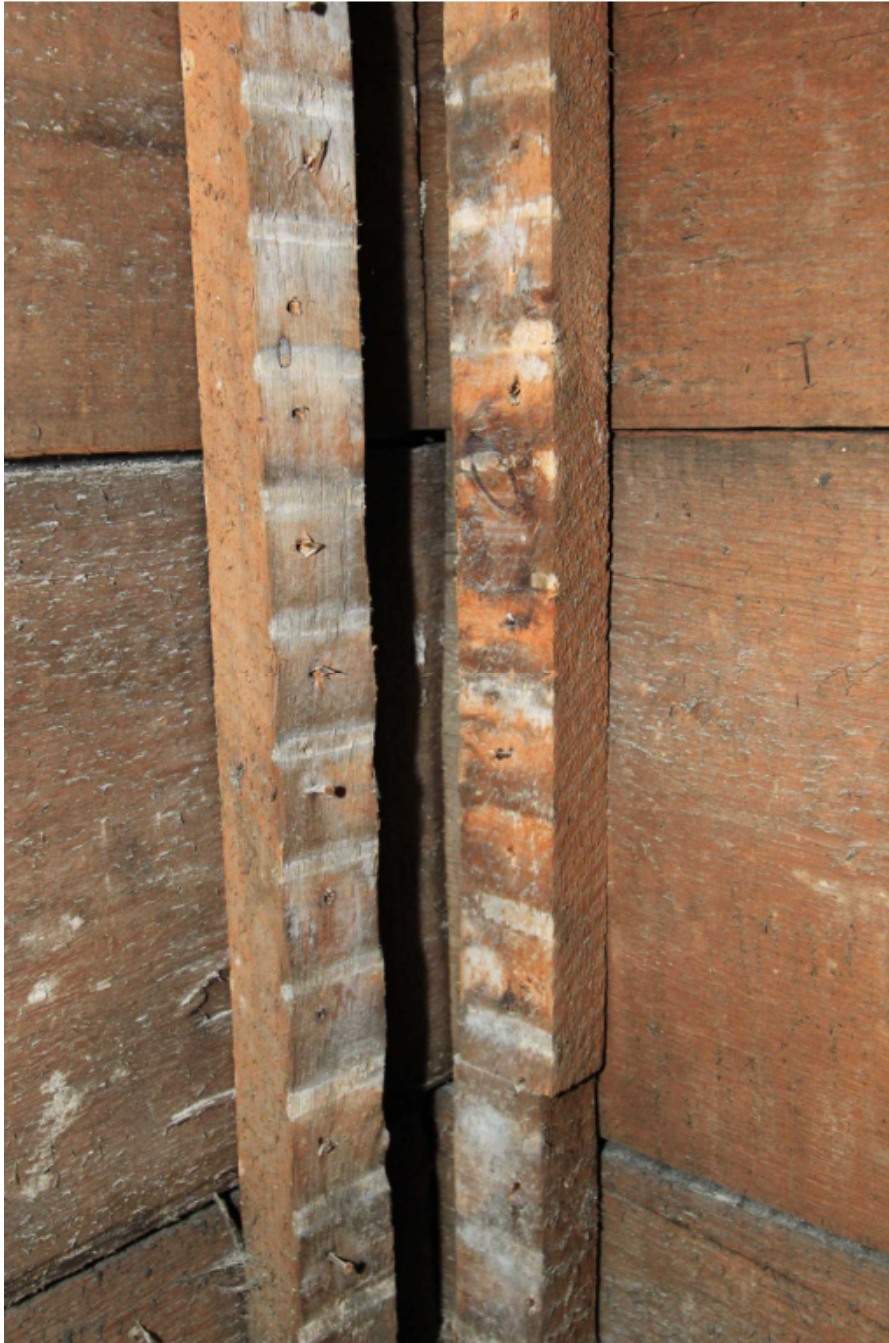
Figure 7. Planks are Overlapped in Corners

The vulnerable parts of this non-conventional framing are the loss of attachment of the planks at corners due to the corrosion of nails, and the rotting of the planks under window sills and at the top of the foundation wall.

The structural integrity of the corners can be restored by inserting new vertical corner pieces to which the original planks can be connected using timber screws. Please note that the vertical strapping must be kept and reattached to the horizontal planks as required.

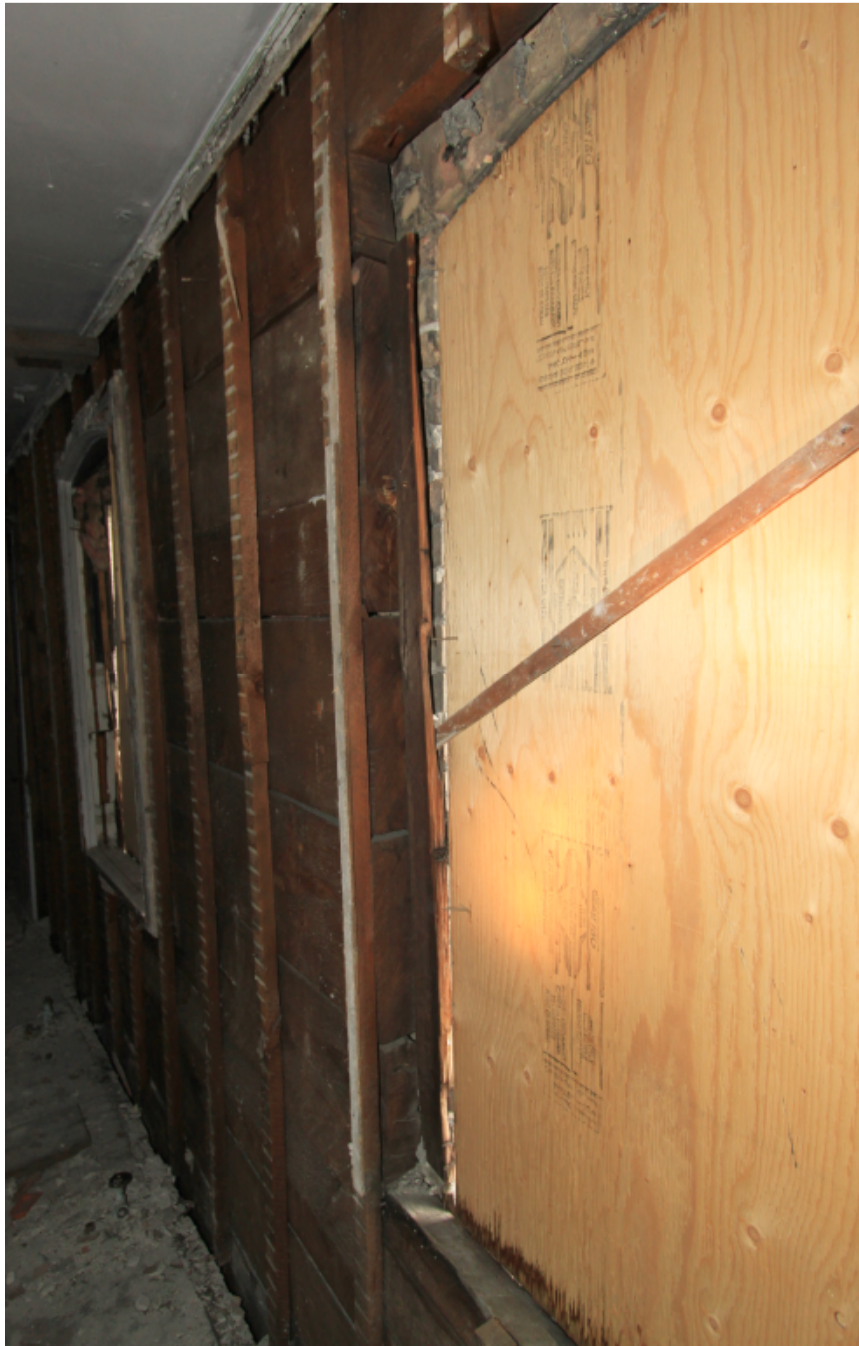
Typically, there are no vertical members that frame the window and door openings, and there are no lintels (Figure 8). The openings are simply punched out through the wall. They were likely cut after the walls were built solid. This means that vertical strapping is the only lateral support for planks between the two openings.

Figure 8. Typical Window Opening

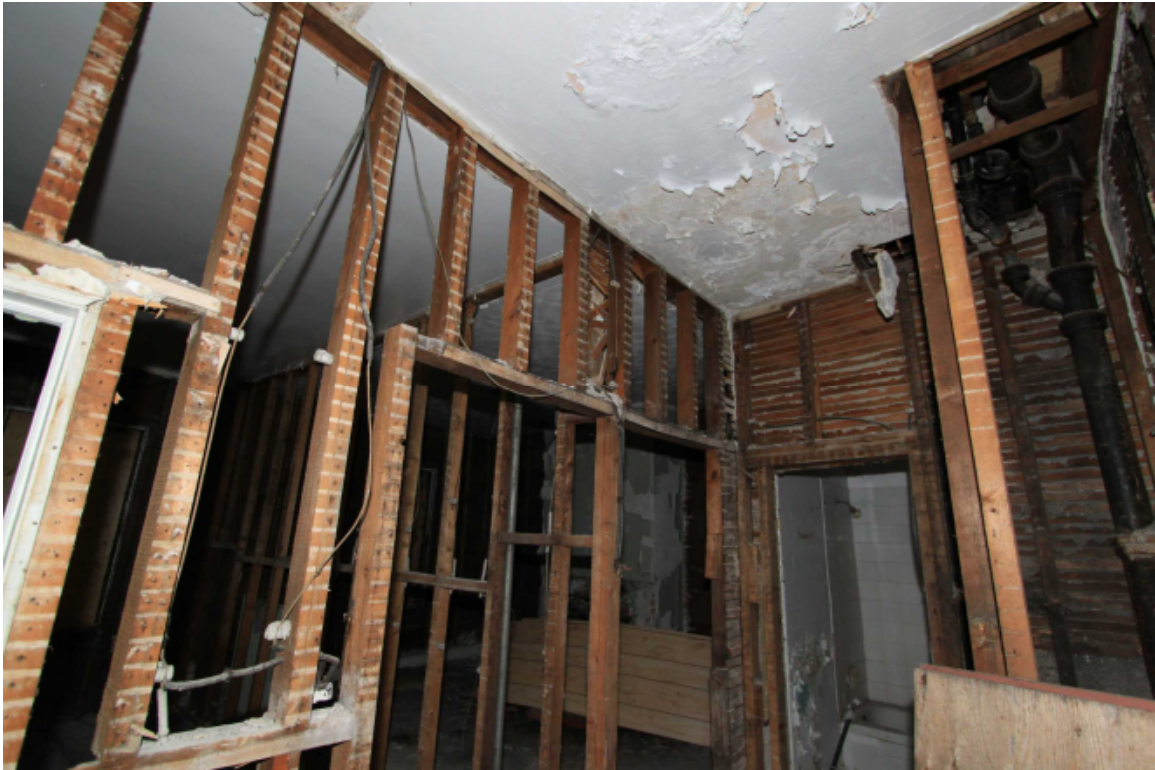
be verified how and if the floor joists are nailed to the wall planks. In general, although tested over 137 years, the lateral stability of the system is questionable. The system is gaining additional lateral stability from a number of interior partition/loadbearing walls. Past alterations have left a number of questionable framing details (Figure 9).

Figure 9. Interior Partition/Loadbearing Walls

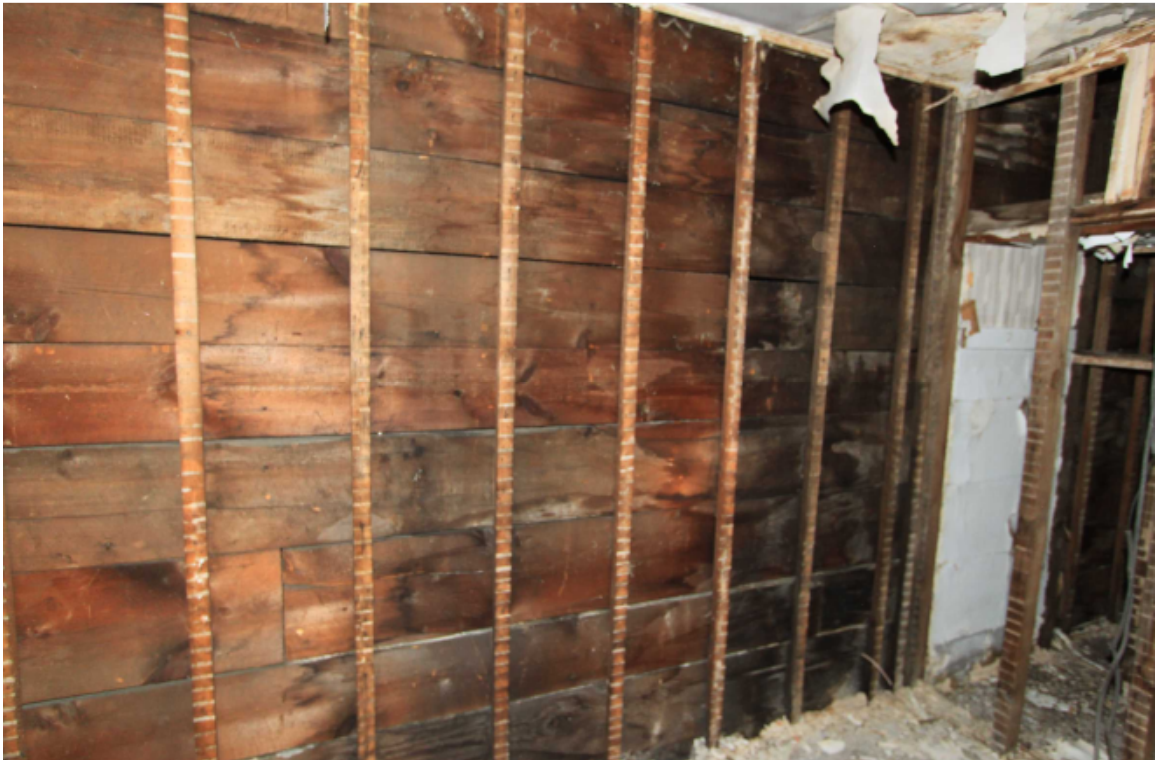
- A number of exposed walls of 197 Wilbrod and plastered or dry walled walls of 201 Wilbrod show traces of sustained water infiltration (Figure 10).
- Dry rot or other wood deterioration is found in several locations. Figure 11 shows deterioration at the base of the east wall of 197 Wilbrod.
- Fire damage of east wall of building at 197 Wilbrod has been repaired by nailing vertical planks (Figure 12).

Figure 10. Water Staining of Exterior Walls

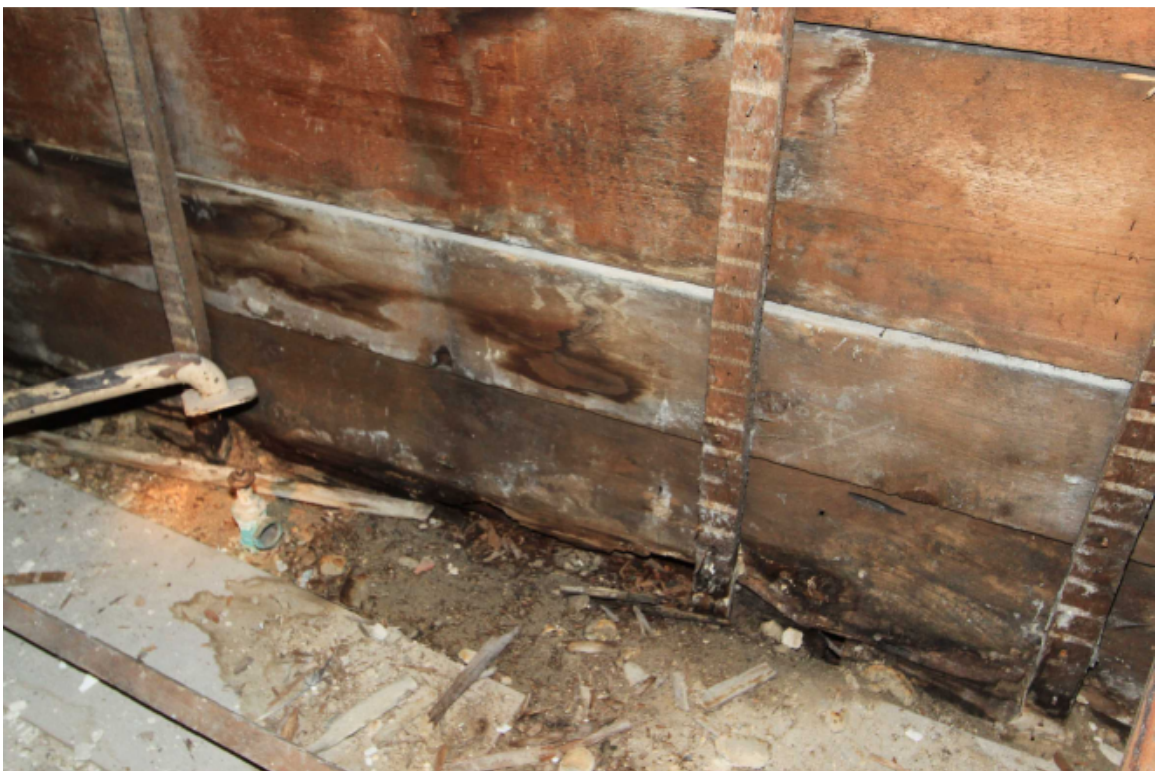
Figure 11. Deteriorated Plank at the Base of Wall

Rotten elements could be repaired by selectively removing rotted portions of planks and inserting new pieces. This is common practice for this type of framing.

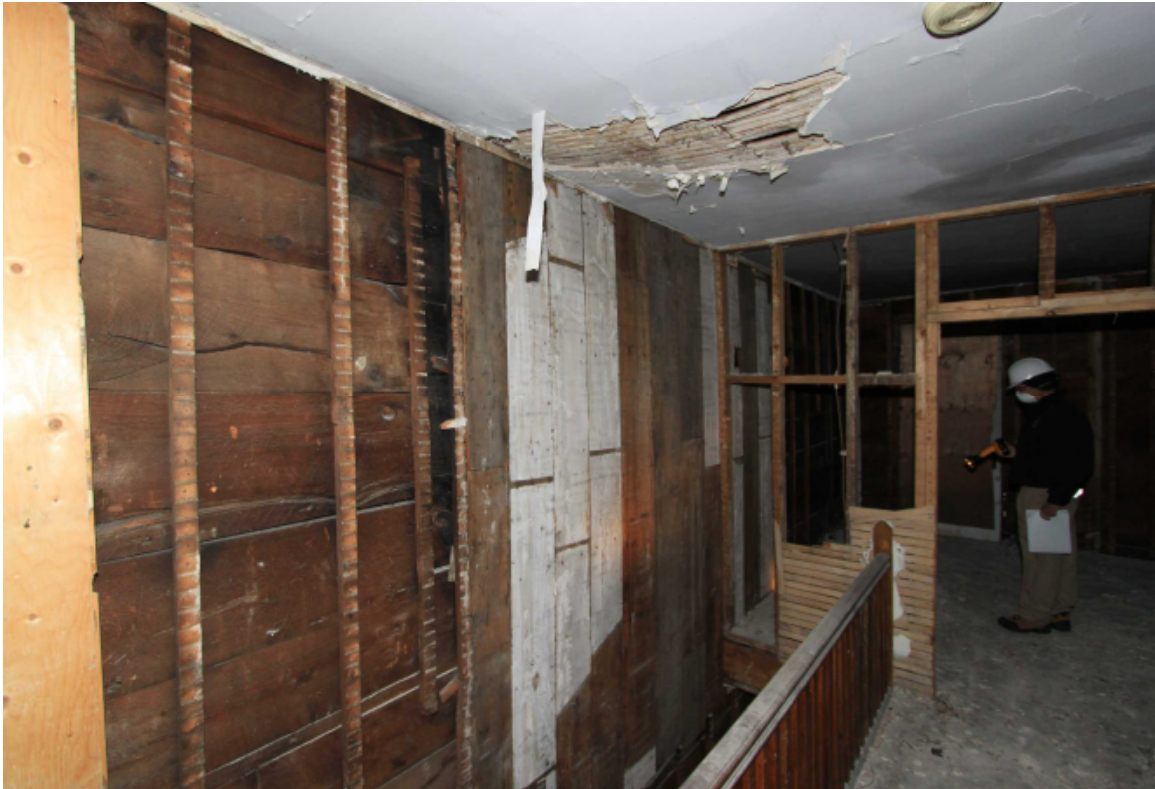
Figure 12. Fire Damage Repaired with Vertical Planks

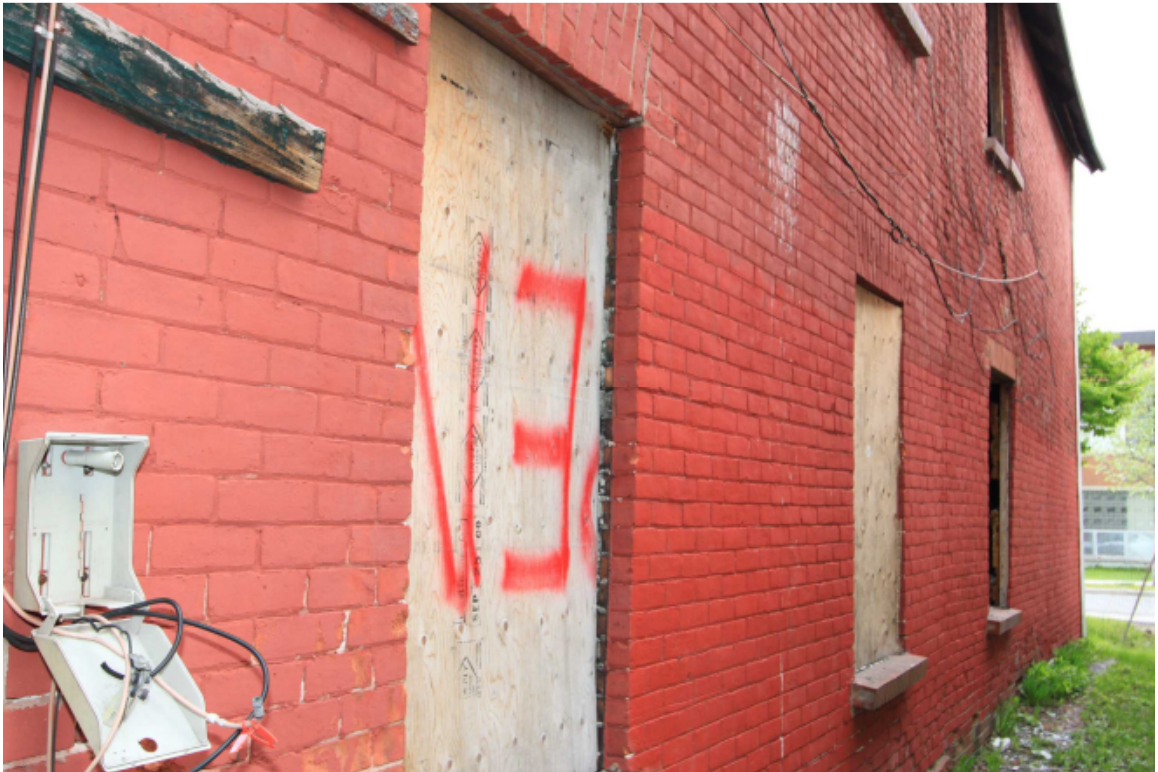
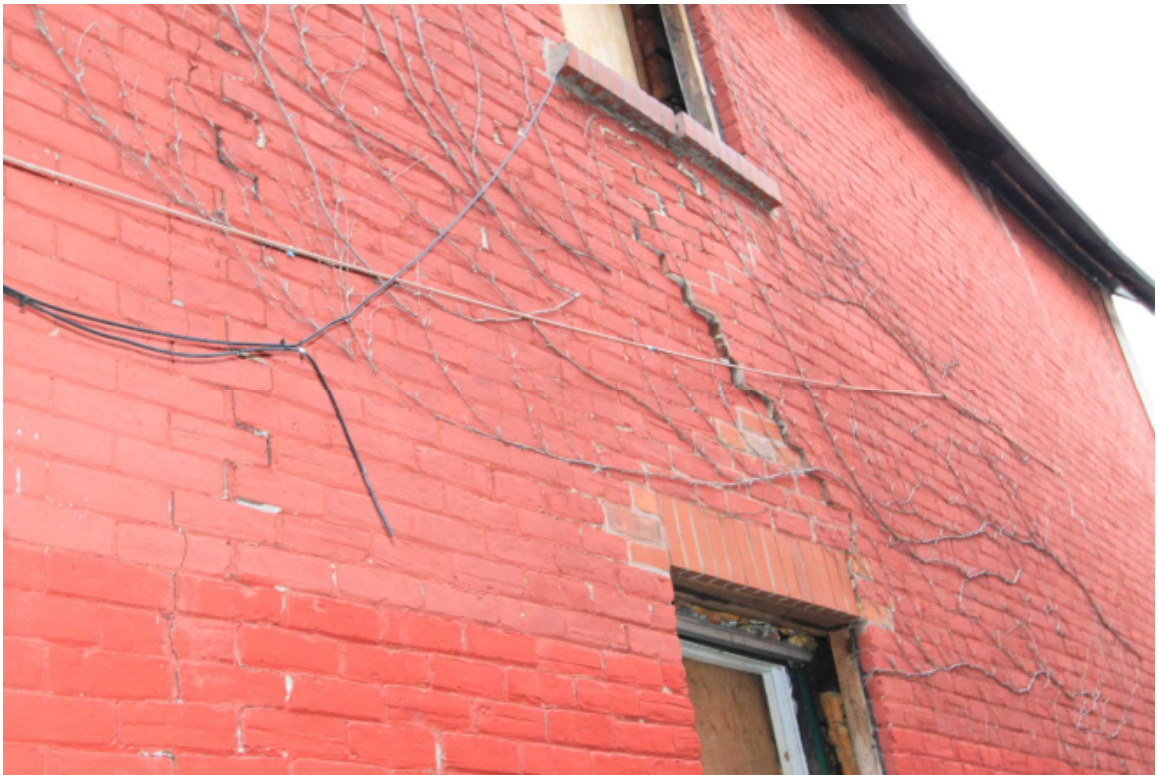
The brick veneer of the west wall of 197 Wilbrod has bulged out severely, and it poses the danger of falling down at any moment. The veneer should either be deconstructed or shored immediately. It does not look like the plank framing is affected. Please see Figures 13 and 14.

Figure 13. Bulged Brick Veneer - West Wall of 197 Wilbrod Street

Figure 14. Close-up of Large Crack at the Bulge

The brick veneer of the west wall of 197 Wilbrod Street is bulged and can fail at any moment. Immediate attention is needed. The wall veneer can either be deconstructed or shored using diagonal wood or steel braces, anchored securely into the ground. Access to this side of the property must be blocked from both sides.

The west veneer wall of 197 Wilbrod Street is bulged and can fail at any moment. Immediate attention is needed. The wall veneer can either be deconstructed or shored using diagonal wood or steel braces, anchored securely into the ground. Access to this side of the property must be blocked from both sides.

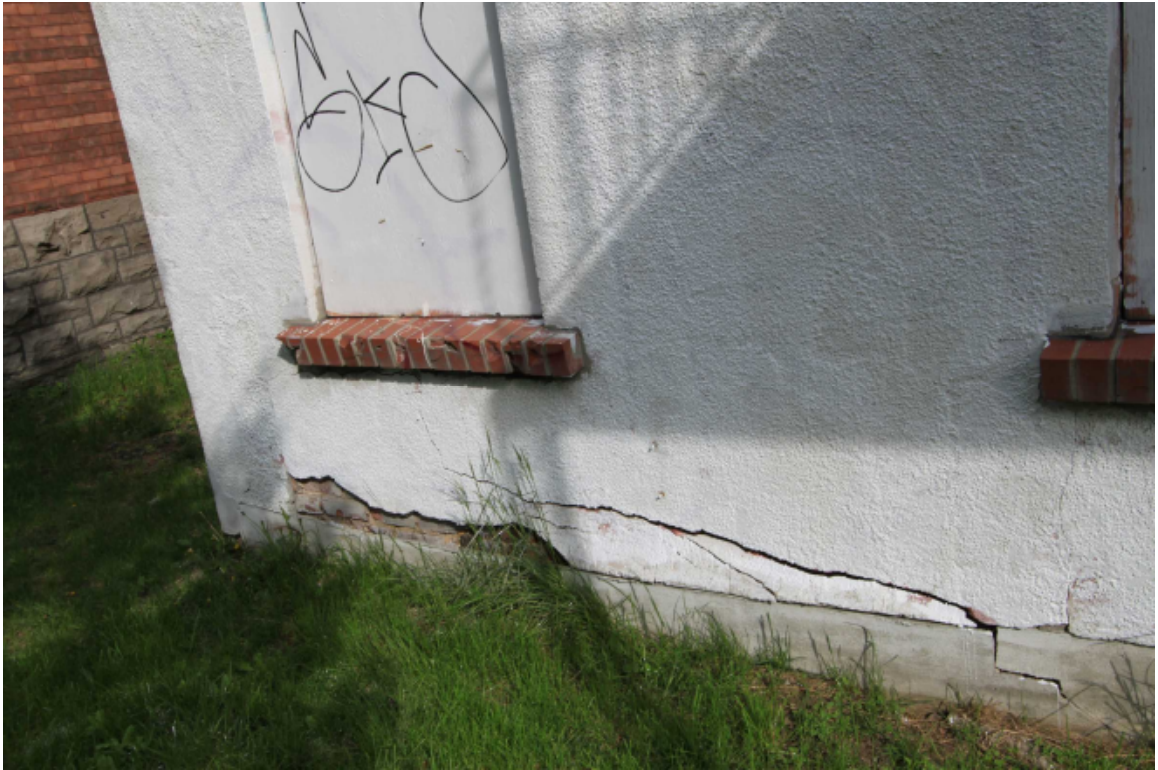
The street facades have received a stucco finish at some point in the past. The stucco is failing in many locations, one of which is shown in Figure 15. It is quite likely that the brick behind the stucco has suffered from repeated freeze-thaw cycling and that it is in poor shape.

Figure 15. Close-up of Deteriorated Stucco and Brick Behind

It is unfortunate that the original street facades have been ruined by the installation of stucco. It is highly unlikely that the brick behind the stucco could be reused either “as is” or in a rebuilt state to provide heritage look of the structure.

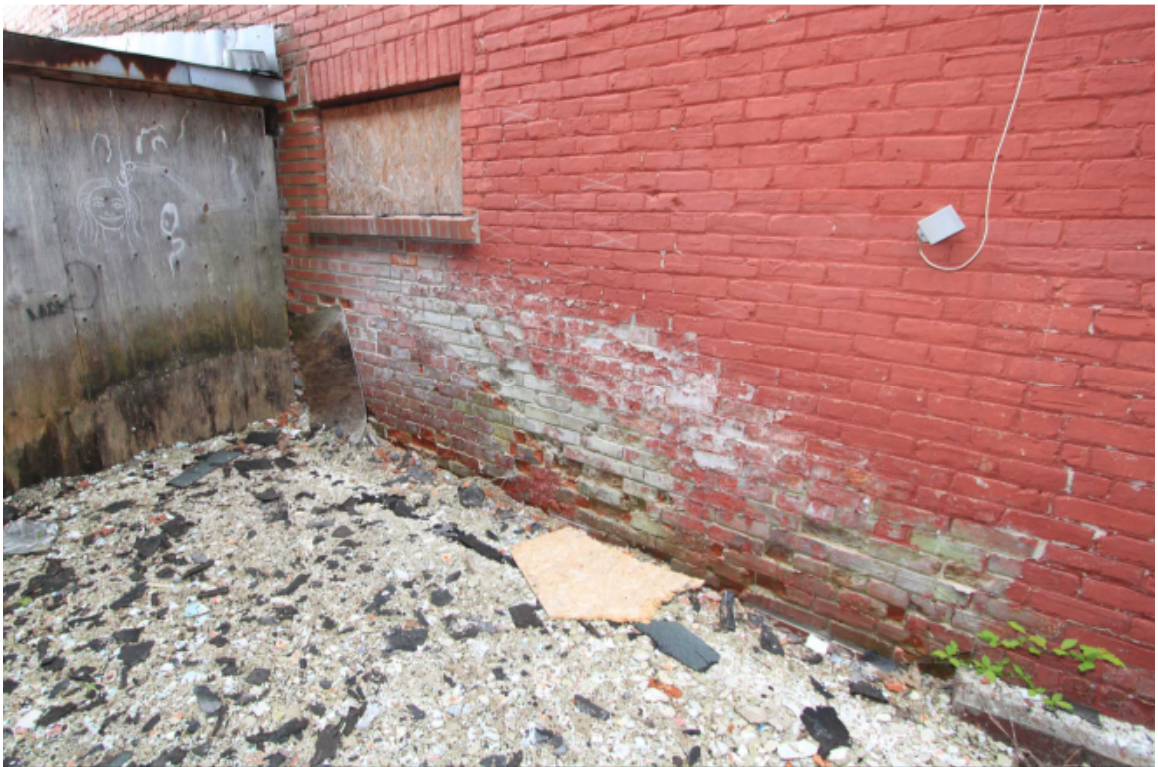
All other veneer walls have been painted. The condition of brick behind the paint is unknown, but it has likely been damaged by frost. In a few locations, the brick damage is substantial and would require brick replacement (Figures 16 and 17).

Figure 16. Frost Damage in East Wall of 197 Wilbrod Street

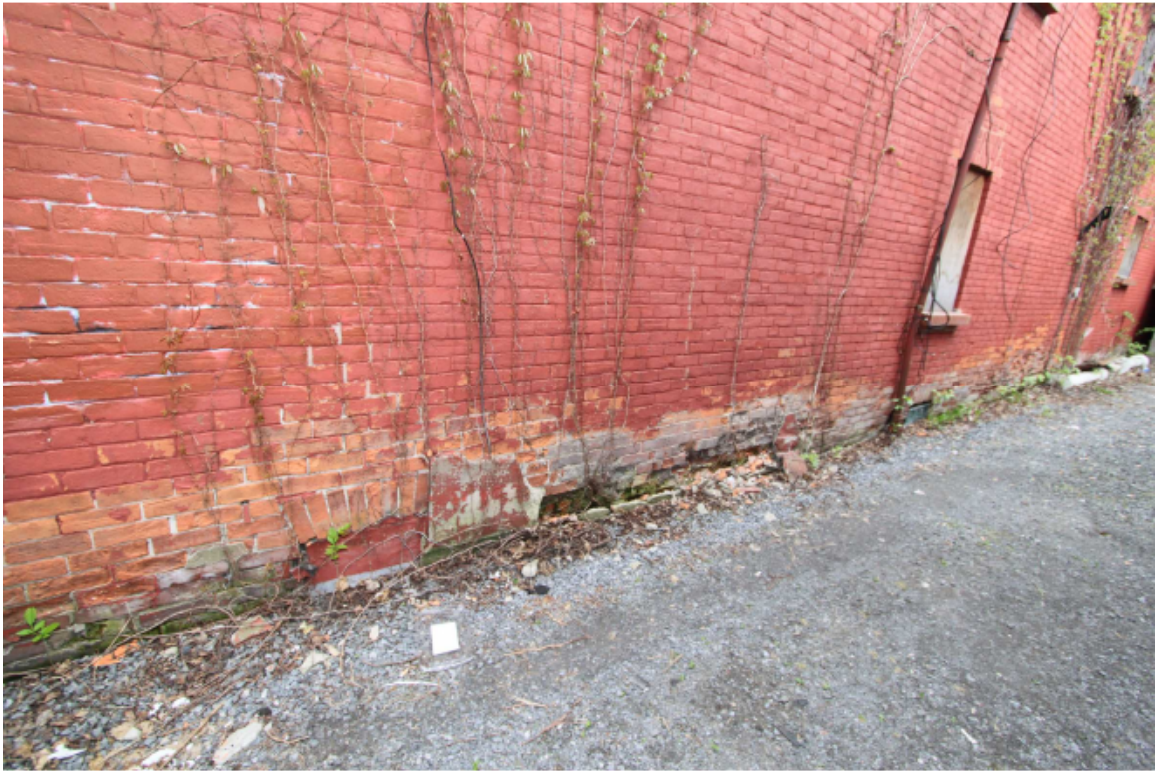
Figure 17. Frost Damage in East wall of 201 Wilbrod Street
