Project No. 3117

FIELD REVIEW – March 29, 2018

DATE: April 4th, 2018
CLIENT: GOR-FAY REALTY COMPANY LIMITED
PROJECT: 197 & 201 WILBROD STREET, OTTAWA, ONTARIO

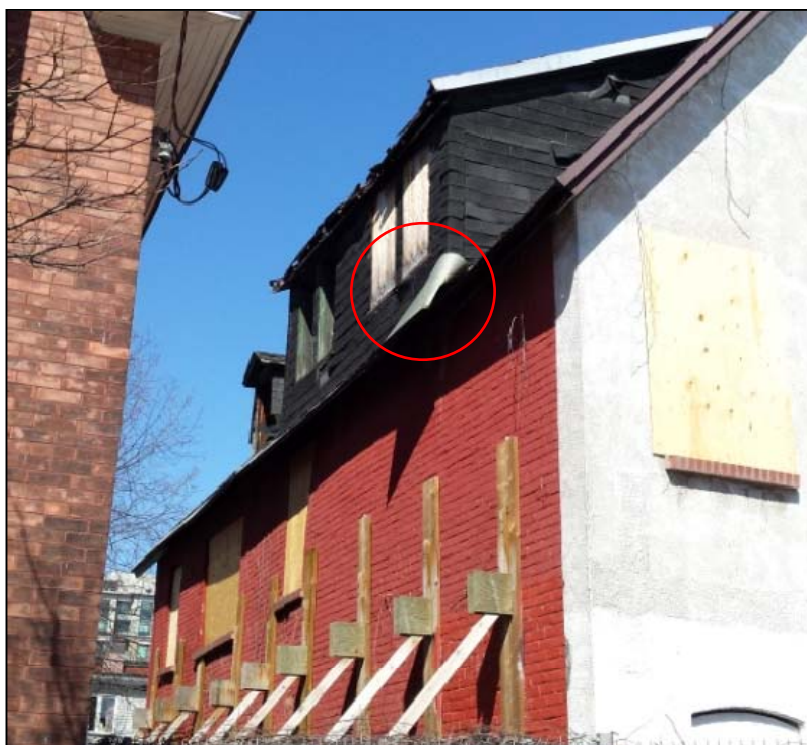
- A piece of sheet metal cladding on the south-west corner of the roof, noted in the last Field Review has not been removed. This and any other loose roof elements shall be removed to prevent possible injury to pedestrians or damage to the adjacent building. Refer to Image 1.

[Image 1: 197 Wilbrod St. Sheet Metal Cladding on West Roof](#)
