A CONSERVATION PLAN

CHAMPLAIN OIL COMPANY SERVICE STATION

70 RICHMOND ROAD OTTAWA, ONTARIO

PREPARED BY: JOHN STEWART, COMMONWEALTH HISTORIC RESOURCE MANAGEMENT

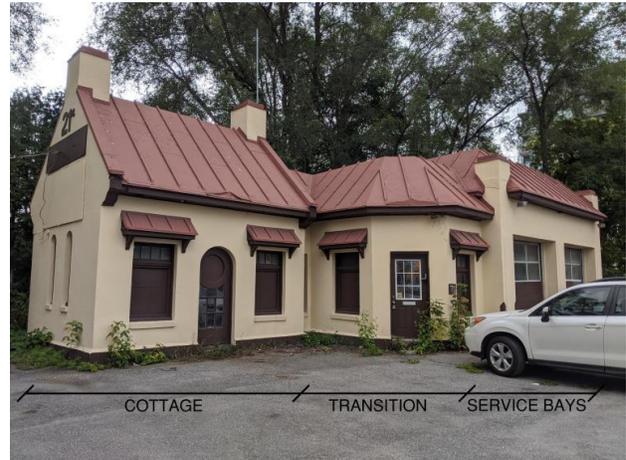
The Champlain Oil Company Service Station has been vacant for a number of years with no maintenance undertaken on the structure. Based on the assessment from both John G. Cooke Consulting Engineers and Cleland Jardine Engineering Limited, the building is in poor to fair condition.

Figure 1: View of the Service Station with the 3 sections cottage, transition, and service bays.

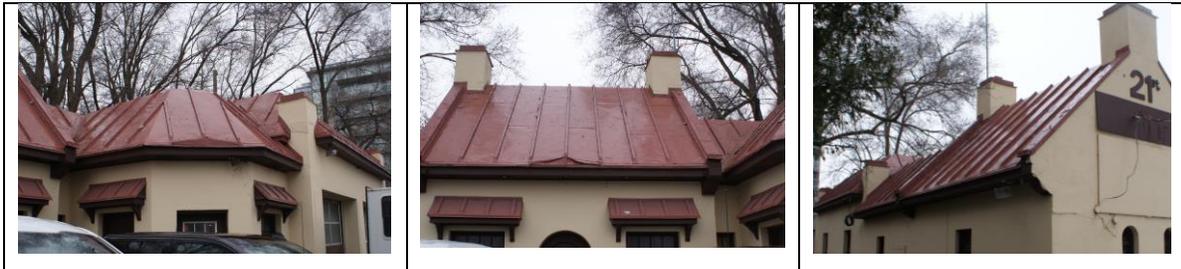
Figure 3A: images of the Roof

The standing seam metal roof membrane is an important character defining feature and will be preserved to the extent that it is feasible. The flashings in the valleys of the roof and around chimneys and at junctions between roof forms have failed as is evident by the stained wood sheathing as noted in John Cooke’s review. The standing seam metal roof will be rehabilitated. The distinctive standing seam metal roofs on the awnings above windows and doors will be preserved as they are in good condition. Remedial work prior to the move includes patching of the existing roof to prevent further damage.

Portions of the roof membrane and decking will have to be replaced due to the deteriorated condition of the roof deck. The roof structure, in addition to requiring repairs, will also be subjected to higher snow loads from being at the base of the new mid-rise structure. It is recommended to reinforce the roof structure for this higher snow load at the same time as the repairs, since many of the solutions will address both.

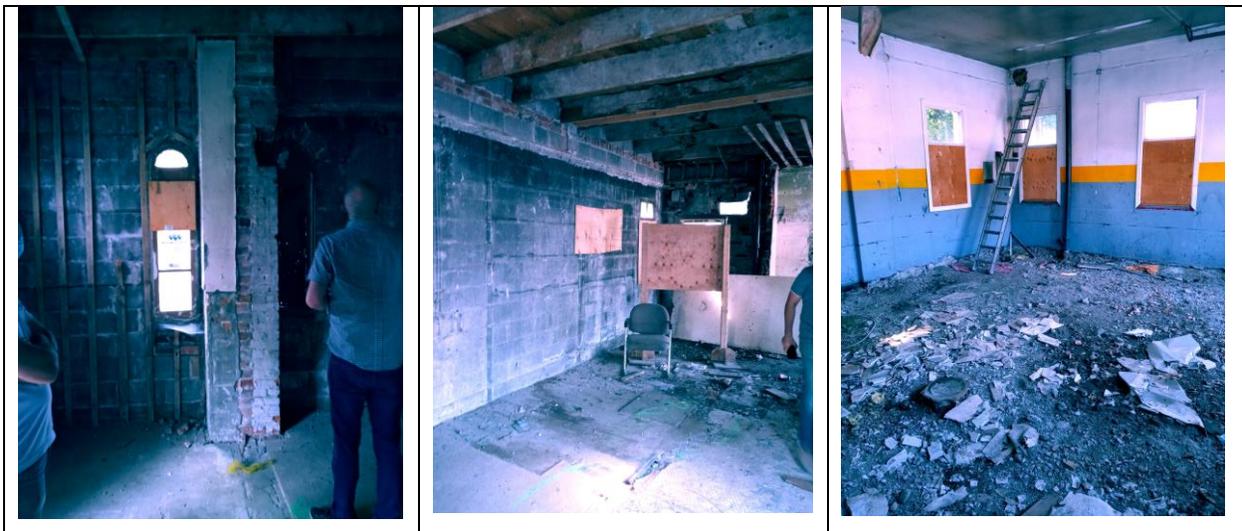
Figure 6: Interior views illustrating the condition, with the interior stripped down to the block walls.

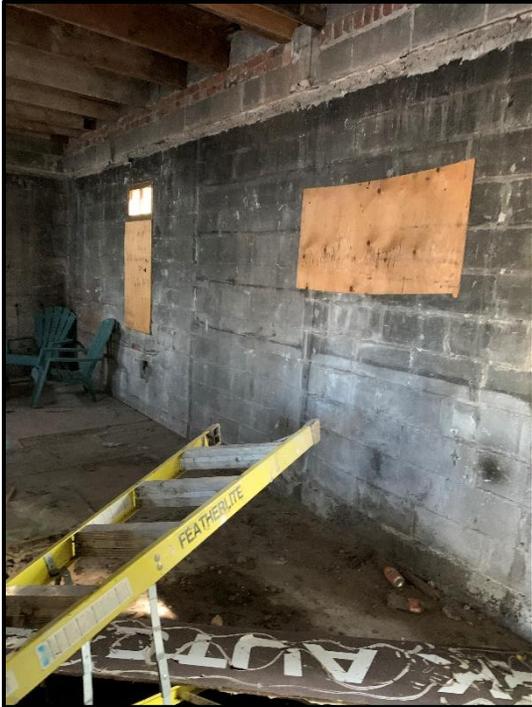
The masonry walls were in overall fair to poor condition with localized vertical cracking noted in several locations. Based on a few limited areas, where holes in the masonry were noted, the masonry does not appear to be grouted nor reinforced.

Exposed Masonry Wall Administration Area

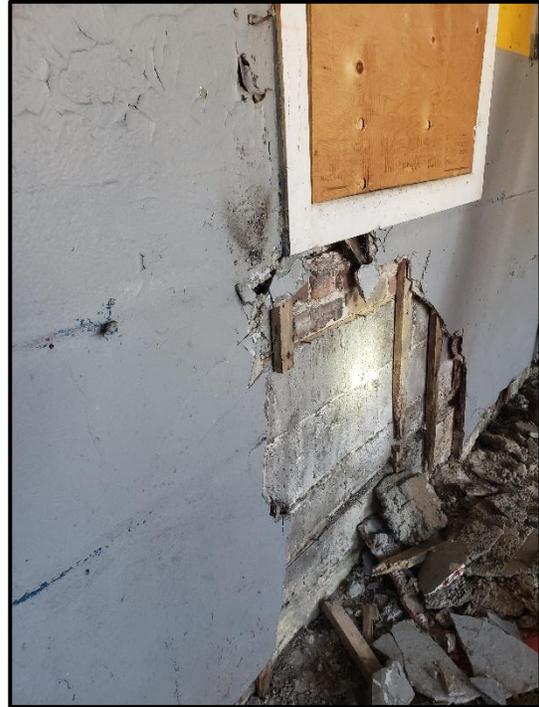
Masonry Wall Behind Plaster Lath - Service Bay

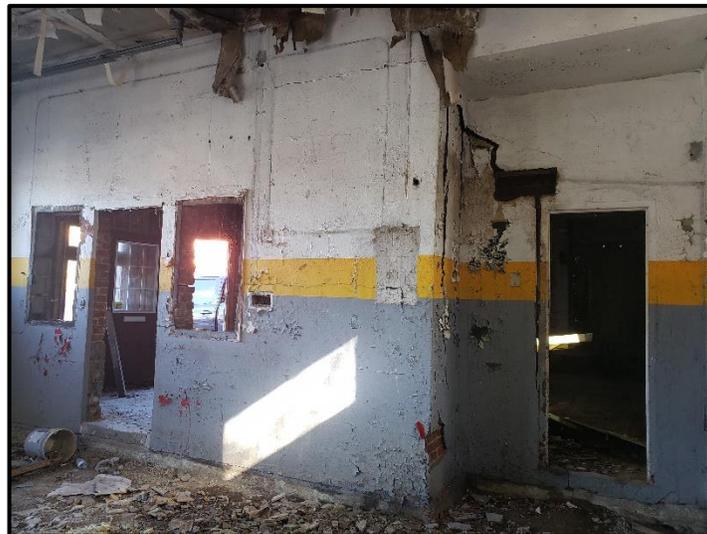
The load bearing masonry wall, between the service bay and administration area, is in poor condition with several cracks and major displacement (40mm) at the back portion.

Interior wall with major crack/displacement at door openings

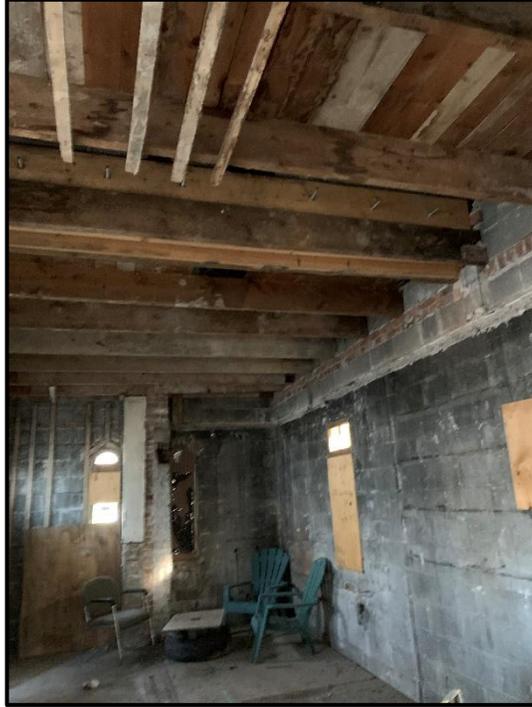
The roof framing has been subject to water infiltration and modification/patching over the years but remains in fair and sound condition.

Roof framing administration area
