A: Pre-project conditions

B: Building Envelope condition prior to project

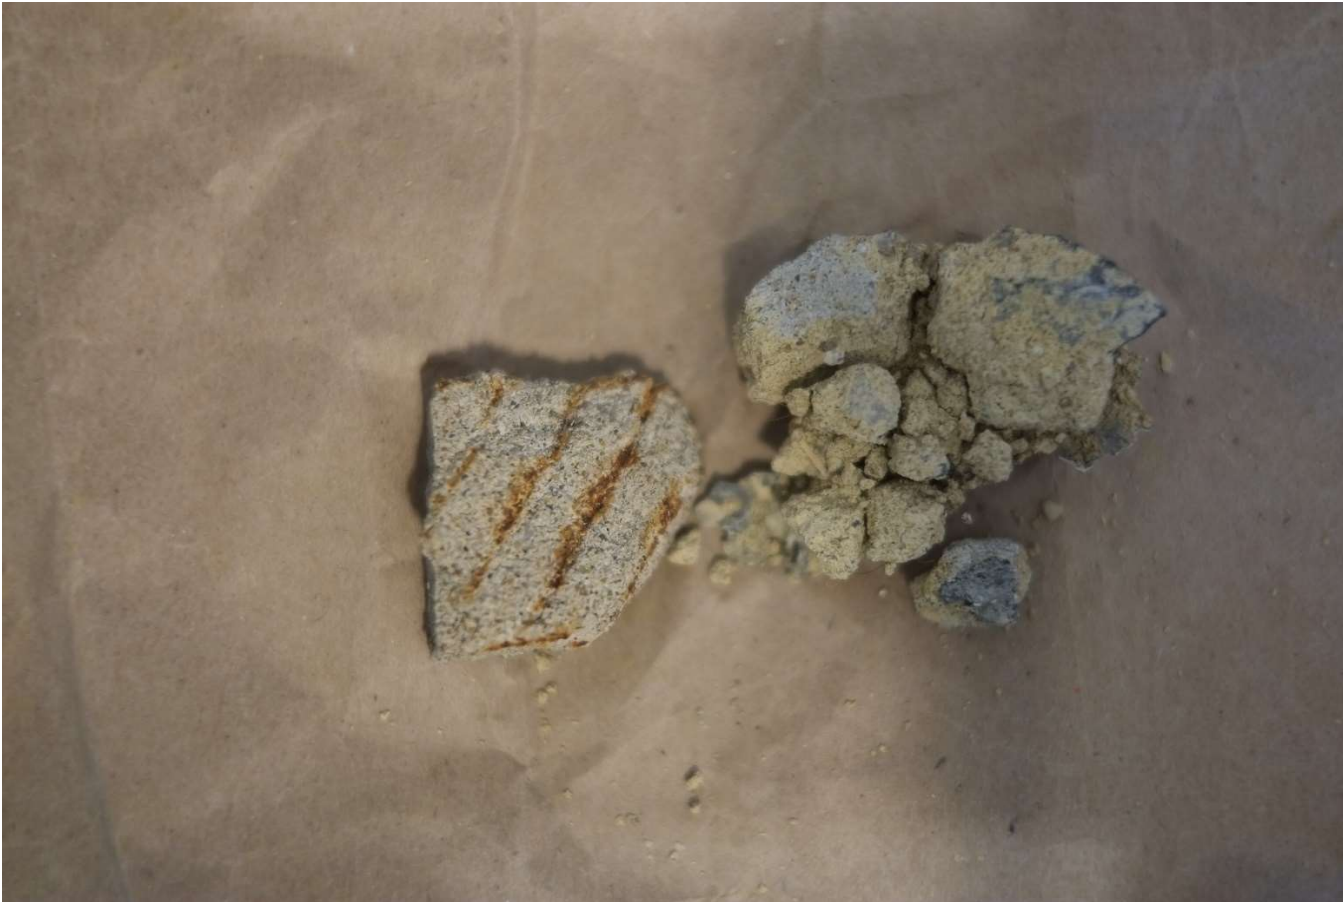
B.1 Stucco panels

Fig. 3: Stucco substrate is crumbling and separating from rusty support wire mesh. Impossible to remove stucco panels without damaging them.

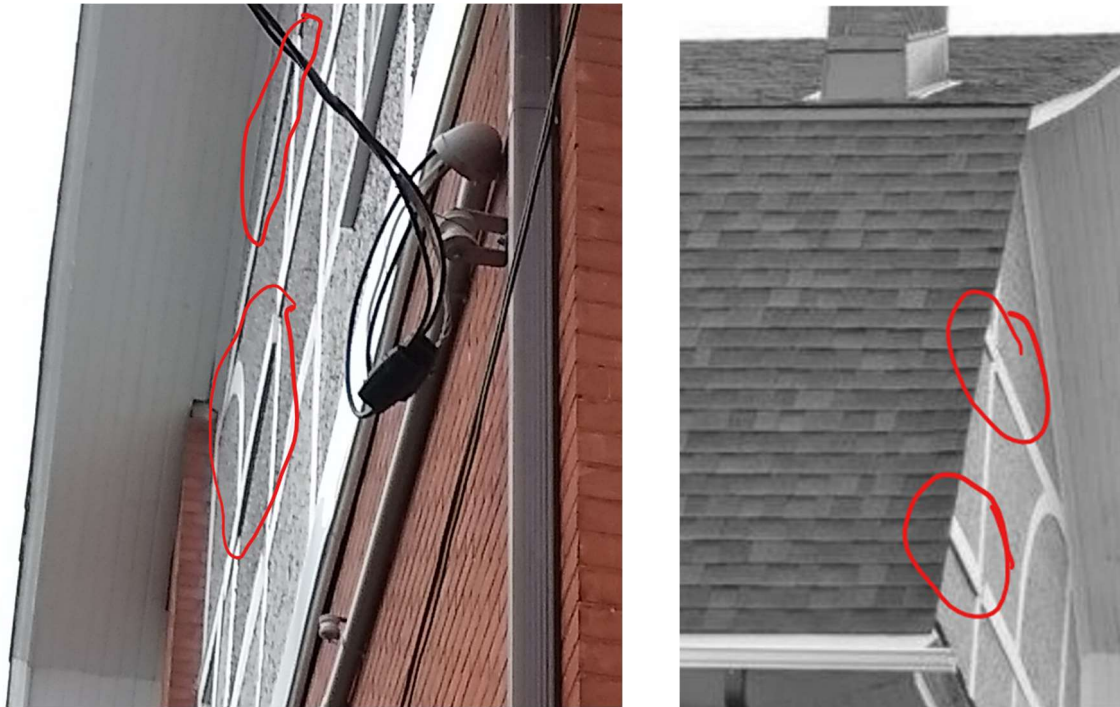
B.2 Battens

Fig. 4 and Fig. 5: Battens have started popping out from the stucco panels. An attempt was made to reset the battens in place unsuccessfully. This is a sign that the stucco panel assembly was no longer secure and safe.

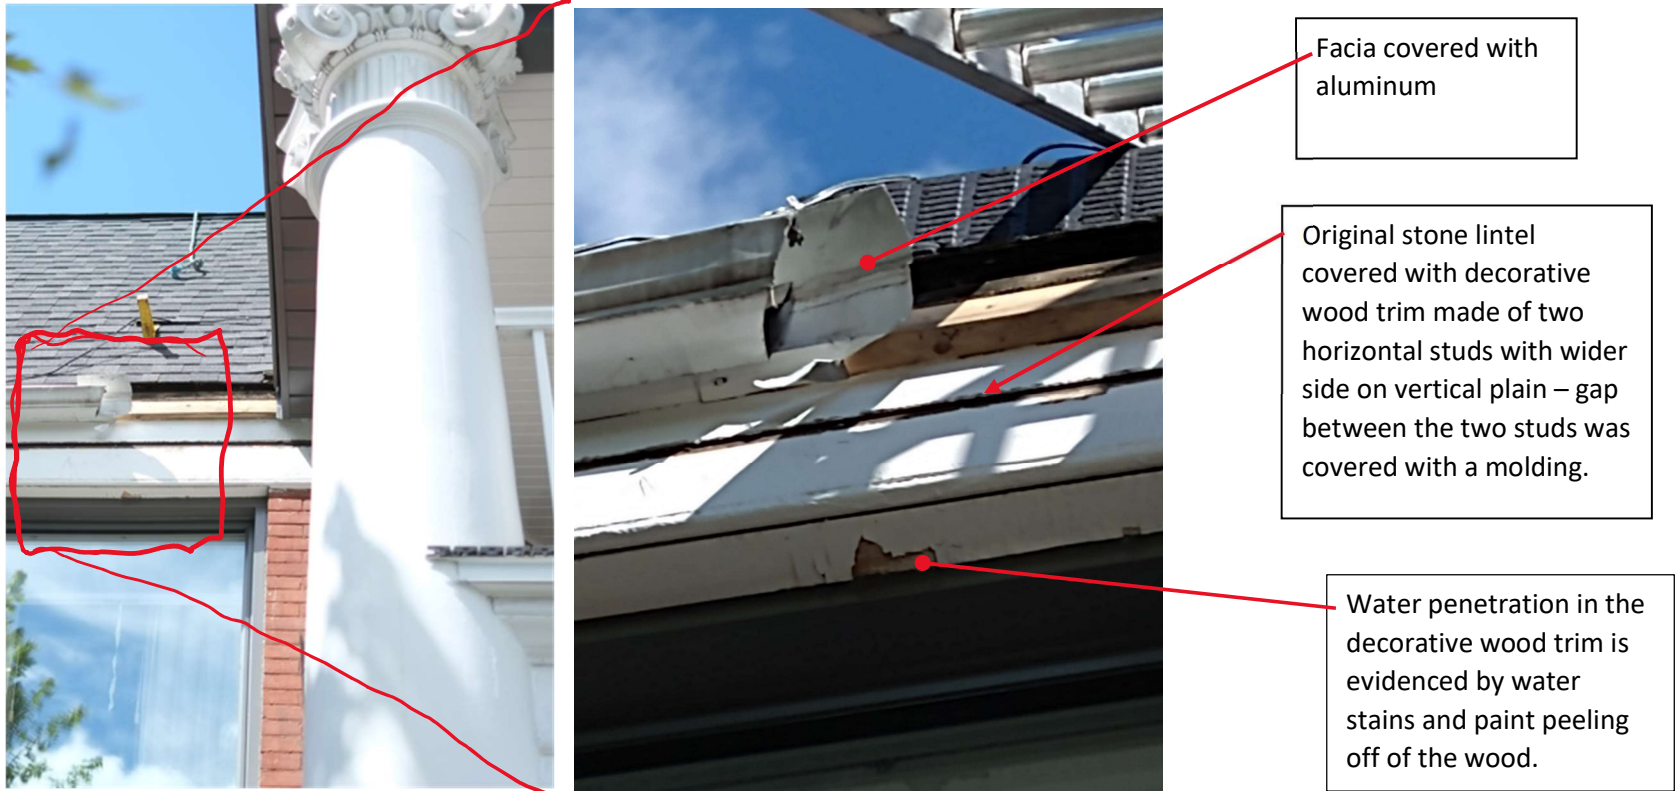
B.4 Covered window lintel and use of aluminum on fascia

Fig. 8 and Fig. 9: Front of house – upper fascia and decorative trim above 2nd floor windows: Photo shows that fascia was covered with aluminum. Rain gutter was also installed. Water penetration is evident. Long term concern is water damaged wood will attract infestation of insects such as carpenter ants.

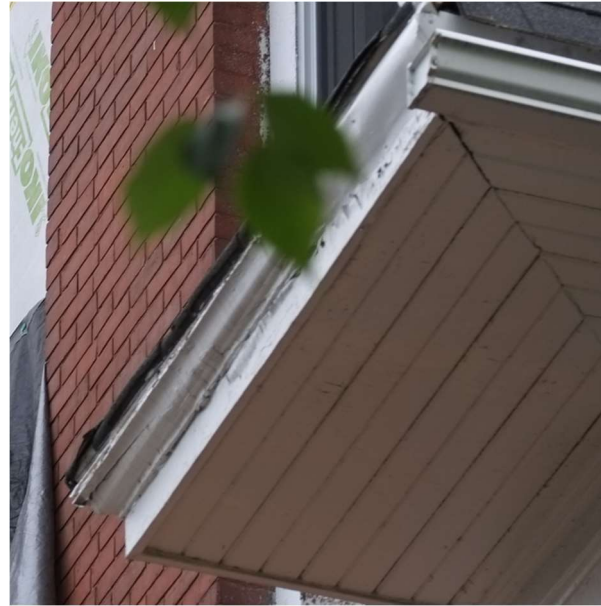
B.5 Crown Mouldings

Fig. 10 and Fig. 11: Crown mouldings have deteriorated pass point of repair. Aluminum caps on the end of the crown mouldings are visible in both photos

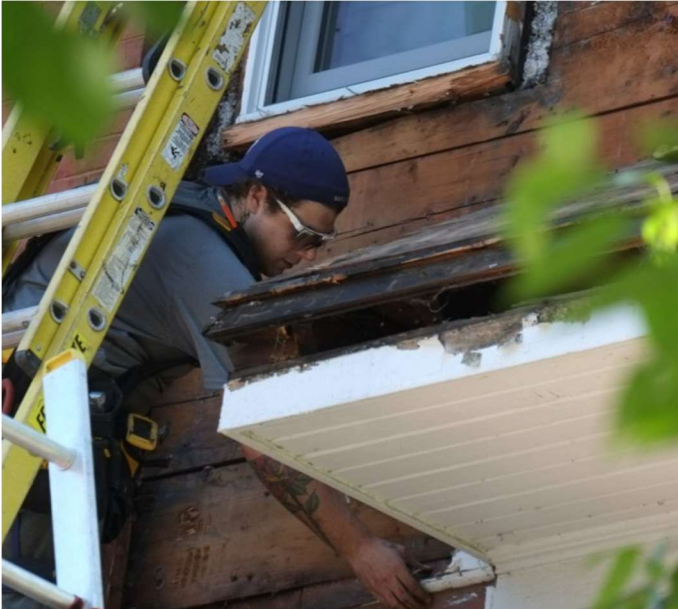
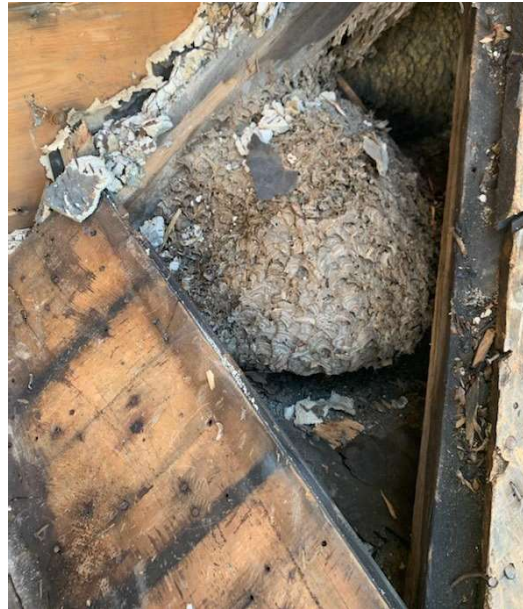
B.6 Flashing was not part of building practices back in 1920's

Fig. 12 and Fig. 13: As flashing was not used in original construction, crown mouldings and boards were subject to rot over the years leaving gaps where squirrels, birds and wasps were able to enter and nest

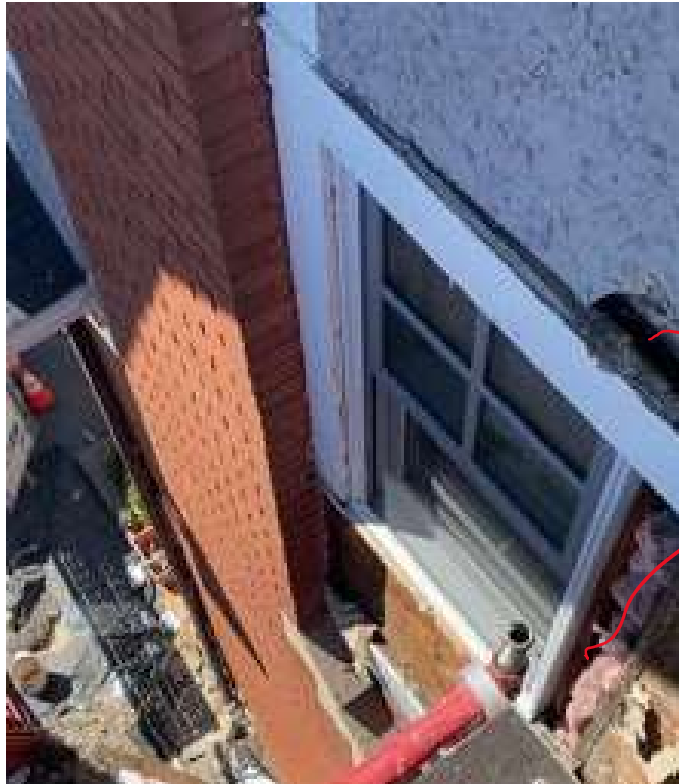
B.7 Insulation

Lack of proper insulation as well as no insulation at all in some areas around the windows of the 3rd floor

Fig. 14: Inadequate insulation at all windows

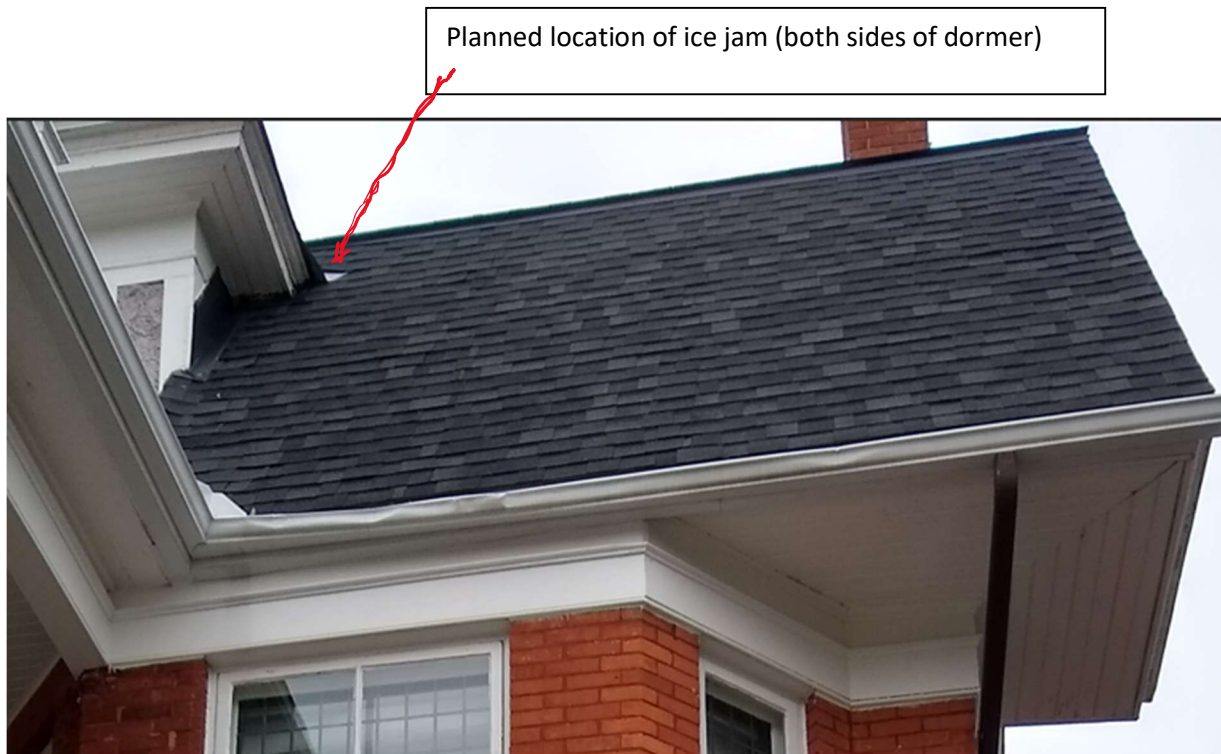
B.9 Ice damage to eavestroughs

Fig. 16: Eavestroughs damaged from ice sliding down from above

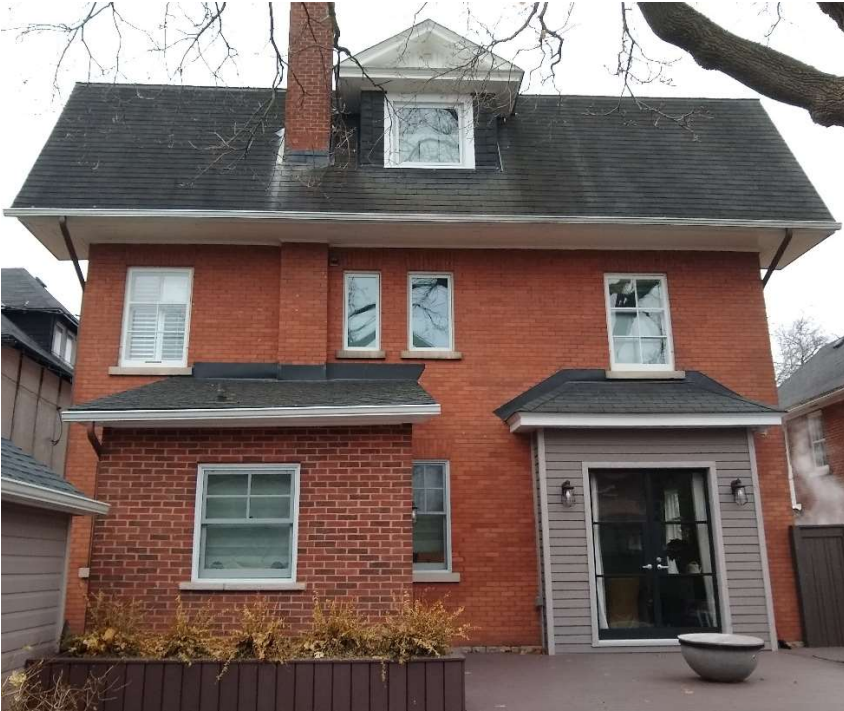
Fig. 17: Before. Asphalt shingles used on dormer

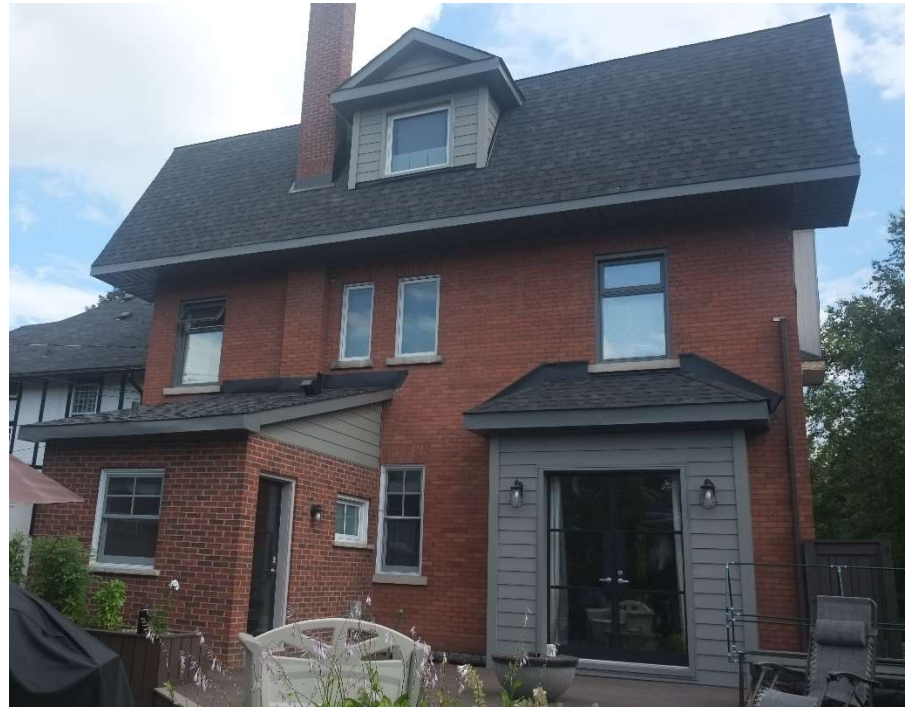
Fig. 18: After – Consistent and uniform appearance

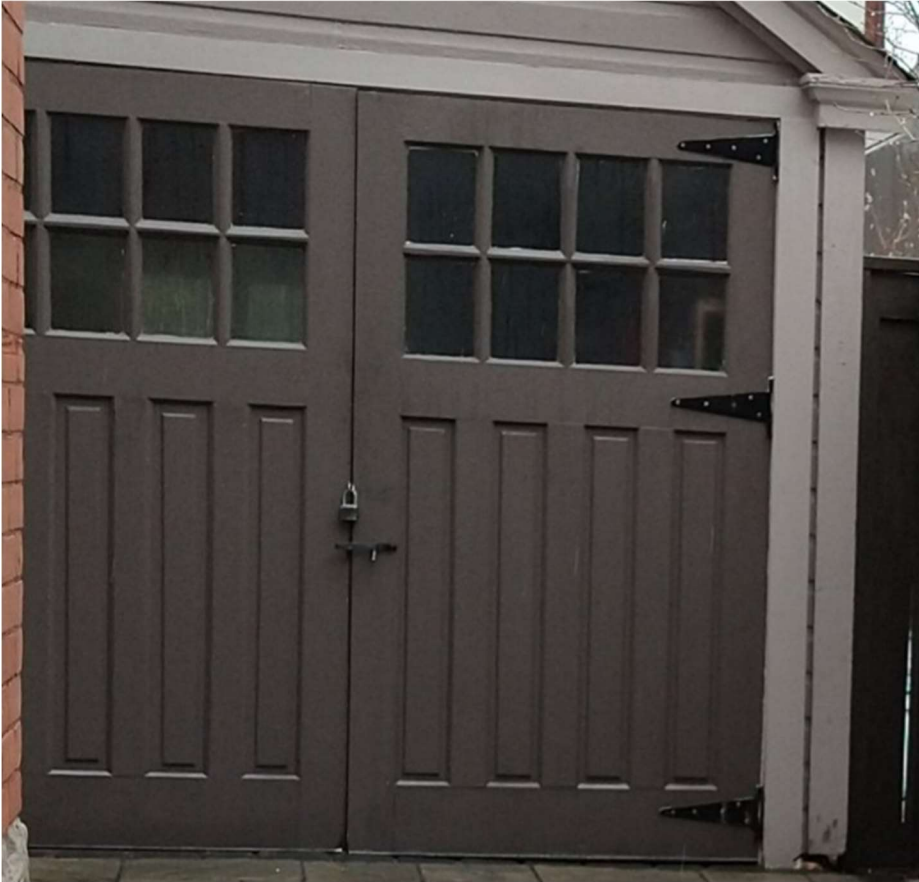
D. Garage door

Fig. 21. Garage doors were replaced by then owner in the 1990's as original doors were finished. Doors swing sideways and cannot be opened during the winter months due to frost heave of the driveway in front of the garage. Doors were cut 2 inches last year to attempt to correct issue, but another 2 inches would need to be cut from the bottom so that they could swing open properly.
