A: Pre-project conditions

## B: Building Envelope condition prior to project

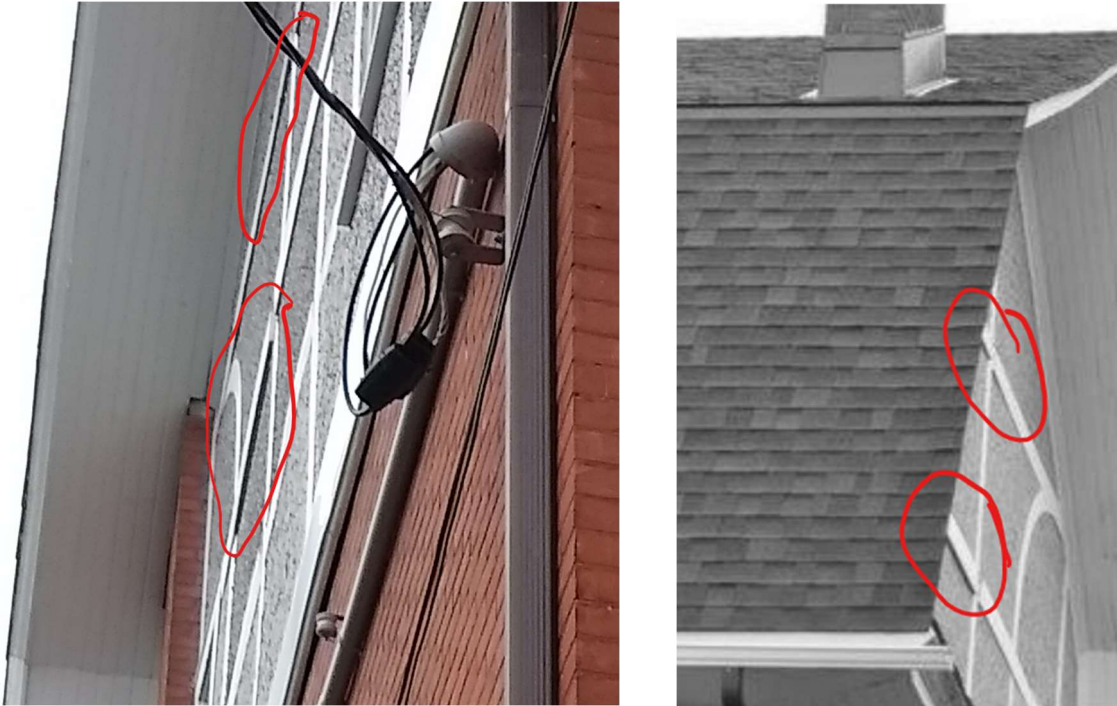
### B.2 Battens

Fig. 4 and Fig. 5: Battens have started popping out form the stucco panels. An attempt was made to reset the battens in place unsuccessfully. This is a sign that the stucco panel assembly was no longer secure and safe.

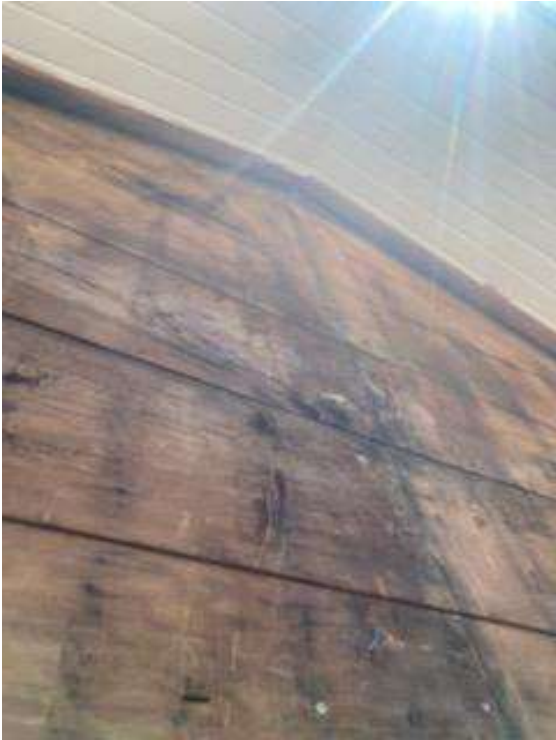
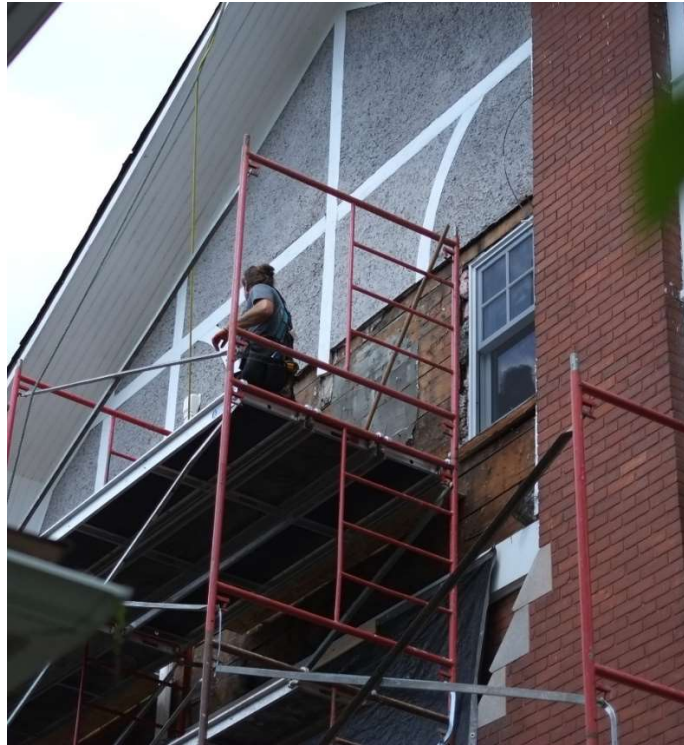
### B.3 Condition of sub-structure boards

Fig. 6 and Fig. 7: Exposed boards after stucco panels were removed

- Darkened boards indicate that stucco panels were no longer waterproof and not protective of the sub-structure of the house which will lead to accelerated deterioration of the boards.
- Many of the sub-structure boards were loose and had to be renailed – whole exterior wall assembly was no longer safe

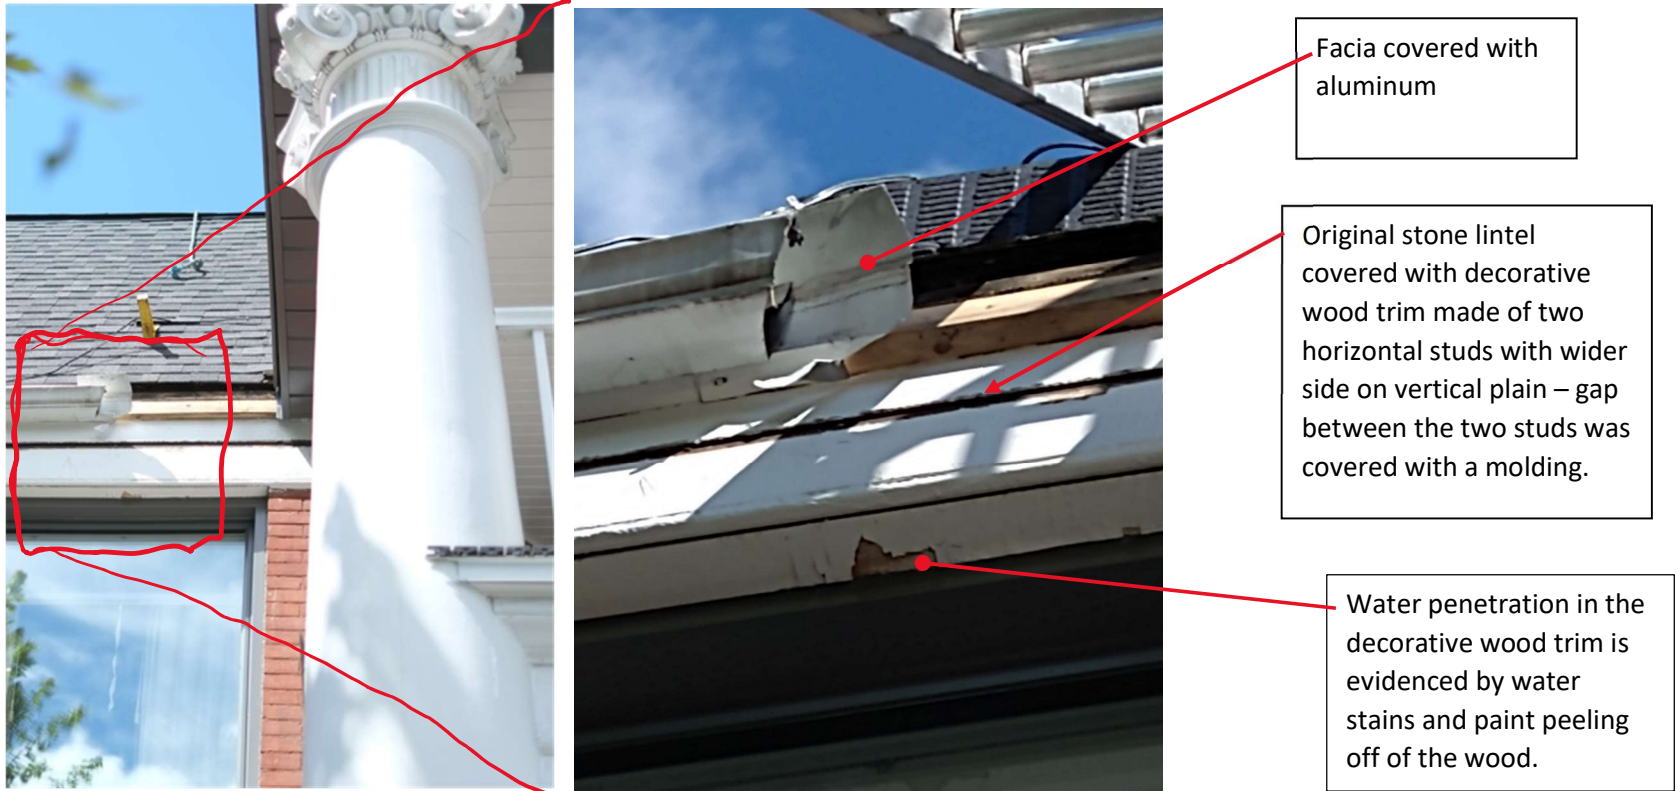
B.4 Covered window lintel and use of aluminum on fascia

Fig. 8 and Fig. 9: Front of house – upper fascia and decorative trim above 2<sup>nd</sup> floor windows: Photo shows that fascia was covered with aluminum. Rain gutter was also installed. Water penetration is evident. Long term concern is water damaged wood will attract infestation of insects such as carpenter ants.

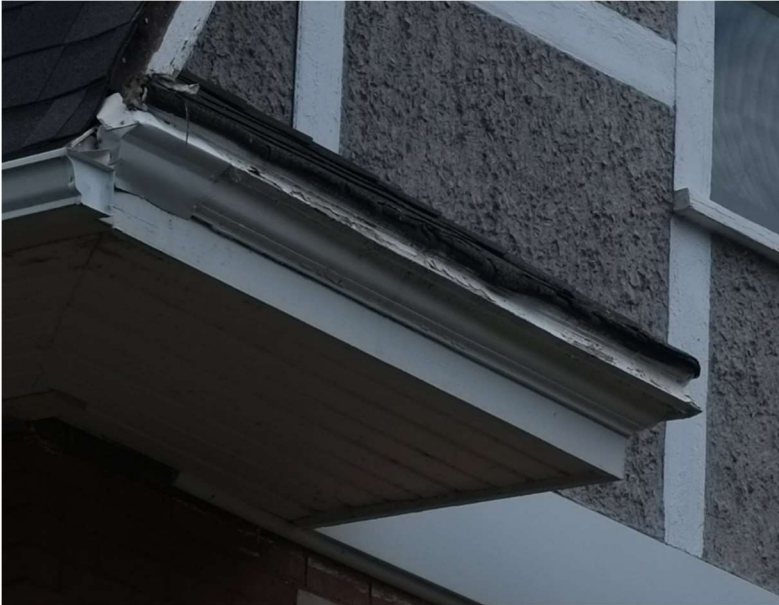
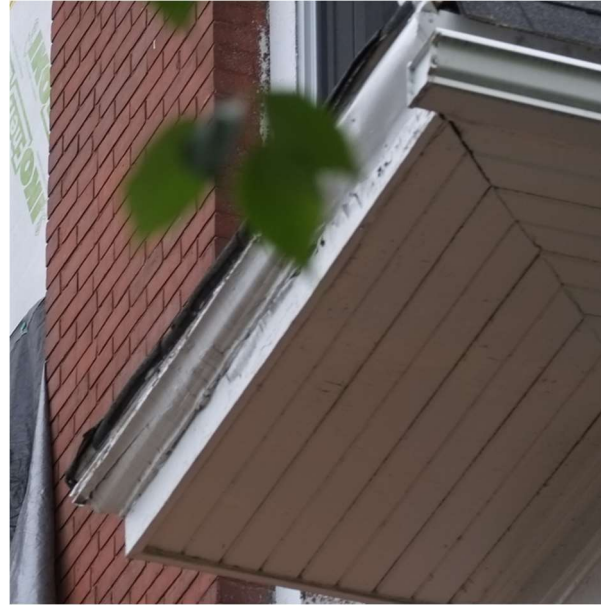
B.5 Crown Mouldings

Fig. 10 and Fig. 11: Crown mouldings have deteriorated pass point of repair. Aluminum caps on the end of the crown mouldings are visible in both photos

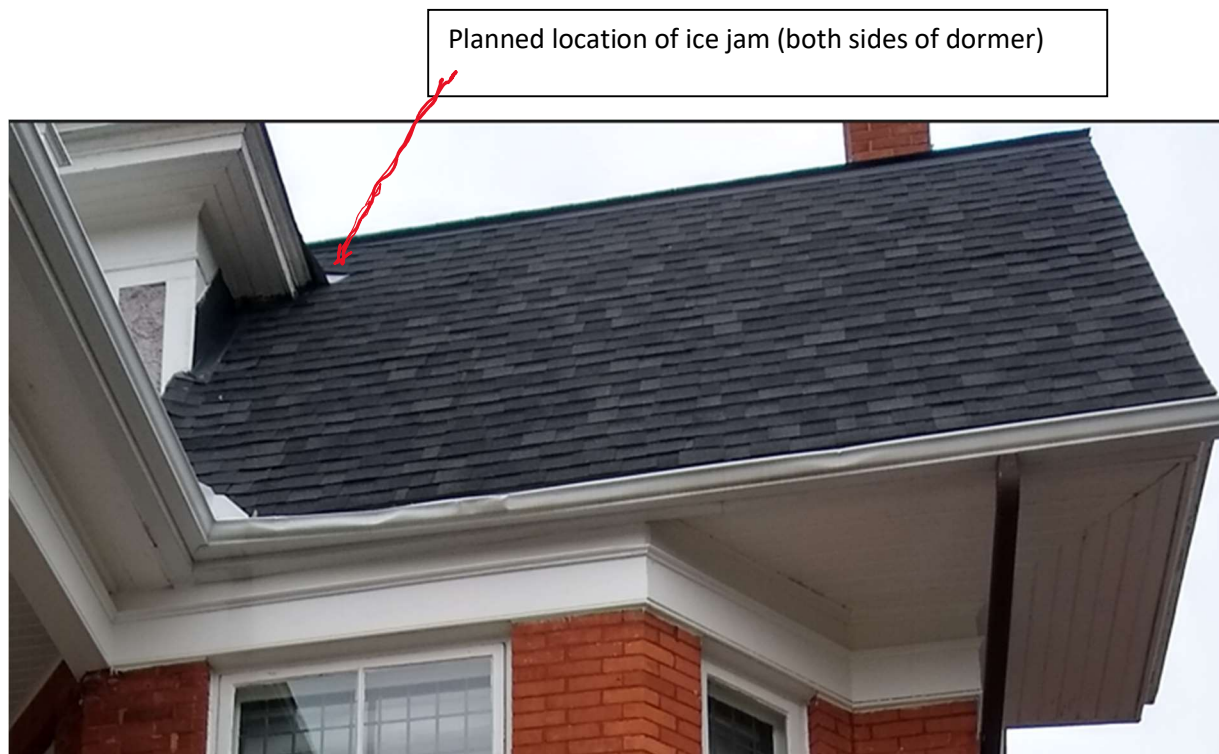
B.9 Ice damage to eavestroughs

Fig. 16: Eavestroughs damaged from ice sliding down from above

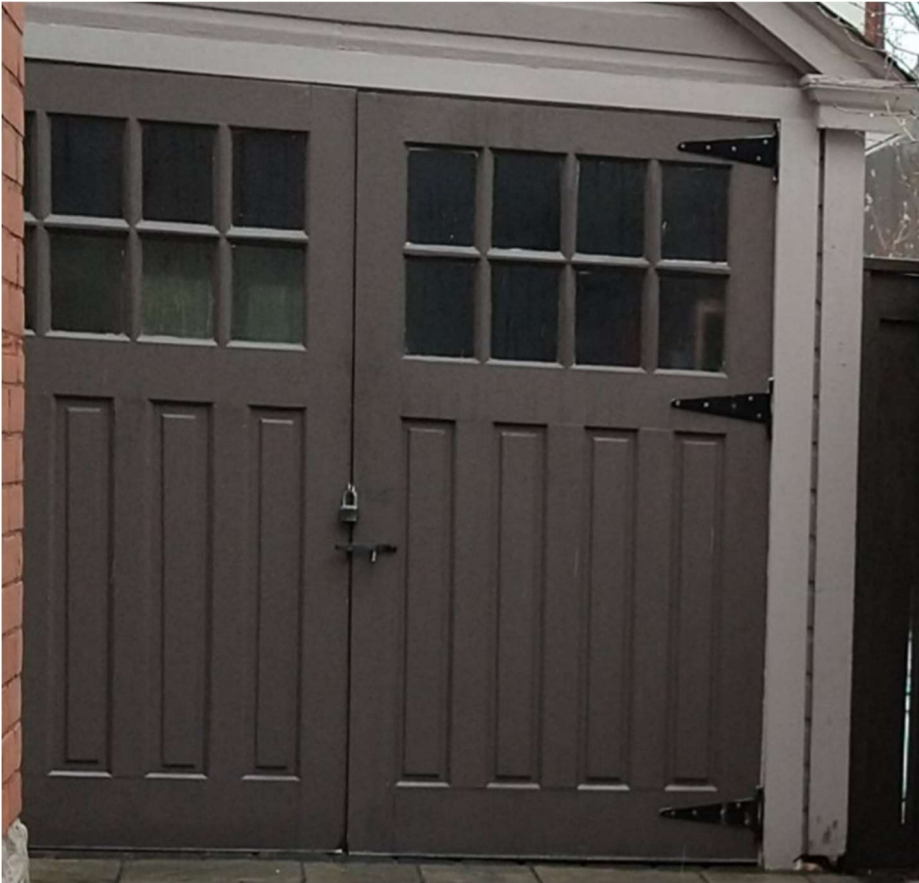
#### D. Garage door

Fig. 21. Garage doors were replaced by then owner in the 1990's as original doors were finished. Doors swing sideways and cannot be opened during the winter months due to frost heave of the driveway in front of the garage. Doors were cut 2 inches last year to attempt to correct issue, but another 2 inches would need to be cut from the bottom so that they could swing open properly.
