March 20, 2019

Project No. 19114

Re: **124 Boteler Street**  
**Structural Condition Review**

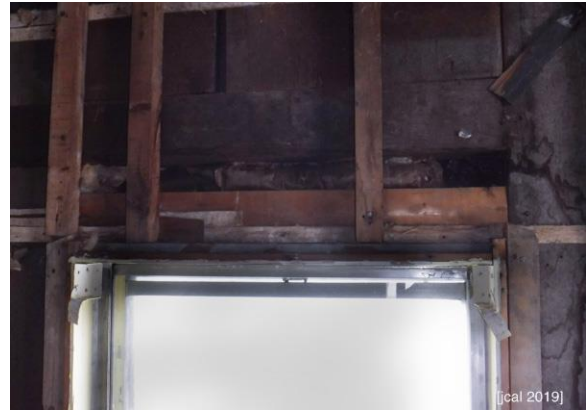
The windows and doors of the house and addition are not original and the replacements do not fit their original rough openings leaving large areas for heat loss. Other original elements have been modified and improperly supported, such as at the rear of the house where a past opening has been modified and improperly framed.

Figure 2: Rough Opening at Window, note unfilled space above

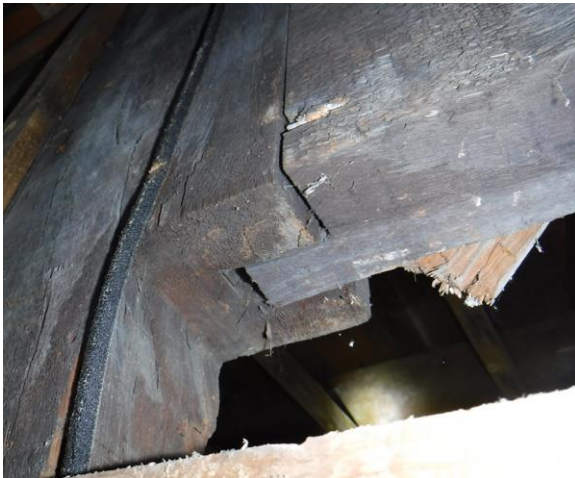
The timber house is built in the modified Post and Plank method which came to be known as *Poteau et Piece Coulissante* or Post and Sliding Piece. In this construction, the exterior walls are built of corner posts grooved to receive squared and tenoned timbers. The timbers at this house are an average of 3"x14". The walls are currently strapped with vertical strapping likely used to support wallboard in a past modification.

Figure 3: Post with Tenoned Timber

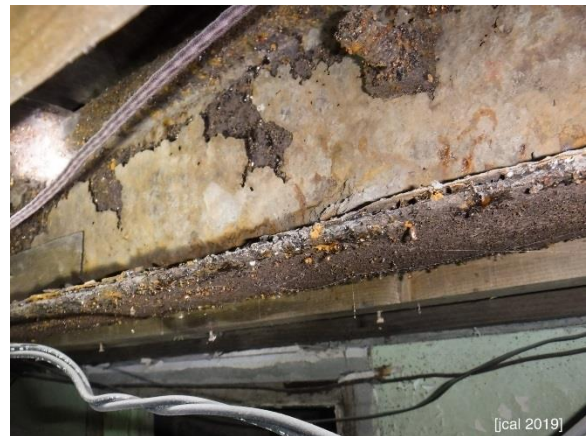
The floor framing at both areas of the house would not conform to the current Ontario Building Code (OBC) requirements but has served the residential occupancy for well over a century. At the original house this can be attributed in part to the higher strength of first cut timber from the era of construction, as compared to mass manufactured lumber of today. The condition of the framing is fair with some openings from past pipe penetrations and past access hatches to the original unexcavated basement. No observations of significant distress of the wood framing were noted however the bearing conditions at the foundation wall were available for assessment. A large log beam supports the back wall of the house and shows a small area of deterioration where it is exposed. The steel beam at midspan is severely corroded at both the house and the addition.

Figure 4: Corroded Beam at Basement

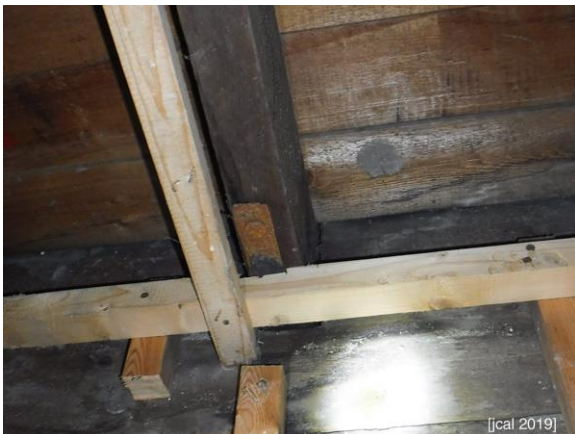
The second floor framing is full span 3"x8" timber spaced at about 48" c/c bearing into notched openings in the timber wall with iron straps as mechanical connection from the underside of the joist to the wall timber. The floor is made up of tongue and groove decking measure to be about 1-1/2".

Figure 5: Connection of Floor Framing to Wall

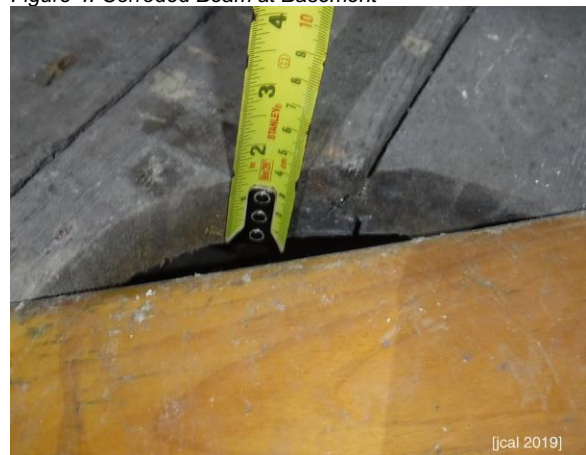
Figure 6: Tongue and Groove Floor Boards

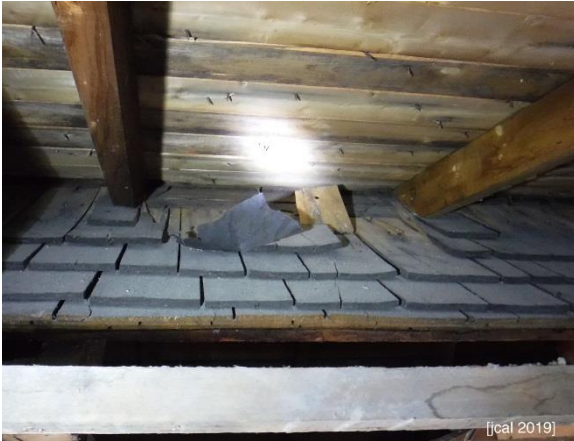
The original roof framing consists of rafters with a tie at approximately mid height which formed the ceiling support. During a modification to include dormers on the east and west sides of the house the rafters were cut at the elevation of the tie and re-supported with 2"x4"s to the exterior dormer wall. The dormer sloped roof of the dormers are built of 2"x4" which bear directly on the original roof shingles without

supplementary support. The vertical face of the dormers are built of 2" x unknown framing at 16" c/c clad with original roof boards at the interior.

Figure 7: Dormer Rafters Bearing on Original Roof

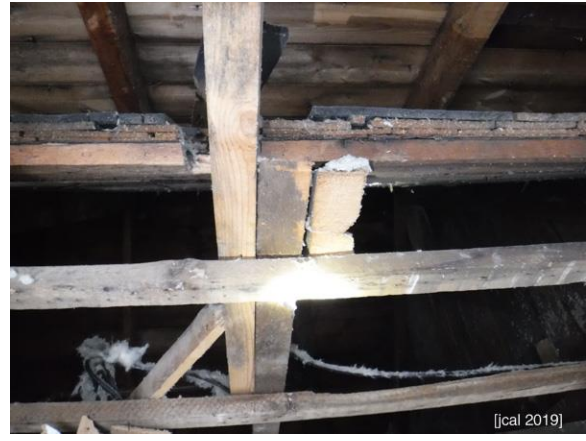
Figure 8: Cut Rafter End

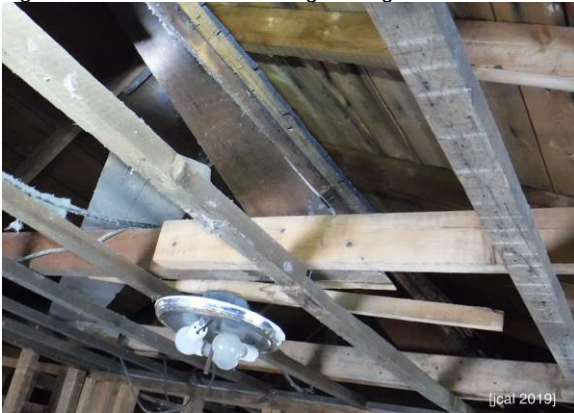
While the as found structure would not be in conformance with modern Building Codes, the satisfactory performance of the structure over at least the past 30 years suggests that upgrades to meet current Code are not necessary. This is based on the National Building Code of Canada (NBCC) Structural Commentary L, which provides this allowance when there is no evidence of significant damage, distress, or deterioration and if the structural system and critical details are examined for load transfer. Further to our review, if the structure is intended to be retained we would consider the dormer to roof connection and collar splice/extension as a critical detail requiring detailed review to ensure load transfer.

Figure 9: Cut Rafter End with Collar Extension at Dormers

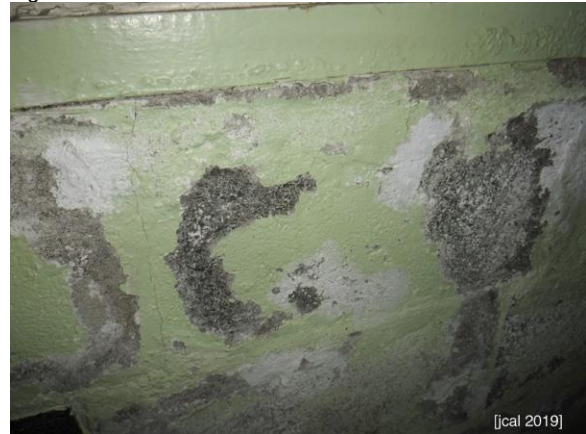
The CMU extension and CMU at the addition is found to be in fair condition at the exposed interior face. There are several locations of paint flaking and salt depositing on the face of the CMU indicating moisture passing through the wall, however no major damage is noted at this time. The condition of the exterior face of the CMU could not be reviewed due to the presence of parging and snow.

Figure 10: CMU Foundation Wall Condition
