Site Structural Inspection Report

114 Stanley Ave, Ottawa, ON K1M 1N9

General View of the Building (From River Lane)

1.0 Structural Inspection

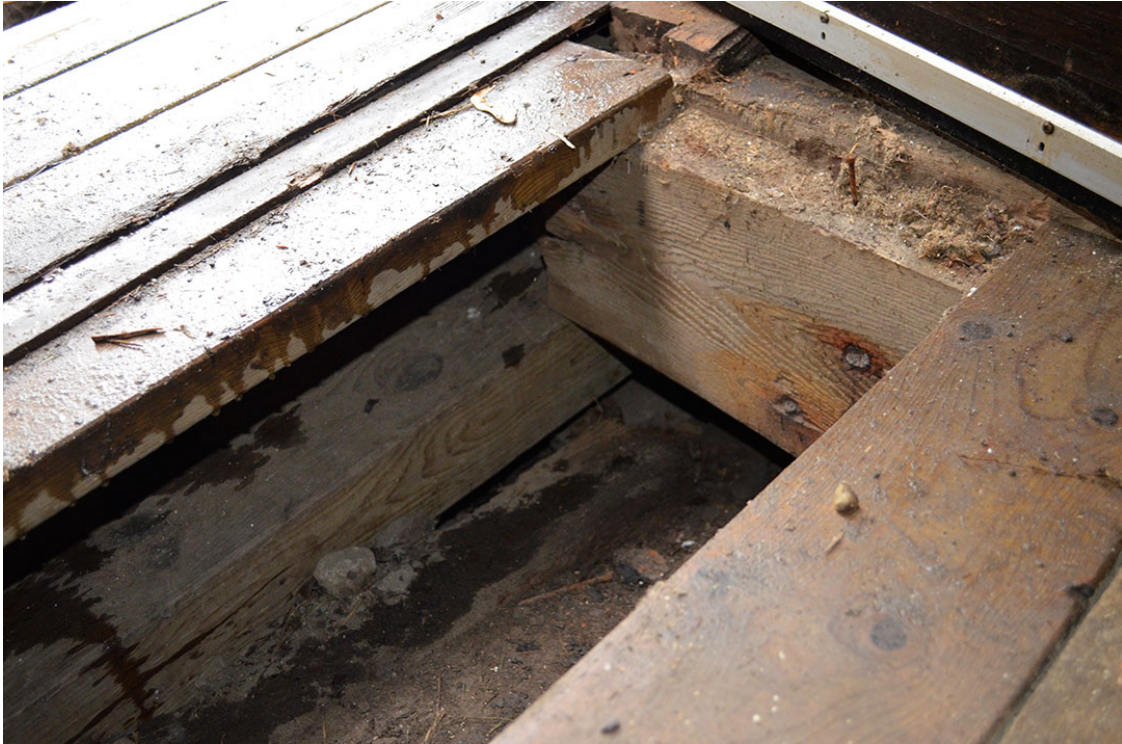
Photo 1

1. No excavation was done on the outside perimeter of the garage. The foundation could not be seen from the outside perimeter. However, under the wood floors on the inside, I could observe a 6x6 wood beam in some sections and in others there is no foundation at all. This wood beam was in turn sitting on rubble or a compacted stone layer. This means the whole garage structure is floating and resting only on the wood perimeter beam or actual ground. This does not allow for any lateral support of the walls and explains why the building is twisted, leaning and uneven.

2. The foundation beams are not original. I could clearly tell the ones I could see had been replaced recently (I estimate the last 10 years). **Photo 1**

6x6 wood beam foundation, sitting on rubble. We can see the floor joists and floor boards sitting above.

1. The foundation has to be a poured concrete slab on grade with thickened edge to be able to withstand the harsh conditions our geographical location demands on a yearly basis.
2. We suggest an 8" concrete curb be poured on the perimeter to allow for the new walls to be built above the finished grade. This would allow snow and rain to be in contact with the foundation and not the wood, this reducing the chance of rot.
3. The concrete slab should have rebar to allow for structural stability and saw cuts to limit cracking within the slab.
4. The slab should be poured on an 8" (min.) bed of crushed stone to allow drainage and compaction.

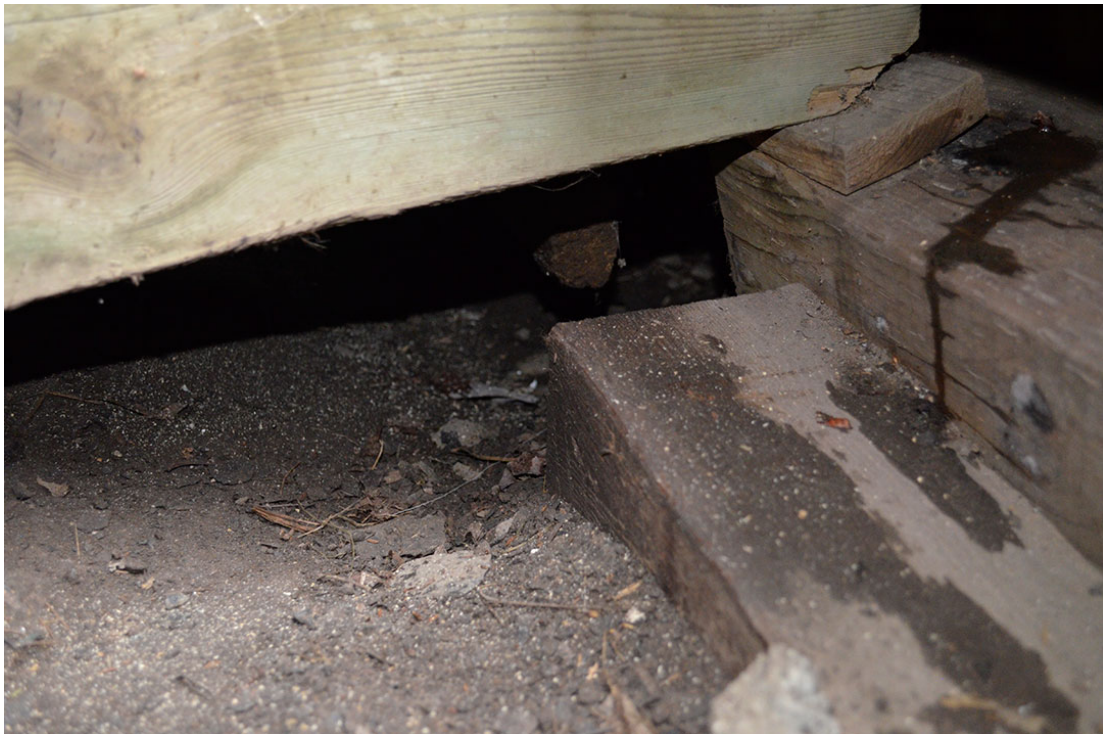
Photo 2

Section of floor without a foundation. We can see an old rotted out piece of wood underneath the floor joist.

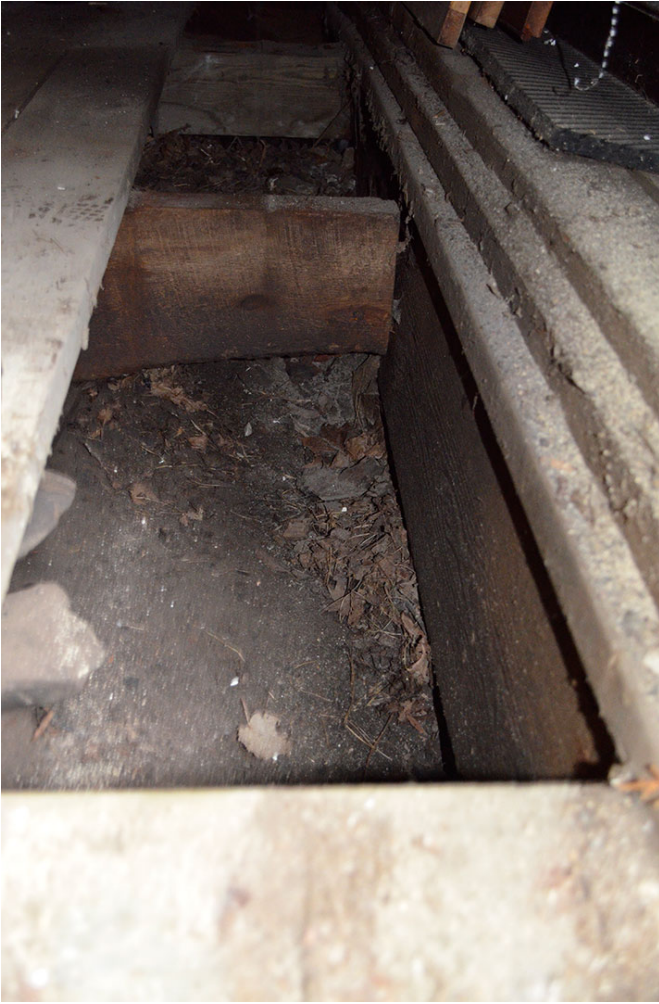
Photo 3

Here we see a section of Floor joist sitting directly on the ground/rubble. We can see voids underneath the floor joist indicating there is no actual foundation underneath these sections.

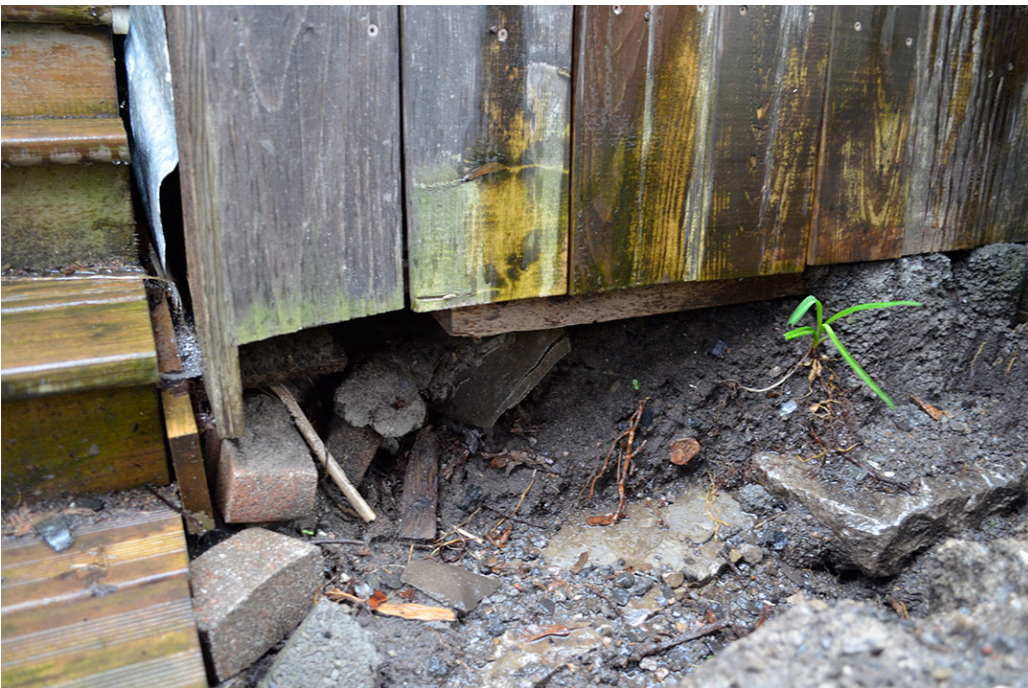
Photo 4

Here is the left corner of the front bump out sitting directly on the ground/rubble seen from the outside. We can see voids underneath indicating there is no actual foundation or anything supporting this section.

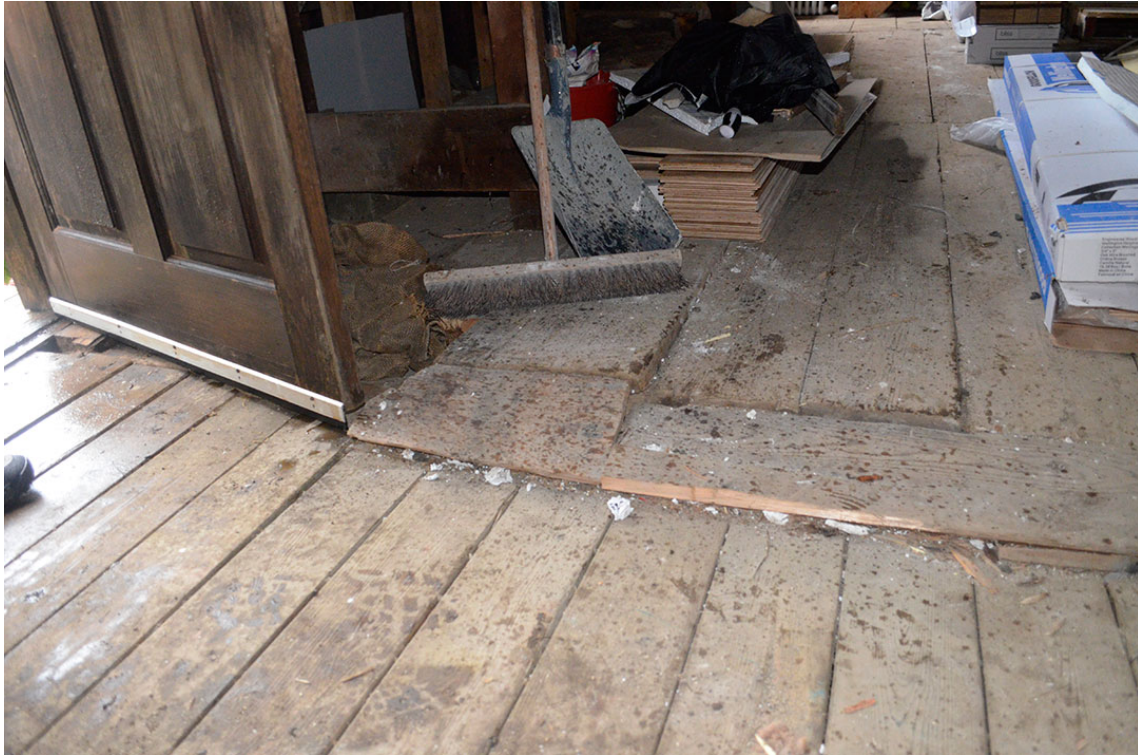
Photo 5

1. The garage has a wood floor comprised of 1x4 wood floor board sitting on a 2x10 wood joist. These are sitting on the wood foundation listed above.
2. There are clear indication of slopping that is demonstrated throughout the floor. All though the floor slopes the joist are in ok condition and I could clearly tell some of them had been replaced recently (I estimate the last 10 years) **Photo 5-6**

3. The floor holds the walls above and the slopping explains the leaning. It is our observations that the wood foundation is not level therefore sloping the floor, which in turn makes the walls and the roof lean.

The floor decking shows many uneven sections.

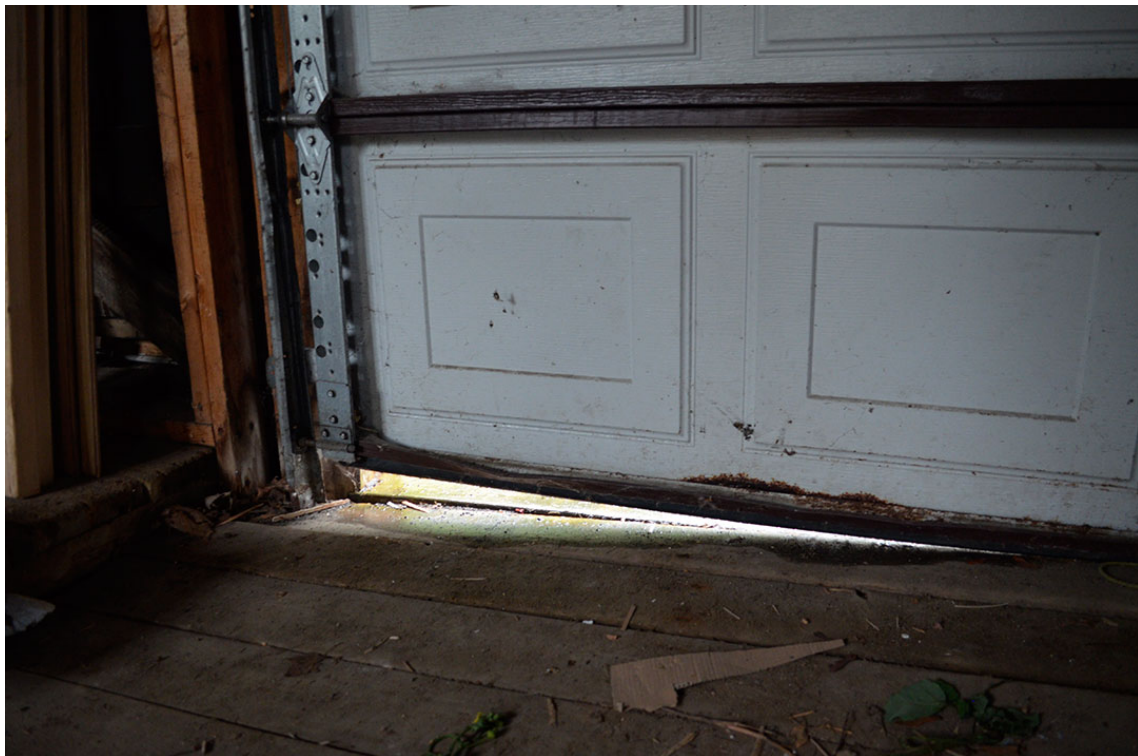
Photo 6

1. The openings on all 4 wall show significant stress with the building being leaning and the roof sagging. Most of the windows are inoperable but the few that were did not open do to the frames being crooked and stressed. **Photo 14-17**
2. The garage door sill is rusted and shows signs of water infiltration. It is hard to tell if the door is also out of square do to the condition of the walls and floor. **Photo 6, Photo 26**

Door sill shows heavy slopping.

1. All windows and doors should be maintained unless the frames are rotted or out of square at which point new windows and doors should be installed.

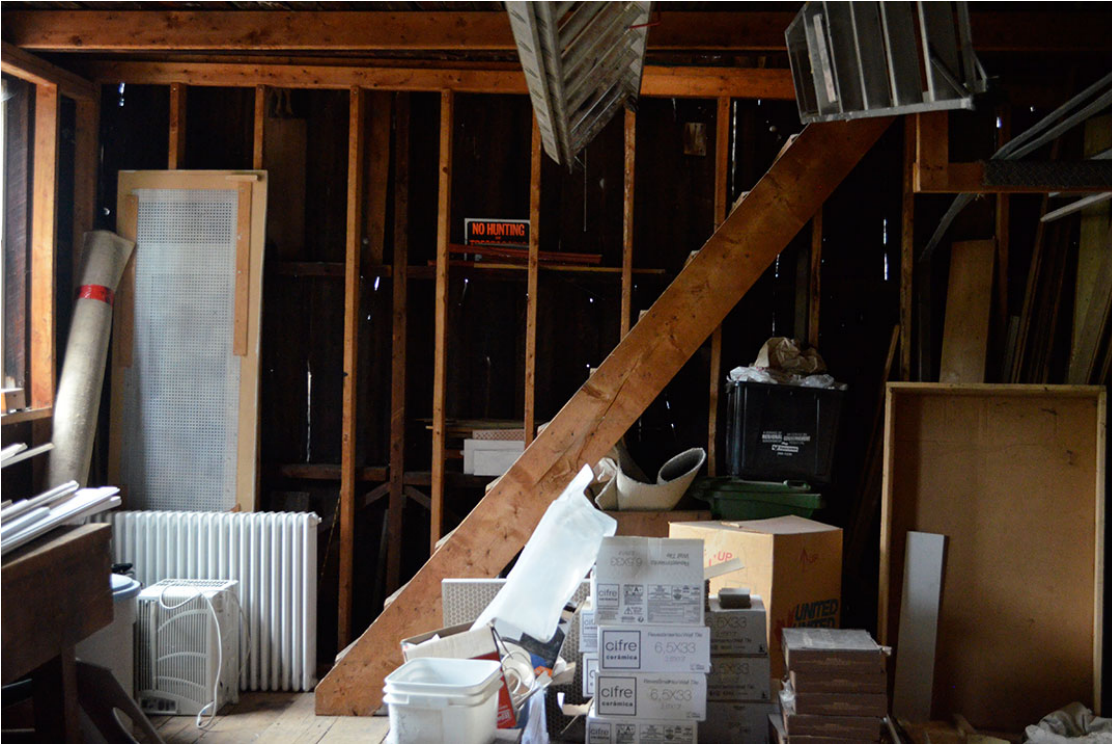
1. The walls are comprised of 2x4 wood studs at 24" O/C clad with board and batten wood siding. **Photo 7**
2. The wall show some leaning and are out of square. It is easy to observe that the building is leaning to the right (looking from River Lane) and is showing signs of stress in the wood studs on the corner of the garage. **Photo 8**
3. There are seams and cracks very apparent in the cladding. It is easy to see rays of light penetrating from the outside in. This explains some of the water stains and also some rot on the lower portions of some of the wood studs. Spray foam has been used to cover some of these gaps. All things considered, the condition of most studs is ok and we suggest that what can be dismantled and reassembled on the new garage framing be done. We anticipate this to be about 70% of the wood studs. **Photo 9-10**

Photo 7
2x4 wood studs
shown from the
inside of garage.

1. The new outside walls should be 2x4 wood studs at 16" O/C. We recommend +-70% of the existing studs could be reused for the construction of the new structure.
2. There should be strapping installed on the outside to allow for better fastening of the board and batten cladding.
3. The board and batten wood cladding should be numbered when dismantled to maximize efficiency and fit when reassembling. Some of the existing should be reused to maintain character and look.

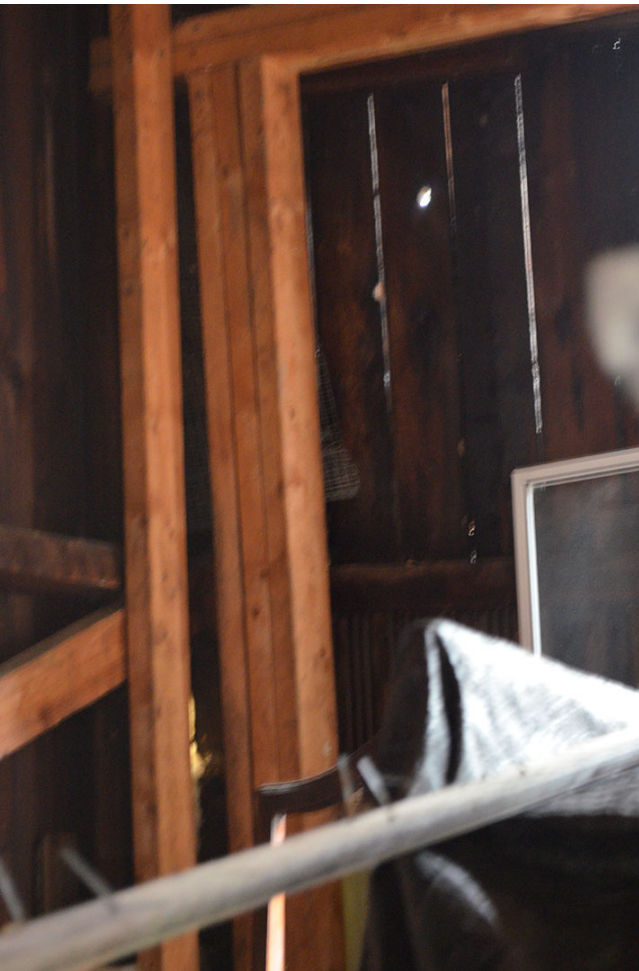
Photo 8
Walls leaning at corner of garage.

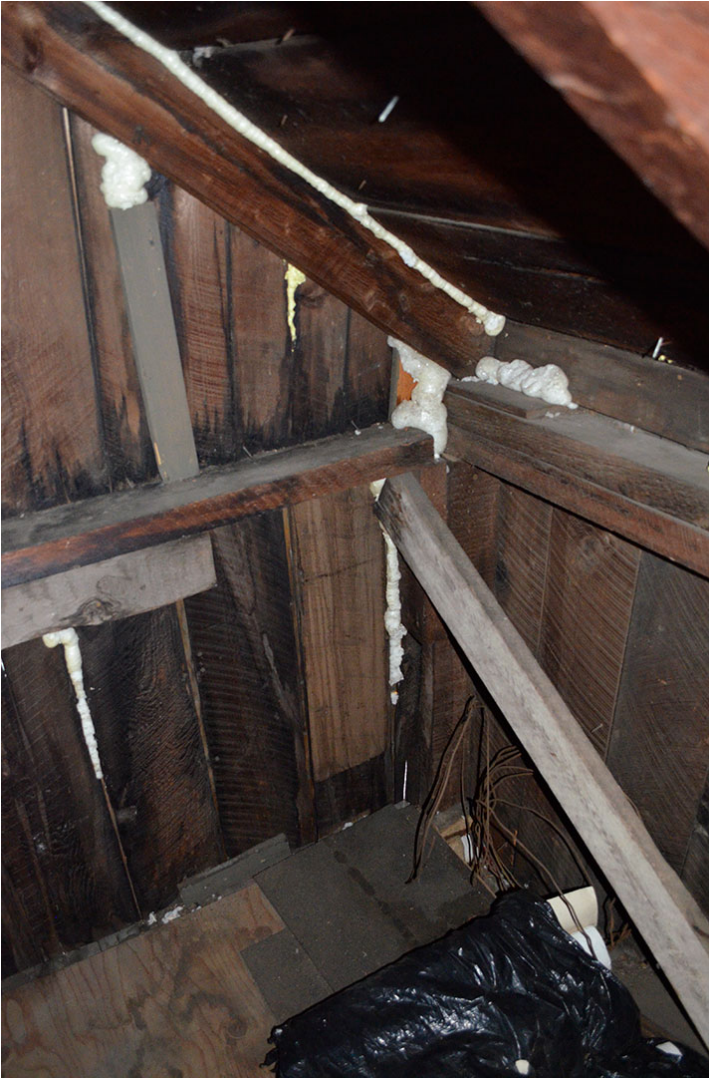
Photo 9
Spray foam used to cover gaps and cracks.

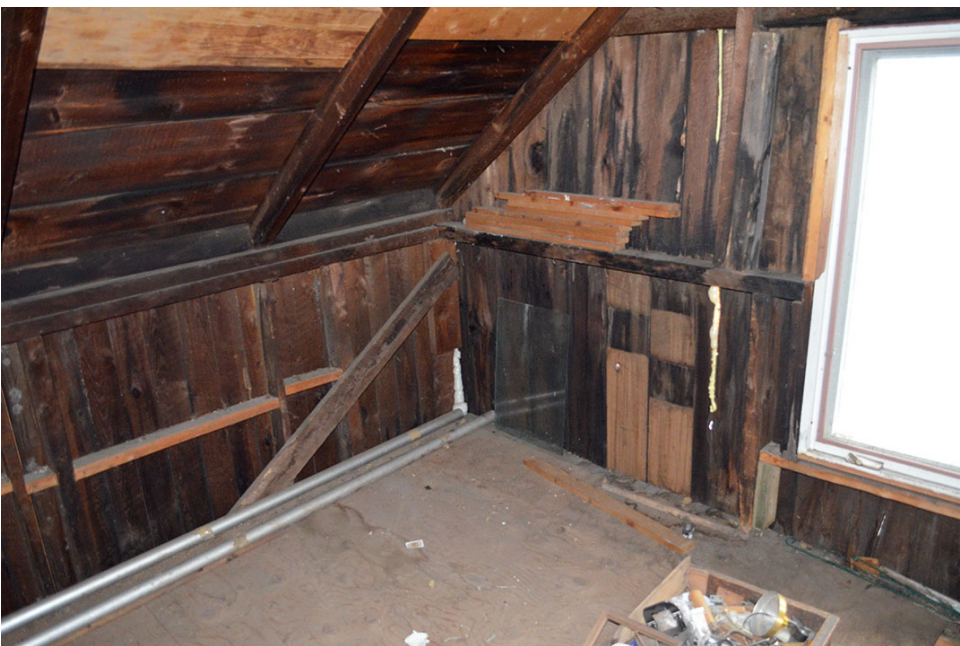
Photo 10
Spray foam used to cover gaps and cracks.

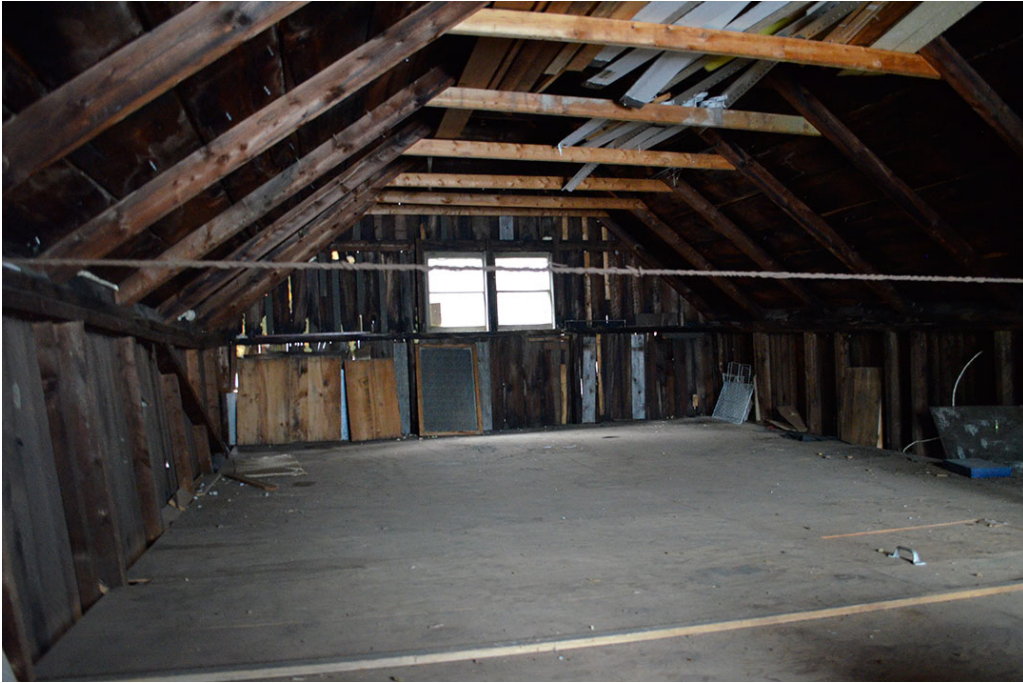
1. The roof structure is framed with typical rough cut 2x6 roof joist at 24" O/C with 1x6 wood decking clad with asphalt singles that seem to be 25-30 years old.
2. The roof joist have significant sagging which shows signs of overloading from snow loads. **Photo 11-12**
3. The interior roof joists have some rope holding them together to help withstand the spreading. Clearly they tried to address the fact that the upper storey walls are spreading towards the outside. Unfortunately this is a band aid solution to help limit the deflection caused by the snow loading on this roof. **Photo 13**

Photo 11
Interior roof composition. Somme sagging visible on left side of picture,

1. The new roof should be a pre-engineered roof truss structure that would allow for the snow loading to be calculated for the next century.

2. The new roof truss should have the same pitch and be built with today's standards would have to comply with Ontario Building Code in effect at the time of reconstruction.
3. A sub membrane like OSB or plywood should be added on the new roof trusses and be clad with new asphalt shingles.

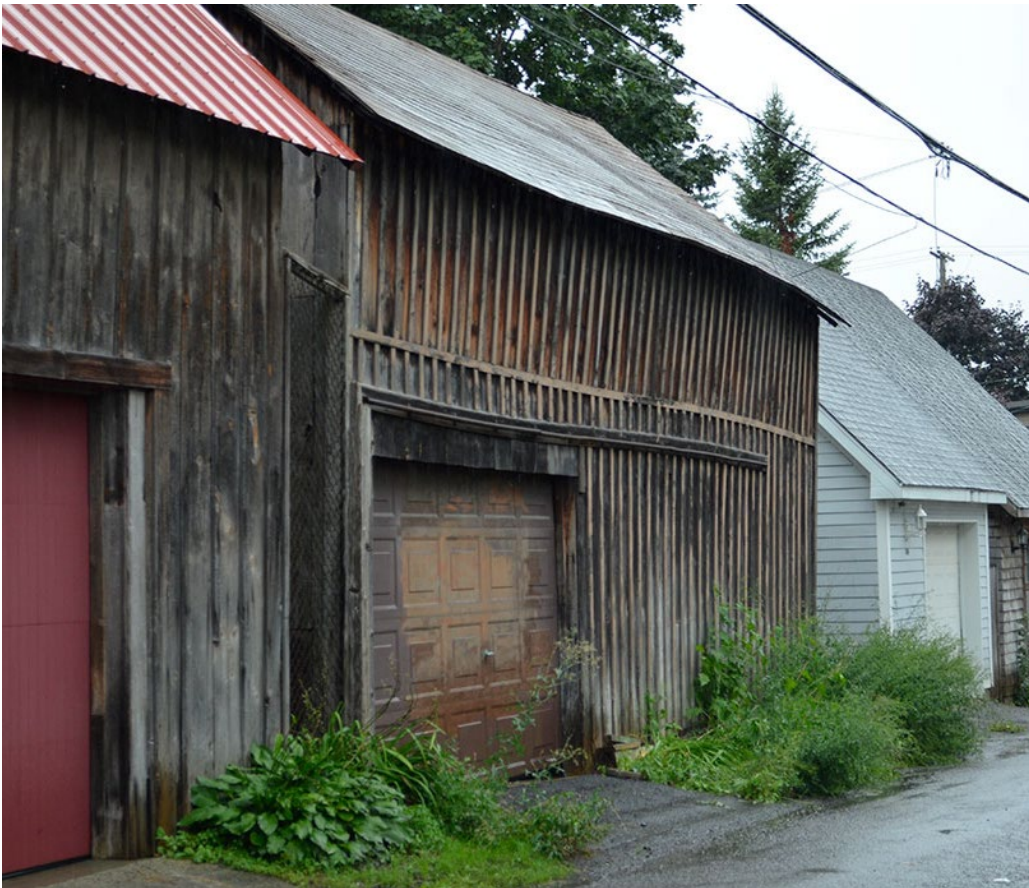
Photo 12
Exterior roof sagging from snow overloading.

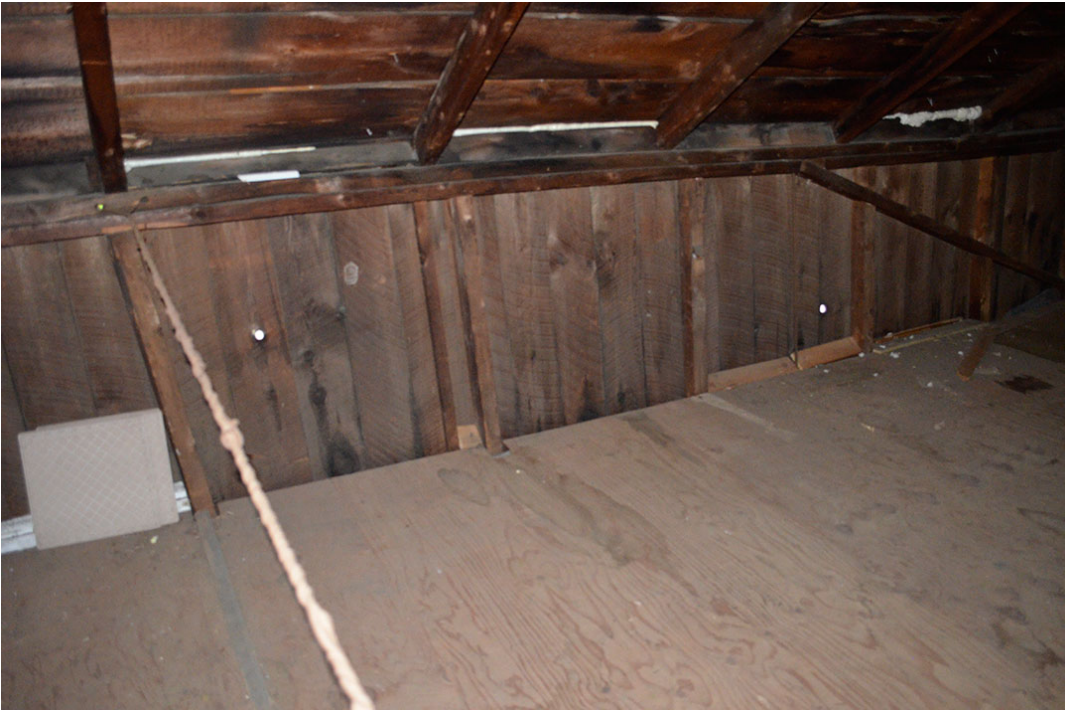
Photo 13
Spreading starting at
roof and wall junction.
Tie rope shown added
from side to side.

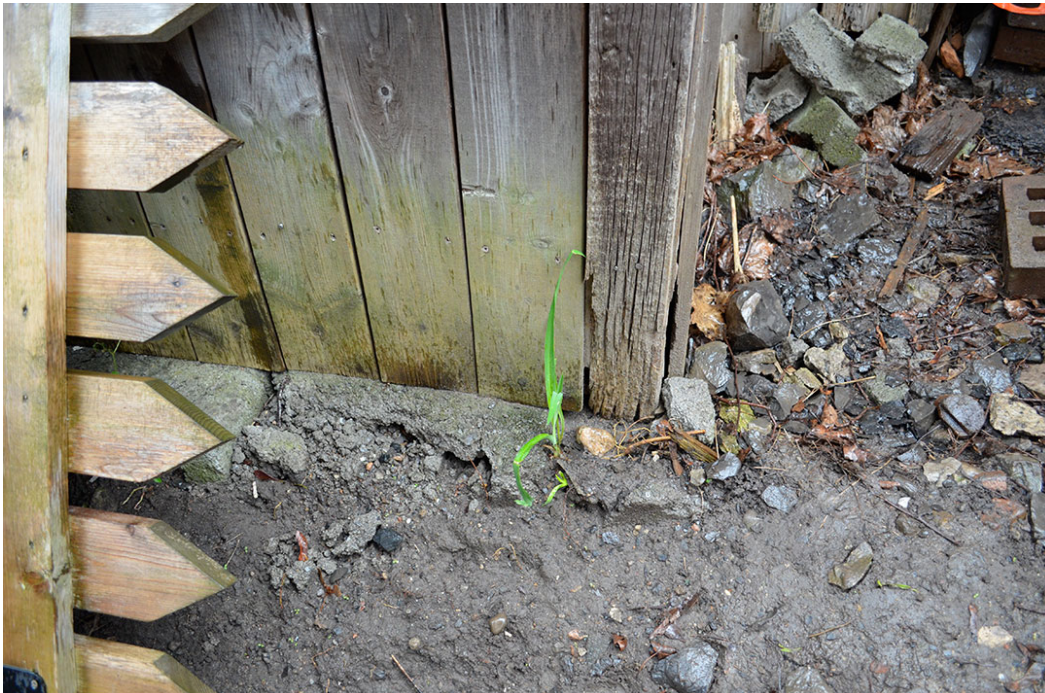
1. The exterior cladding board and batten wood shows significant signs of weathering and water damage. However the rot is minimal other than the corners, bottom of the boards and around openings. **Photo 18-26**

Photo 18
Rot and damage on front bottom left corner.

2. The condition of the board and batten is not great but we suggest the portion that can be dismantled and reassembled on the new garage framing be done. We anticipate this to be about 30% of the exterior cladding.

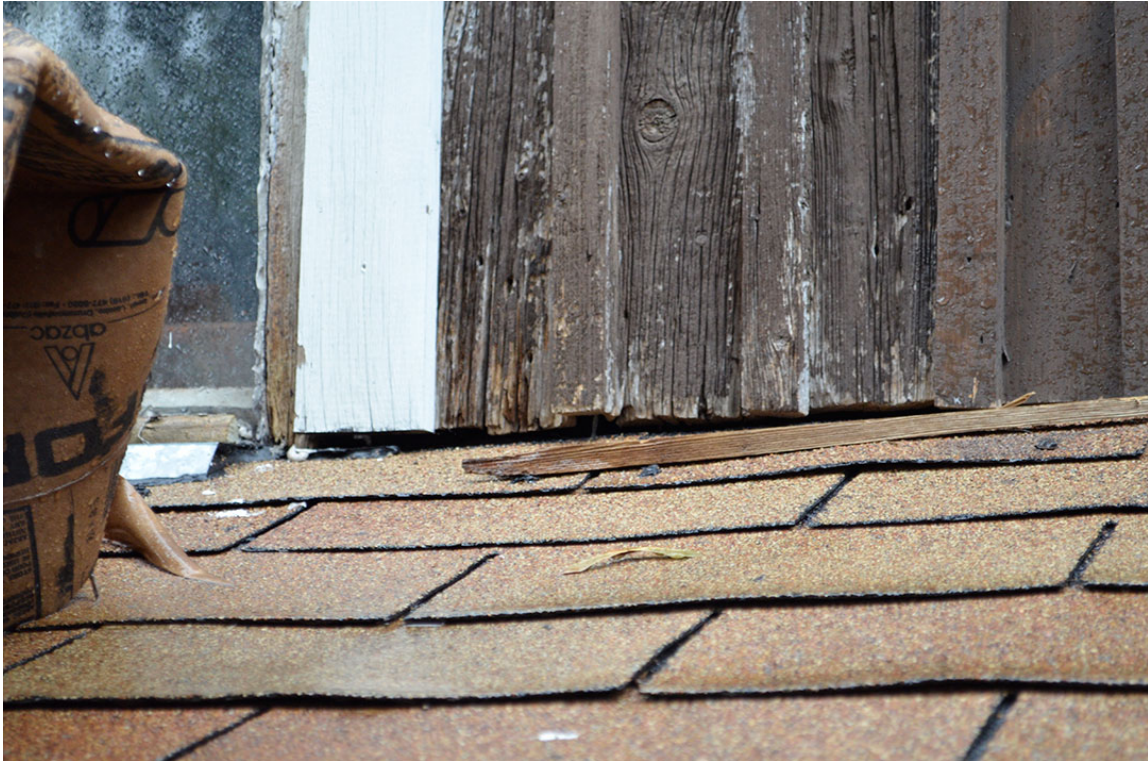
Photo 19

Rot and damage above small lower roof on front side.

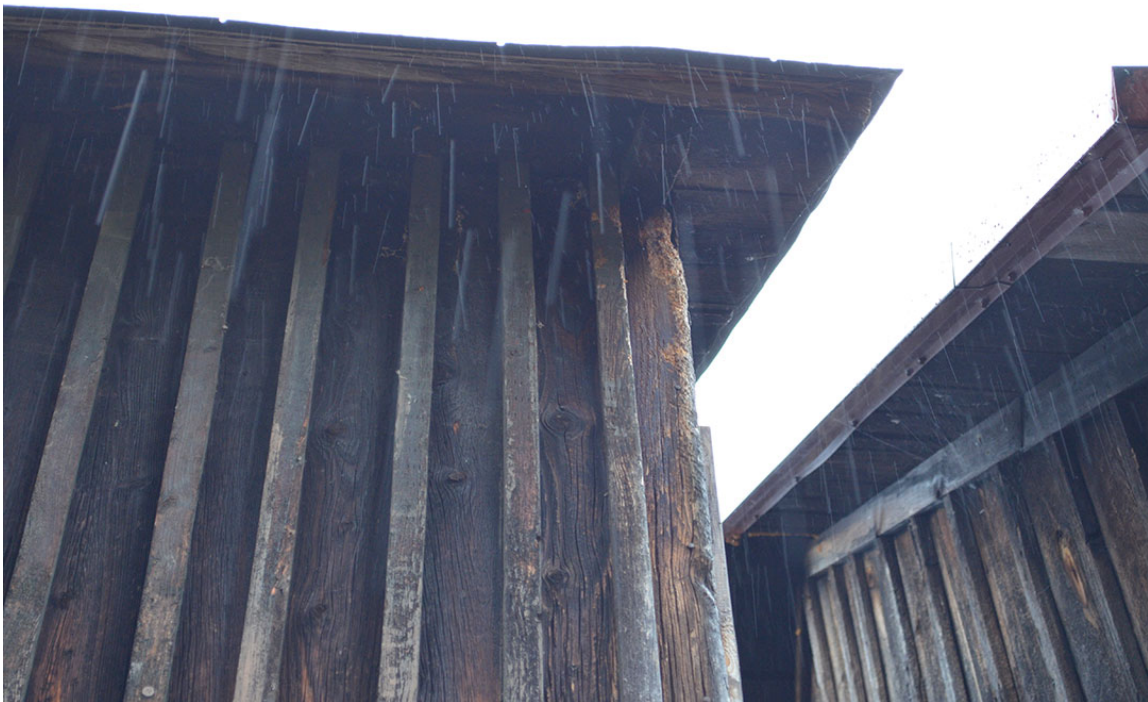
Photo 20

Rot and damage on front side upper right corner.

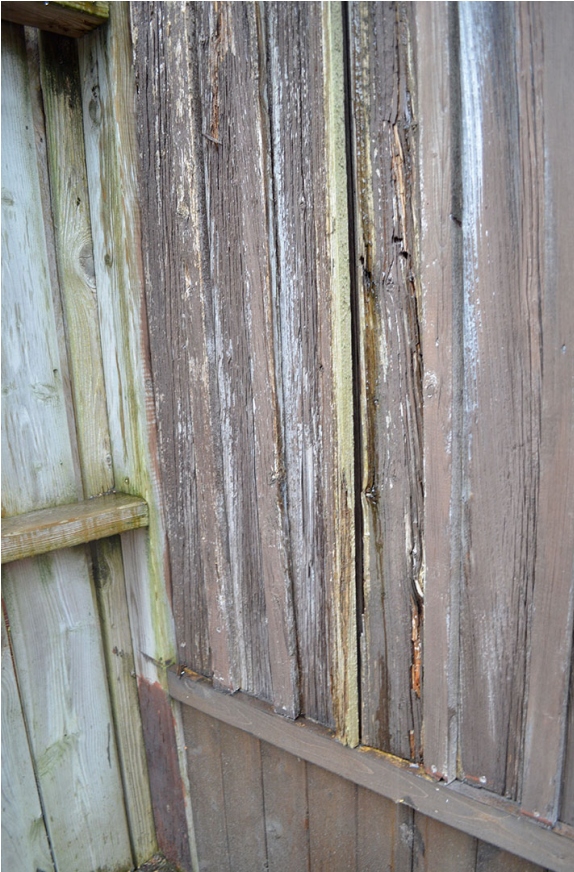
Photo 21

Rotten and damaged boards on left side.

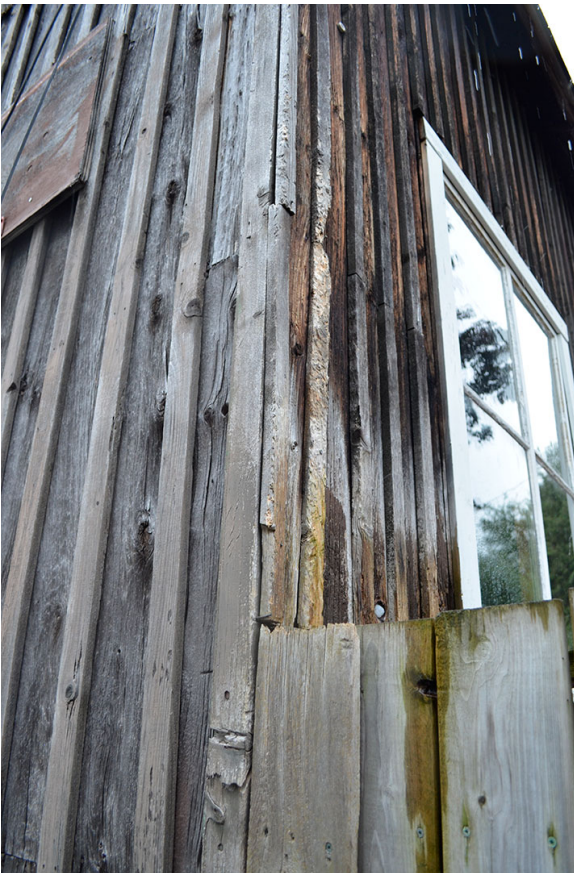
Photo 22

Rot and damage on left front corner.

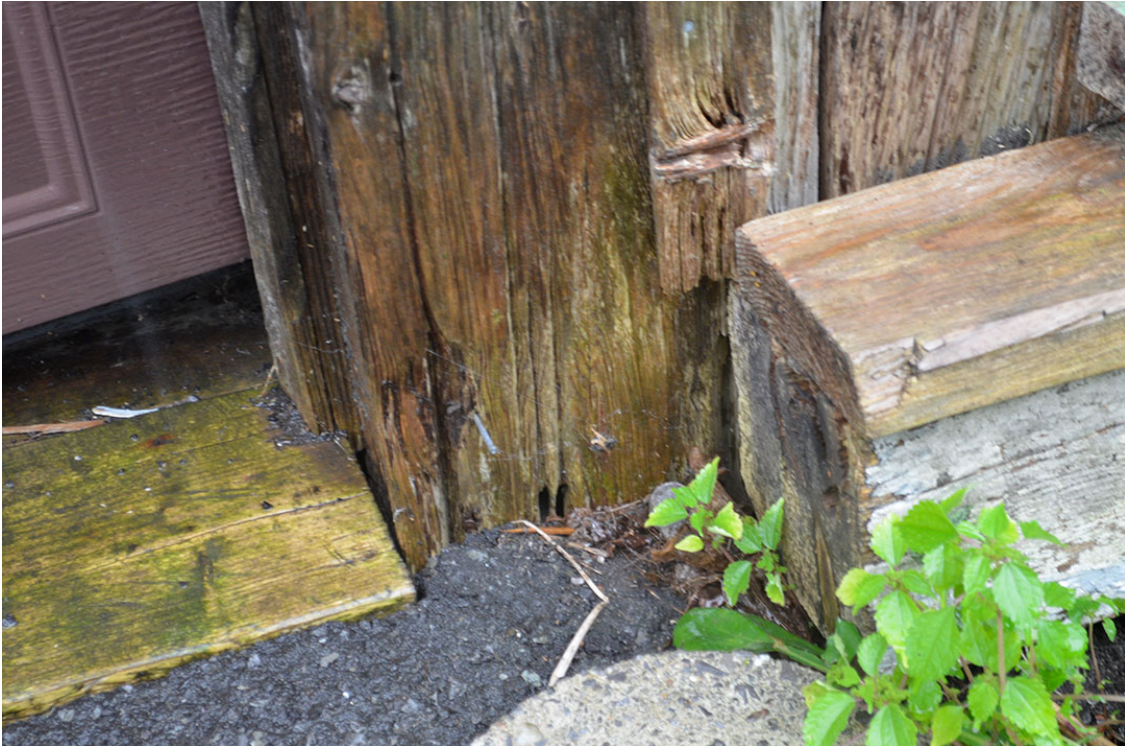
Photo 23

Rot and damage around garage door sill.

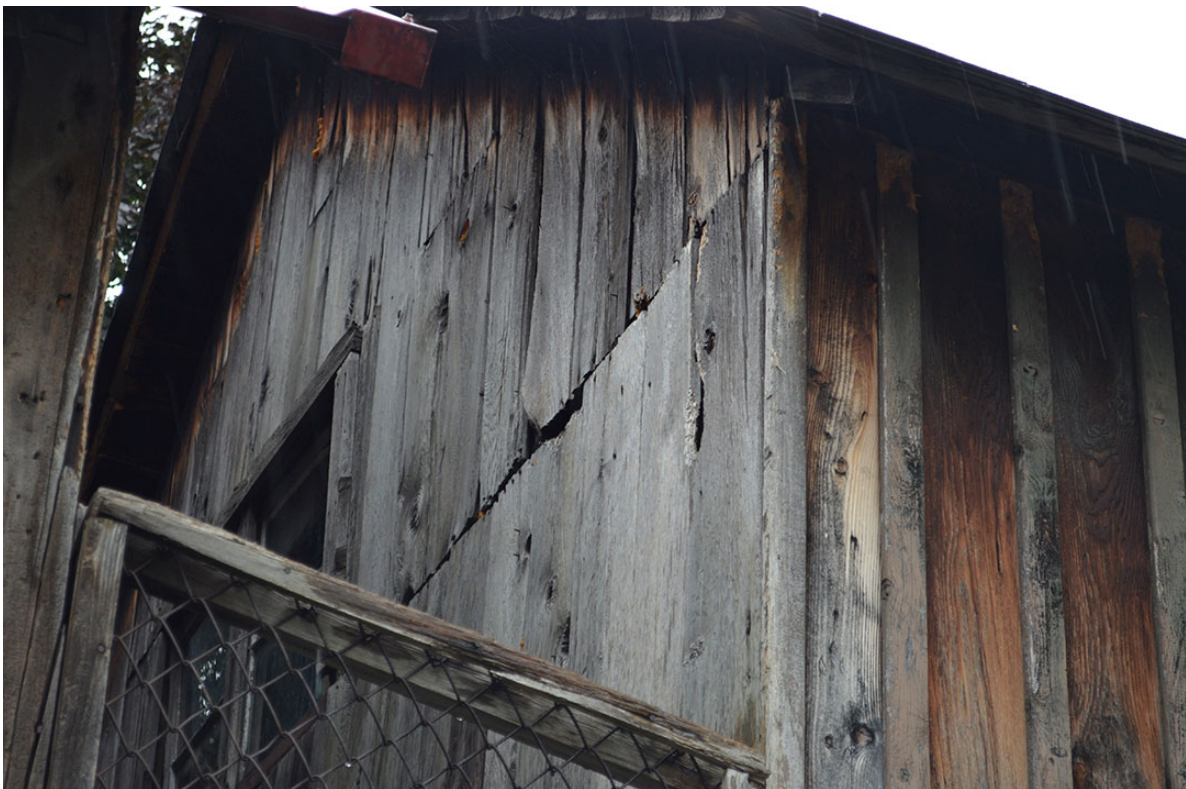
Photo 24

Rot, damage and holes on upper left side.

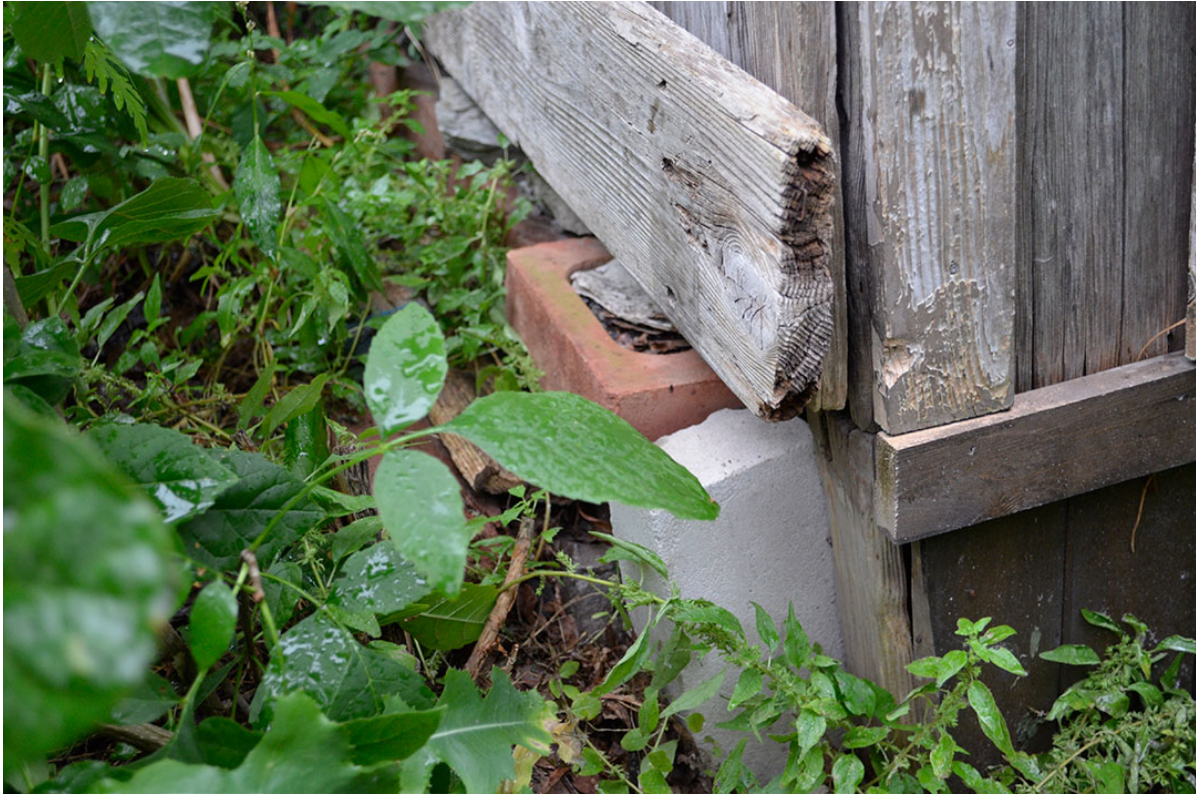
Photo 25

Rot and damage on left side lower right bottom portion of wall.

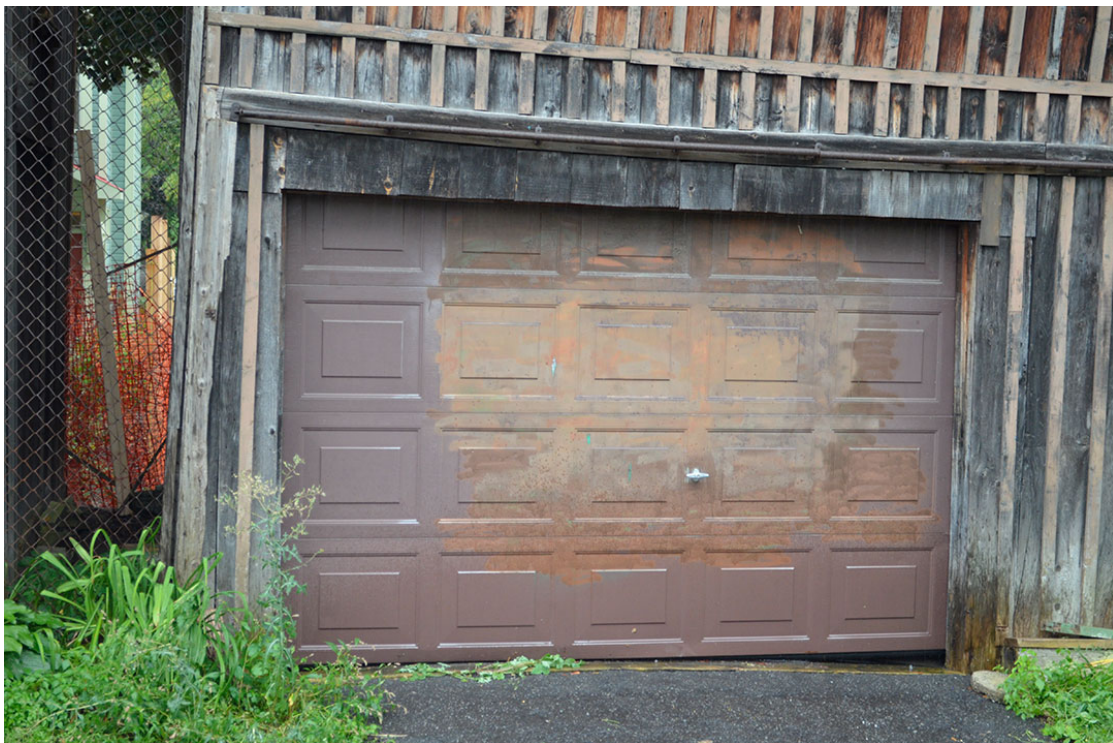
Photo 26

Damaged, crooked structure around door and door.
