DILLON
CONSULTING

May 2019

CITY OF OTTAWA

Long-Term Strategy Review and Decommissioning Impact Study Porters Island Pedestrian Bridge (SN013260)

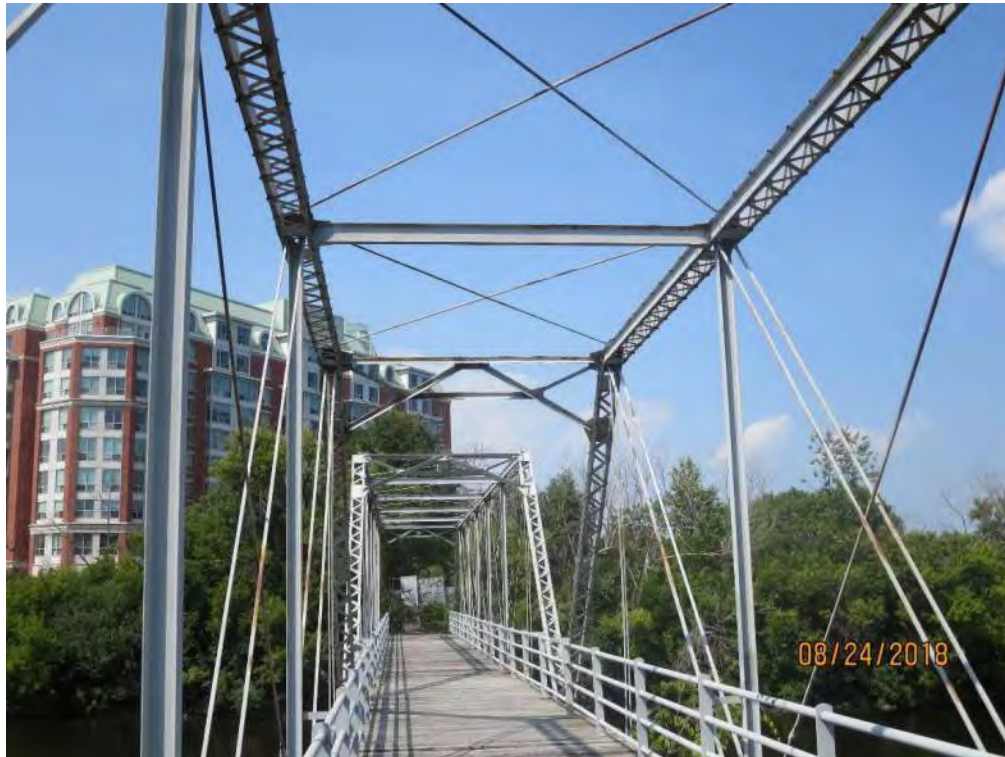
Photograph 4: Cross section of structure looking south at the pier.

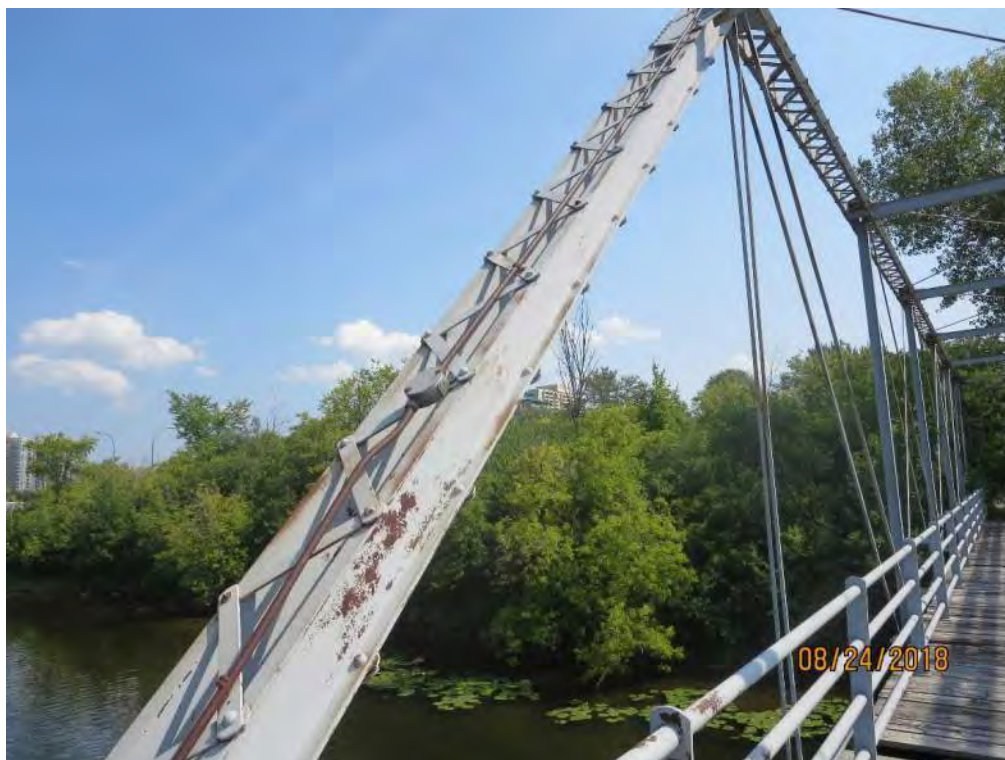
Photograph 5: Typical condition and general view of truss members.

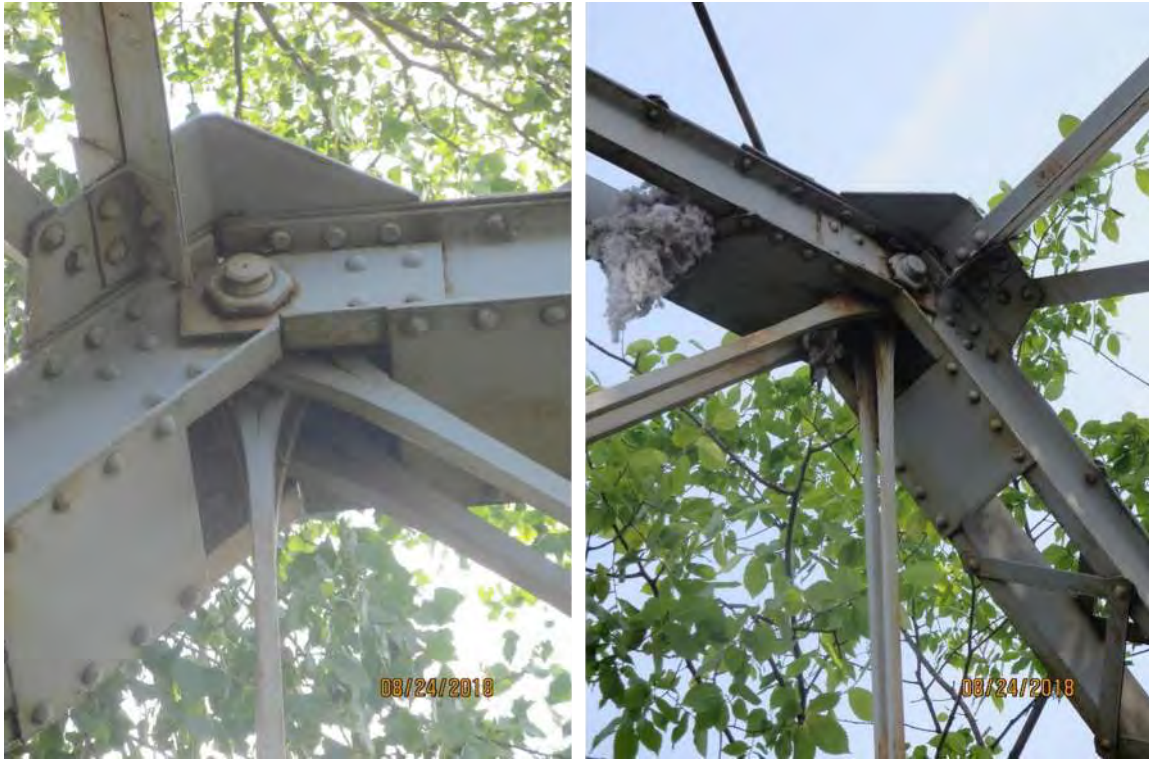
Photograph 6: Typical condition of end post.

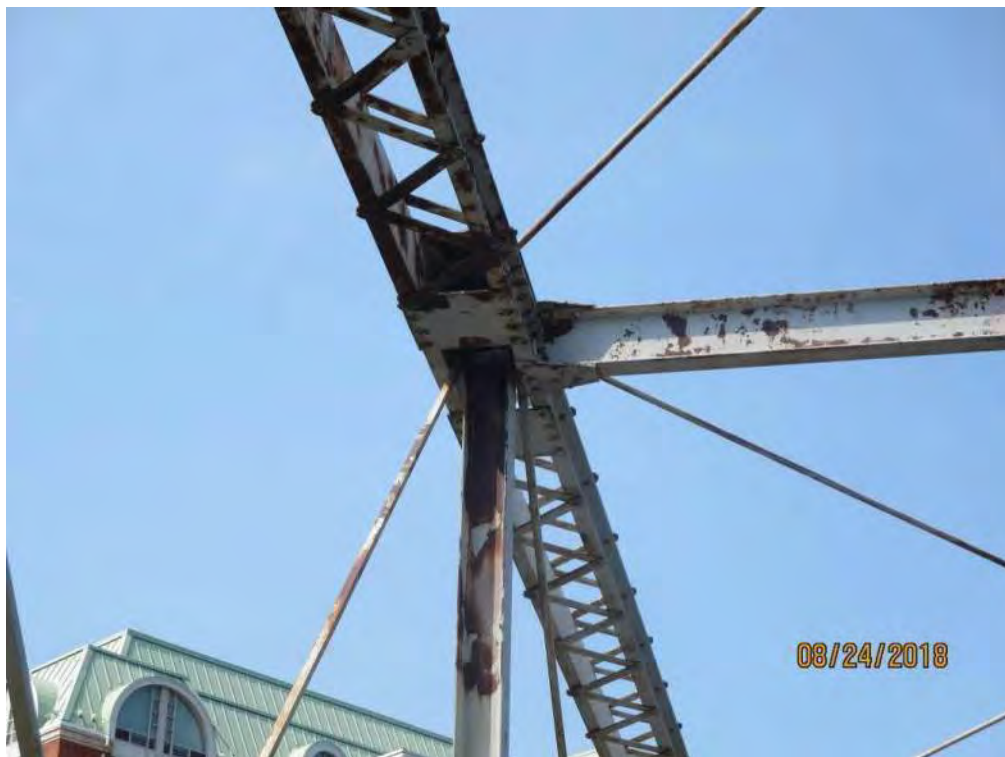
Photograph 7: Typical top chord to end post connection. Debris/nesting was noted at southeast corner of the structure.

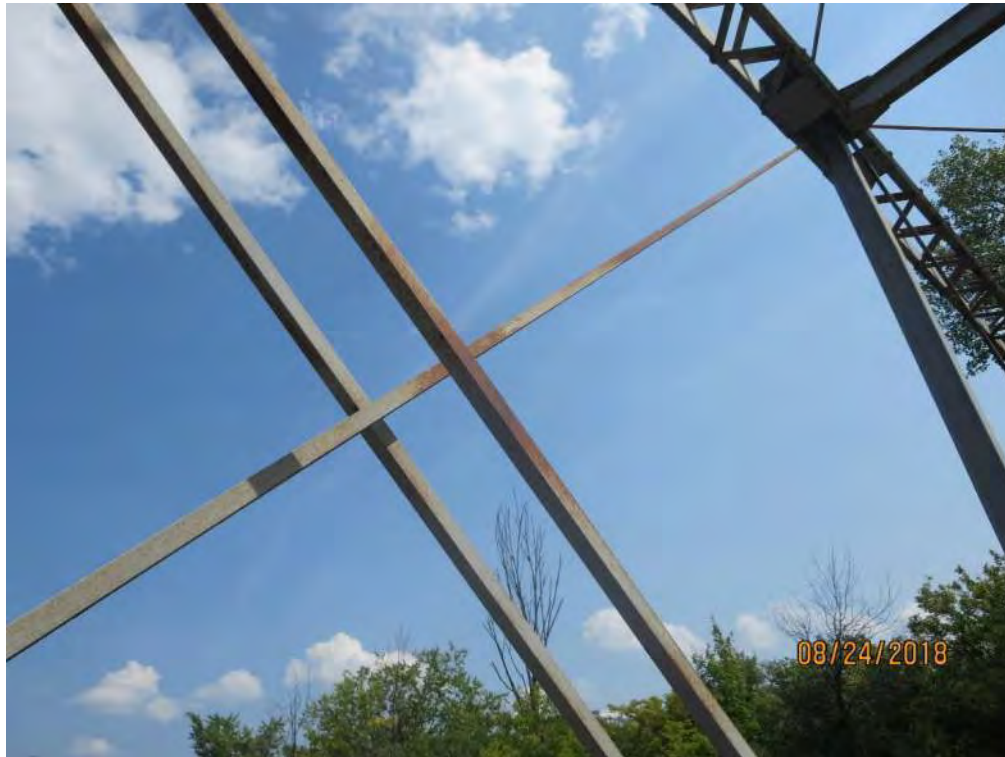
Photograph 10: Typically pitting corrosion on truss verticals at previous railing connection.

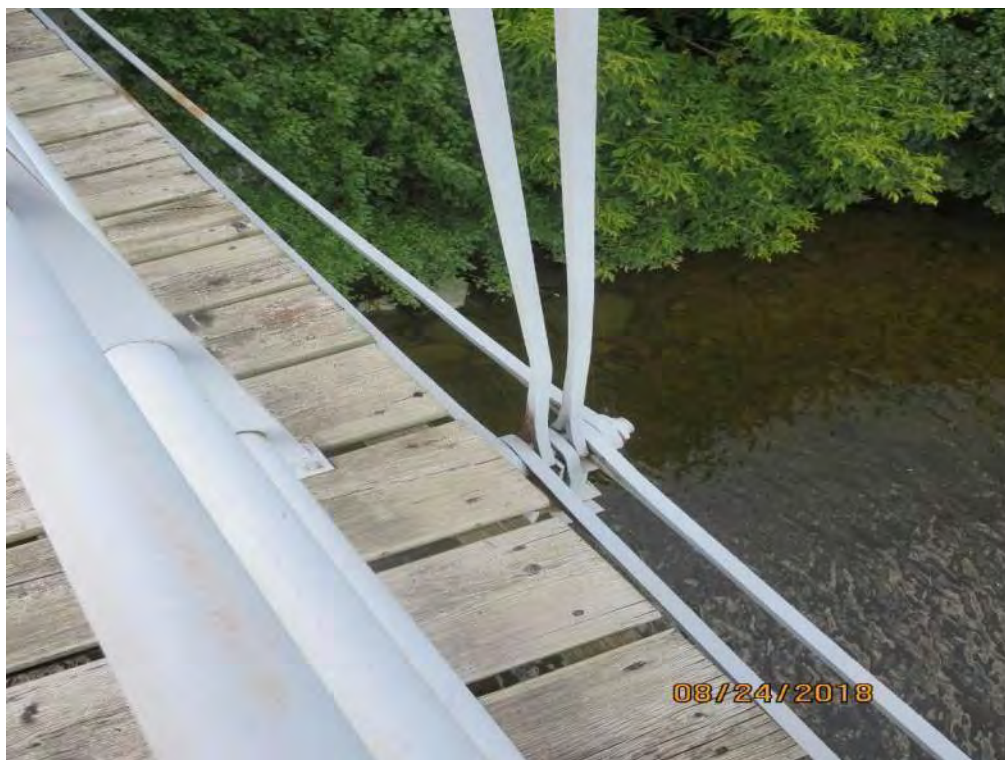
Photograph 11: Typical configuration and condition of diagonals.

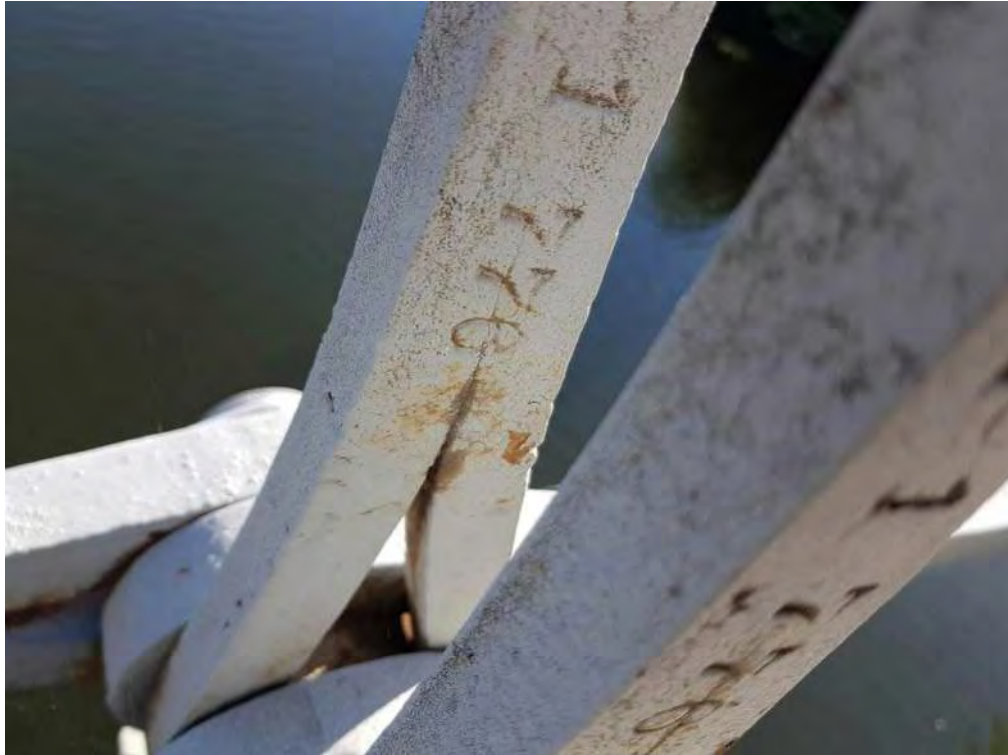
Photograph 12: Kinked exterior vertical at north end of north span.

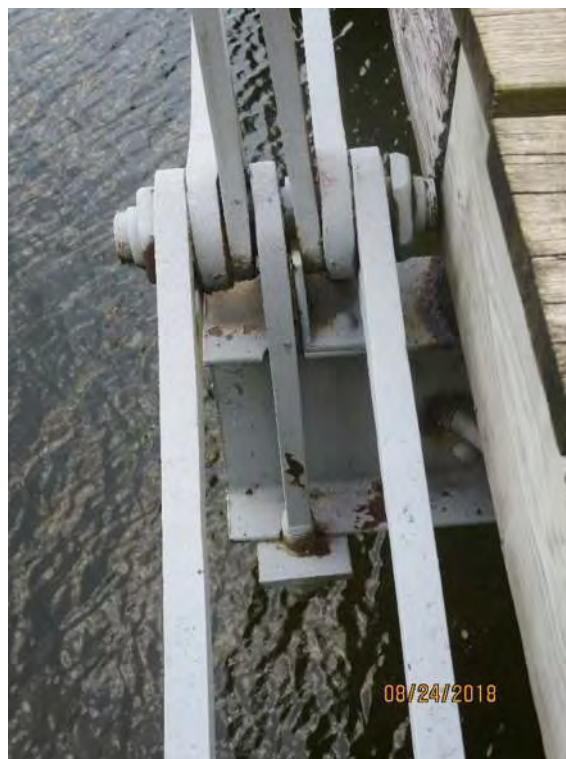
- Visual crack indications were on several loop-welded eye bars including bottom chords, diagonals, and verticals located at the forged lap of the eye bars near the pin connections;

Photograph 13: Possible crack initiation at loop welded forged eye bar. Typical condition noted at several eye bar locations for verticals and diagonals.

- The visual crack indications and forging imperfections on this bridge should be assessed through Non-Destructive Testing (NDT) as primary tension members with active cracks should not remain in service if open to public.

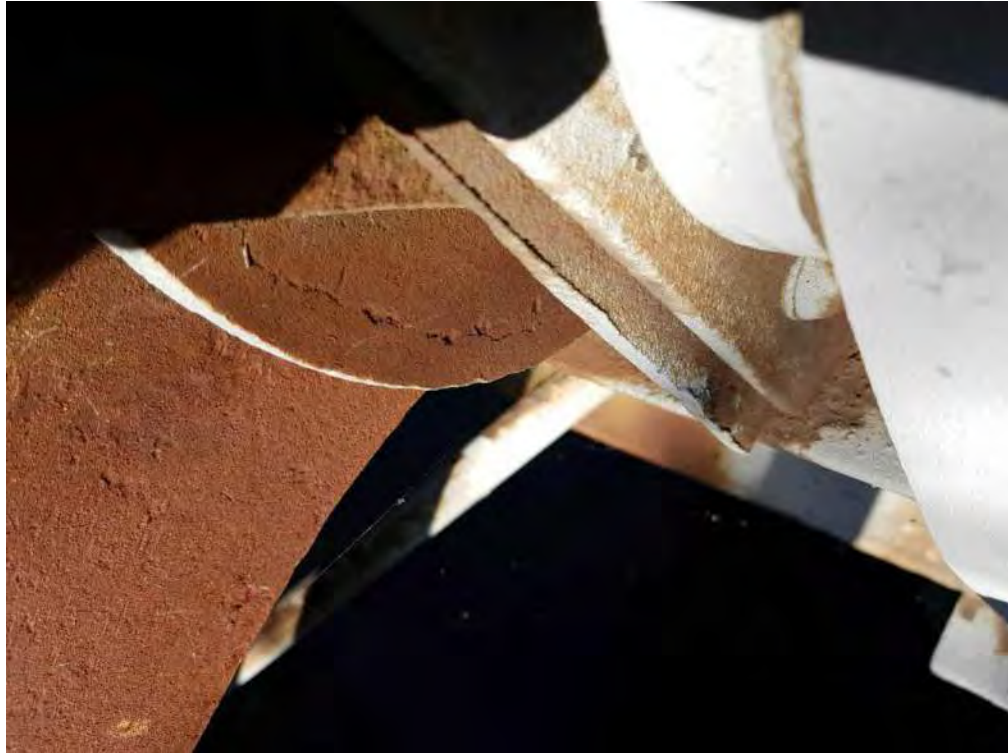
Photograph 16: Severe flaking of coating on interior panel vertical at middle of North span.

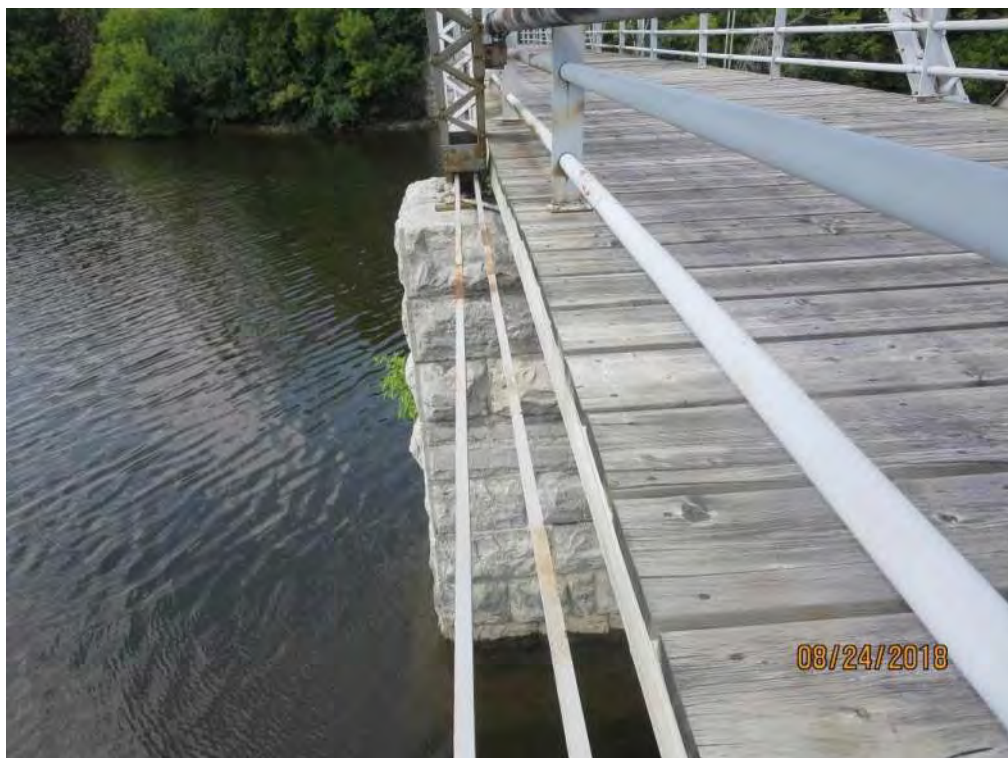
Photograph 17: Typical surface defect on bottom chord members at pin connections.

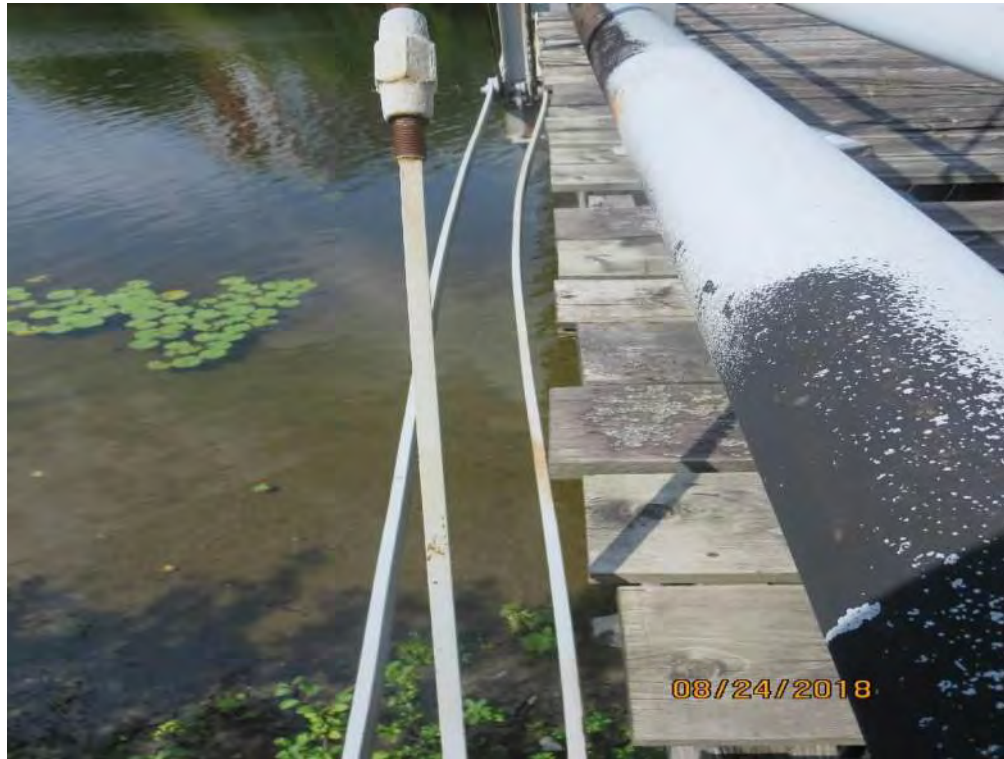
Photograph 18: End panel square rod bottom chord members within south span at pier. The bottom chord appeared engaged at this location.

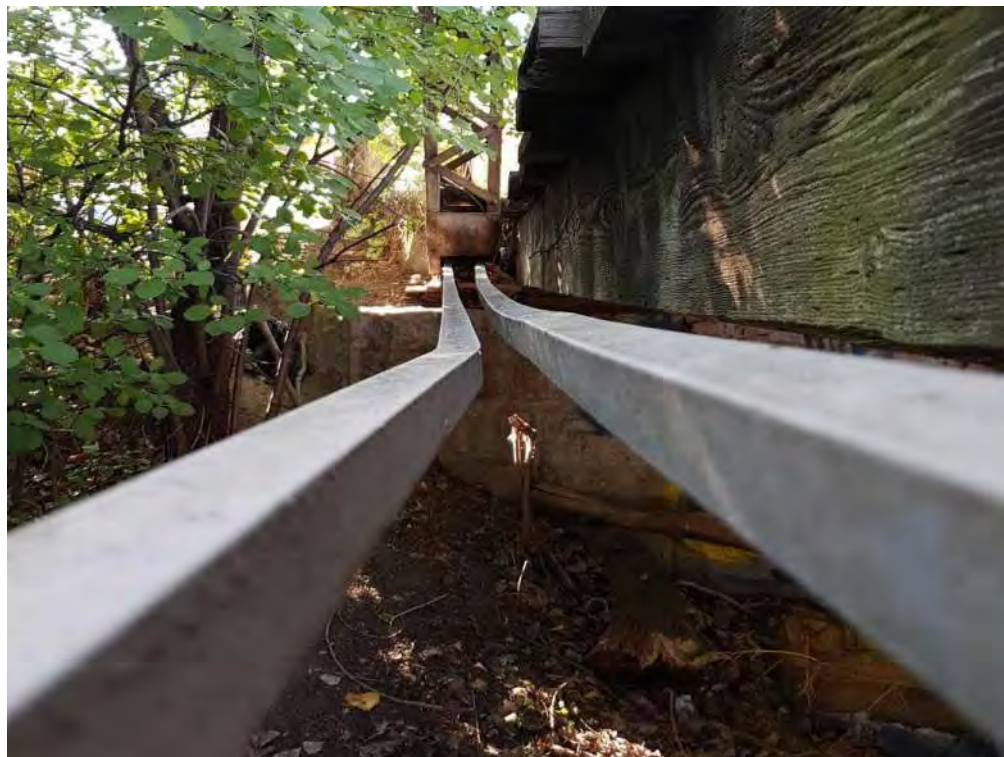
Photograph 19: Bowed and disengaged bottom chord at an interior truss panel. This deformation was observed at several locations.

- Additional investigation of the potential bottom chord bracing system loading including observing the structure in different thermal and loading conditions is recommended to properly assess and correct the structural behavior.

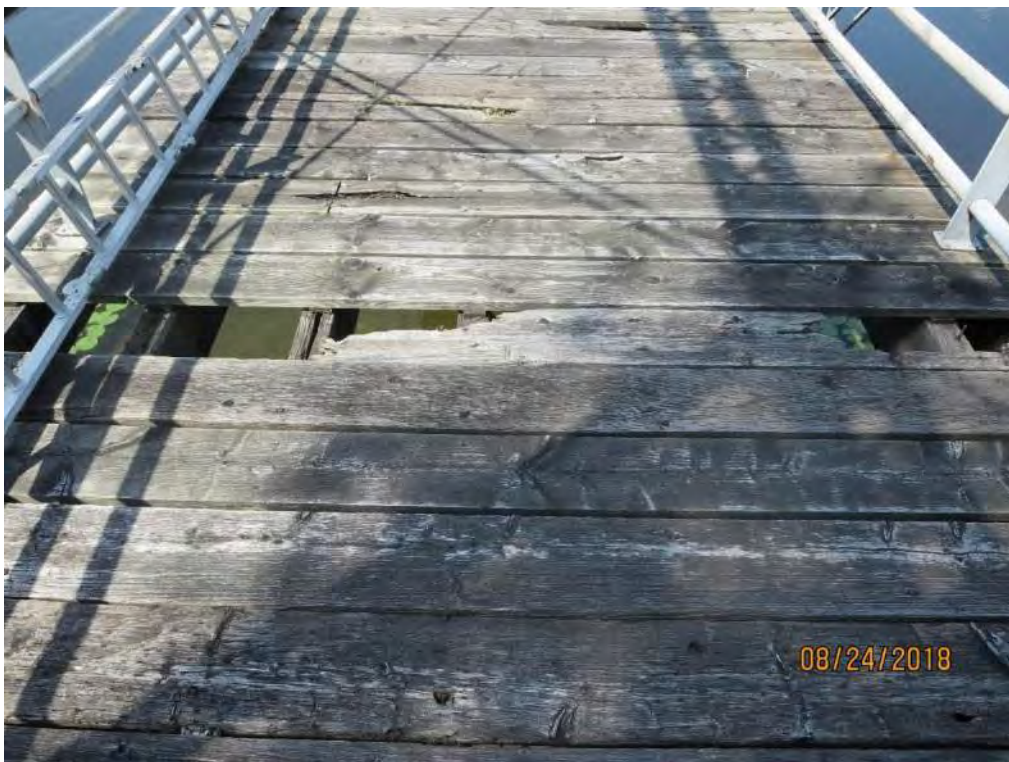
Photograph 23: Typical condition of deck.

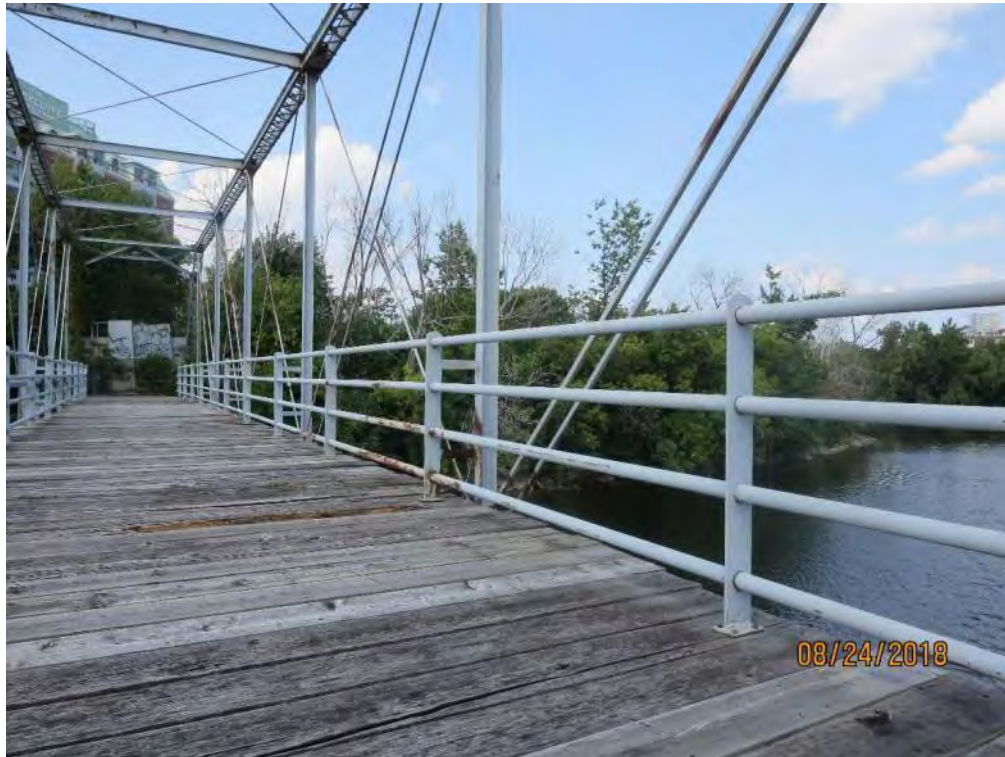
- The wood deck and stringers were generally in poor condition. Approximately 40% of the wood deck exhibited weathering, rotting, decay and 17 deck planks were missing or severely weathered. Approximately 40% of wood stringers showed signs of weathering, and rotting. Localized fire damage was observed on the stringers, deck and blocking near the south abutment. Medium to severe checking/splitting on outer stringers. Connection deficiencies noted between timber blocking and stringers.

Photograph 24: Close up of deck condition. Note that several planks are damaged, severely weathered and rotting.

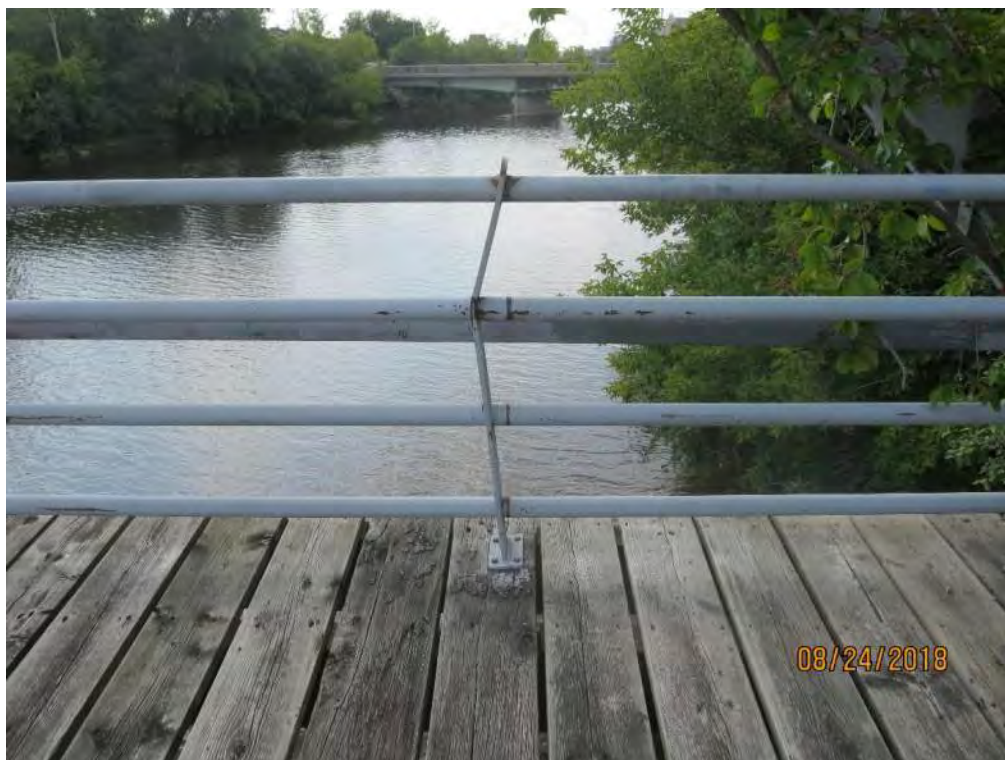
Photograph 25: Typical condition of hand rails and posts.

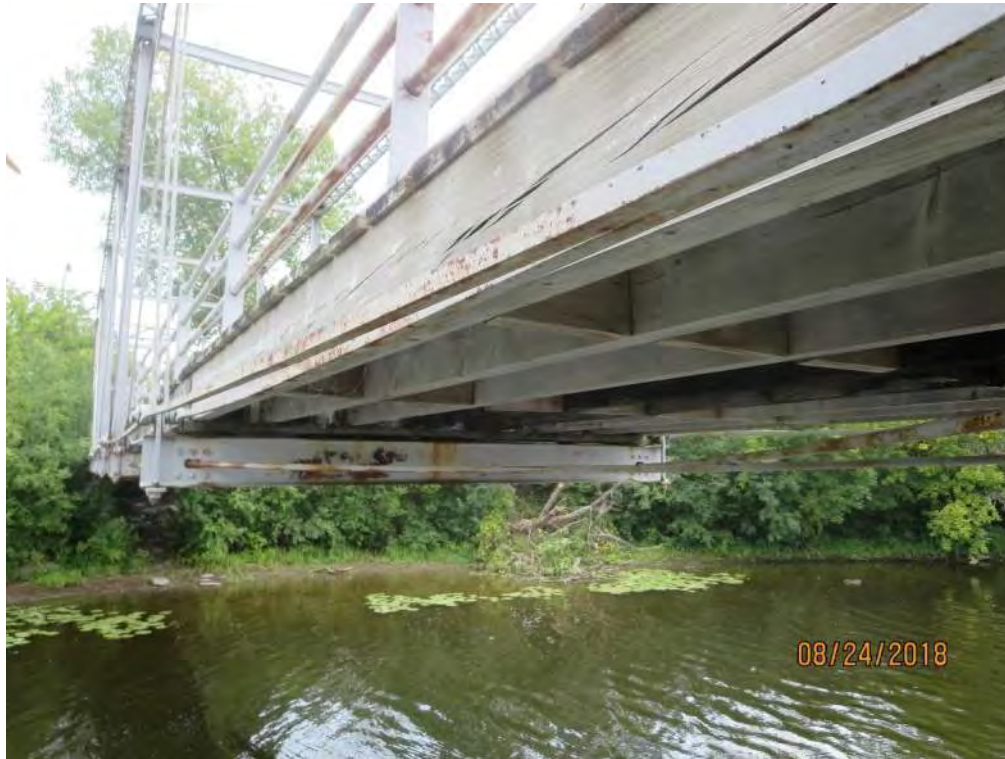
Photograph 26: Deformed post near North Abutment.

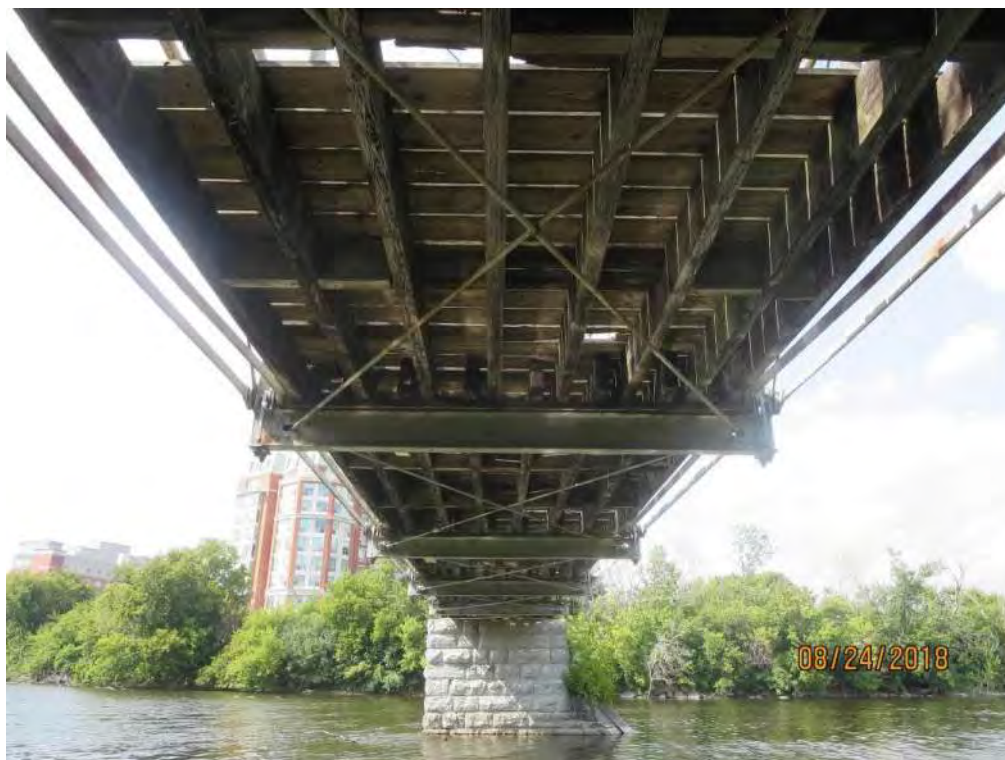
Photograph 27: Light to medium checking and splitting of replaced outer stringers (typical condition).

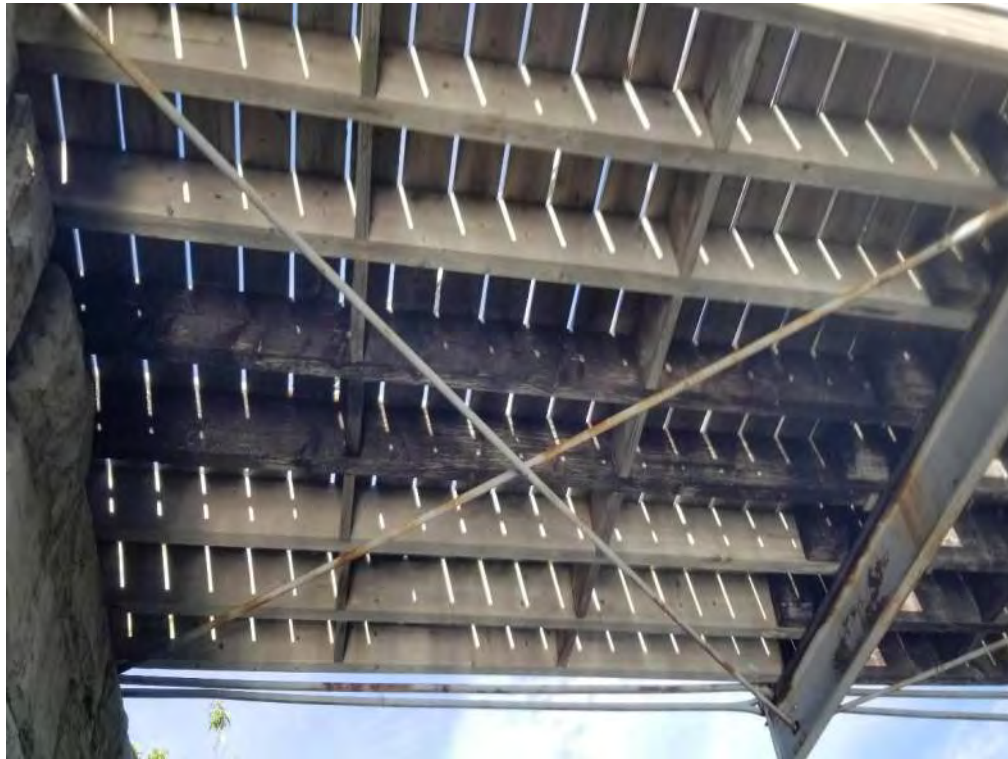
Photograph 28: Typical condition of underside of deck and cross bracing.

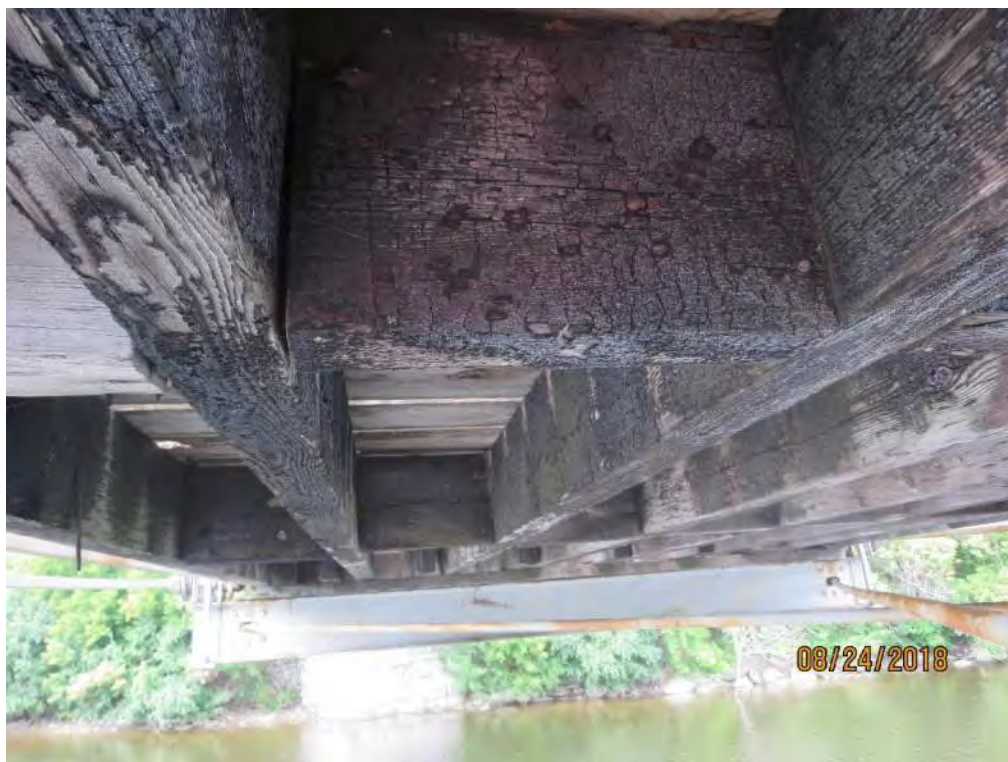
Photograph 29: Deck underside at pier. Note new stingers vs. original.

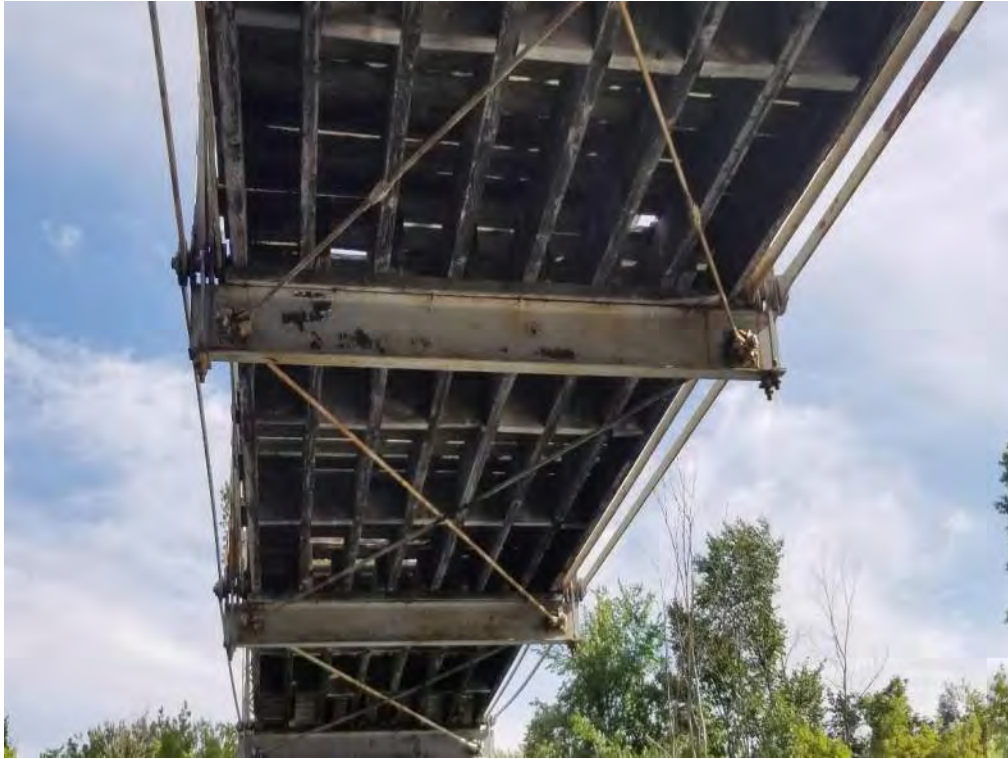
Photograph 30: Light to medium fire damage to stringers and blocking near South Abutment.

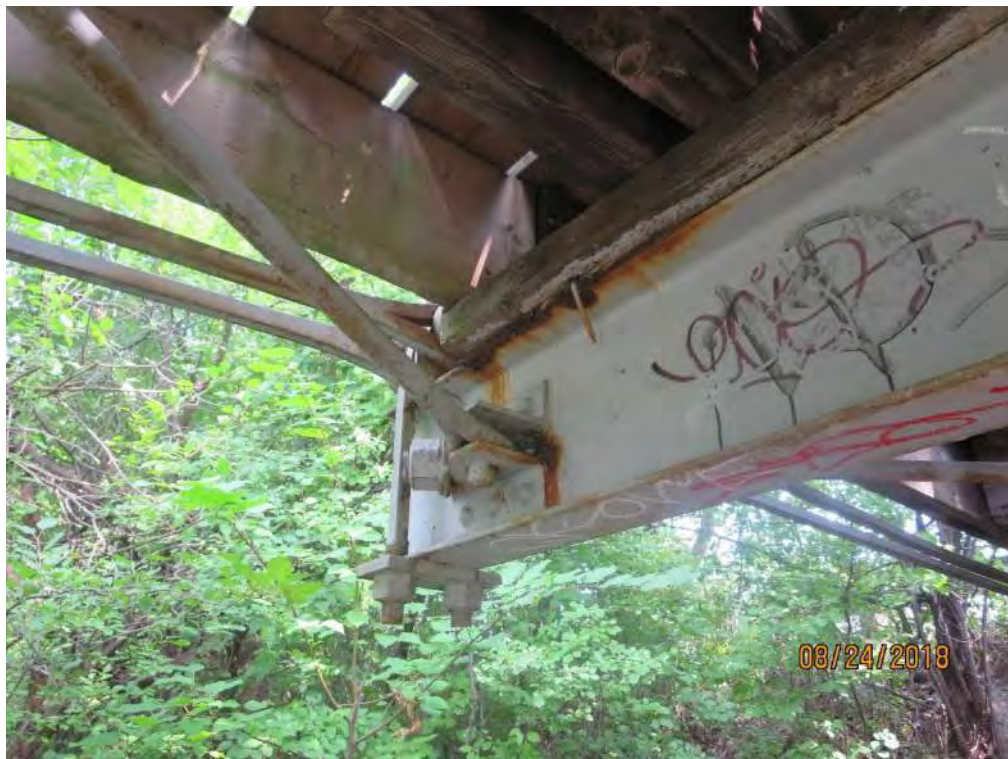
Photograph 31: Typical condition of floor beams. Floor beams generally in fair to good condition with corrosion typically limited to deck curb line and localized coating failure (peeling, light to severe surface rust).

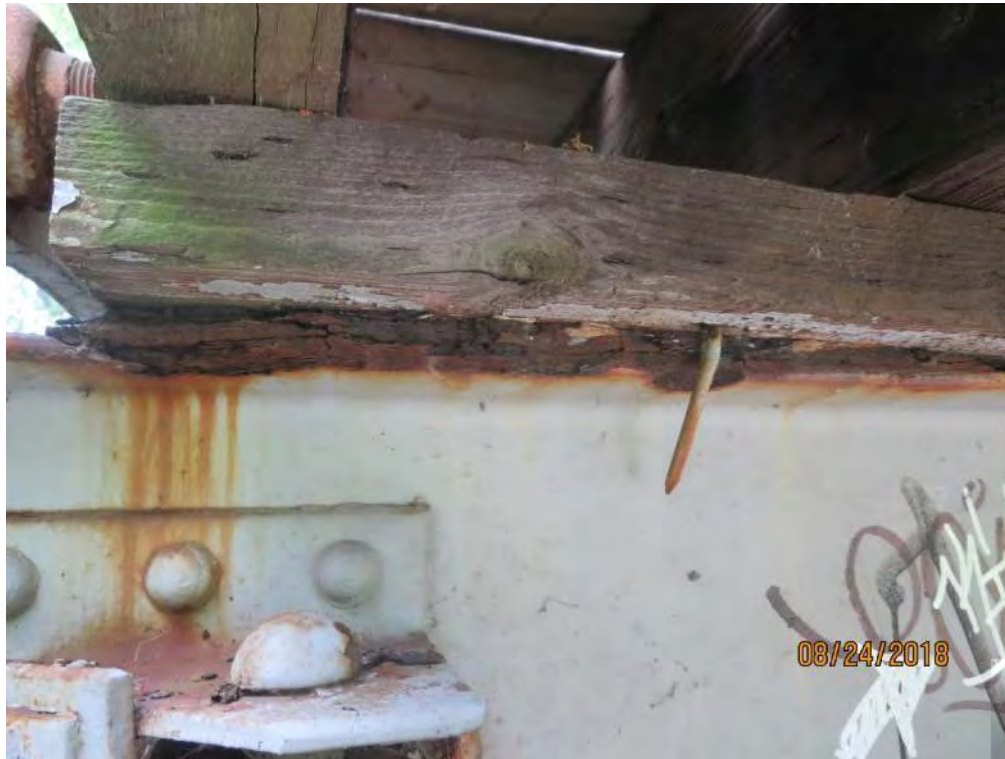
- Floorbeams were generally in good condition with localized corrosion of the top flange, particularly near the pin hanger connections.
- The roller bearings at the south abutment were seized, severely corroded, and surrounded by debris. North abutment was not accessible for inspection but is suspected to be in the same condition.

Photograph 32: Typical corrosion of top flange at floor beam ends (below curb line).

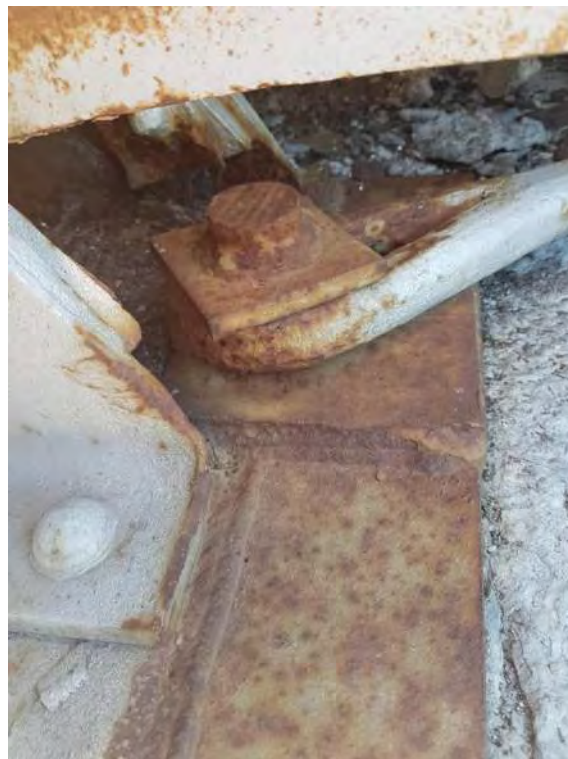
Photograph 33: Close up of Photograph 34, showing severe corrosion and perforation of floor beam top flange near South Abutment.

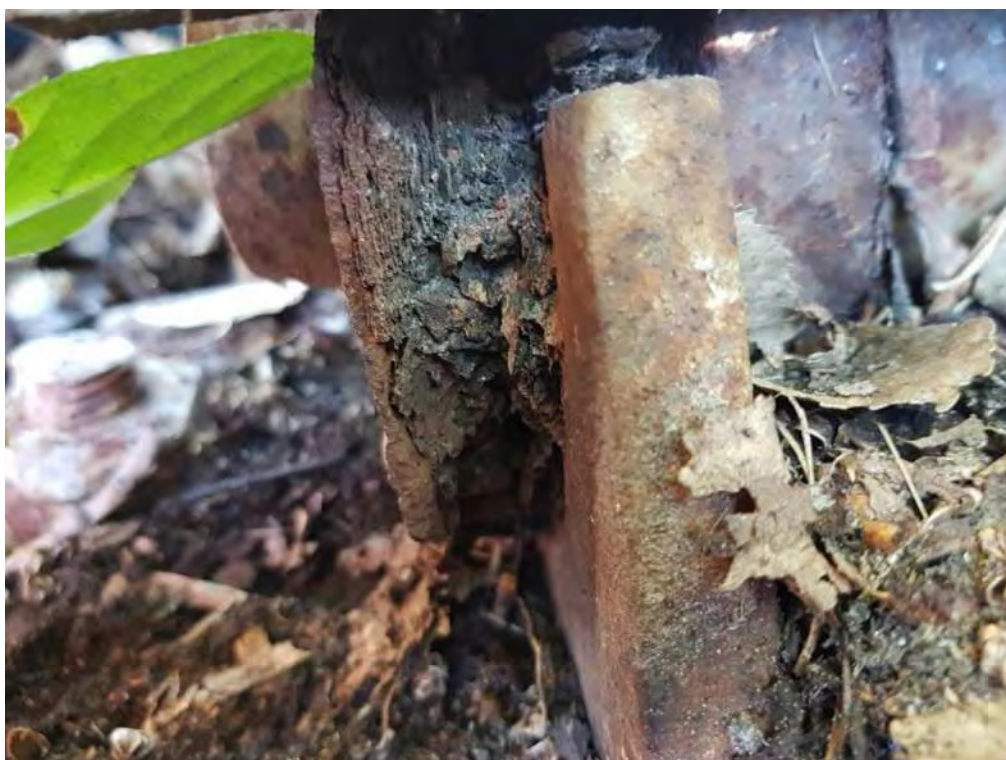
Photograph 37: Close up of Photograph 36.

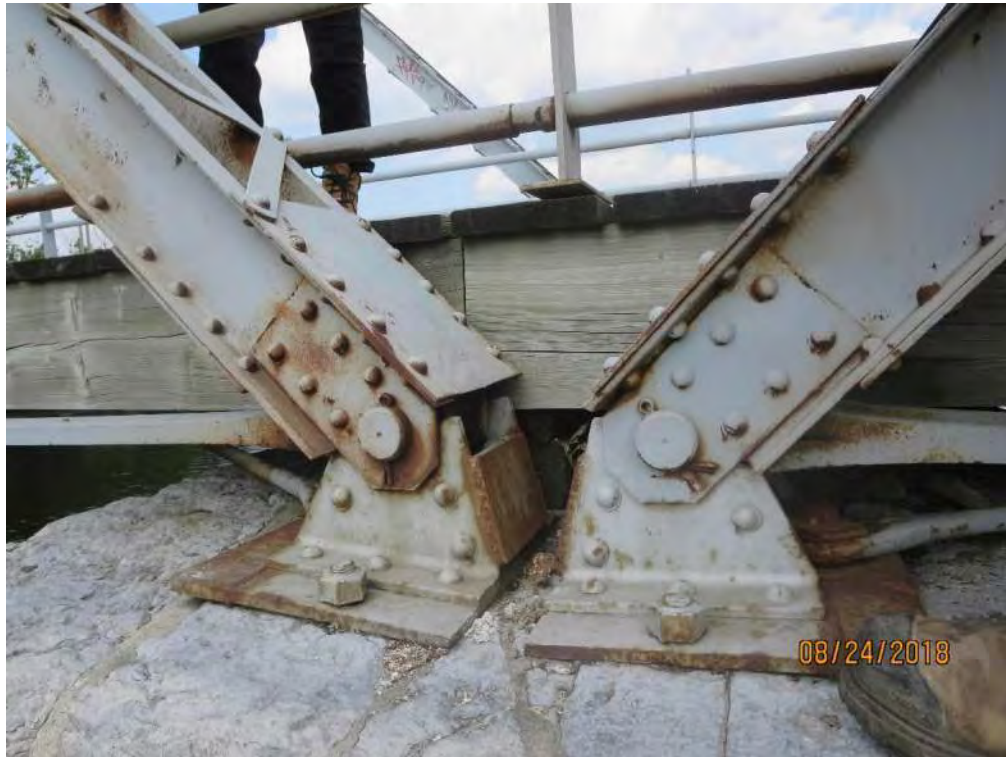
- The truss members were found to vary in condition from poor to good. Significant defects and structural concerns in select truss members include:
 - Severe localized section loss on the bottom chord, end post, and cross bracing at the abutment pin connections;

Photograph 38: Severe corrosion and rust jacking of end post at South Abutment pin connection.

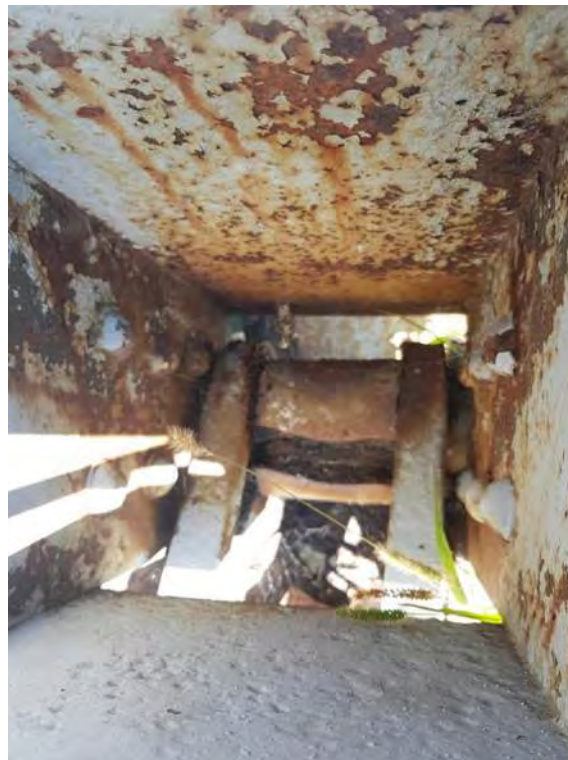
Photograph 39: Typical condition of Pier bearings.

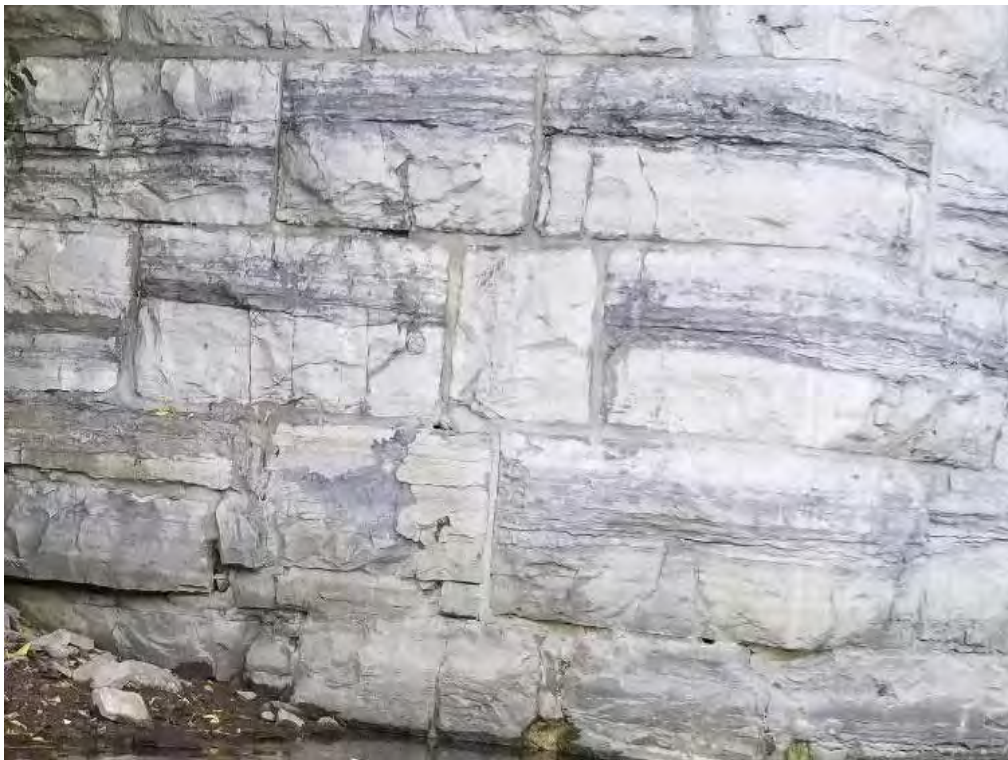
- Dry stone retaining wall noted at northwest quadrant was in poor condition.

Photograph 43: West wingwall and dry stone masonry retaining wall at the North Abutment.

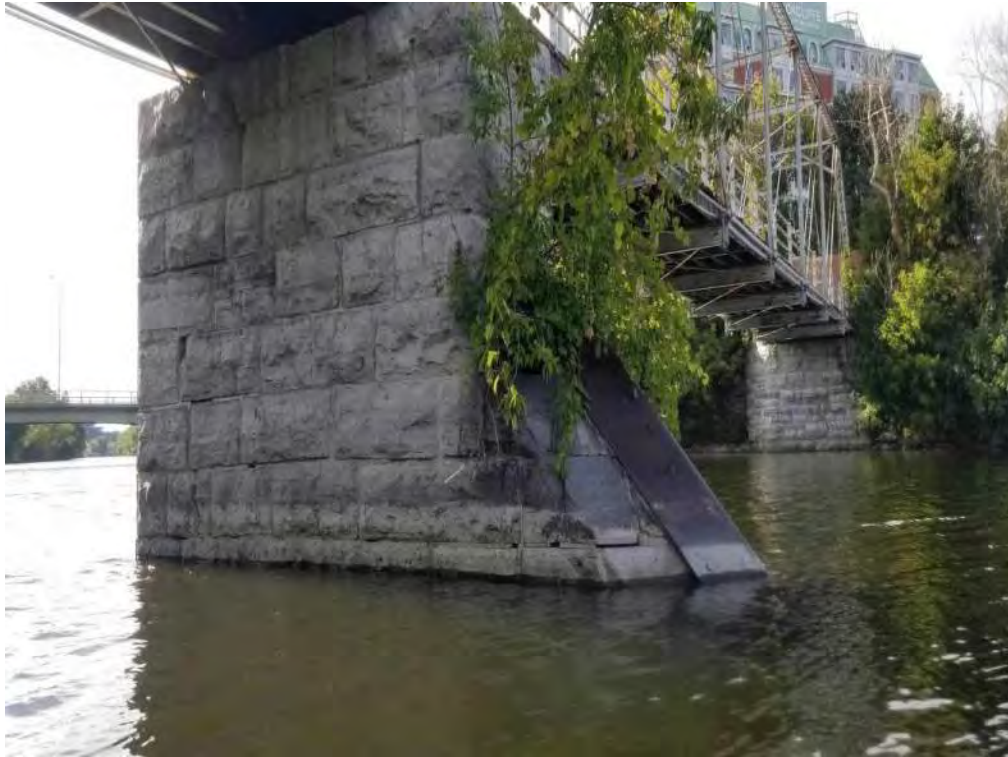
- North and south abutments were in good overall condition. Deterioration limited to vertical narrow to wide cracks with a localized spalling of one stone at the north abutment. Mortar joints were generally in good condition. Loss of mortar was observed near waterline at North Abutment.

Photograph 44: Close up of the west wingwall showing some vertical cracks and localized spalling of stone.

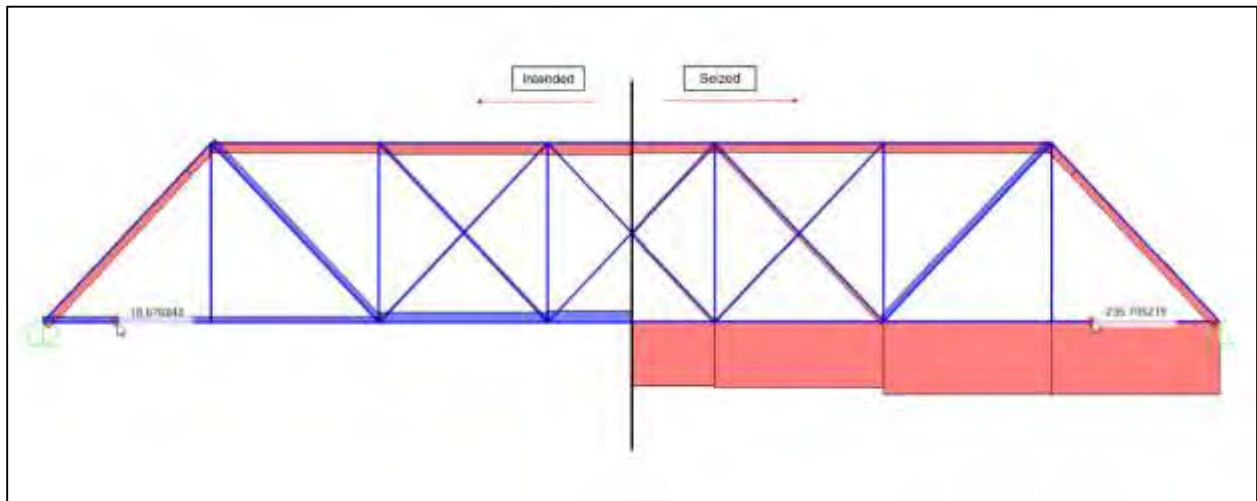
FIGURE 3: INTENDED ARTICULATION VS SEIZED SUMMER CONDITION (T+)

The behaviour of the truss has been significantly impacted by the seized abutment bearings. A bounded analysis was conducted where the roller bearings modeled as being restrained. The tension chord is subjected to significant compression forces in the summer. The tension chord is comprised of dual eye bars and will buckle when subjected to compression. During the winter the opposite occurs, and the bottom chord is subjected to significant tensile forces until displacement occurs relieving the thermal stress.

Figure 3 and Figure 4 show the truss forces (Dead + Thermal) in the baseline condition on the left and the seized condition on the right. The results of this bounded analysis support the observed existing condition.

- Condition and capacity of deck system (for inspection purposes).
- If the structure is to be maintained or rehabilitated:
 - Replacement of the expansion bearings is recommended as bearing fixity is causing the structure to behave in an unintended manner and resulting in stress redistribution.
