December 18, 2018

RE: TREE DISCLOSURE REPORT – 518 MARIPOSA CRESCENT

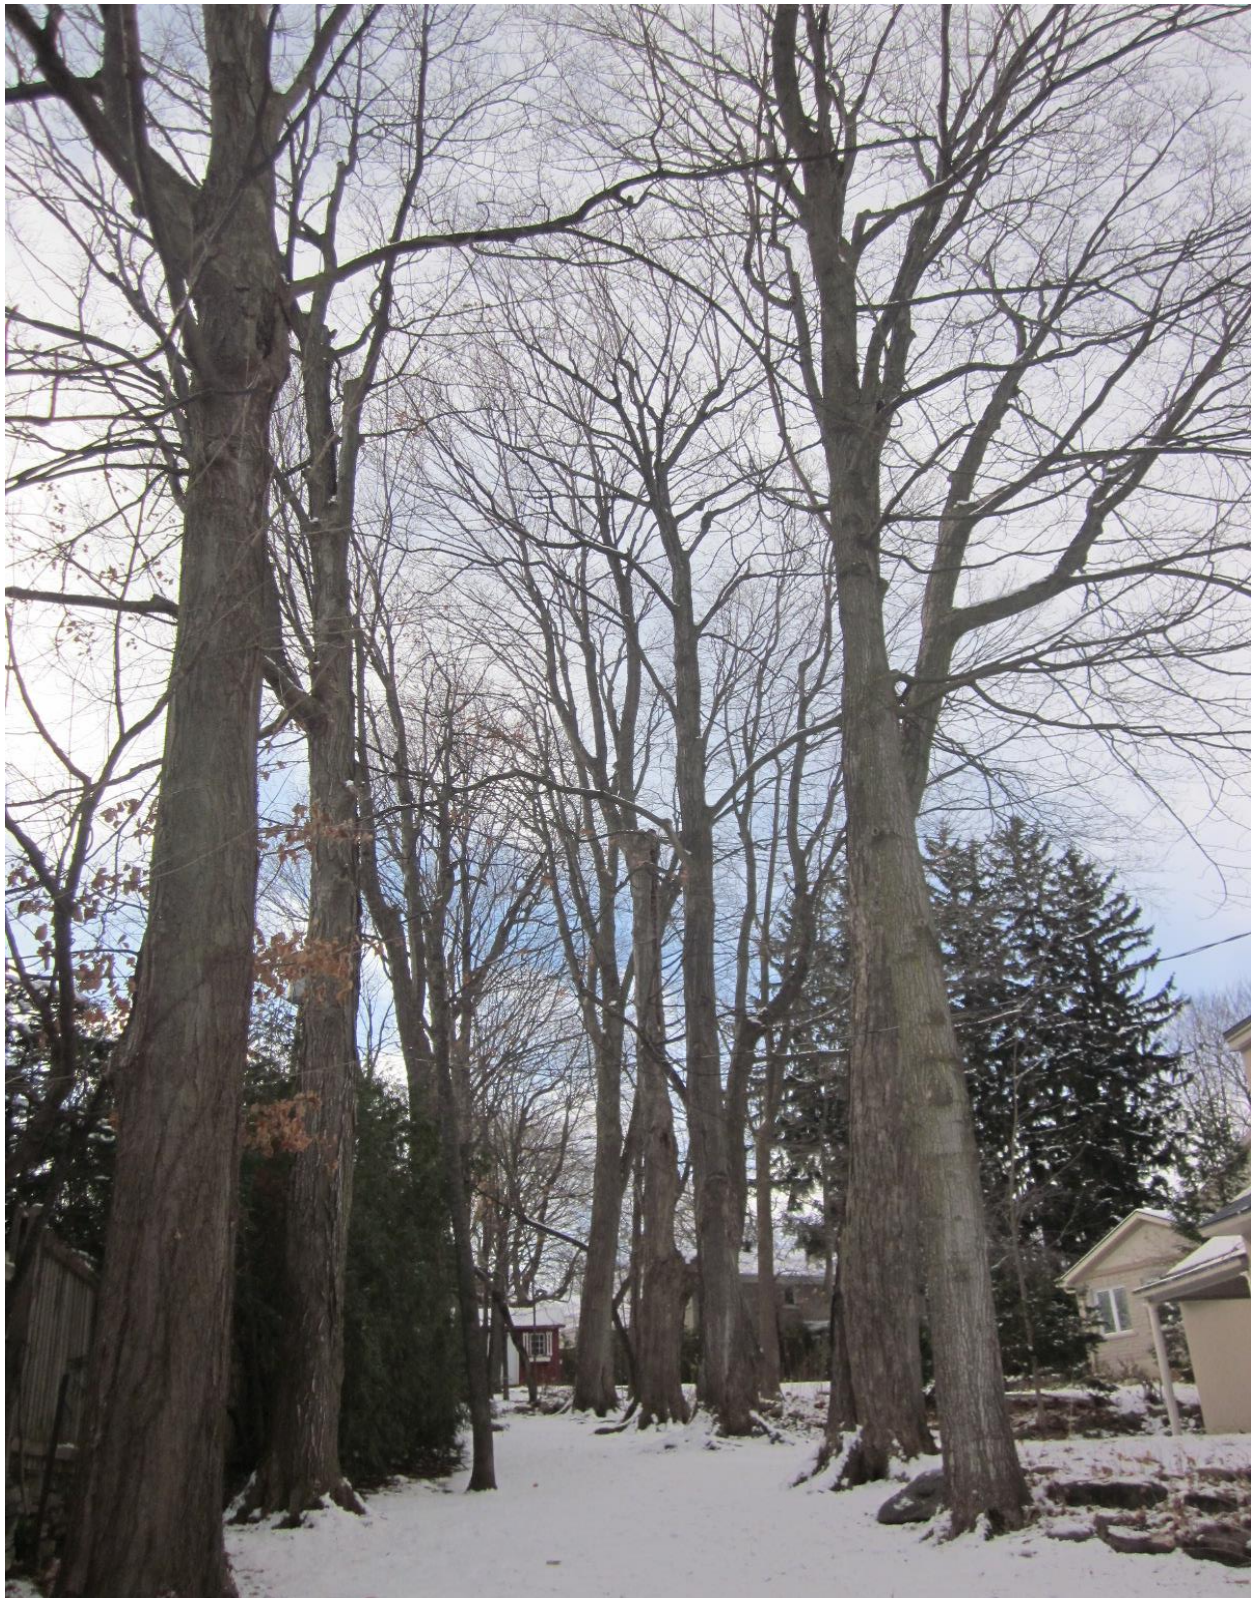
Tree No.	Tree Species	D.B.H ¹ (cm)	Ownership	Tree Condition, age class and Status (to be removed or preserved and protected)
1	Sugar maple	59.4	Private	Fair; mature; upright stem form with crown asymmetrical towards south/southeast due to competition with adjacent trees; competing lateral on southwest at 8m – extends over hydro lines; former co-dominant leader dead – major deadwood present; good root collar; to be preserved and protected
2	Sugar maple	57.5	Private	Fair; mature; crown asymmetrical towards south due to adjacent trees – extends over hydro lines; suppressed lateral at 8m with cavity at union; good root collar; to be preserved and protected
3	Sugar maple	86.3	Private	Fair; very mature; central stem with competing lateral at 7m with weak union (reaction wood present); both stems divergent towards northwest due to adjacent trees; co-dominant leaders at 11m with cavity at union; major deadwood present; to be preserved and protected

Picture 1. Sugar maples in rear yard of 518 Mariposa Crescent (note asymmetrical nature of crowns in foreground).

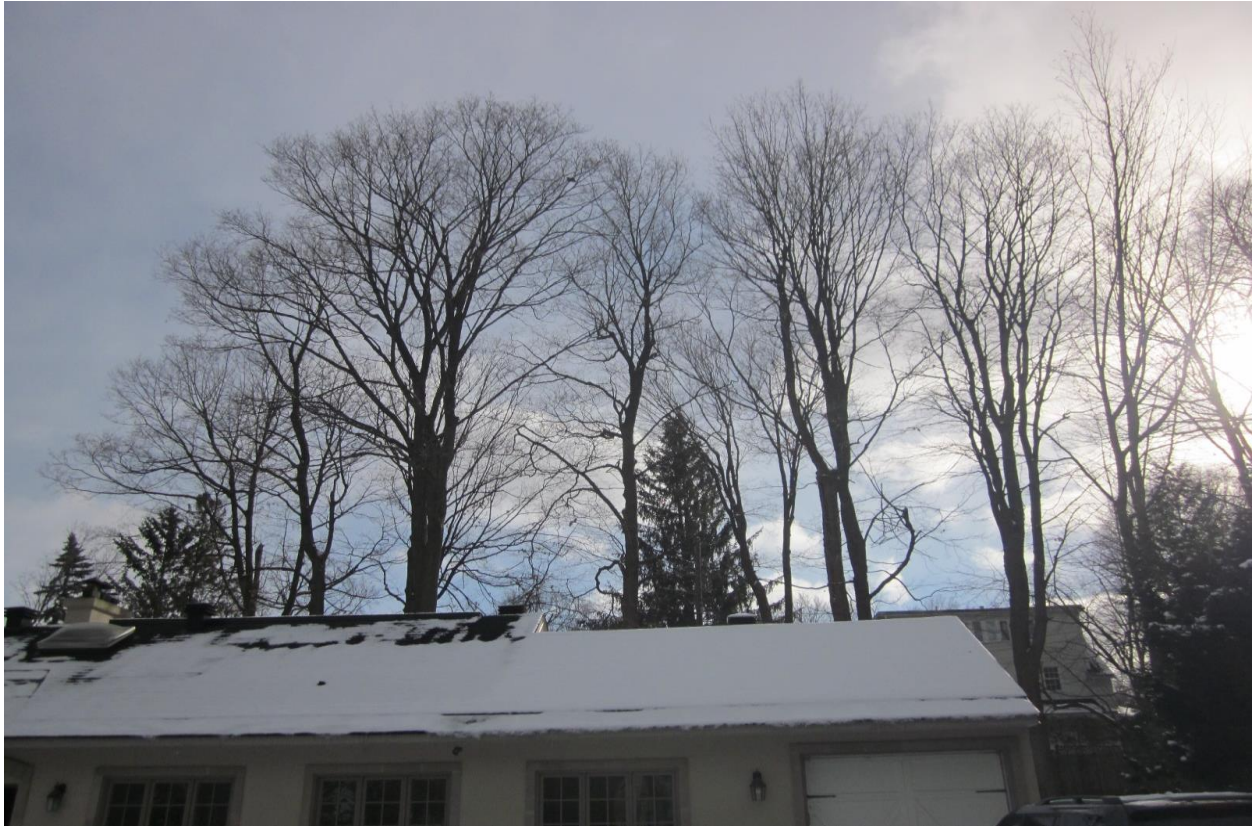
Picture 2. Sugar maples in rear yard of 518 Mariposa Crescent in relation to existing house.

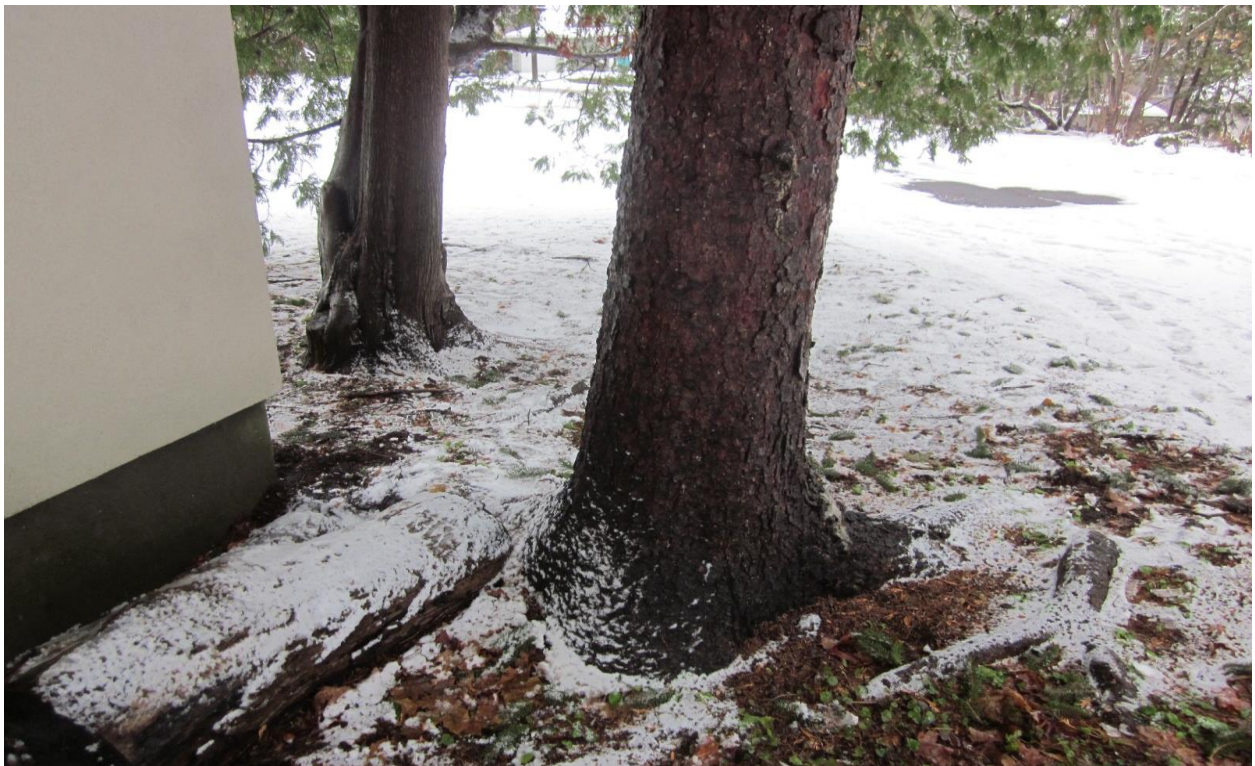
Two other private, non-distinctive trees are included in this report as they were flagged as important elements by the Rockcliffe Park Heritage Committee. These trees, a Norway spruce (*Picea abies*) and eastern white cedar (*Thuja occidentalis*), are located directly adjacent to the north-eastern corner of the existing house. The lack of eavestroughs on the house allowed water to pond at the foundation edges for many years, creating one of the primary factors necessary for tree root growth - consistent soil moisture. A cursory visual inspection shows an abundance of both tree's roots near and directly against the foundation wall. Unfortunately, the demolition of the foundation wall will greatly impact these two trees so the point they will not survive.

Picture 3. Spruce (right) and cedar trees in relation to front corner of 518 Mariposa Crescent.

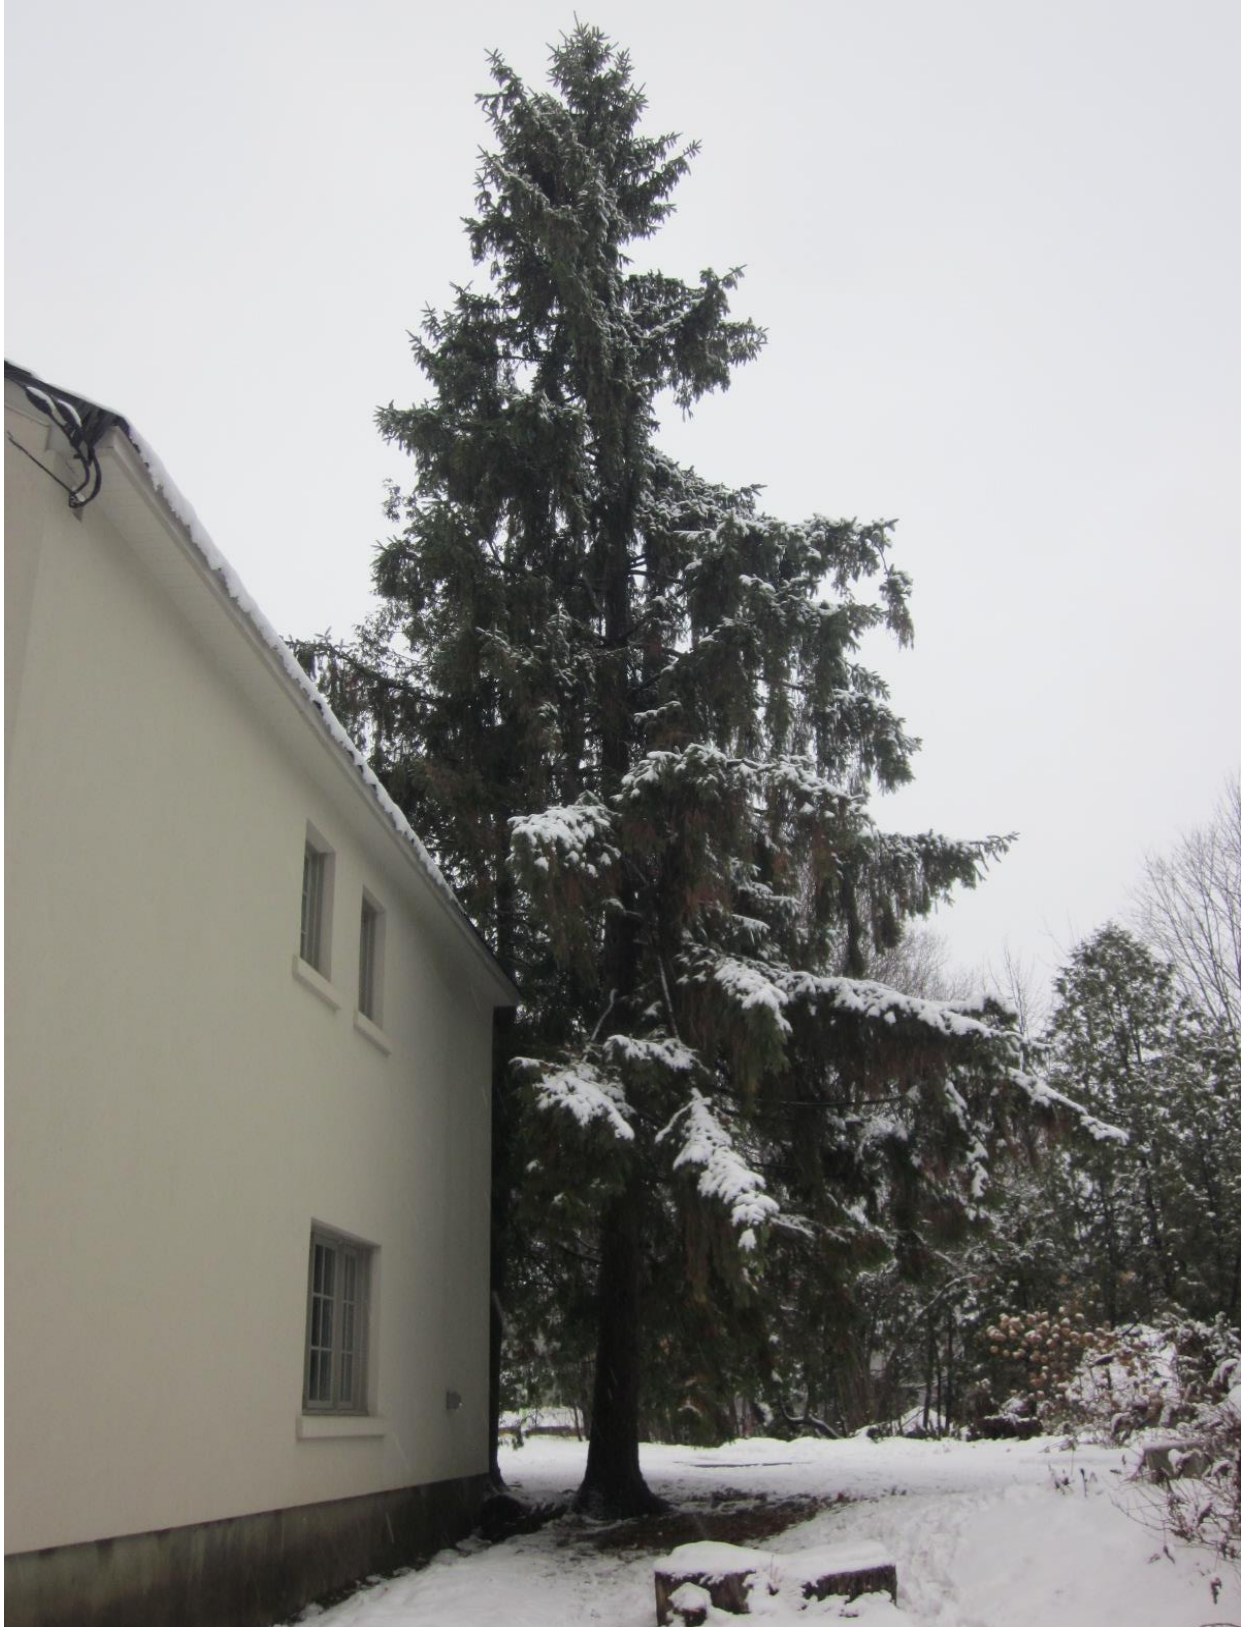
Tree No.	Tree Species	D.B.H ¹ (cm)	Ownership	Tree Condition, age class and Status (to be removed or preserved and protected)
8	White cedar (<i>Thuja occidentalis</i>)	33.8	Private	Good; mature; good crown density, annual growth increment and needle colour; to be removed (roots have grown directly against nearby foundation wall and will be greatly disturbed during demolition)
9	Norway spruce (<i>Picea abies</i>)	40.5	Private	Fair; mature; fair good crown density, annual growth increment and needle colour; within restricted rooting zone – suffering growing stress (esp. drought); non-native species; to be removed (roots have grown directly against nearby foundation wall and will be greatly disturbed during demolition)

Picture 4. Front corner spruce and cedar trees at 518 Mariposa Crescent.
