A CULTURAL HERITAGE IMPACT STATEMENT

234 O'Connor Street, Ottawa, Ontario

**SUBMITTED TO: Gemstone Development Ltd.
PREPARED BY: COMMONWEALTH RESOURCE MANAGEMENT**

August 2016

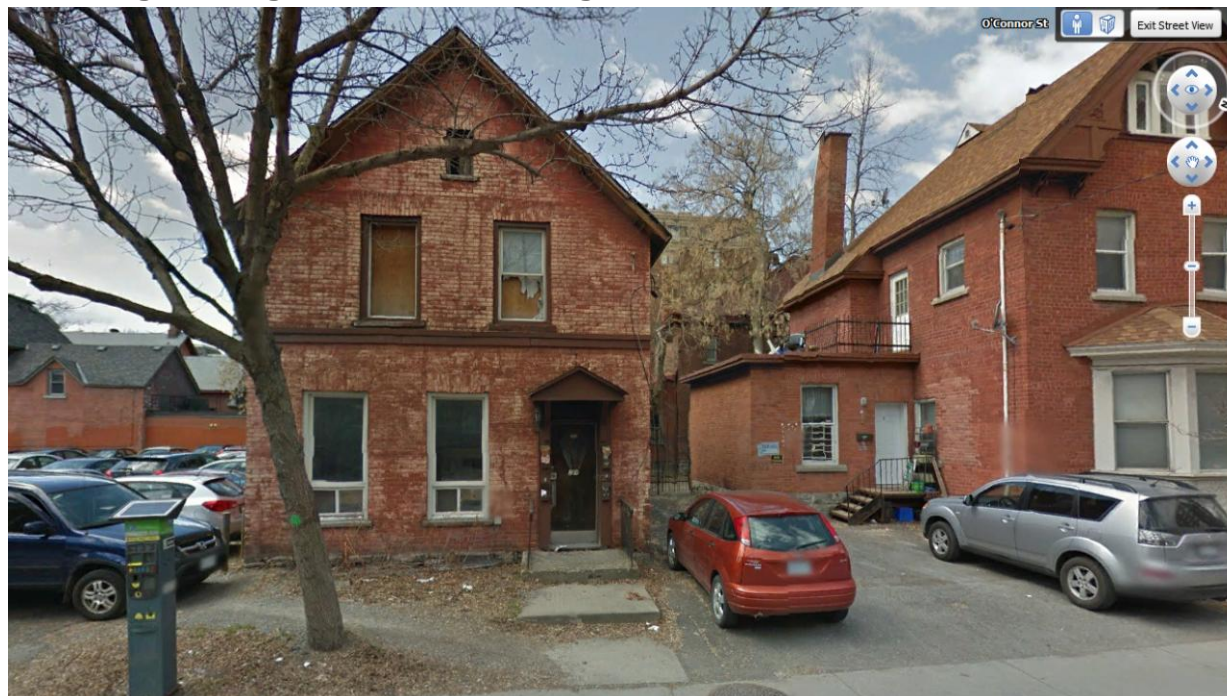
Figure 8: Context view of the site at 234 (left) O'Connor Street. The building is identified as Category 2 heritage resources in the HCD Plan. The exterior brick was painted to protect the relatively soft brick and has peeled off due to the building being vacant and unheated. Credit: Google Earth 2015

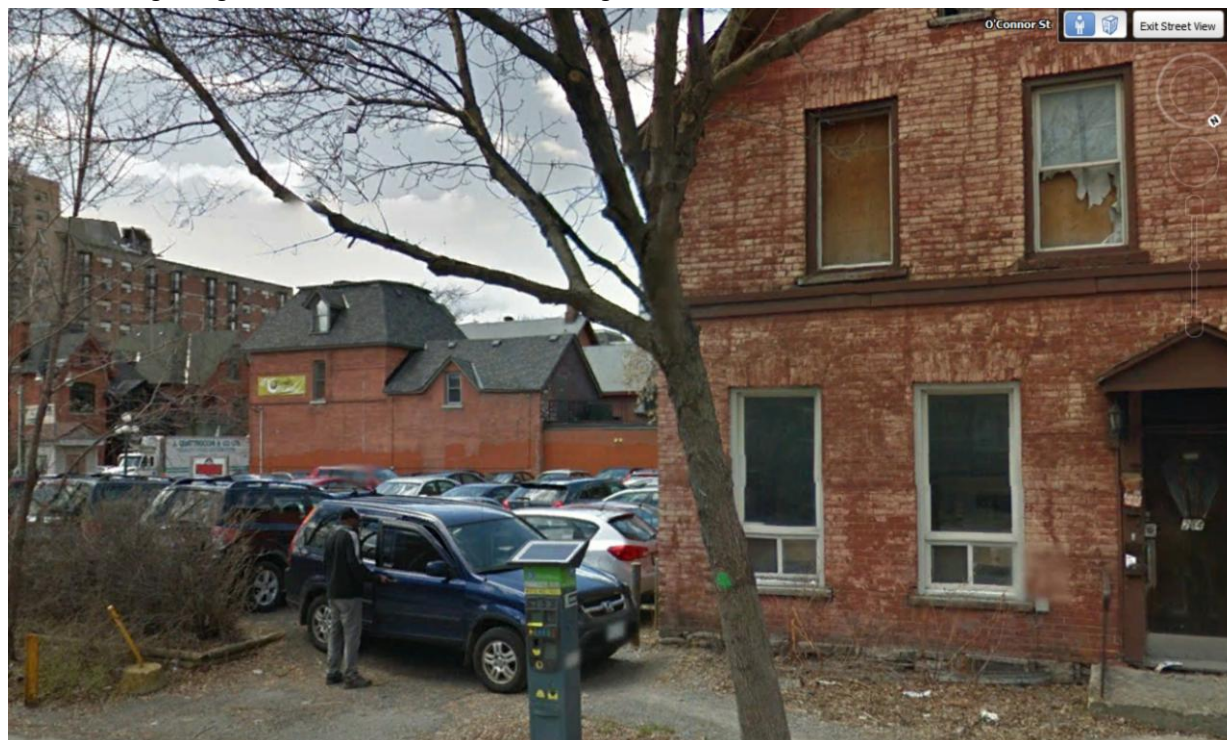
Figure 9: View of the site at 234 O'Connor to the parking lot to the south. Note that the verandah has been removed from the front of the building. Credit: Google Earth 2015

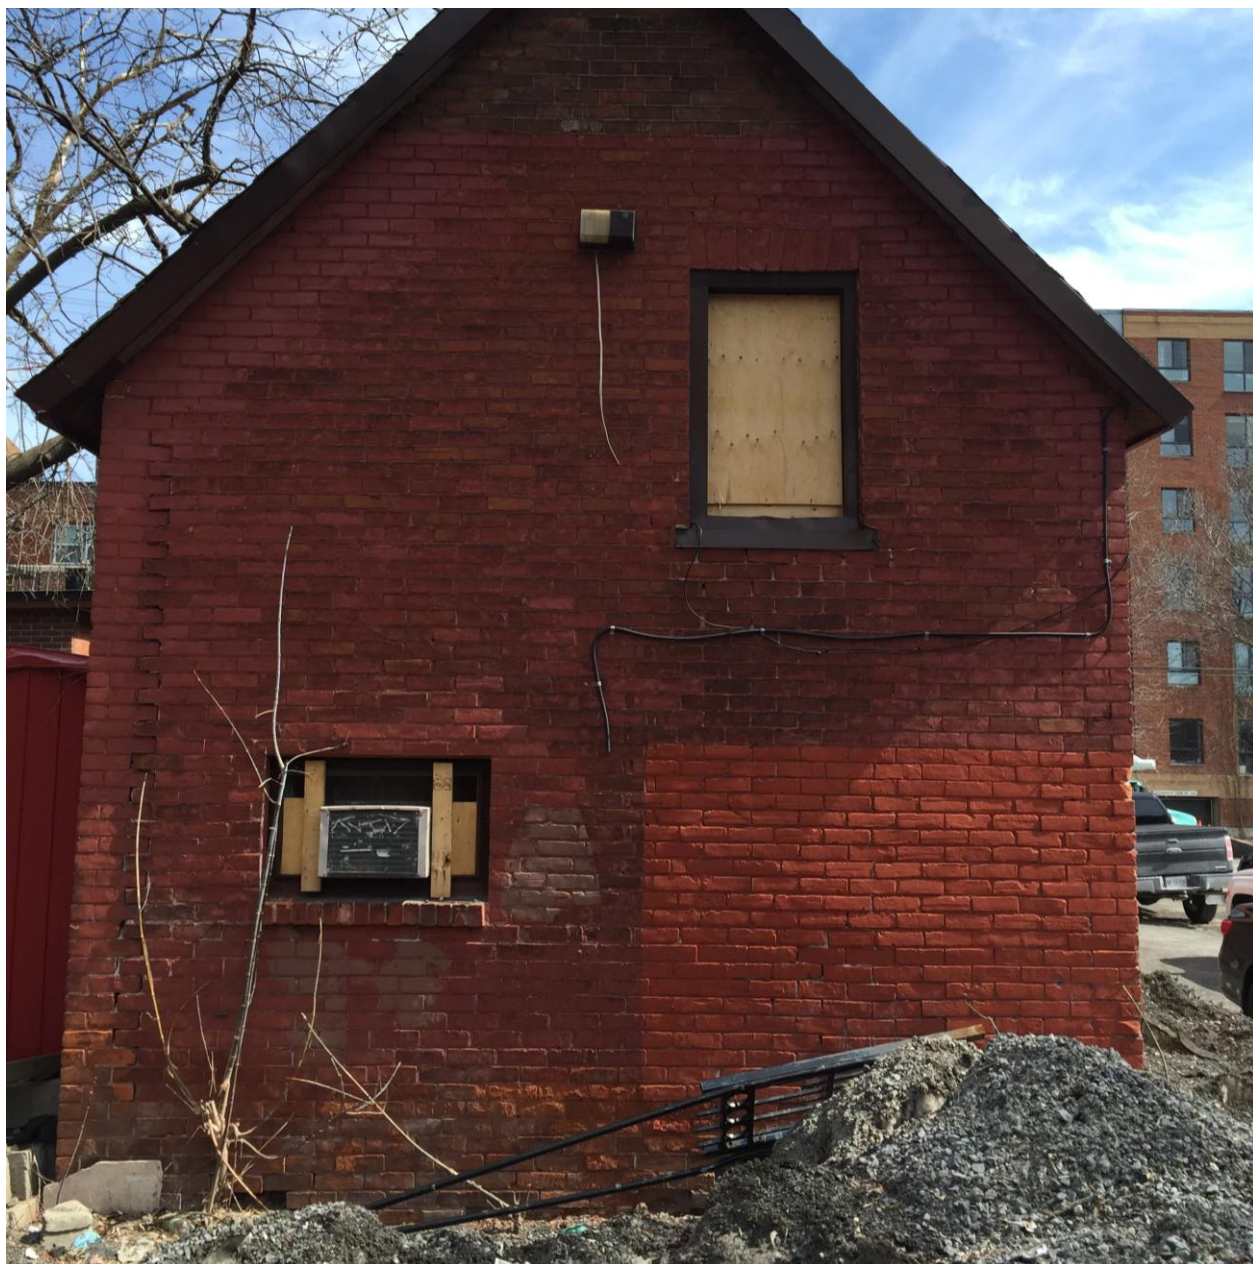
Figure 10: View of the rear (west) wall of the building. Note the structural crack in the brick veneer extending up the left corner of the building due to settlement / movement in the stone foundation. Credit: Neil Zaret 2016

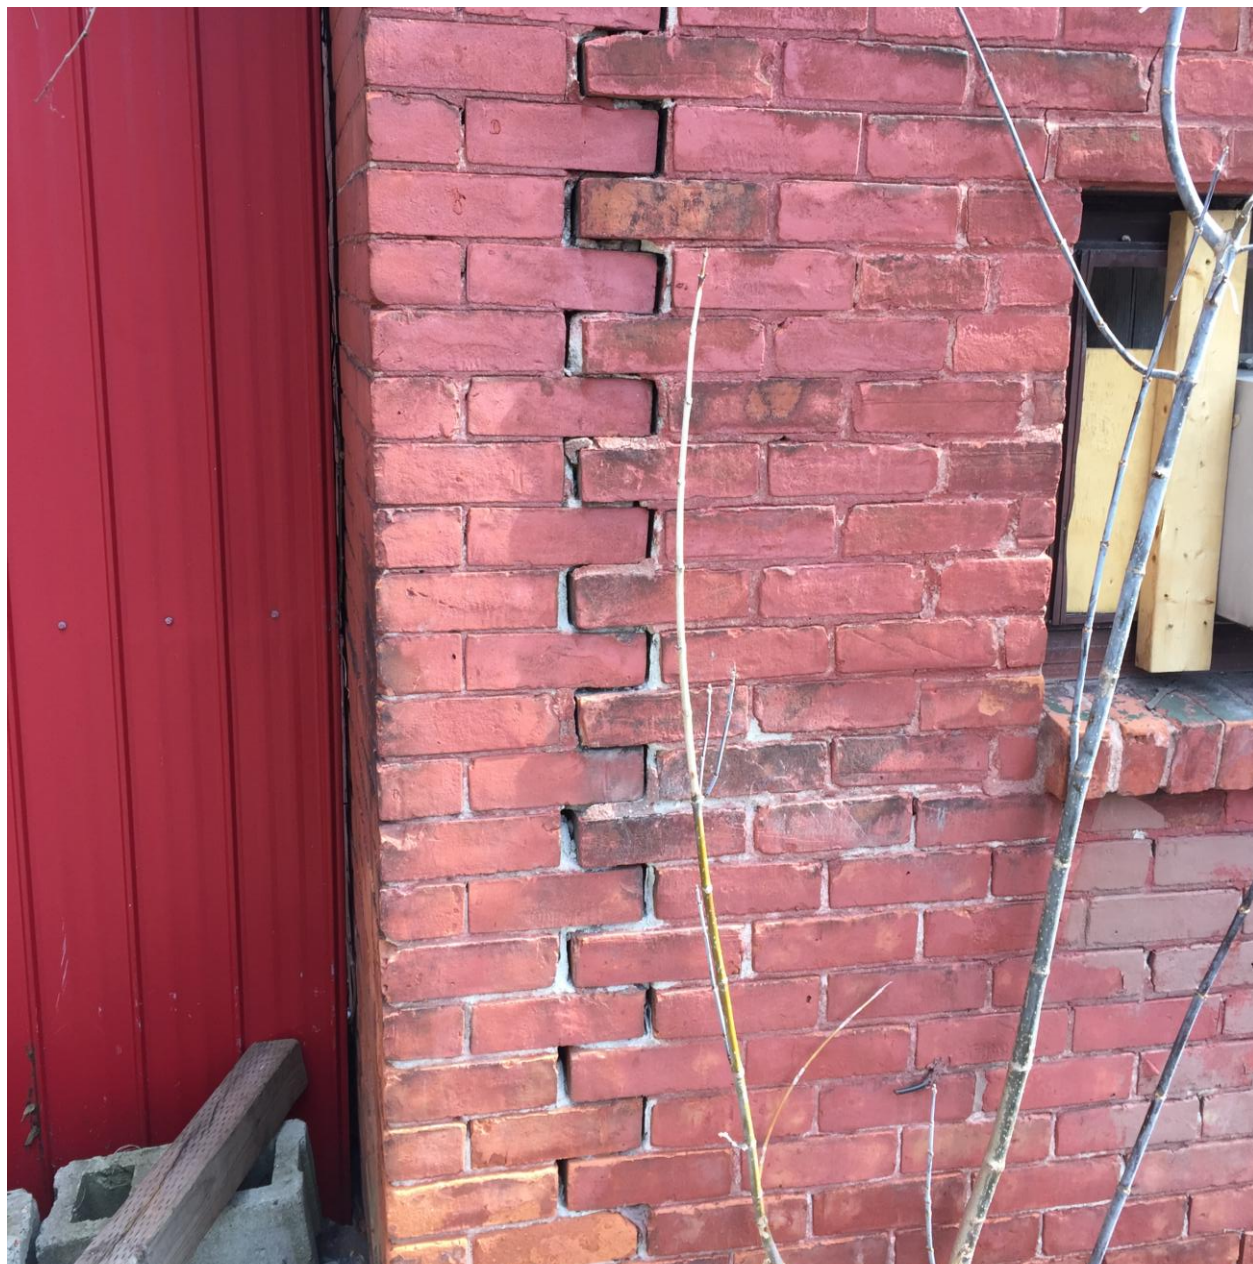
Figure 11: Detail view of the crack in the brick veneer on the rear (west) elevation. The brick veneer has been displaced outward possibly due to the rusting of the metal ties that secured it to the board sheathing. Credit: Neil Zaret 2016.

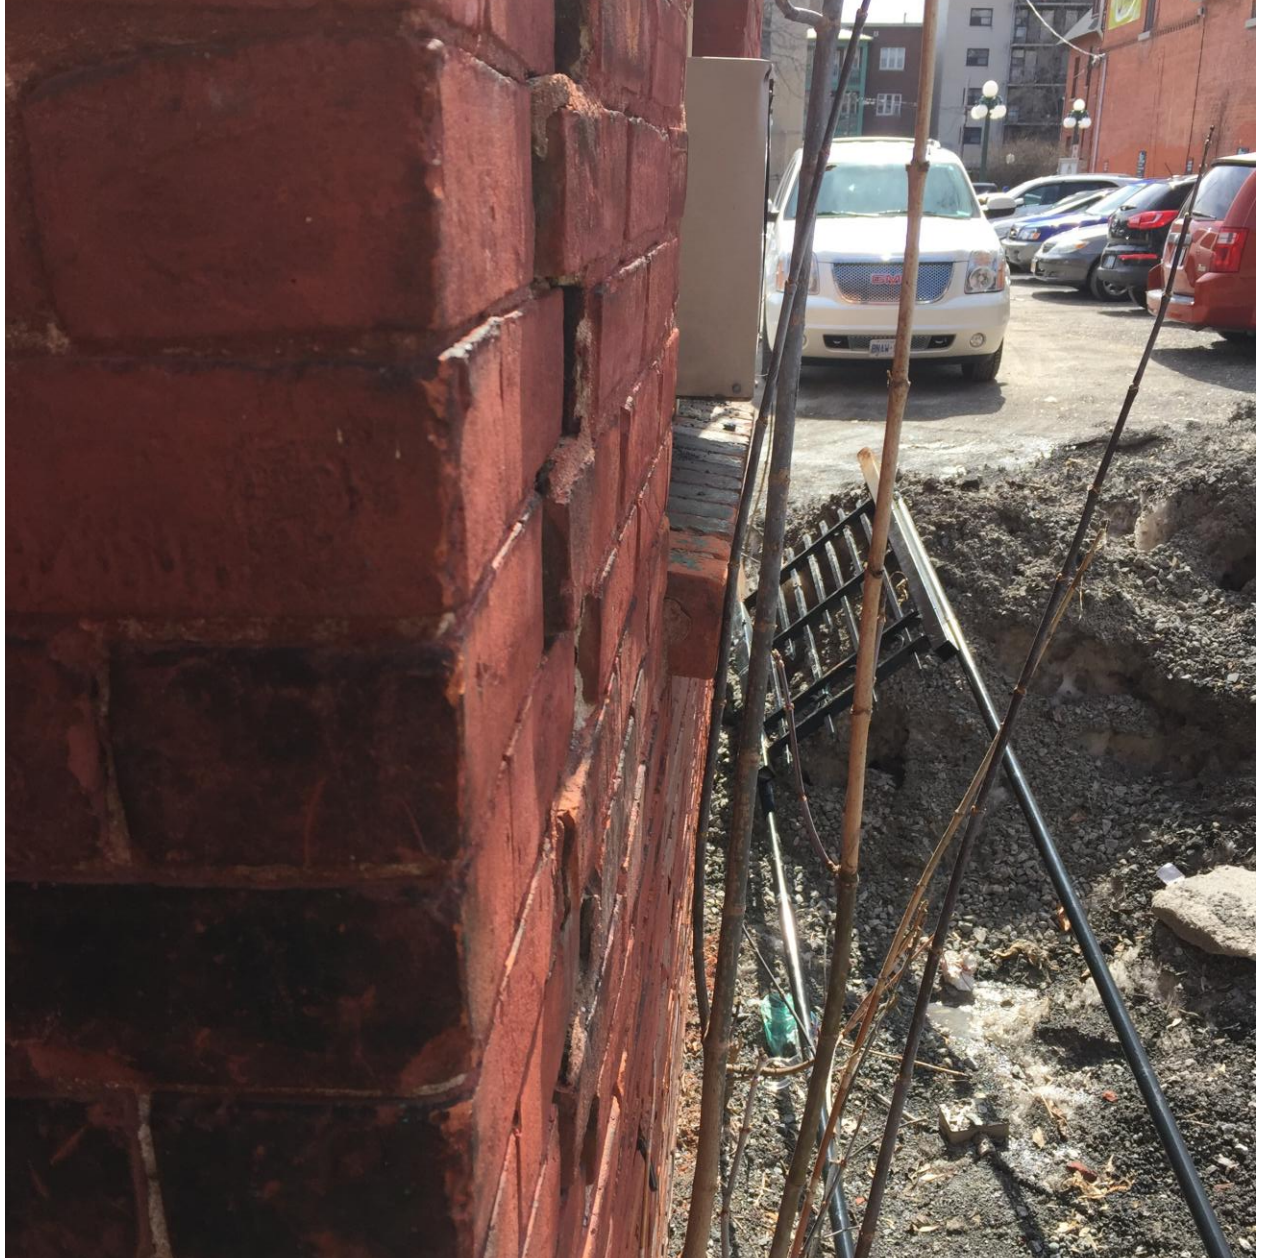
Figure 12: View of the rear (west) wall showing the outward displacement of the brick veneer. Credit: Neil Zaret 2016.

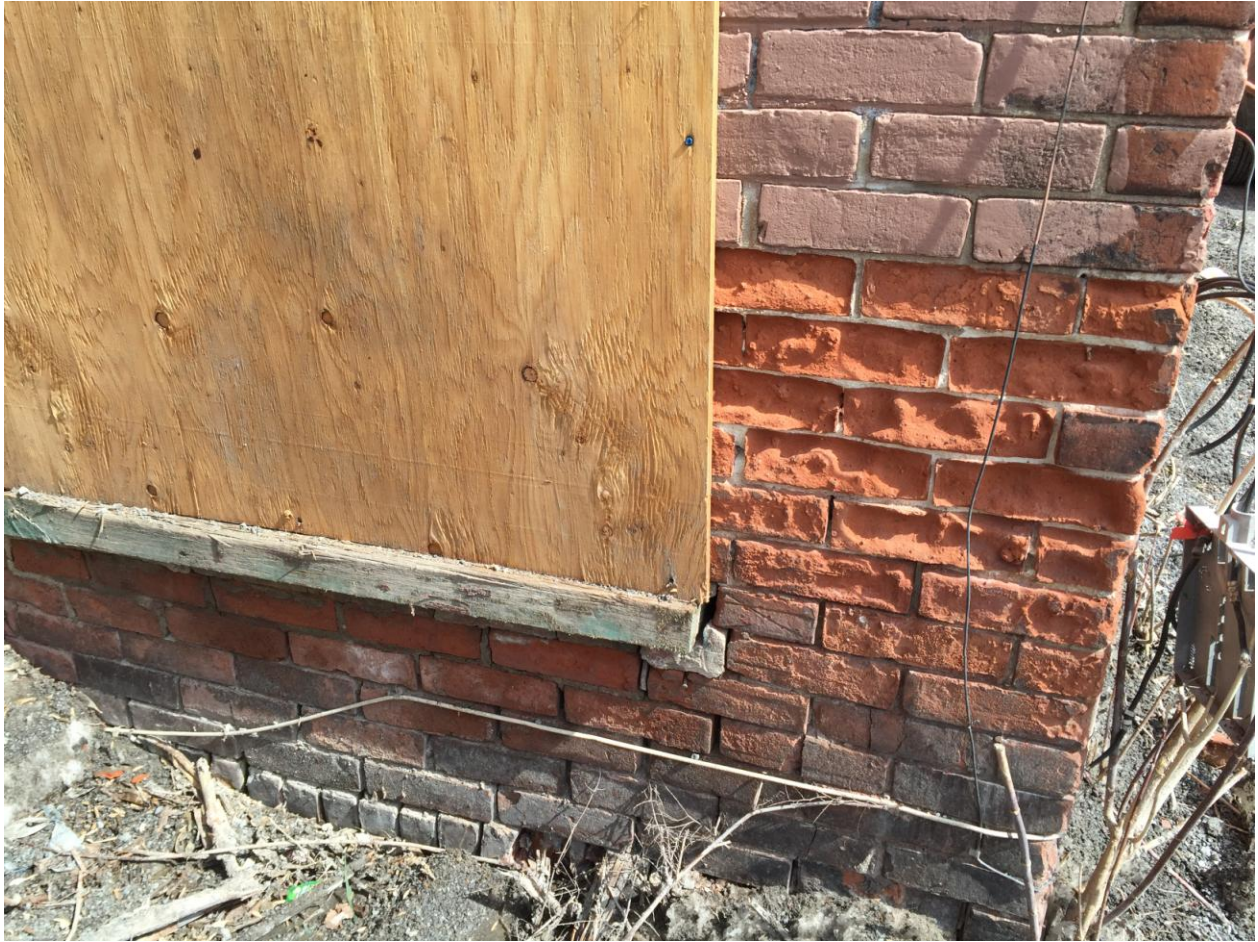
Figure 14: View of the deteriorated brickwork and pointing. Credit: Neil Zaret 2016.

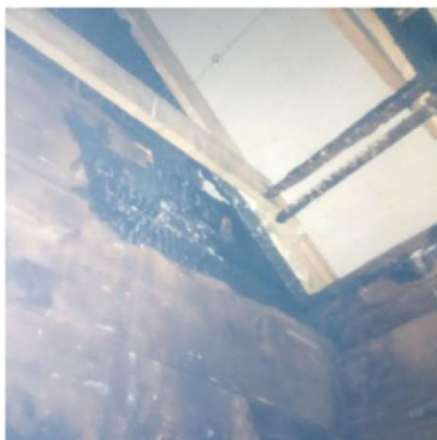
- The building is a two storey structure that was constructed in two phases. The age of the building is unknown, however, the original house along O'Connor Street dates back over 100 years.
- At the time of our site visit, the house was unoccupied and it is readily apparent from the extensive deterioration of the interior finishes that it has been abandoned and unheated for many years.
- The main structure is wood framing supported on rubble stone foundation walls.
- The building is clad with a masonry brick veneer.
- The wood framing was found to be in fair to poor condition. There had been a previous fire in the attic space of the original house and extensive charring was evident on the rafters. Supplemental wood framing has been installed beside the damaged members (See Photo One).

Photo One – Fire Damaged Roof Framing

Wood Framing: It is our opinion that extensive localized repairs are required on the wood framing to address the dry rot deterioration located on the ground floor joists. In addition, further investigation is required on the fire damaged roof rafters to confirm the structural integrity of the repairs performed in that area.

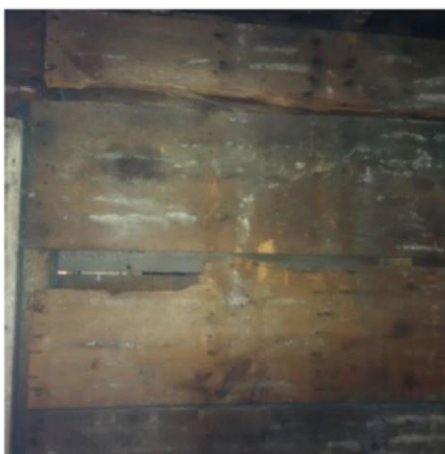
- Localized areas of dry rot are evident in the basement where the floor joists are supported on the rubble stone walls (See Photo Two).

Photo Two – Dry Rot on Wood Framing

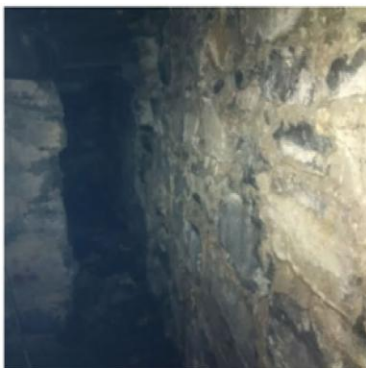
- The foundation walls are constructed of rubble stone and are in poor condition. Cosmetic parging repairs have been previously performed over the mortar joints in the basement. The parging was easily displaced and the underlying joints were found to be very soft and easily scraped away with a screwdriver (See Photos Three and Four).

Photo Three – Rubble Stone Wall

Foundations: It is our opinion that the existing rubble stone foundations have deteriorated to a point where they must be replaced. The scope of work would involve the following:

- Upon completion of the brick repairs, install temporary shoring to carry both floors of brick and the roof loads.
- Excavate the entire perimeter of the rubble stone walls.
- Demolish the walls and construct a new reinforced concrete block foundation on reinforced concrete strip footings.
- Install new waterproofing and perimeter foundation drainage.
- Backfill and reinstate landscaping.

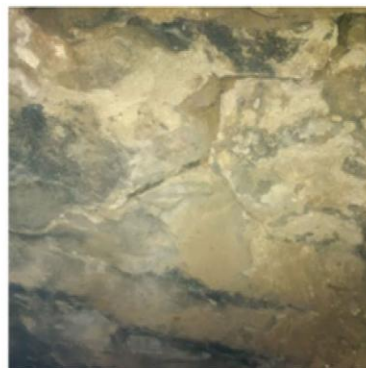
Photo Four – Deteriorated Mortar

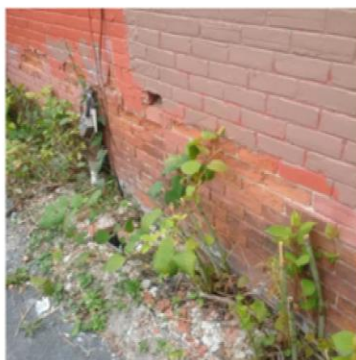
- The brick cladding was found to be in very poor condition. There is extensive deterioration present around the base of the entire structure in the form of face shell spalling, cracking and mortar joint deterioration. The damage is most prevalent on the entire north and south walls, extending four to five feet above grade (See Photos Five and Six).

Photo Five – Face Shell Spalling

Brick Masonry: It is our opinion that the brick masonry deterioration around the base of the building has progressed to the point where it represents an immediate structural concern. The deterioration is related to prolonged freeze thaw cycles on the brick resulting in extensive deterioration of the face shells. As the deterioration progresses over the coming winter, there is a moderate potential for a localized collapse of the wall.

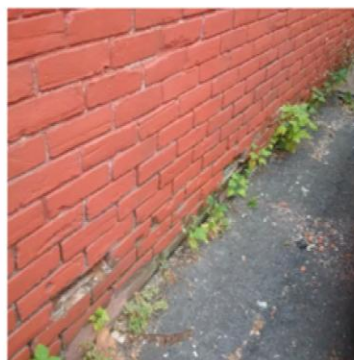
Photo Six – Mortar Joint Deterioration

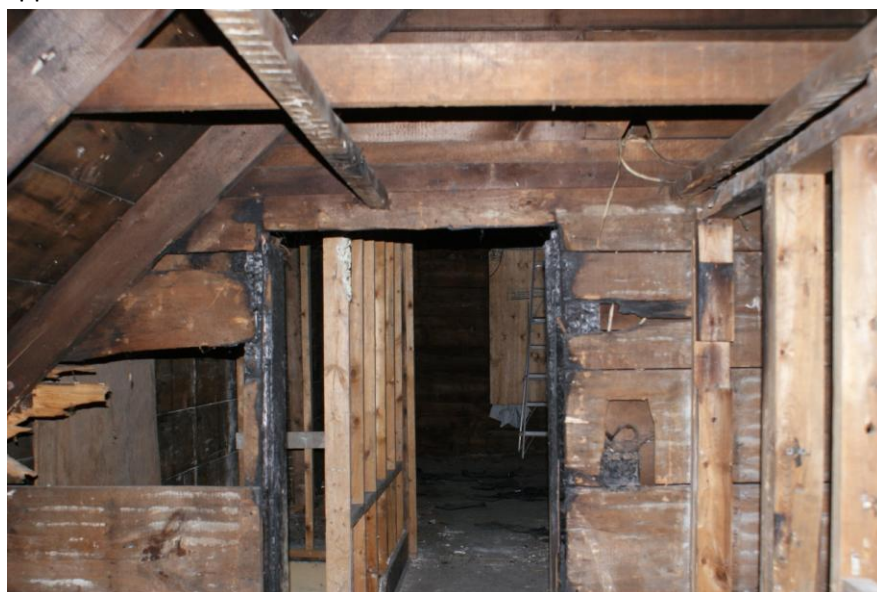
The building has been vacant for an extended period of time after a fire (approximately 15 years). The fire would appear to have started in the kitchen of a second floor unit in the rear wing of the building and spread into the attic space of the front portion of the building (Figure 1). Damage was limited to the upper floor and the attic.

Figure 1: View from the second floor to the rear wing of the building where the fire would appear to have started.

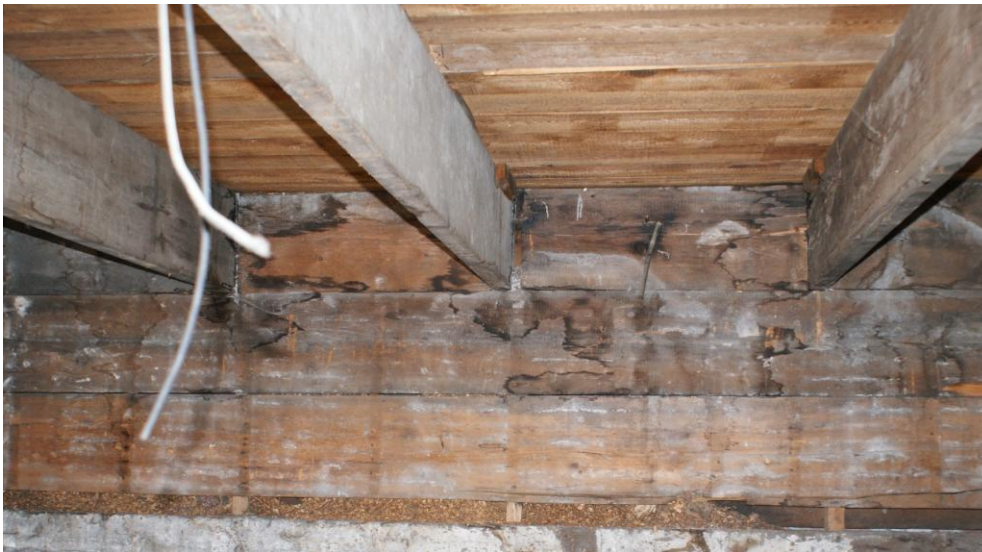
The exterior walls are balloon frame construction and consist of 1" board sheathing applied to both sides of the 2" x 4" studs with a brick veneer applied to the exterior. The cavities in the walls are filled with sawdust. The framing in the exterior walls consists of 2" x 4" studs at 2'-8" on-centre supporting 2" x 8" floor joists supporting the second floor both of which do not meet current building code requirements (Figure 4). The joists of the first floor level are set into the limestone foundation walls on the east and west interior walls of the front portion of the building, as well as the south and north sides of the rear wing. The framing in the building including exterior walls, floors, and roof structure will require a substantial upgrade to meet current building code requirements.

Figure 4: View of the balloon frame construction with second floor joists in the rear wing supported on 2" x 4" studs which are visible at the bottom of the photograph.

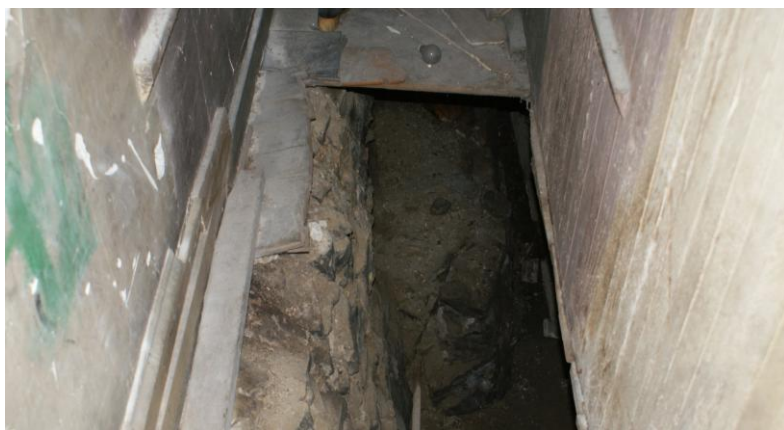
The foundation walls on the main portion of the building are poorly constructed when the building was built as is evident in the stone coursing. The foundation wall at the stairs to the basement has been pushed into the interior of the building (Figure 5). A secondary coursed limestone foundation wall built up at the base of the walls on the interior side of the foundation appear to be due to the upper portions of the walls being pushed inward by earth pressure from the exterior in combination with the poor quality of the materials and workmanship.

Figure 5: View down the stair to the basement. Note the displaced foundation wall which has been pushed into the building and the floor boards which have rotated upward.

The deteriorated foundation walls could be sequentially underpinned, which involves supporting the interior framing, removing short sections (5 feet) of the stone foundation, excavating for a footing, and sequentially pouring new footing and foundation wall sections. The process would be repeated until the deteriorated wall sections have been replaced with a new concrete footing and foundation wall. The work would be labor intensive and therefore, expensive. The north side of the foundation would also have to be shored, and the work would encroach on the neighbour's driveway and property.

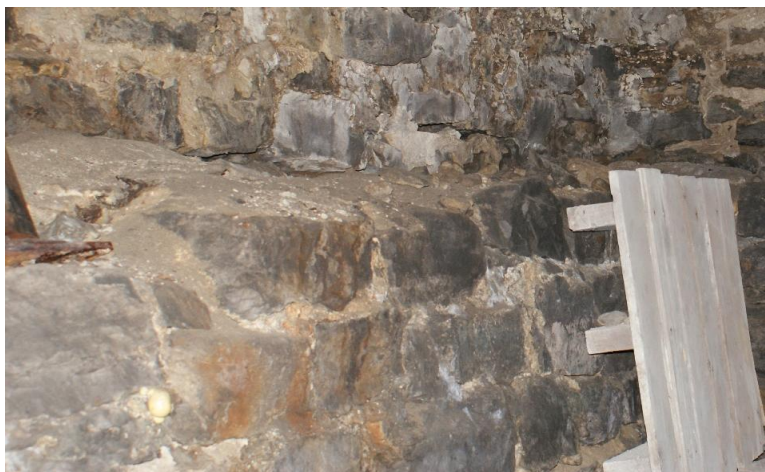
Figure 6: View of the foundation wall in the basement. Note the secondary stone wall at the base of the upper wall. This is a typical condition for foundation walls in front half of the building.

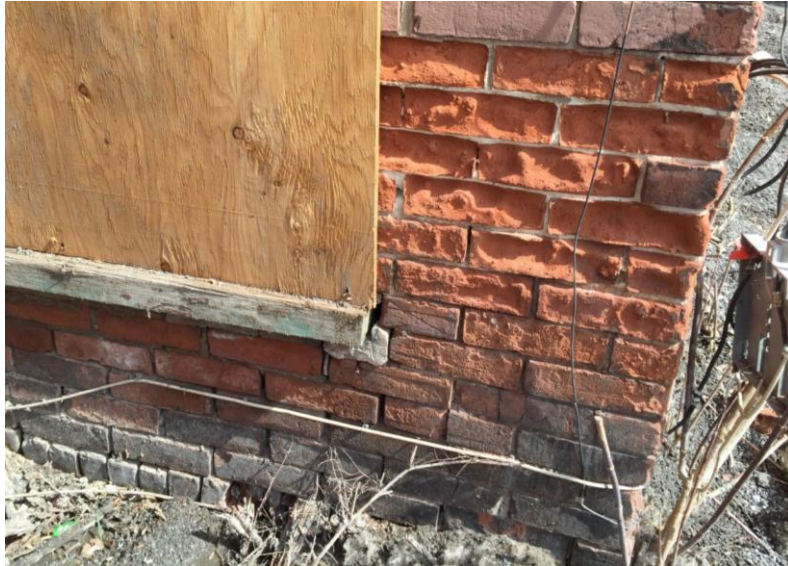
The brick veneer consists of soft porous clay masonry units that are susceptible to frost damage as is evident by the spalled brickwork at the base of the wall. The spalling of the brickwork tends to be at grade and in exposed locations, i.e. at external corners. Sections of the brick veneer have been removed and replaced on the upper north-west corner of the rear wing. Previous owners painted the brick in an attempt to minimize the spalling.

The brick siding has become detached from the frame wall in a number of areas. The brick is detached and bowing outward below the two windows at the second-floor level of the east elevation fronting on O'Connor, as well as the west elevation where a structural crack extends from the foundation to the roof level. The brick veneer is also detached on portions of the north elevation below a window (Figures 7, & 8).

Figure 7: View of deteriorated brick at the base of the wall at the south-west corner of the front half of the building. Note the raised grade above the level of the stone foundation, and the buried brick headers at the top of a basement window.

The only solution to the problems with the brick veneer is to dismantle the brickwork and reapply it after the foundation walls have been replaced, and the interior frame has been rebuilt to meet code. There is some potential to salvage bricks and re-use them on the exterior as there are substantial portions of the brick veneer that have not been painted and appear to be in sound condition; however, our experience with similar projects is that modern brick units available from commercial suppliers are not a good match to the size of the older bricks.

Remove and replace the brick veneer. The cost estimate for the replacement of the brick is in the order of \$80,000 based on trade pricing from another project. The cost has been included in the construction budget estimate prepared by Gemstone Corporation, which is appended to this report.

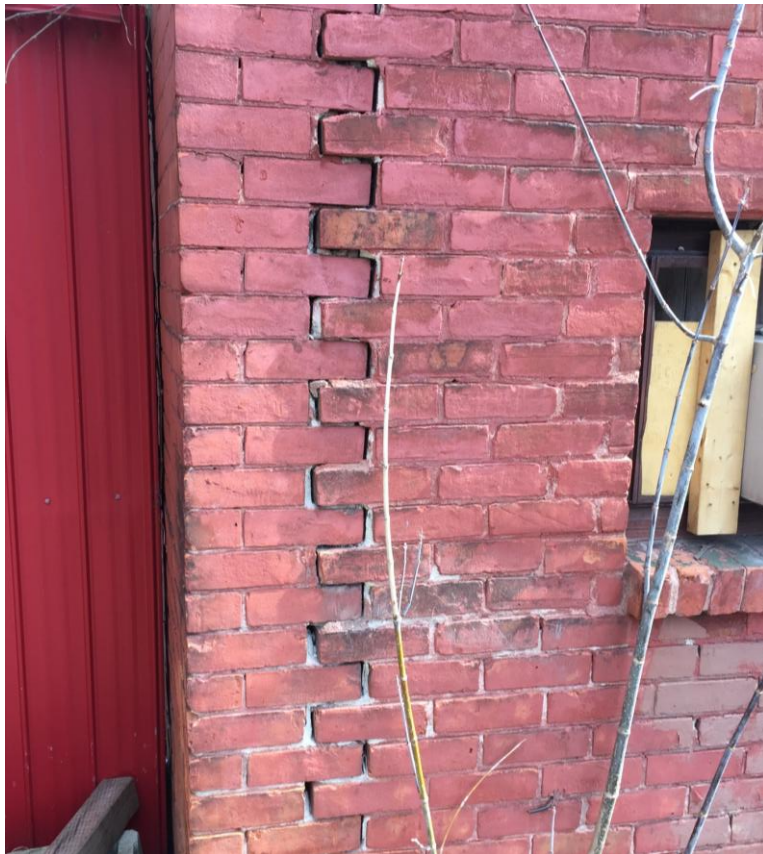
Figure 8: View of the west wall of rear wing illustrating the detached brick veneer.
