Re: 234 O'Connor Street, Ottawa
Structural Review
Our Reference Number: 15-1415

As requested, Cleland Jardine Engineering Ltd. has updated our previous report of November 6, 2015, regarding the condition of the structural components of the two storey house located at 234 O'Connor Street, Ottawa.

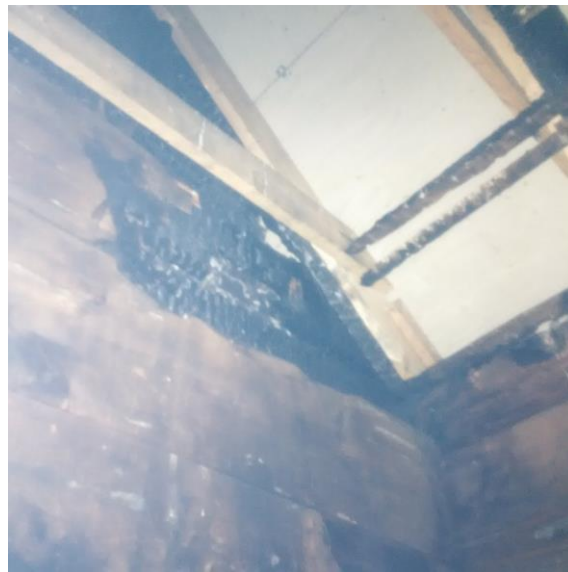
- The wood framing is in fair to poor condition. There had been a previous fire in the attic space of the original house and extensive charring was evident on the rafters. Supplemental wood framing has been installed beside the damaged members (See Photo One).

Photo One – Fire Damaged Roof Framing

1. Extensive repairs are required to the wood framing.
2. The foundation deterioration has progressed to a point that complete removal and reconstruction is required.
3. Deterioration of the brick cladding has progressed to the point that it now poses a significant risk to public safety.

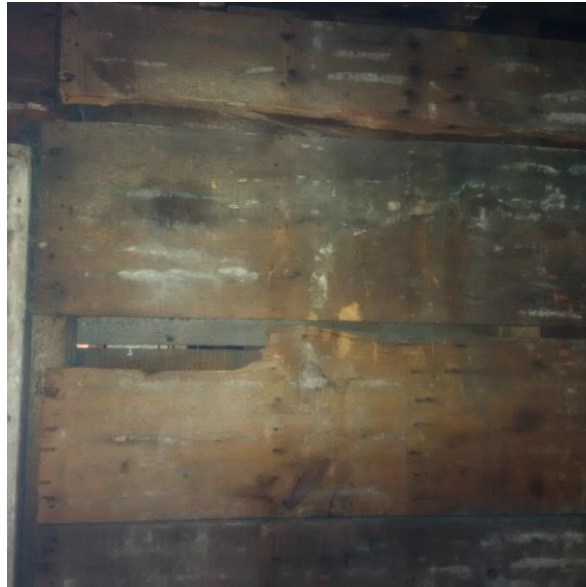
- Areas of dry rot are present in the basement, primarily where the floor joists are embedded in the rubble stone walls (See Photo Two).

Photo Two – Dry Rot on Wood Framing

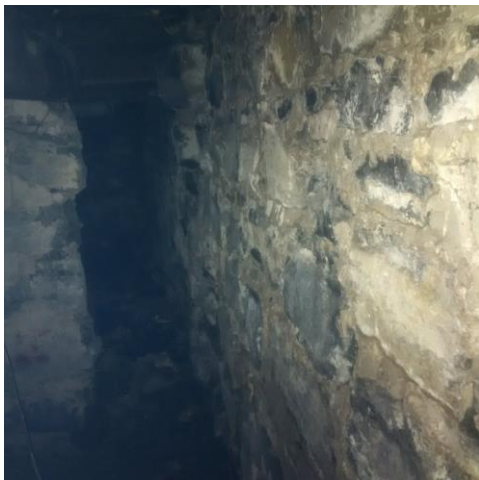
- The foundation walls are constructed of rubble stone and are in poor condition. There has been no significant change since our November 2015 inspection in that the mortar joints are very soft and easily scraped away with a screwdriver to the full depth of the walls (See Photos Three and Four).

Photo Three – Rubble Stone Wall

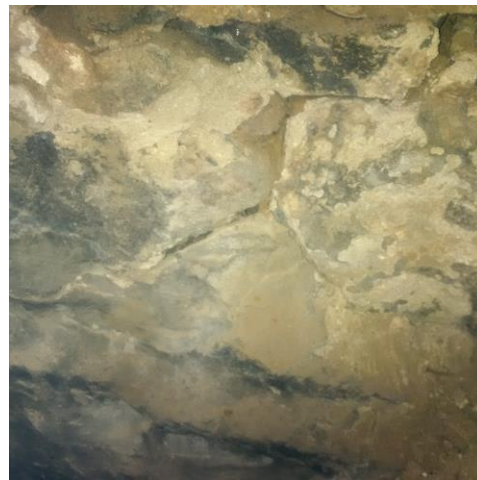
Photo Four – Deteriorated Mortar

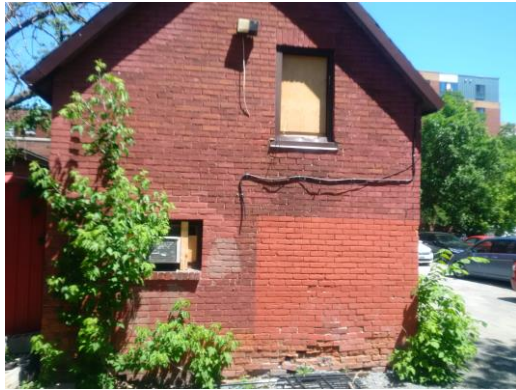
- The brick cladding is in very poor condition. The deterioration appears to have advanced significantly since our November 2015 inspection and it is our professional opinion that an appreciable risk to public safety now exists.

The brick at the rear (west elevation) is significantly cracked and bulging outward and is in imminent danger of collapse (See Photos Five and Six).

Photo Five – West Elevation Brick

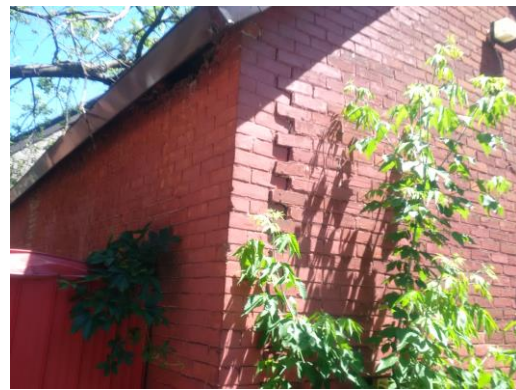
Photo Six – Significant Brick Bulging

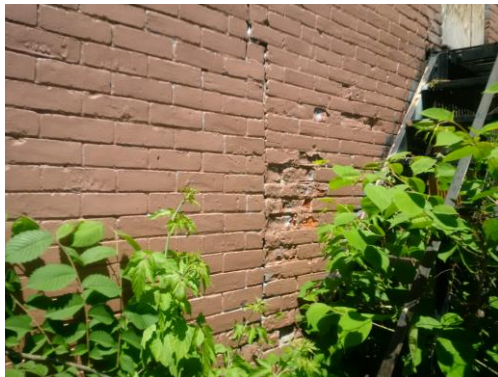
The brick on the north and south elevations is also in an advanced state of deterioration. Extensive crumbling is evident at the base of both walls (See Photos Seven and Eight)

Photo Seven – South Elevation

Significant outward bulging of the brick is evident on the south elevation, near the steel stairs, and on the entire north elevation.

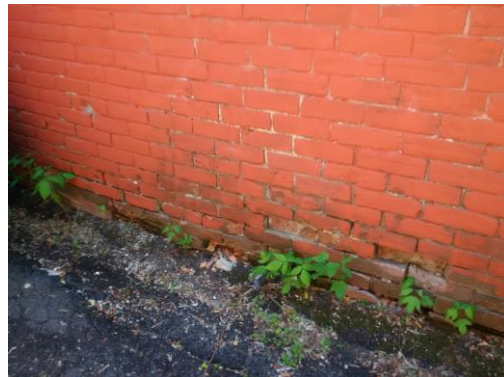
Photo Eight – North Elevation
