# **Building Condition Report**

**234 O'Connor Street  
Ottawa, ON**

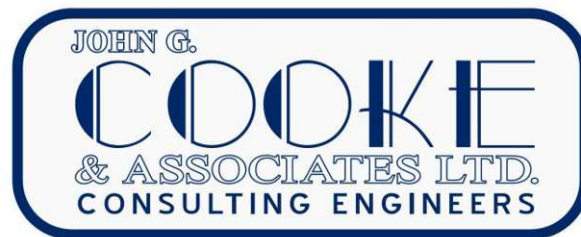
## TABLE OF CONTENTS

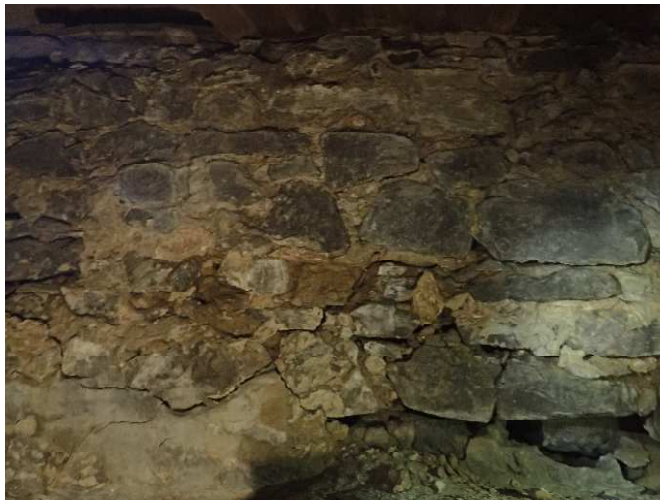
**Photograph 1 – North wall with void joints, JCAL (2016)**

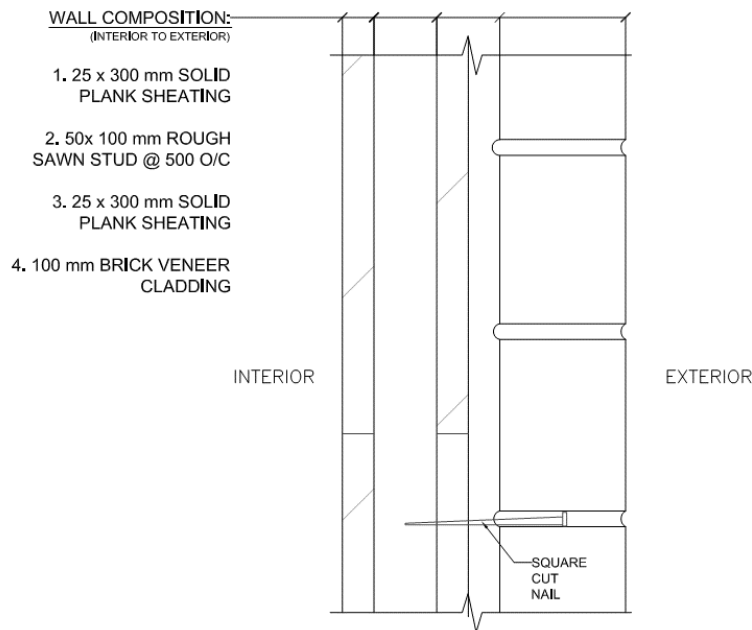
as illustrated in Figure 2. Based on JCAL's experience, the nails are most likely spaced at 850mm both horizontally and vertically. These nails act in the same way as modern brick ties – they brace the veneer brick against wind loading and support it laterally to avoid a slender buckling failure due to the brick's self weight.

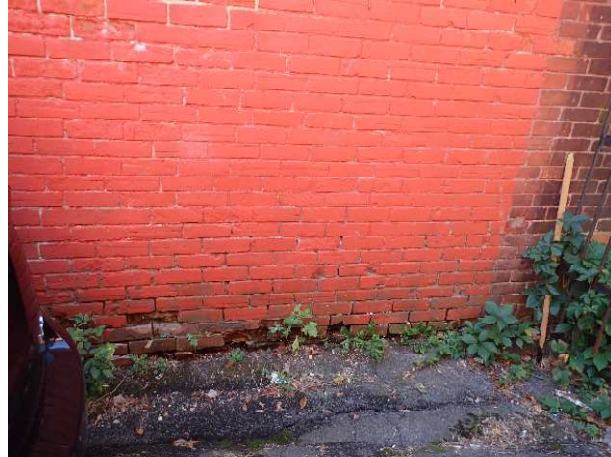
compatible to the original than modern brick. The heritage brick's strength is higher (35MPa) and has a lower porosity, but will match the original size.

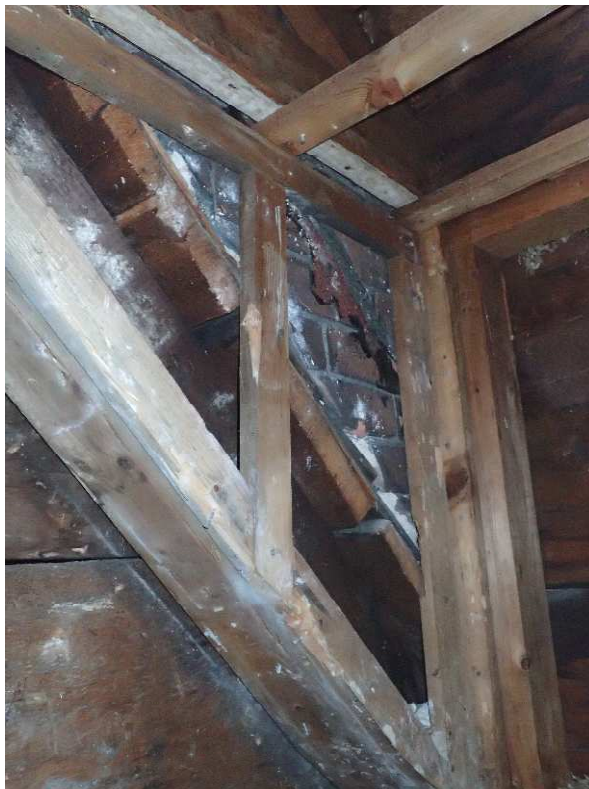
**Photograph 4 – Brick supported on wood framing, JCAL (2016)**

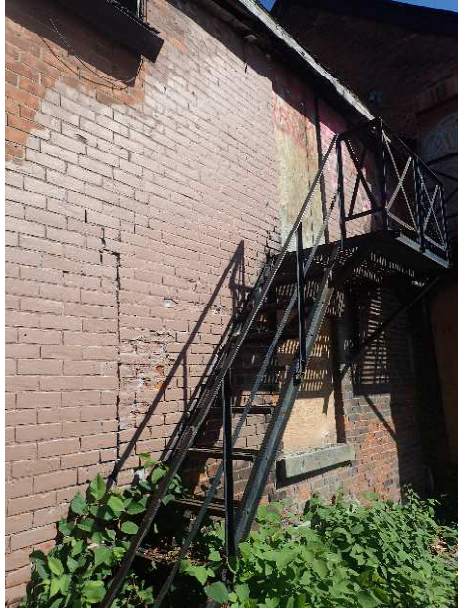
**Photograph 5 - Break in running bond pattern between rear additions and spalling of painted brick, JCAL (2016)**

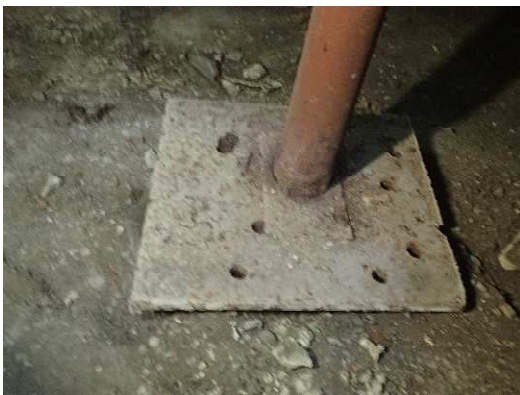
**Photograph 6 – Steel tele-post bearing on soil, JCAL (2016)**

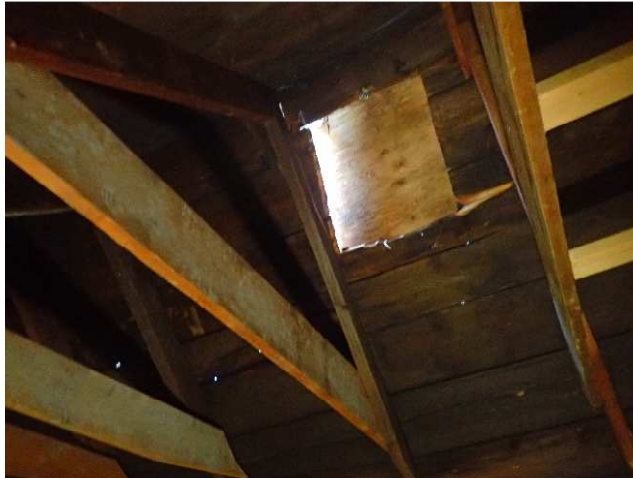
**Photograph 7 – Daylight seen through holes in rear addition roof, JCAL (2016)**

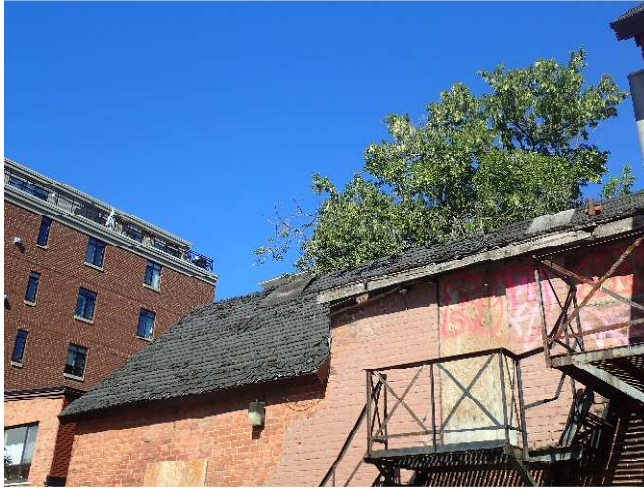
**Photograph 8 – Roof of rear additions, JCAL  
(2016)**

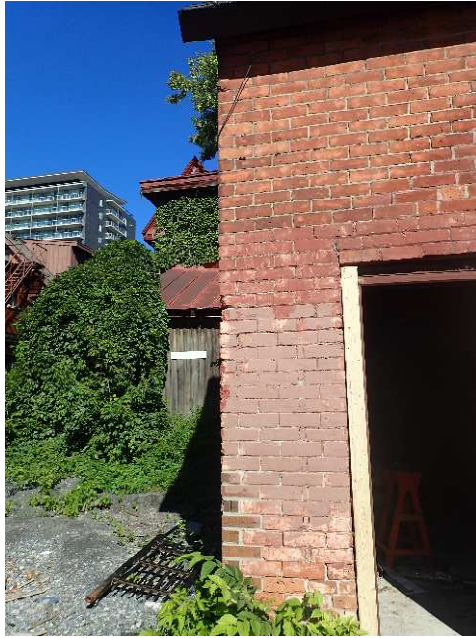
**Photograph 9 - Step cracking above opening in west end of south wall, JCAL (2016)**

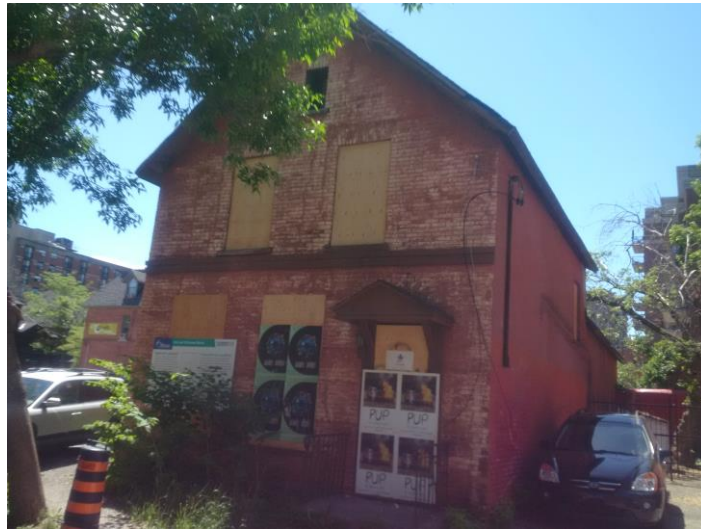
**234 O'Connor – East Elevation Viewed From O'Connor Street**

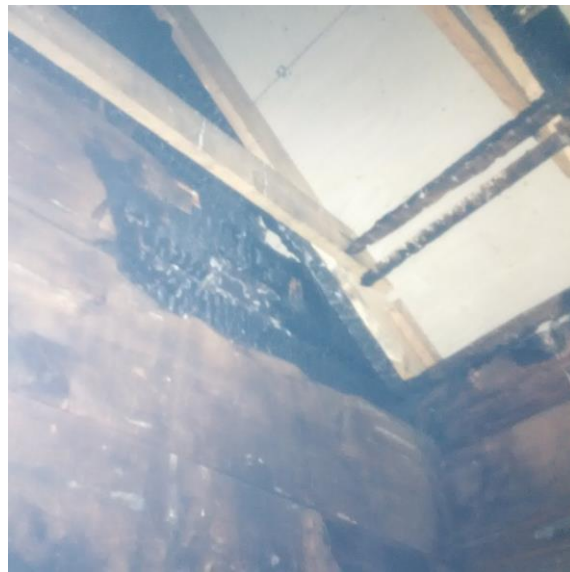
**Photo One – Fire Damaged Roof Framing**

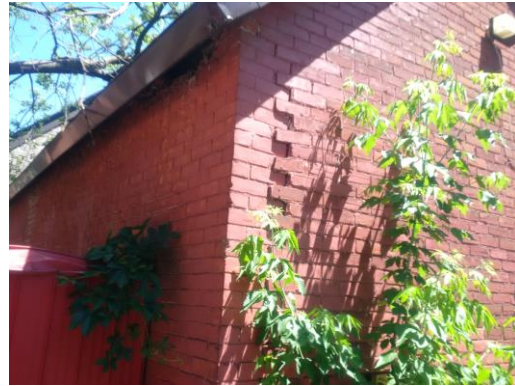
**Photo Six – Significant Brick Bulging**

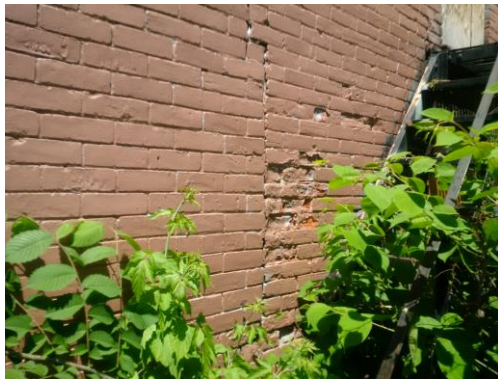
**Photo Seven – South Elevation**

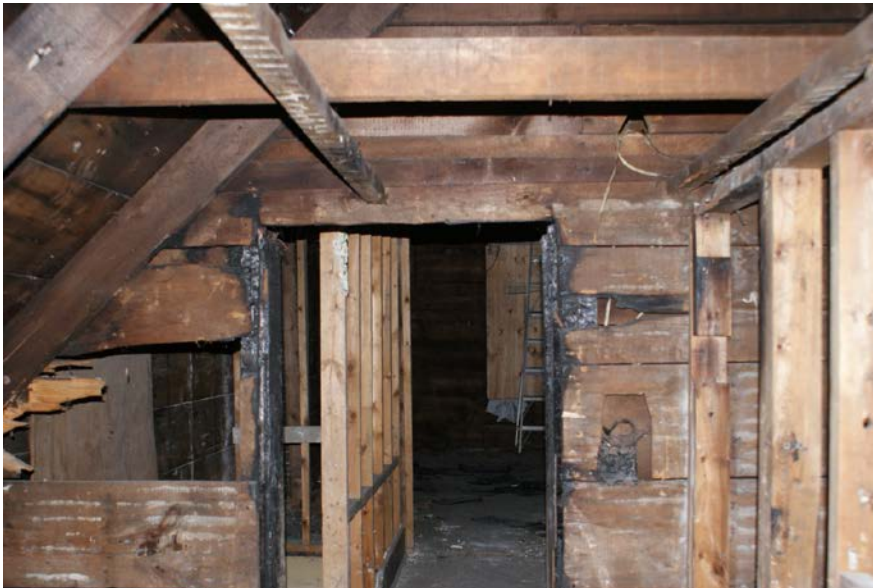
*Figure 1: View from the second floor to the rear wing of the building where the fire would appear to have started.*

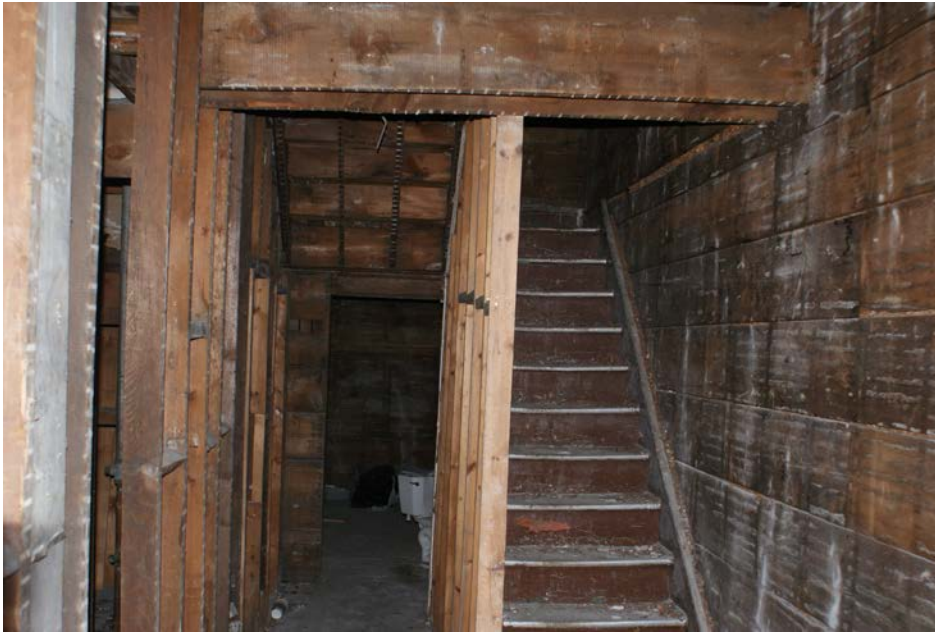
*Figure 2: View of the interior stair. Note the horizontal board sheathing applied to the interior walls.*

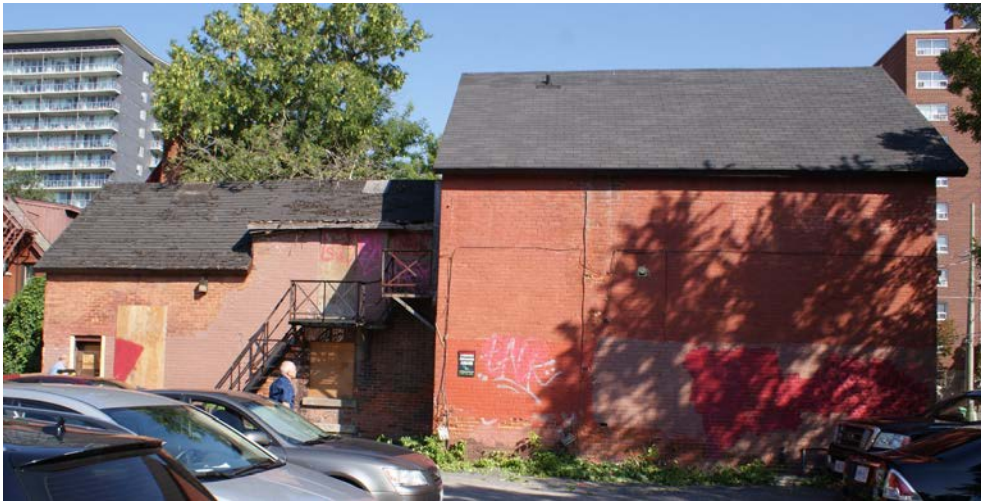
*Figure 3: View of the south wall of the main building and rear wing. Note the lack of windows in the south wall.*

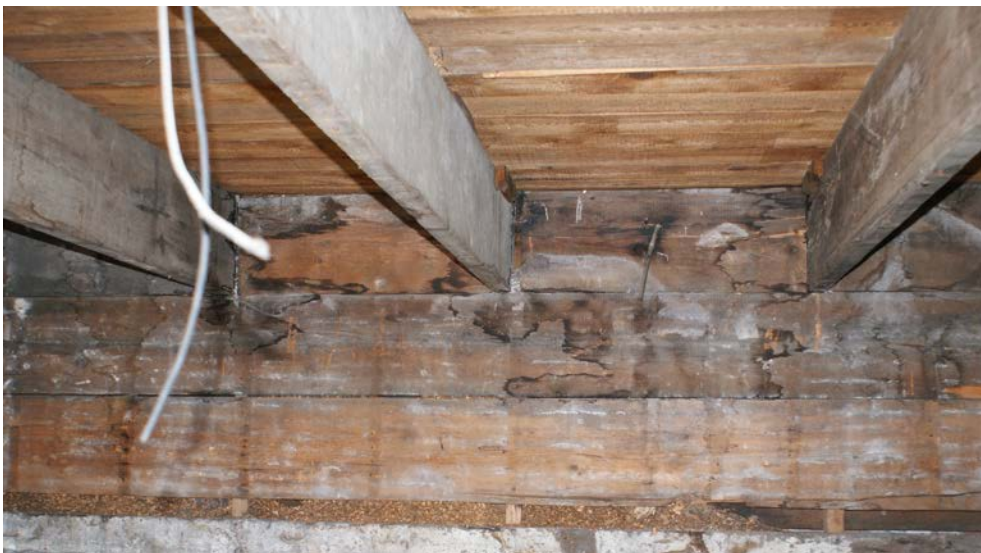
*Figure 4: View of the balloon frame construction with second floor joists in the rear wing supported on 2" x 4" studs which are visible at the bottom of the photograph.*

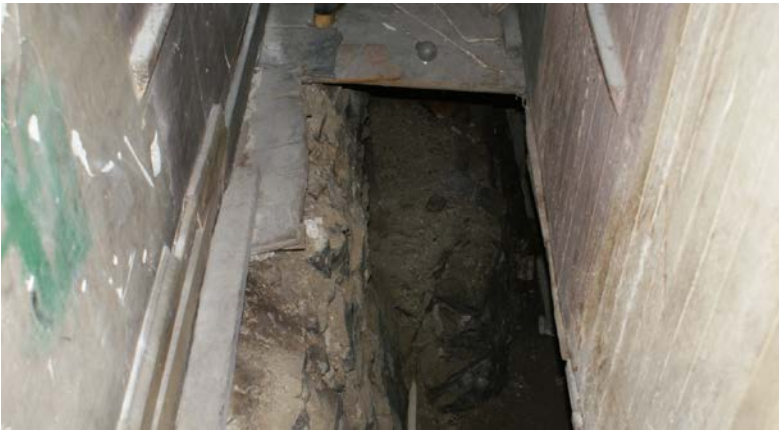
*Figure 5: View down the stair to the basement. Note the displaced foundation wall which has been pushed into the building and the floor boards which have rotated upward.*

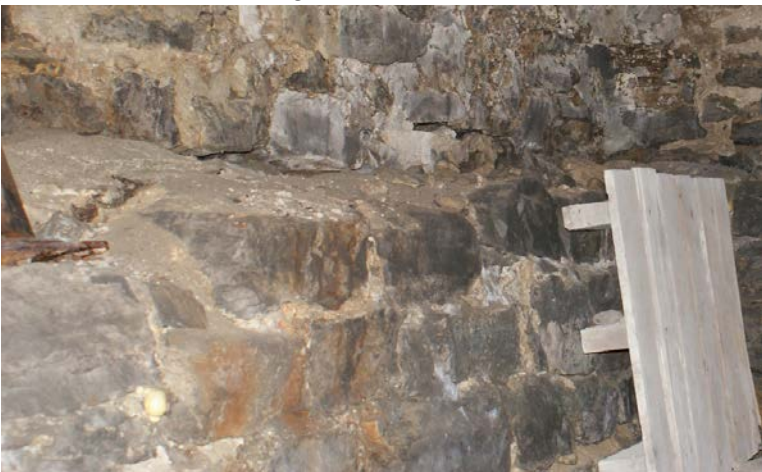
*Figure 6: View of the foundation wall in the basement. Note the secondary stone wall at the base of the upper wall. This is a typical condition for foundation walls in front half of the building.*

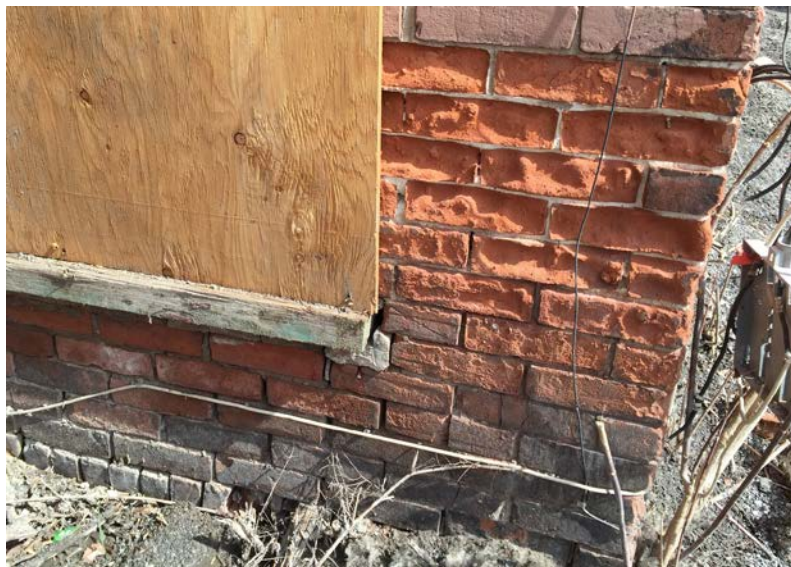
*Figure 7: View of deteriorated brick at the base of the wall at the south-west corner of the front half of the building. Note the raised grade above the level of the stone foundation, and the buried brick headers at the top of a basement window.*

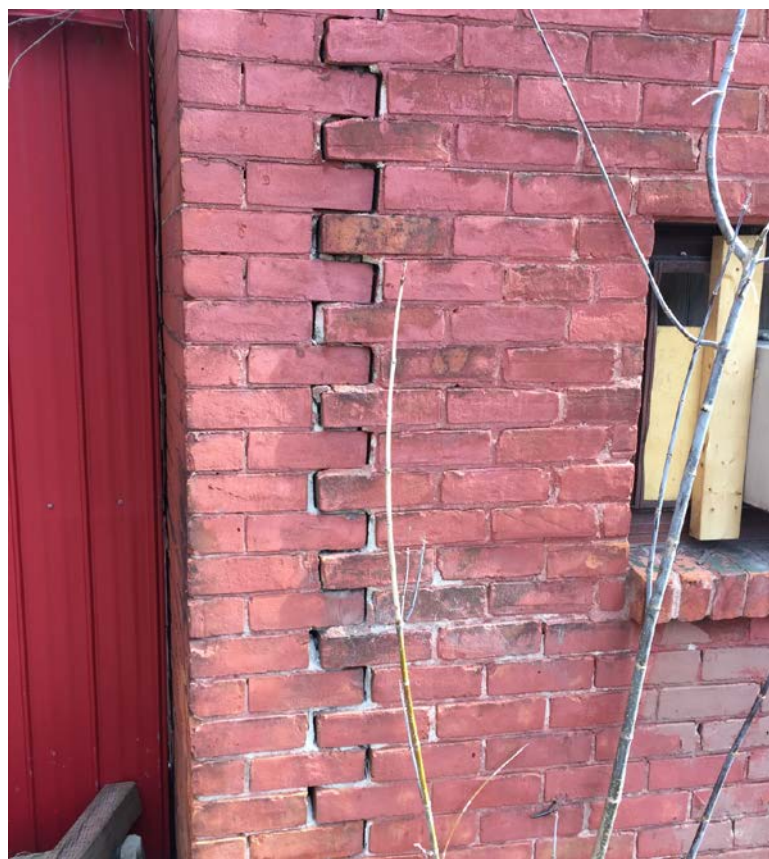
*Figure 8: View of the west wall of rear wing illustrating the detached brick veneer.*
