**Capacity  
Engineering  
Limited**

CEL Project # 1078

**Re: Somerset House Deterioration, Immediate Repairs & Restoration**  
**Location: 352 Somerset Street, Ottawa**

## **Evaluation of Existing Structure & Discussion**

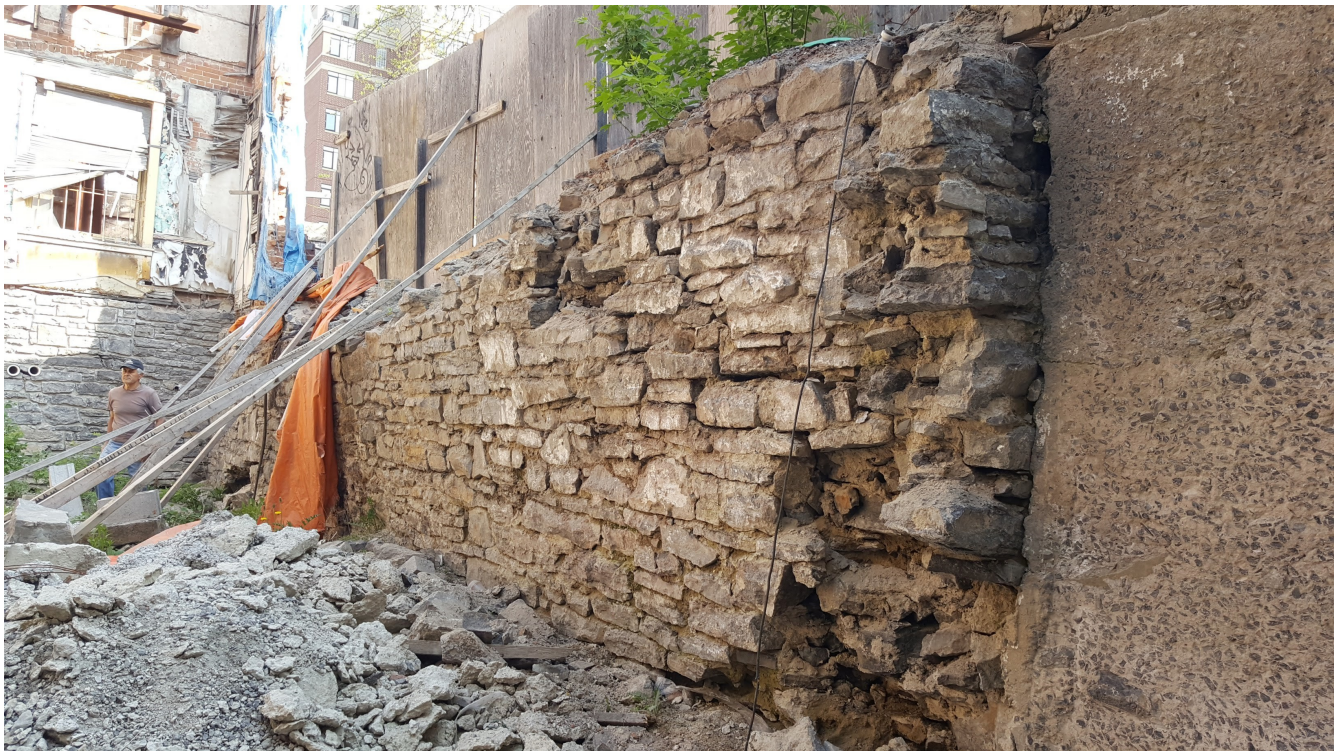
## **1.3 Foundation wall along GL 8**

The stone foundation wall along GL 8 is actively failing. The wall has moved in excess of 400mm at peak, the construction site hoarding fence built along GL 8 is sinking into the exposed foundation pit, and changes in the wall are being observed week to week. Note that the cause of this failure would appear to be a combination of lack of vertical load (NB: such walls perform best under moderate vertical confining load), lack of sufficient maintenance (pointing and generally poor mortar condition), as well as exposure to freeze-thaw cycling and weather. Long poles or staves have been installed to support the temporary hoarding fence, whereas maintenance of the wall was required. Refer to Photo 1.3.

*Photo 1.3 - Failing Stone Foundation at adjacent Parking Lot*

**Elemental:** This is a critically dangerous situation. The Owner is advised to install new hoarding and fencing to prevent anyone from approaching within fifteen feet (~5m) of the wall. Once the fence is in place, we recommend the

immediate demolition of the top portion of the wall and a new temporary construction ramp be installed both to facilitate further works and to prevent further collapsing of the vertical excavation face along GL 8.

**Global:** Clear all detritus from the excavation, introduce new drains in the base of the excavation and place layers of Granular B in 100mm maximum layer thickness to achieve 400mm of granular fill compacted to 95% standard proctor dry density to OPSS 1010.

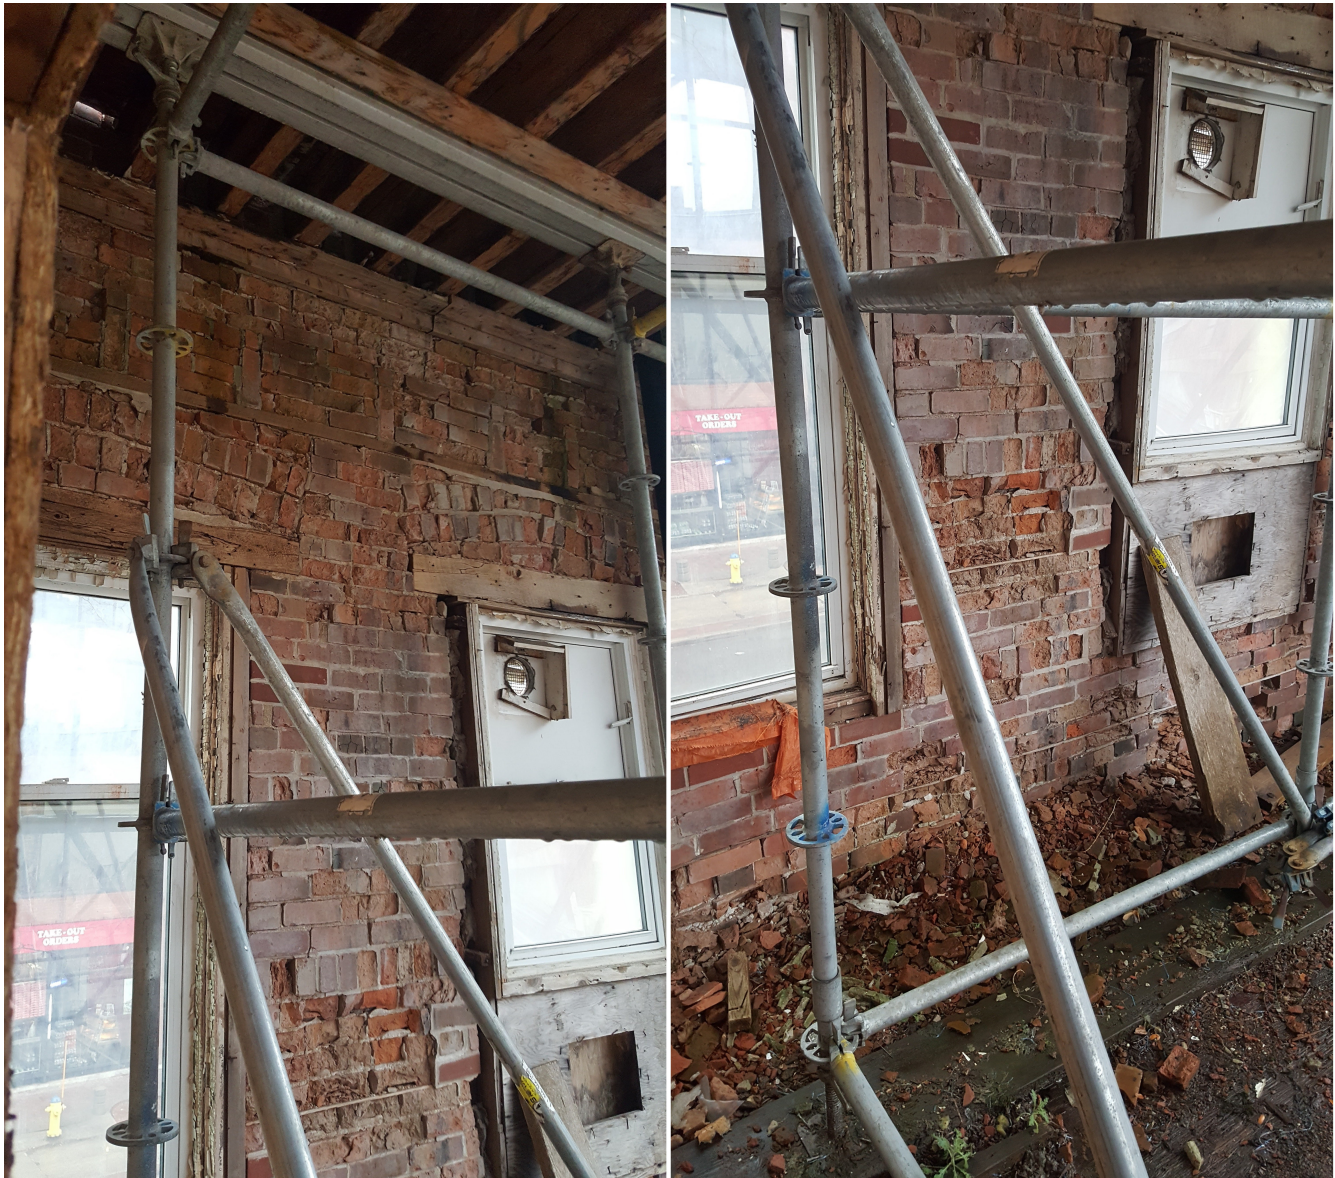
#### **1.4      Gridline A at Gridline 4 to 5 Masonry Condition**

Separately from the overall instability of this section of wall, the condition of the masonry in the URM wall along GL A from GL 4 to 5 is seriously deteriorated. It appears to have been subject to extreme freeze-thaw cycling as well as a great number of wet-dry cycles. Refer to Photo 1.4.

*Photo 1.4 - Masonry Wall Deterioration along GL A from GL 4 to 5*

**Elemental:** Once the wall section has been stabilized (refer to Observation 1.1), deficient masonry units shall be replaced one at a time, waiting for mortar to achieve sufficient strength to permit further units to be removed prior to undertaking further removals.

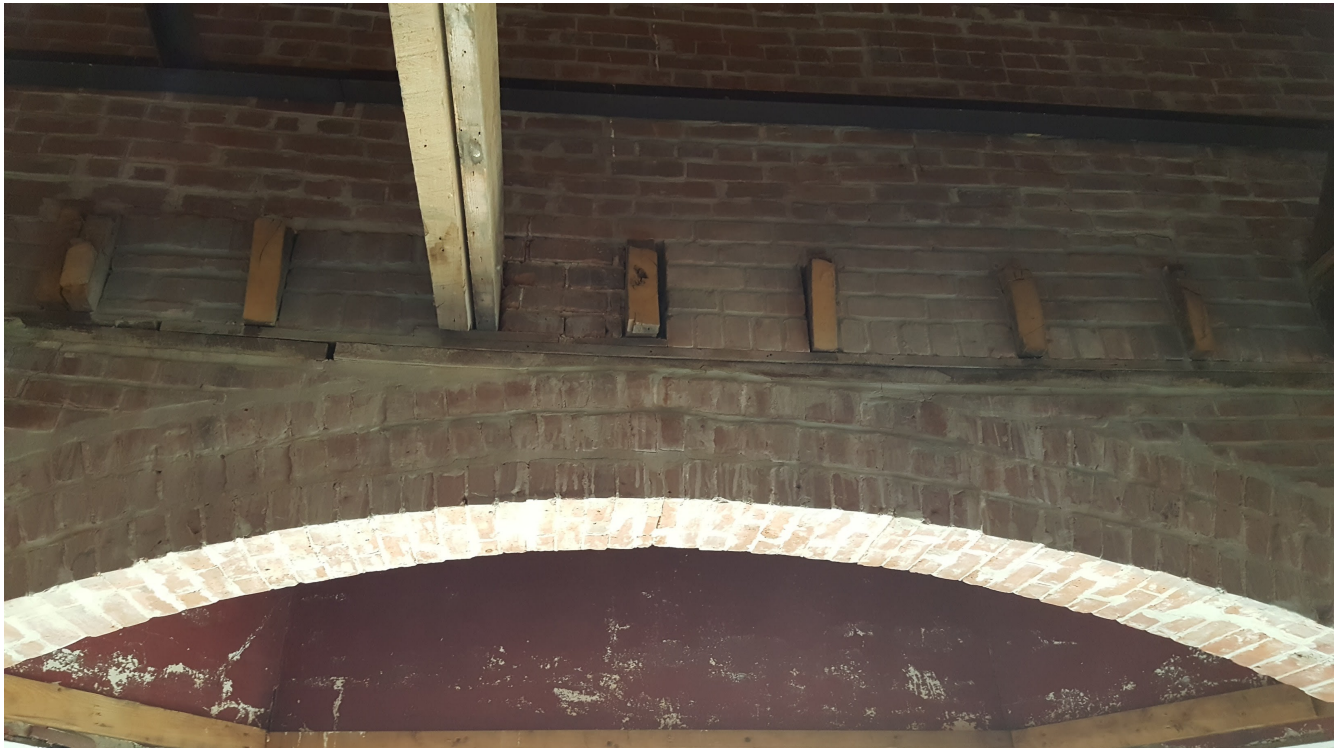
*Photo 2.1 - Cut off Ceiling Joists*

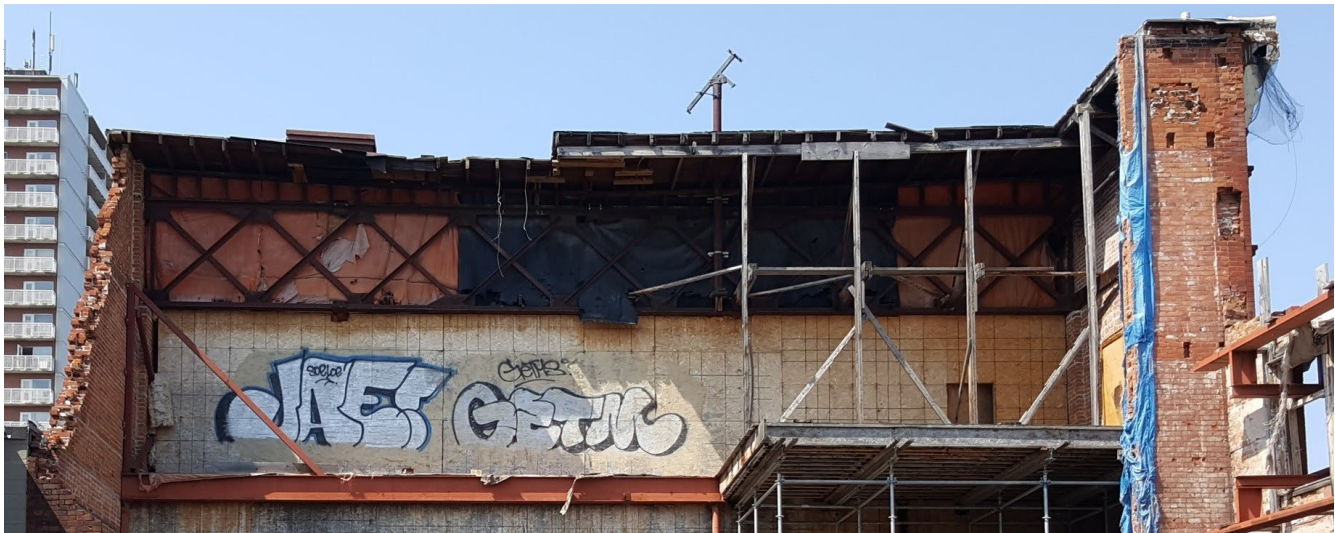
The existing conditions leave one side of the easternmost original iron truss (roof level, along GL 4) exposed to the environment. This is an unacceptable condition which may lead to irreversible deterioration and the loss of another Heritage Element. See Photo 3.1.

*Photo 3.1 - Heritage Roof Truss Exposed to Elements*

**Elemental:** Extend moisture barrier to encapsulate the truss and prevent further exposure to the elements.

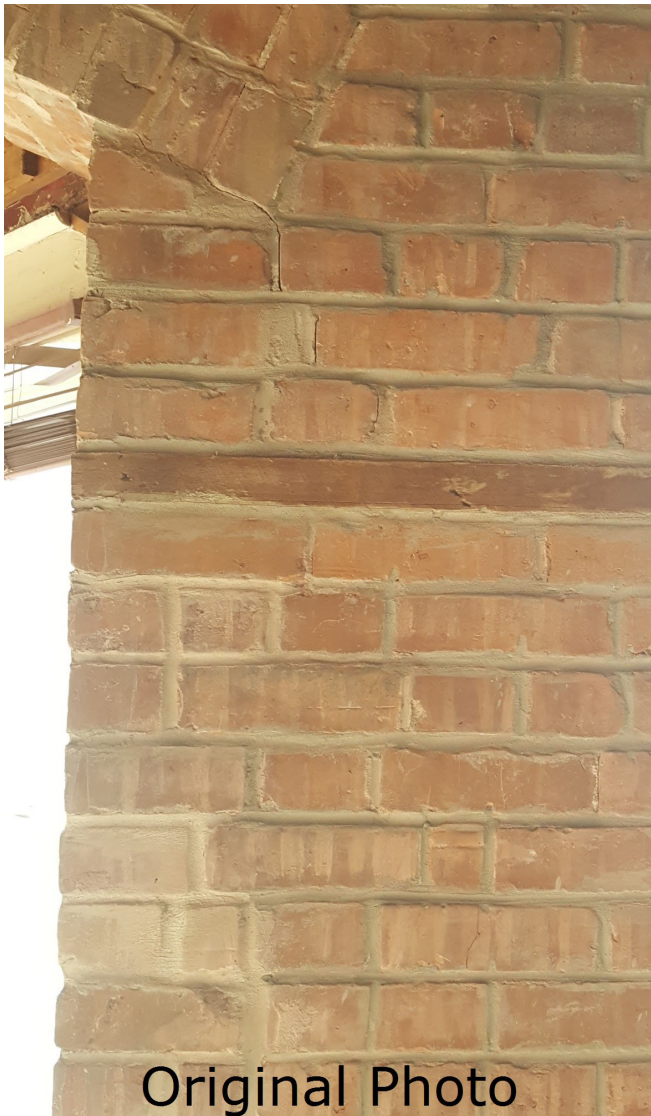
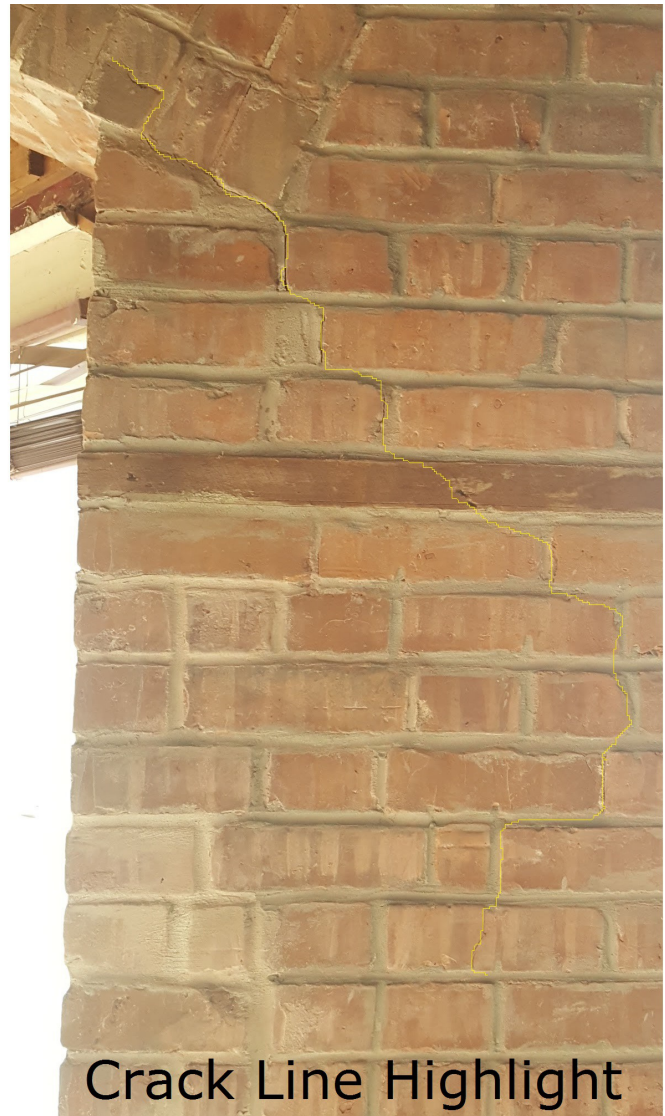
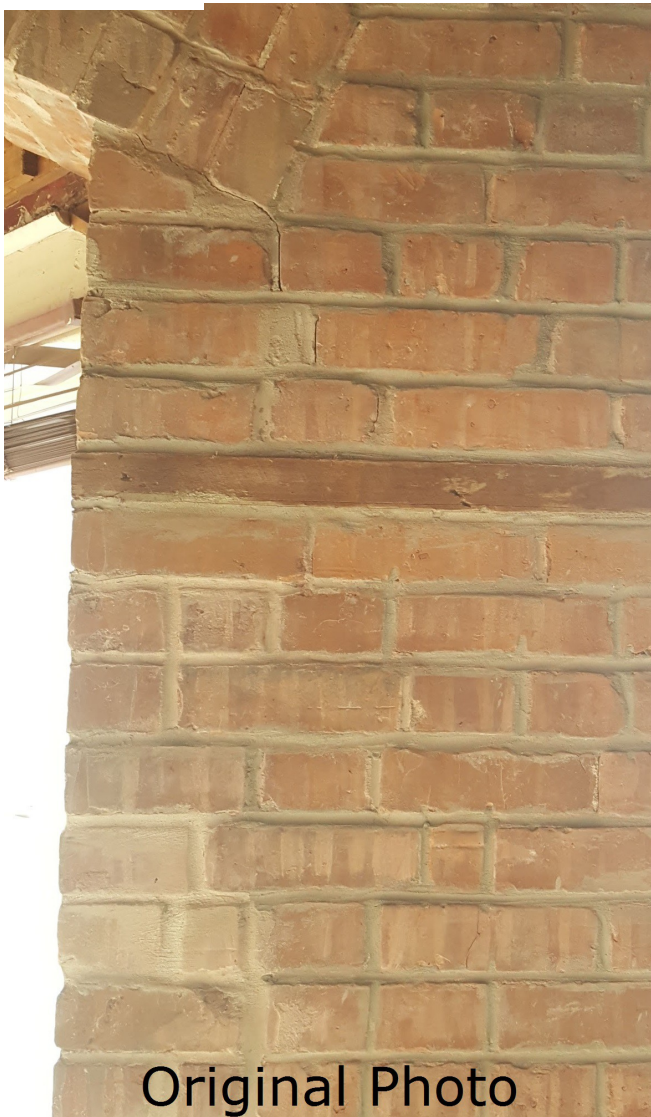
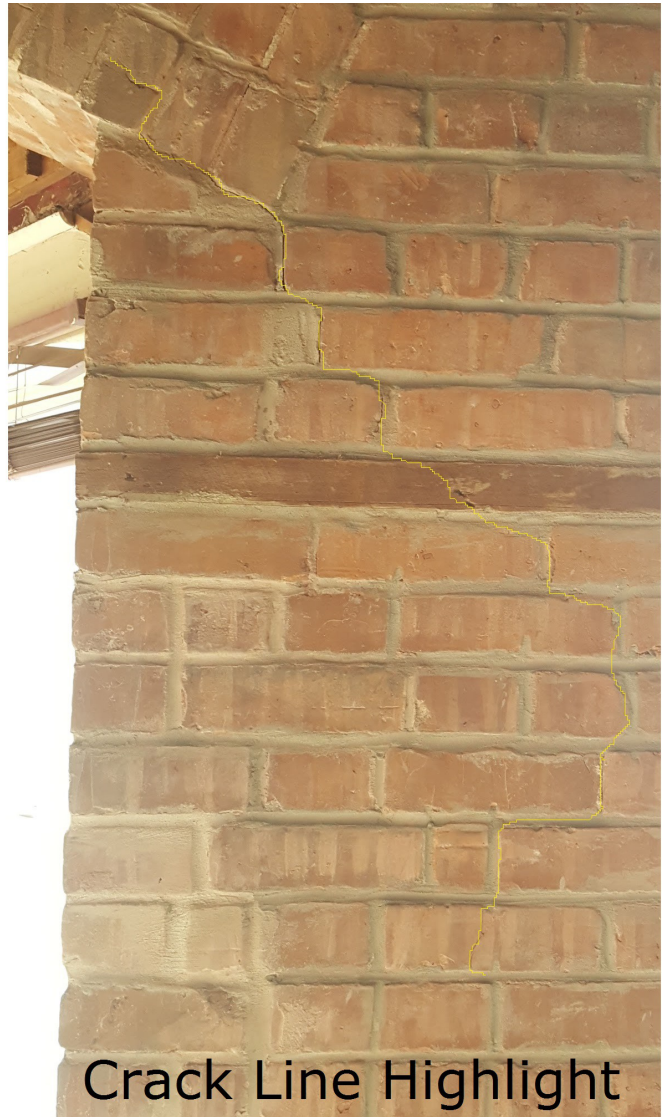
Both segmental arches at the third floor of the bank street façade appear to be in an overstress condition. The reason for this overstress would appear to be the deterioration of the arch and not an overload condition, however this cannot be definitively determined without a more detailed history.

The shape of both arches is indicative of past settlements, and the condition is indicative of recent repointing. While this maintenance work appears to have restored the strength of the arch itself, it has not prevented the overstress condition of the springer. Further, it appears that the repointing was carried out with an incompatible mortar; where these arches naturally settle small amounts both immediately following completion and in service, the modern cementitious mortar used has not permitted any movement of the joints, further causing tensile stresses within the matrix, and resulting in the cracking of the brick units (which are now being subject to across-width tension loads they have heretofore been protected against by the use of weak mortars). Thus while the mechanism of the arch behaviour has changed from weak mortar strong brick to strong mortar, weak brick, the condition is not easily reversed. Once installed, cementitious mortars bond very well to the masonry units and create a condition wherein, like most systems, the most likely element to be damaged in removal works are the weakest elements, unfortunately this is now the bricks themselves. Refer to Appendix B "Masonry Behaviour – Soft Brick/Hard Mortar versus Hard Brick/Soft Mortar" and Photo 3.2. See Illustration 2 for arch terminology used in this report.

*Photo 3.2 - Segmental Arch Abutment Cracking*

**Elemental:** Start high accuracy recording of the length of the stringer line and install crack gauges on the cracks which have occurred in the bricks at and about the springer.

**Global:** Ensure the correct, materials compatible, mortar is used in all repairs.

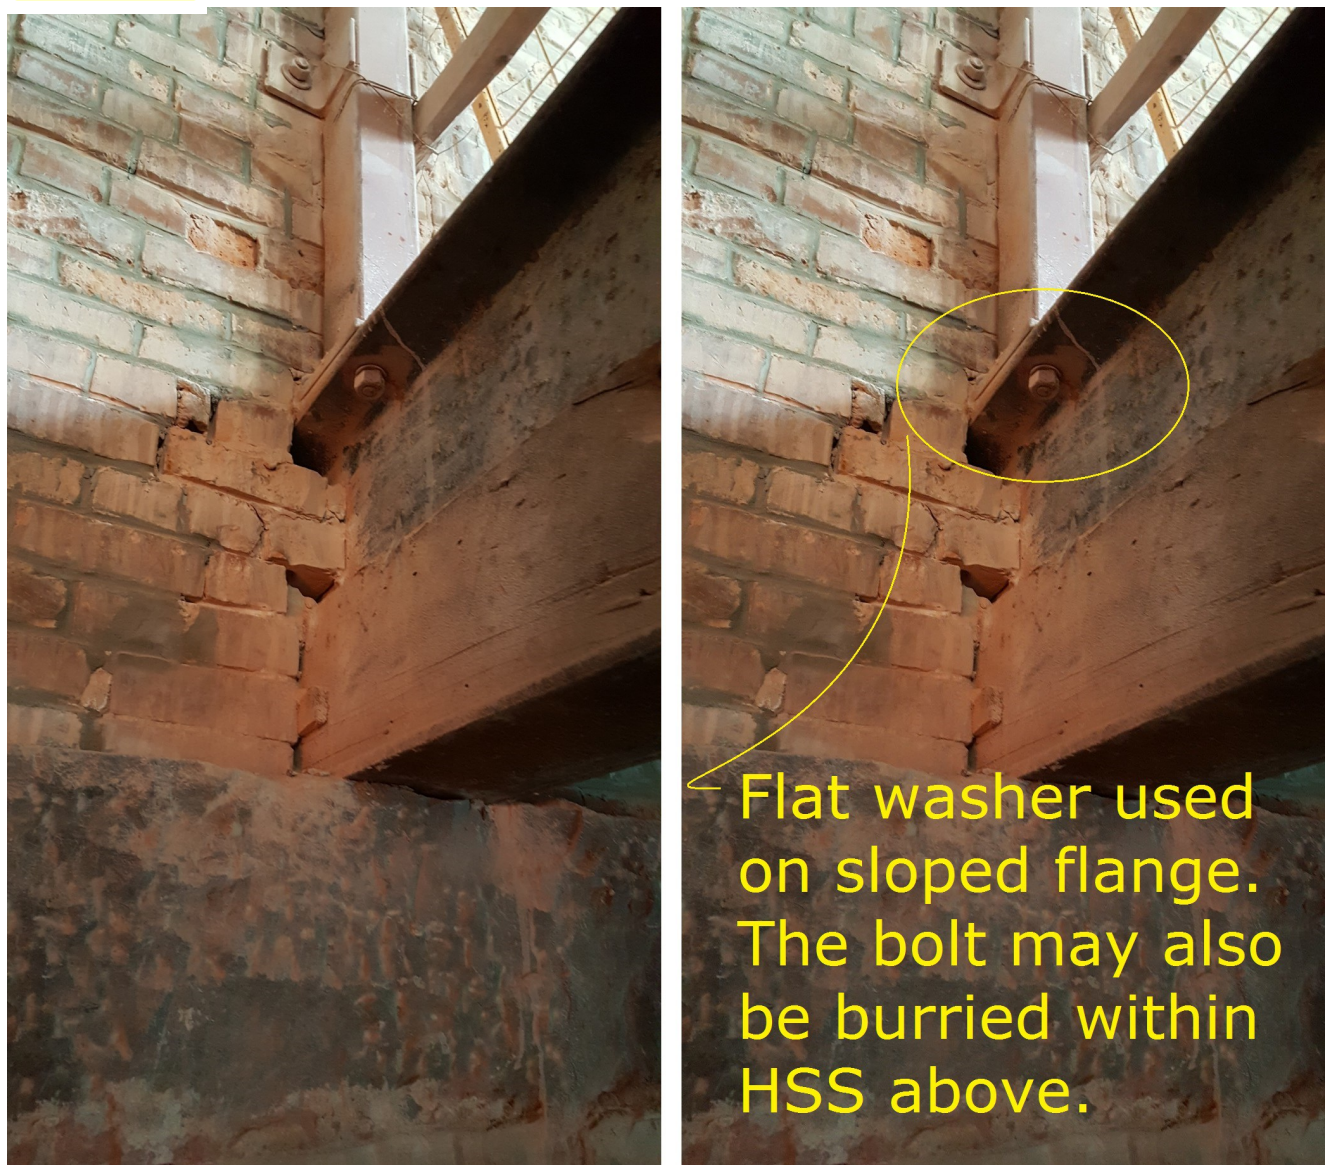
*Photo 4.1 - Flat washer and resultant twisted bolt on S shape*

**Elemental:** The use of a modern bolt and washer, rather than a mild steel bolt and bevelled washer, have resulted in a compromised installation with less strength than a correct installation. We recommend the anchor bolts be removed, one at a time, and replaced with new A325 bolts using the correct bevelled washers, if possible given the installation.

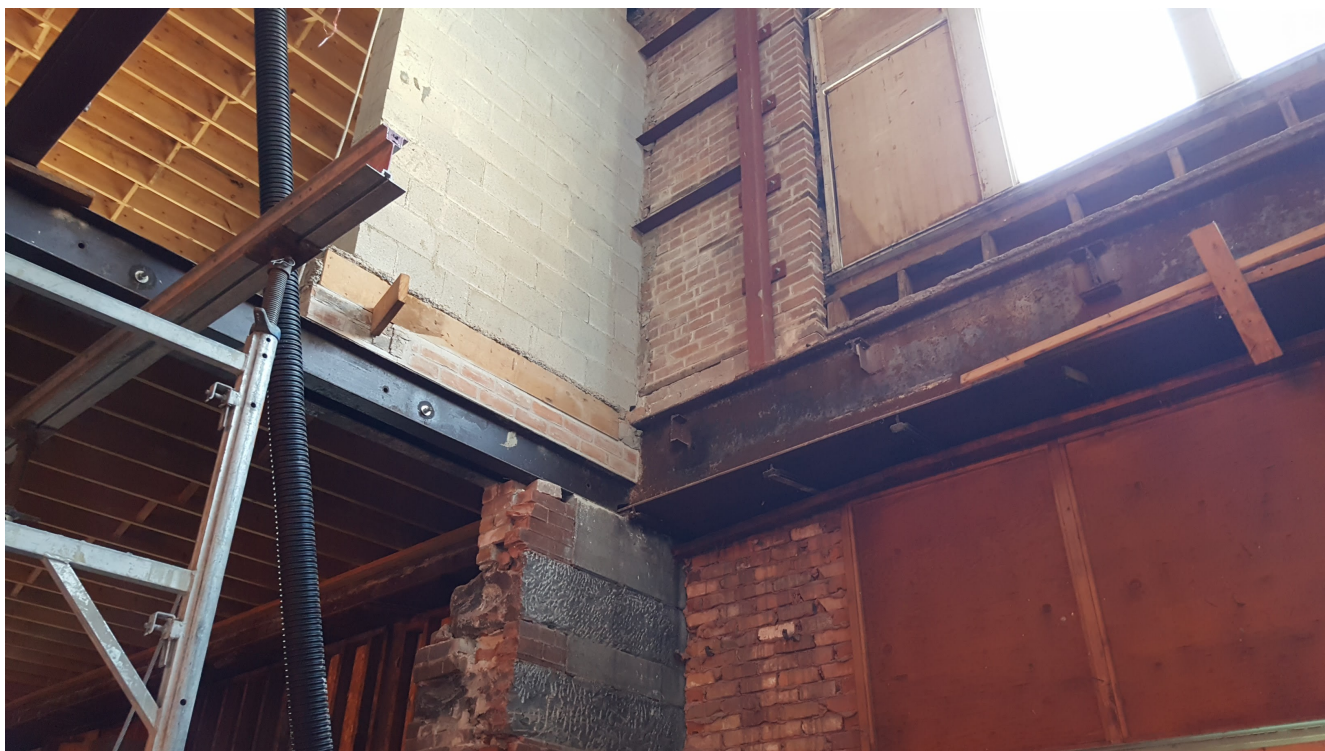
The steel framing for the new elevator shaft appears to rely upon a T-shaped fish plate into the existing stone masonry foundation wall. Such a connection can be made to function reliably when the condition of the foundation wall is excellent, the wall will be in a visible, highly likely to be maintained, location and the wall has been provided with a reliable waterproofing or water removal (weeping tile, etc) system. Refer to Photo 4.4

*Photo 4.4 - New Elevator Shaft*

**Elemental:** The connection design should be confirmed during future works. The wall should be provided with a reliable durability solution prior to being relied upon to carry vertical transportation system loads. The new elevator shaft should be provided with an independent deep foundation.

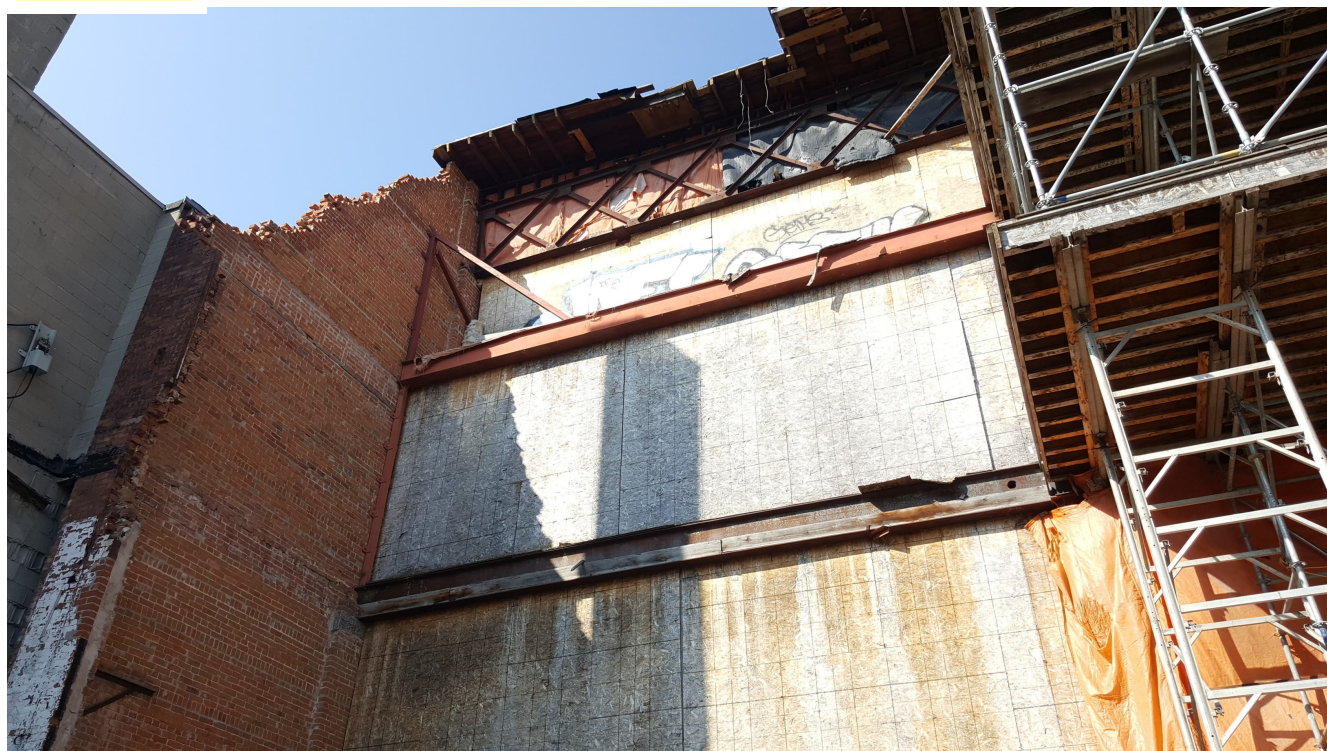
Where one structure has been built to rely upon the presence of another, the condition may be termed a Party Wall. Whereas party walls were originally load bearing walls shared between two buildings, the term has expanded to include areas of walls in contact between two buildings which effectively results in a similar condition with respect to lateral loads. The adjacent property at Bank Street is built tight to our structure from the 1<sup>st</sup> elevated floor framing to the 2<sup>nd</sup> elevated floor framing; the reason for this is not yet clear. Refer to Photo 4.7.

*Photo 4.7 - Adjacent Building Built Composite with Somerset House*

**Elemental:** Restore the party wall area, if possible. Review the supporting condition and supplement the bearing if required.

**Global:** Request and obtain access to the adjacent property, as well as the adjacent property records. Confirmation that modification to Somerset House will not affect the adjacent property is needed prior to removing the party wall condition.
