**Reference:** Conjunct geotechnical and structural site review in heritage building at 352 Somerset Street West, Ottawa, ON, conducted on June 03, 2016.

**Subject:** Conjunct preliminary discussions regarding geotechnical issues and foundation alternatives.

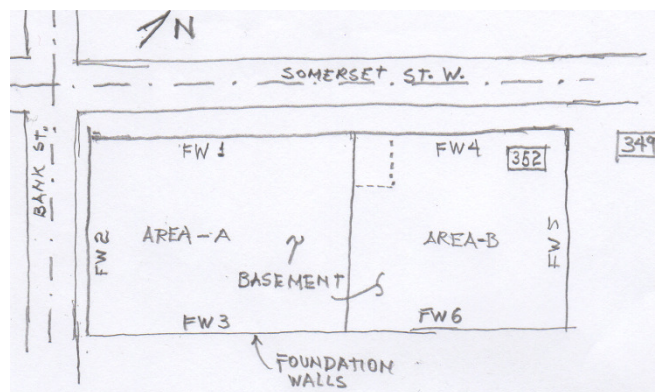
Figure 1. Basement Sketch

The site is presented in the sketch in figure 1 below. At this site soil conditions have been investigated previously.

The building was originally built more than a 100 years ago. Area A lays at approximately (~) 3.3 m below the level of the perimeter sidewalk. The west side of area B lies about the same level and the reminding area B is covered by debris and fill. These areas have been subject to excavations exceeding the depth of the existing foundations by ~ 0.6 m with the purpose of underpinning a number of years ago. The underpinning work was never finished. The building portions in area B collapsed and were removed so that presently are exposed to weather conditions. Verbal information indicate that the basement in area A has been kept heated during winter, however there have been no formal monitoring of the temperatures as the building has been vacant since failure occurred.
