June 21, 2016

OEI File: N009-003

RE: Heritage Structural Review of 352 Somerset St. W., Ottawa

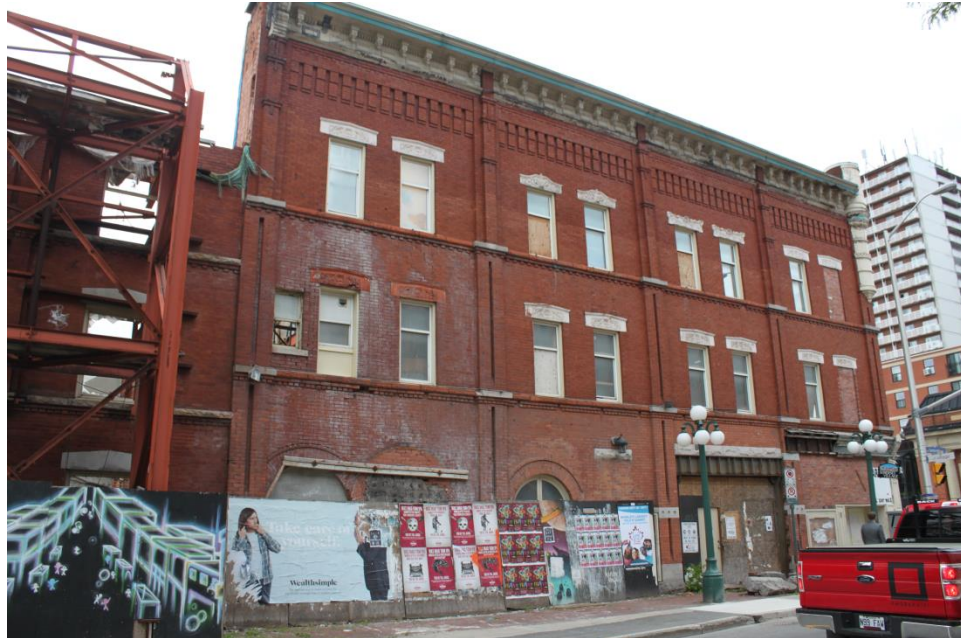
The original corner building has four distinct bays along Somerset Street. The bay on the east, next to the four storey addition, is currently partially exposed to the elements as a result of the collapse. It is not laterally stabilized by the steel frame, Figure 3.

Figure 3. Current view of the part of the Somerset Street façade

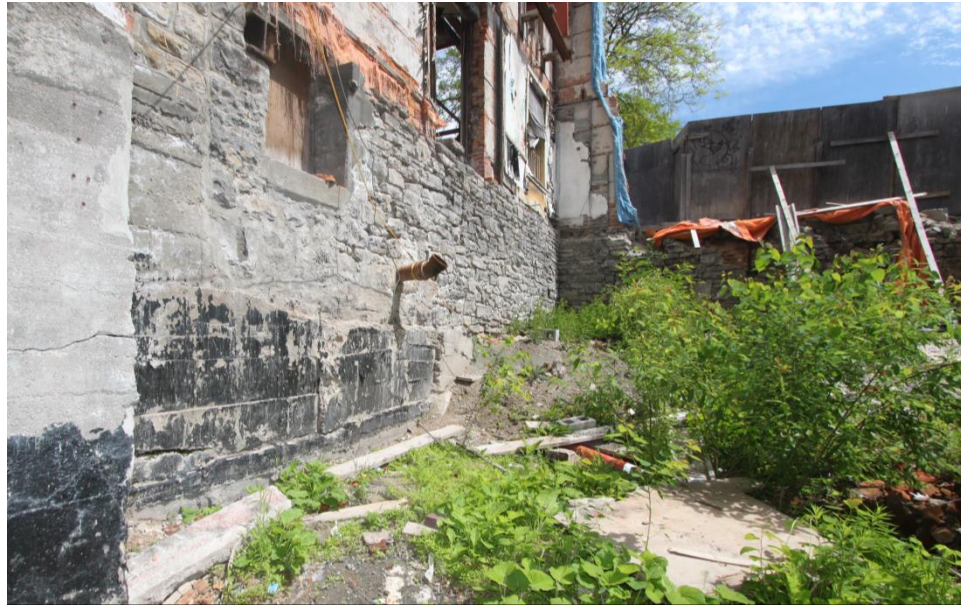
Review and repairs to all foundations. There were several underpinning campaigns. It would be prudent to closely examine all foundations and make repairs as necessary. The east-most foundation wall towards the parking lot that remained after the partial collapse of 2008 has unfortunately reached the end of its service life, and it cannot be repaired. As it is unstable, we recommend either immediate shoring or hoarding on the side of the parking lot in order to restrict car access to approximately 4 meters away from the foundation. Parts of the exposed foundation wall along the Somerset Street appear to have also exceeded its useful life. See Figure 4. It should be noted that there is no lateral support at both the ground floor and basement levels. A short perpendicular wall in line with the original three storey building provides some lateral support for the last bay of the original building, but there is no ground floor support. A professional engineer should be retained to design necessary shoring and hoarding.

Figure 4. View of the part of the Somerset Street façade foundation wall and the partly collapsed foundation along the parking lot in the background

The rubble stone masonry foundation walls along the former basement of the four storey addition should be, in general, demolished. An engineer should be retained to design retaining walls that will support the sidewalk and the parking lot until the construction of the new building in place of collapsed one.

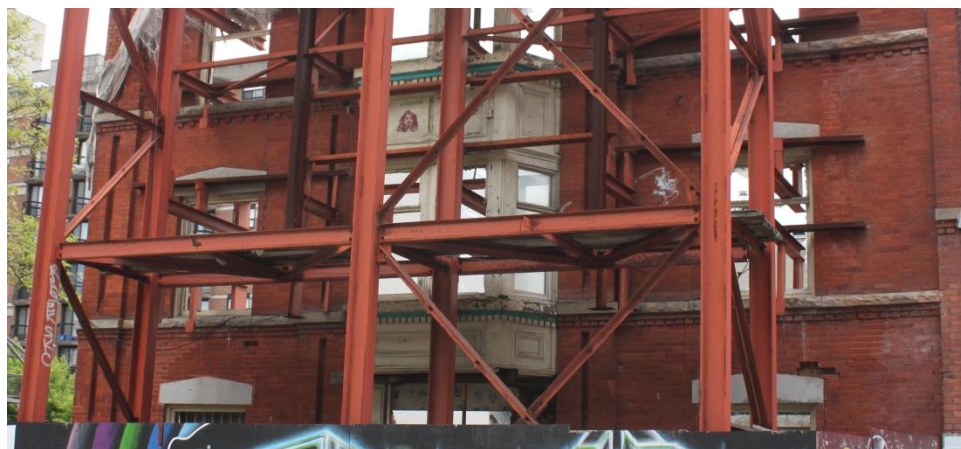
Three storey wall of the four storey addition. This wall has been exposed to the weather from both sides since the partial collapse of 2008. Although it does not show signs of major deterioration, it is very likely that exposure to the water and freeze-thaw cycling has damaged the wall beyond reasonable repair in situ. Closer inspection from the existing shoring tower could determine how much of the existing brick and stone etc. can be salvaged for re-use in restored building, Figure 5. Heritage recording of the wall would be a must if the rebuilding of this section is to have historical appearance. We did not have a close-up access to the wall in order to confirm CEL's assertion that the wall is in immediate danger of collapse. We also disagree about the method of demolition. There is a good chance that a large number of original bricks can be salvaged for reuse somewhere else in the building. The stone bands at window sill level and stone window lintels may also be salvaged.

Figure 5. View of the part of the Somerset Street façade wall

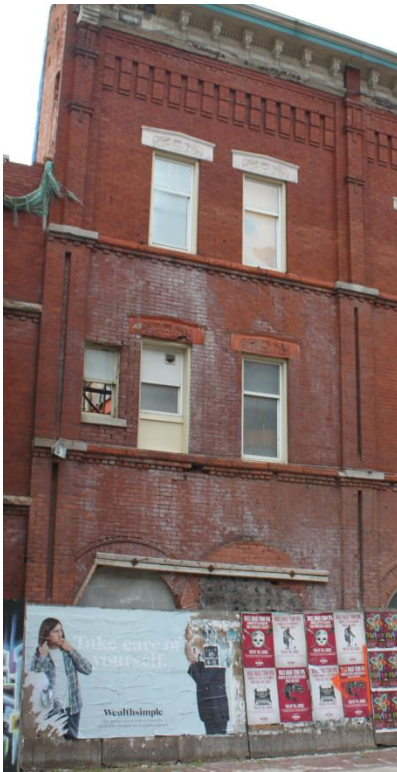
The first bay of the original building, adjacent to the four storey addition. This bay (CEL's reference: Gridline A between gridlines 4 and 5) has unfortunately been exposed to the weather since the collapse as well. One could dwell on the reasons why it seems to be in the worst shape than the remaining wall of the addition. The efflorescence on the street (north) side and excessive spalling of the brick face on the building (south) side caused by the freeze-thaw cycling indicates that the load bearing characteristics of this wall have been completely jeopardised. Although CEL report suggests that it could be possible to repair the wall in situ by careful removal and replacement of the brick on a brick-by-brick basis, it is quite likely that the middle wythe of the three-wythe wall is also damaged by the frost action. We are of the opinion that much better result would be achieved by careful recording, dismantling, and rebuilding of the wall using as much of the original brick and terracotta features as possible. **Heritage architectural recording of the façade is required in order to retain as much as possible of the original building fabric, and to be able to replicate damaged elements and the original building appearance** A detailed laser scanning could be used for replication of elements deteriorated beyond repair. The brick reclaimed from the four storey addition could be used as needed to complete this part of the wall with 100% original material.

Figure 6. Efflorescence as evidence of constant wetting of the wall

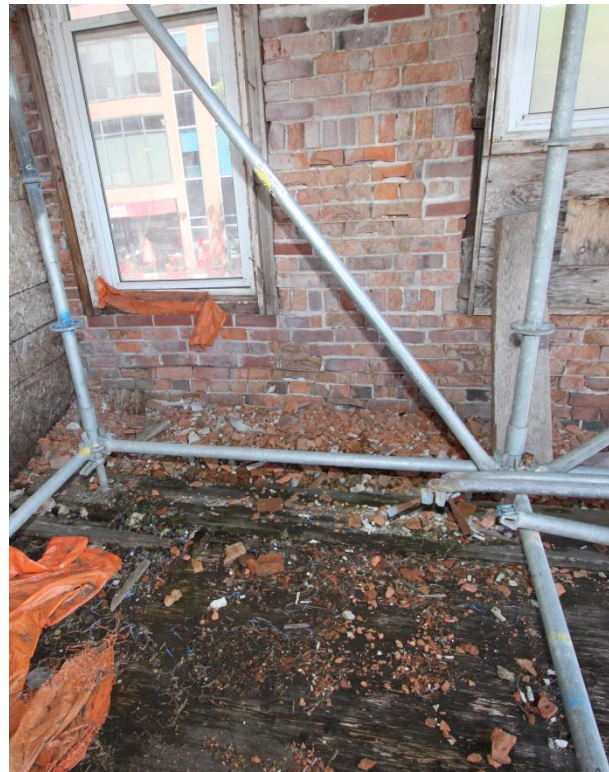
Figure 7. Substantial spalling of the interior face of the brick exposed to the sun during the winter months

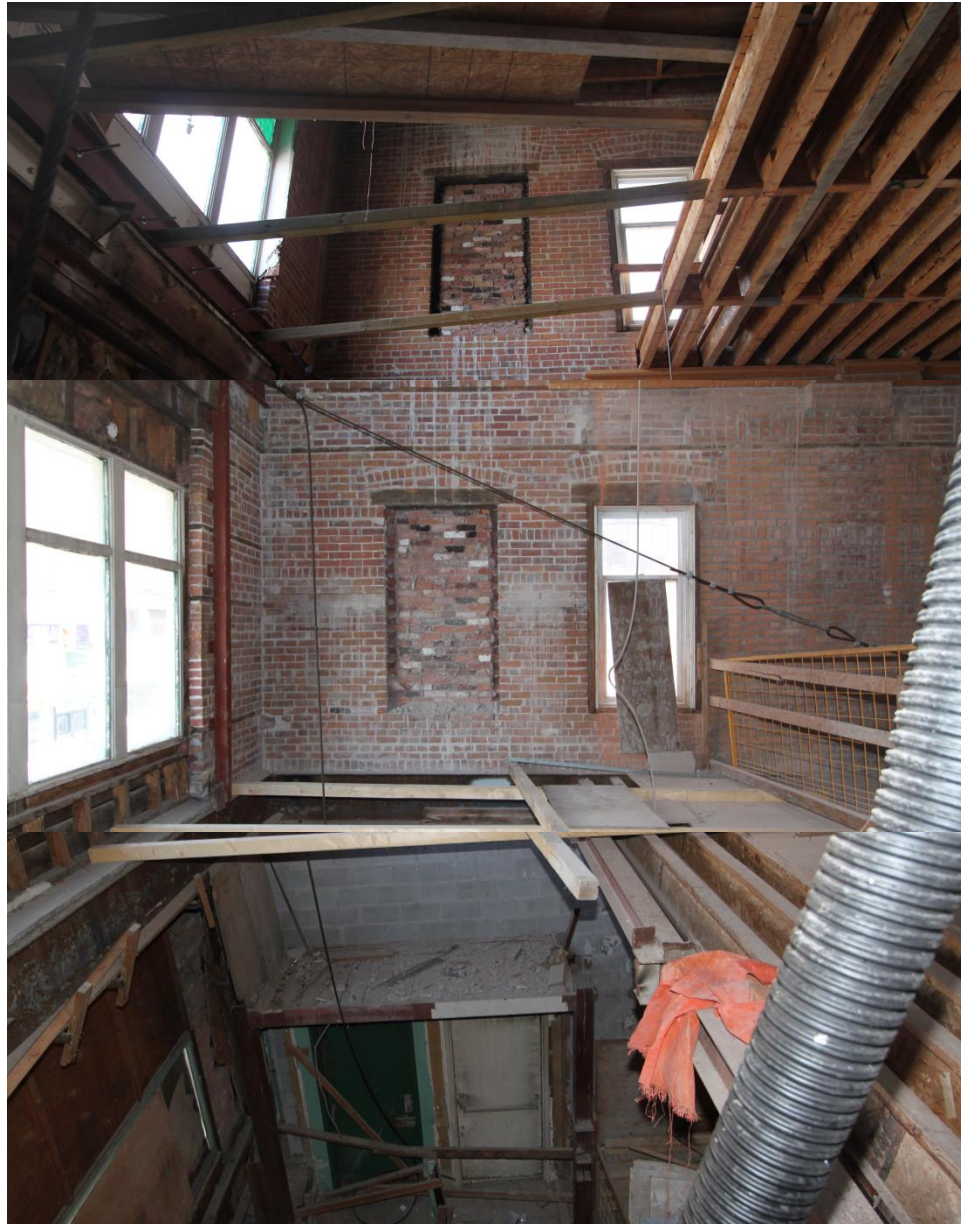
Remaining walls of the original building on Somerset and Bank streets. These walls appear to be in reasonable state of repair. We are concerned with the stability of the walls at the corner of the building and at the south-west staircase. The floor diaphragm is missing in the first bays along Somerset and Bank Streets. Some temporary ties seem to be installed to support the wall along the Bank Street, but it is not clear if anything has been done for the Somerset Street wall. See Figure 8. The staircase opening in the south-west corner leaves high wall unsupported.

Figure 8. Composite view of the unsupported walls at the corner of Bank and Somerset Streets

A holistic approach should be adopted for the remainder of the building. Several deficiencies noted above focus around the need for establishment of the lateral force resisting system. Once the program for the building is determined, a heritage structural engineer experienced in seismic analysis and design of strengthening of masonry buildings similar to this one should be retained to perform the analysis and design. The scope should include strengthening of the floor and roof diaphragms, their attachment to the walls, verification of the stability of slender and unsupported walls where they are needed (staircase, for example), verification of the roof trusses and roof framing in general, etc.
