CONSERVATION PLAN

ALEXANDER FLECK HOUSE DEVELOPMENT

593 LAURIER AVENUE, OTTAWA, ONTARIO

Conservation Plan – Alexander Fleck House Development (593 Laurier Avenue)

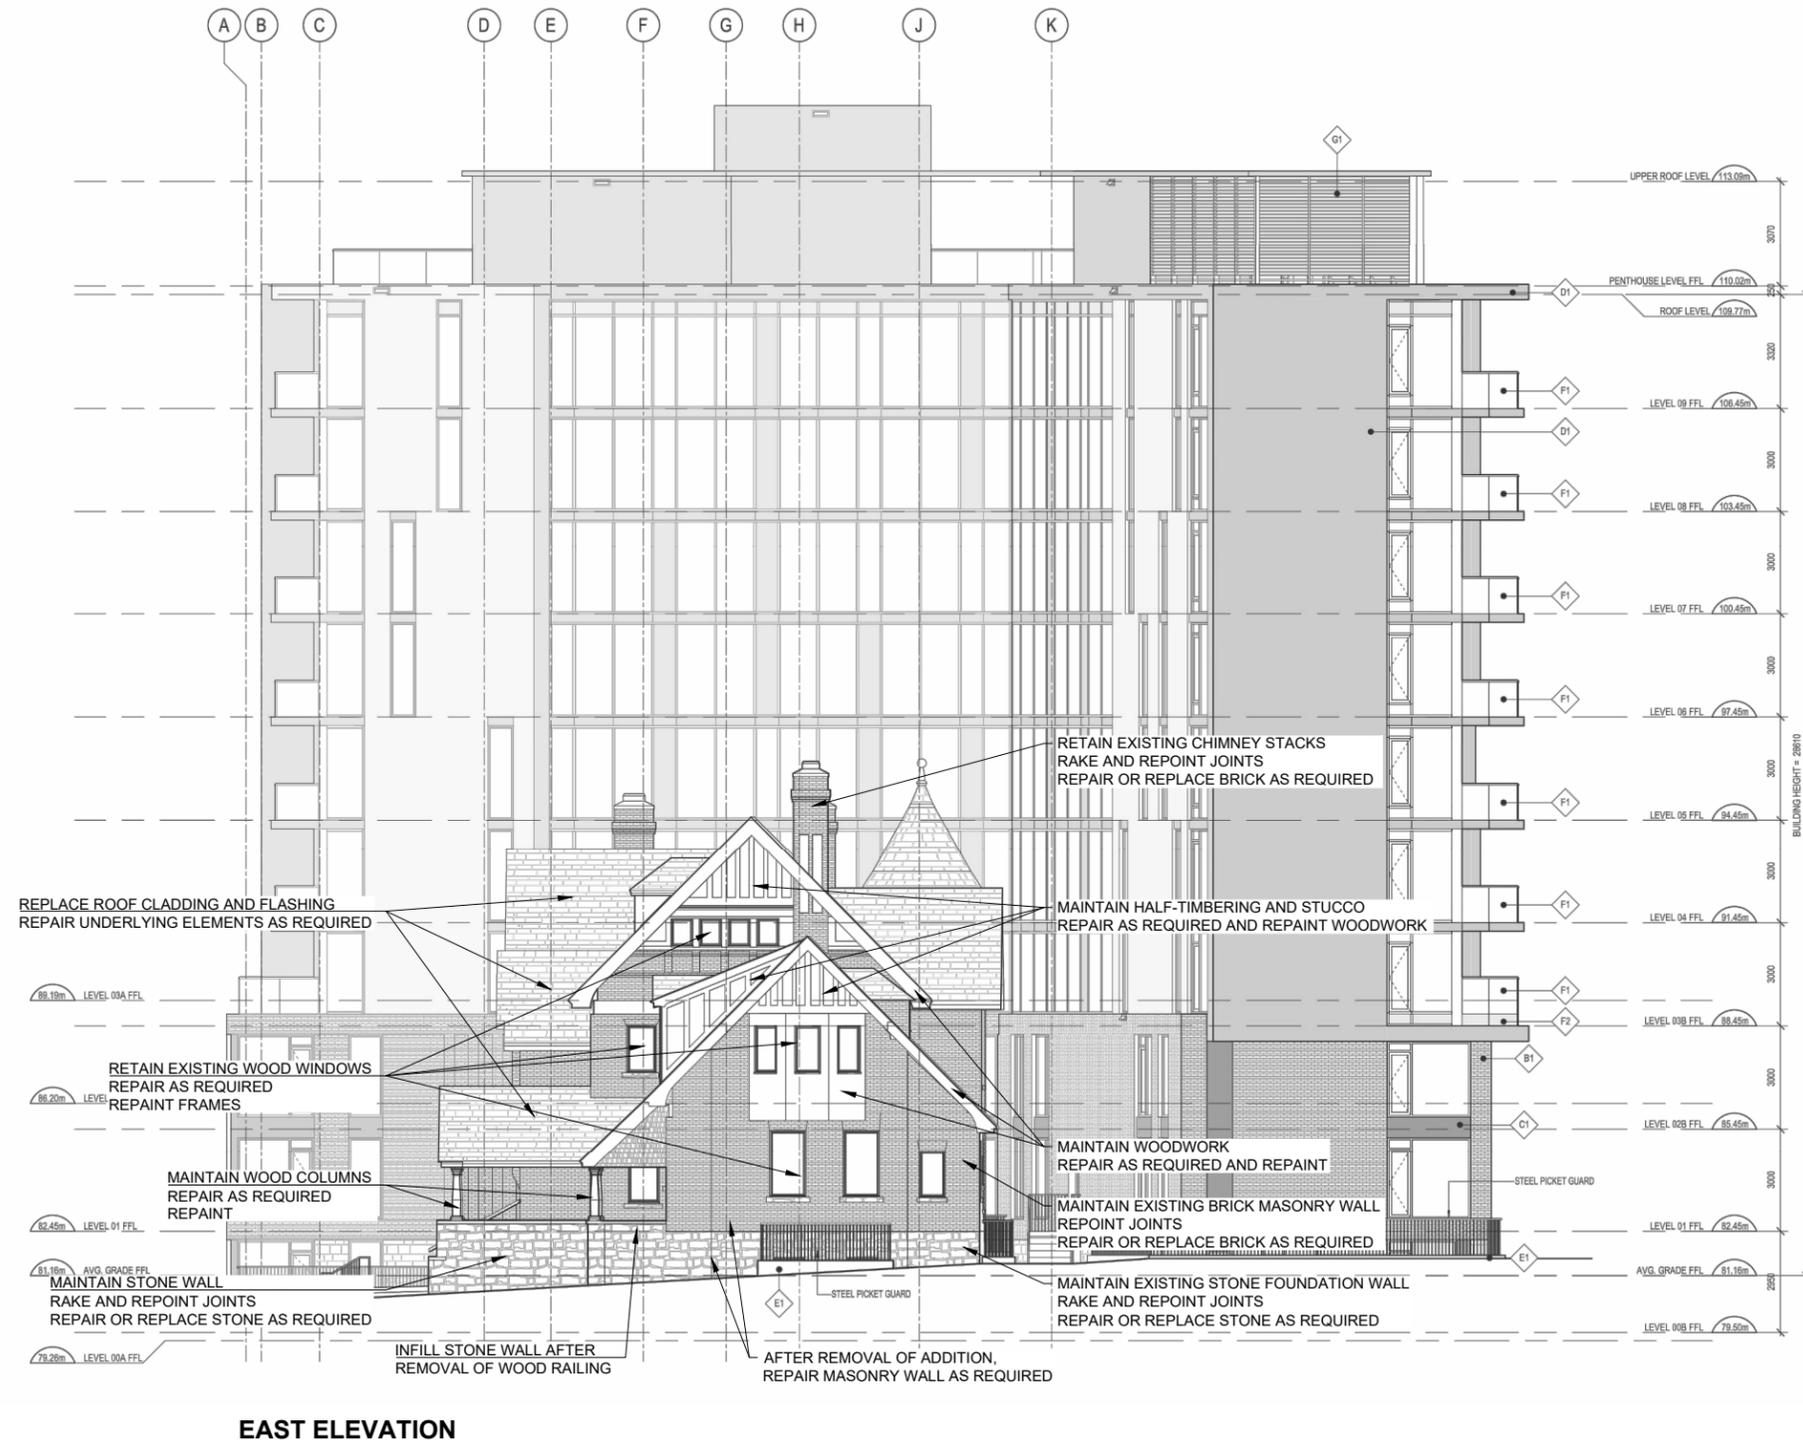
The bay window on the east side of the building consists of three wood-framed windows, surrounded by painted wood cladding and trimming. The bay window should be preserved and repaired. Of note is the deterioration of the wood seen at the base of the central window. This, and other deterioration, should be repaired with dutchmen repairs or by replacement in kind of the damaged components if beyond repair. Further investigations should be conducted to ensure that no further damages have occurred and that the bay window remains structurally sound. The wood frames and surrounding woodwork and cladding should be repainted, as per the *Woodwork* section above.

The woodwork should be stripped, any damaged element restored and repaired if possible or replaced in kind if beyond repair, and repainted with compatible paint. Rotting or damaged wood, as seen at the east bay window, should be repaired through dutchmen repairs if possible, or replaced in kind and refinished to match. Proper drainage should be maintained from the roof to prevent the accelerated deterioration of the woodwork.
