THE MATERIAL CONSERVATION PLAN 100 ARGYLE AVENUE, OTTAWA

COMMONWEALTH HISTORIC RESOURCE MANAGEMENT

REVISED NOVEMBER 2020

THE MATERIAL CONSERVATION PLAN

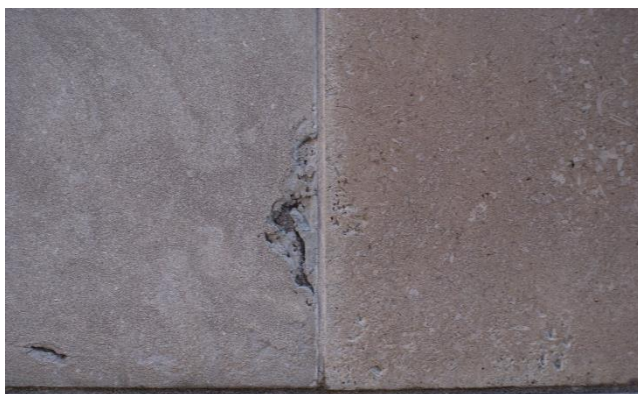
Figure 8: Detail view of ashlar limestone blocks with voids or vugs in the unit to the left. Note the shell fossils in the block to the left. Source: CHRM.

Conservation Approach: Selective retooling and removal of loose or disaggregated stone. Application of a repair mortar such as Jahn M70 Limestone custom coloured to match the stone.

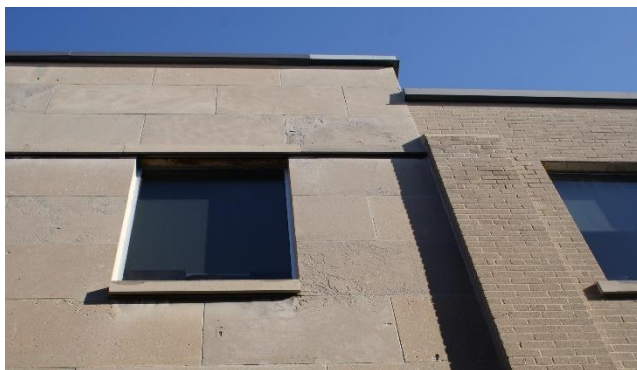
Delamination - Delamination corresponds to a detachment following the bedding or schistosity planes of a stone. This is a relatively common problem with the stones on the three façades, being more common on the two secondary or return walls where the mason chose to place the poorer quality material.

Figure 9: Detail view of a portion of the west façade. A delaminating stone is located to the bottom right of the window, as well as the face stone to the right of the window above the belt course. There are also a number of vugs or inclusions evident in the face stones. Source: CHRM.

Conservation Approach: Selective retooling of the surface to remove loose and scaling material.

Complete replacement of stone face units with more severe surface delamination.

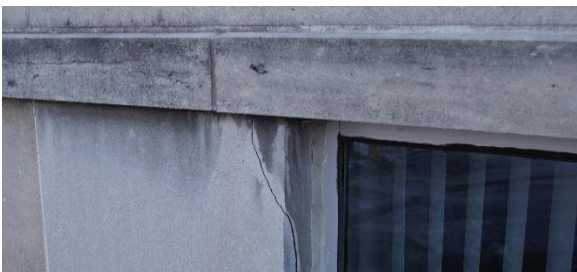
Fracturing – Delamination of a stone at a bedding plane that has different material characteristics. This is more common with the stones in the belt courses, and windowsills.

Figure 10: View of a stone in the belt course (left) that has different material characteristics in the process of fracturing at a bedding plane. Source: CHRM.

Conservation Approach: The options in regards to the stone windowsills are to replace defective units. This would entail a minimum of effort in that the slip sills are not tied into the adjacent walls. The course of action for defective stones in the belt courses is to replace the units by cutting out the mortar joints and removing the stone.

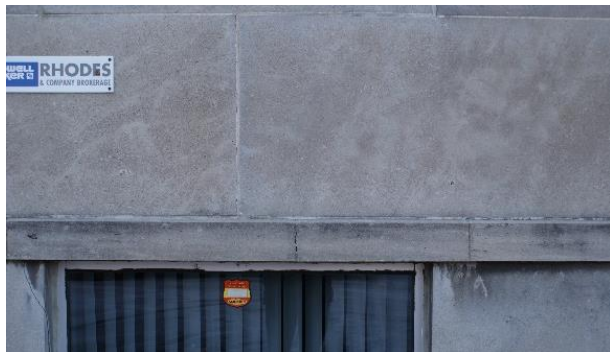
Cracking – A very limited number of stones in the belt course, one face stone, and a doorsill have cracked.

Figure 11: Detail of east elevation at the basement level. The stone belt course is cracked at the mid-point, and the face stone at the lower left below the window has sheared at an external corner. Source: CHRM.

Conservation Approach: Varies from complete replacement, to inserting stainless steel pins and applying a repair mortar such as Jahn M70 Limestone, custom coloured to match the stone. Alternately, if left in-situ, leave the stone in place and do nothing depending upon its visibility.

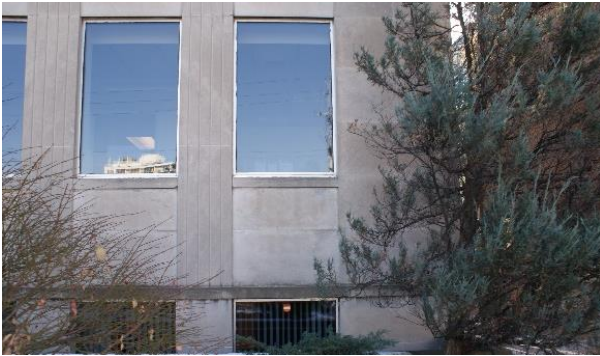
Compression Chipping - Small chips detached from the stone at masonry joints due to settling or deflection of the wall due to loading. This is evident in four of the reeded stones at the top of the first floor windows on the east side of the north façade (See Figure 11).

Figure 12: Detail view of north elevation with vertical reeded blocks, and the recessed panels below the first and second floor windows.

Conservation Approach: Remove chips and retool the area. Review structural loading conditions that caused the deflection.

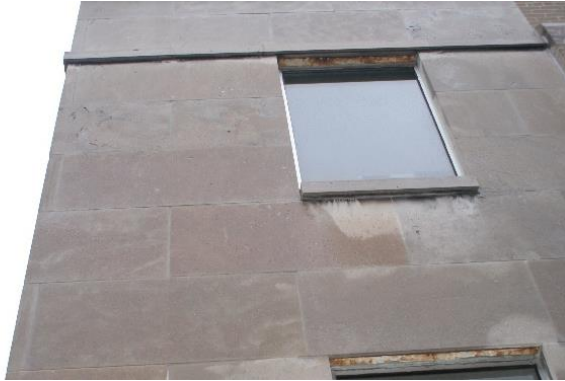
Figure 14: Note the rusting steel angle below the parapet belt course and the first floor window. There are indications on the north façade that the shelf angle below the parapet belt course is continuous. If this is the case, there is a high probability that the steel angle is secured to steel buried behind the wall.

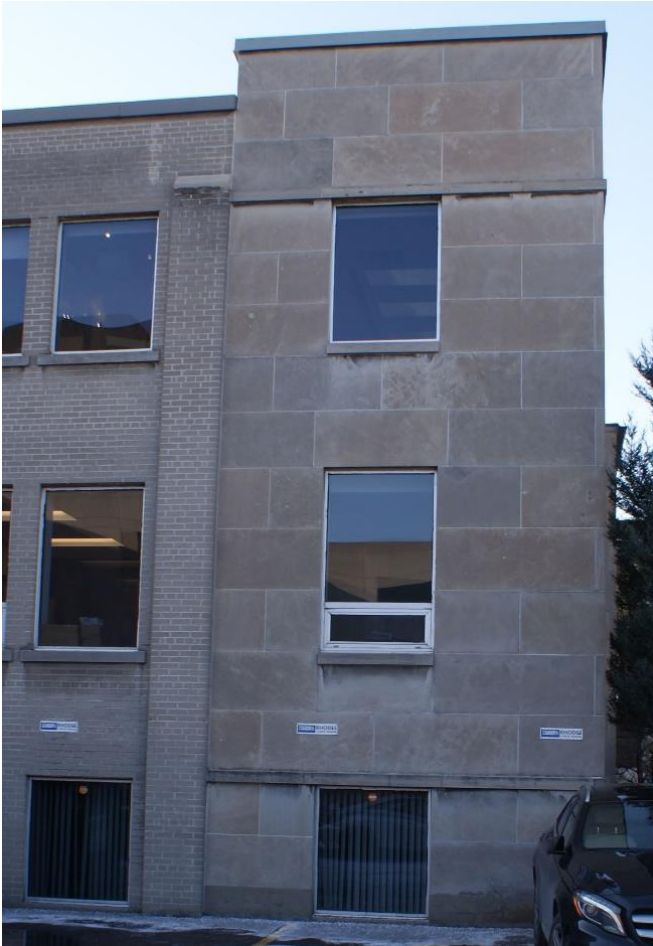
Figure 15: View of the east façade of the building. Note the lintel stone above the first floor window that overlaps onto the adjacent stones indicating a traditional load-bearing application. Note the projecting brick pilaster and its termination at the top. A steel column is likely buried behind the pilaster. The beam may support additional horizontal steel beams that would support the parapet, to which the continuous shelf angle evident below the parapet belt course would be attached.

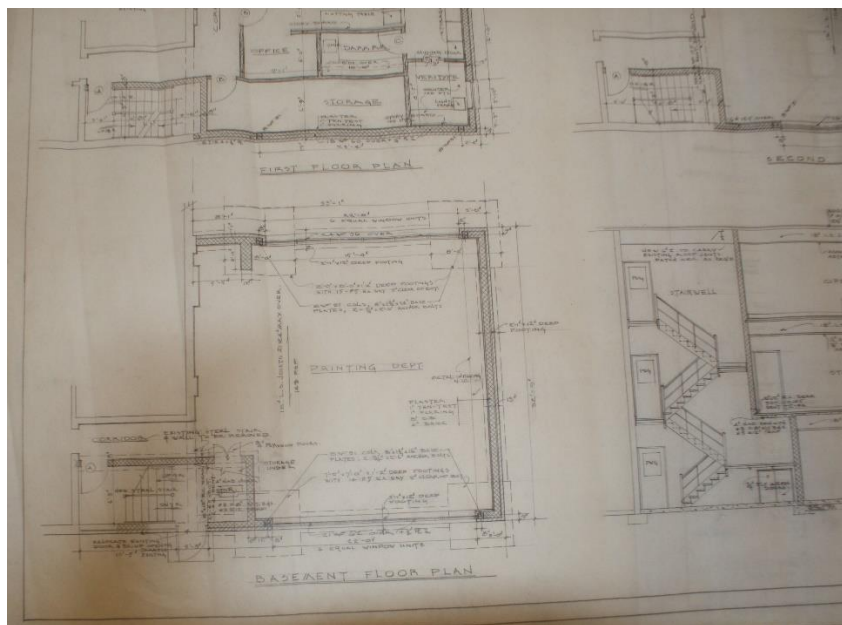
Figure 16: Partial drawing for the 1959 addition. The addition and the main building were completed within 5 years of each other. The likelihood is that the same construction methods and techniques were used in the main building and the addition. Note how the floor slabs are shown penetrating the interior concrete back-up wall, which should be documented during the demolition of the floor plates. Similar wide flange steel beams specified in the 'Notes' may have been used in the main building to support the masonry above the main entrance and other locations. Source: LAC Lithwick Collection Mikan No. 4002312.

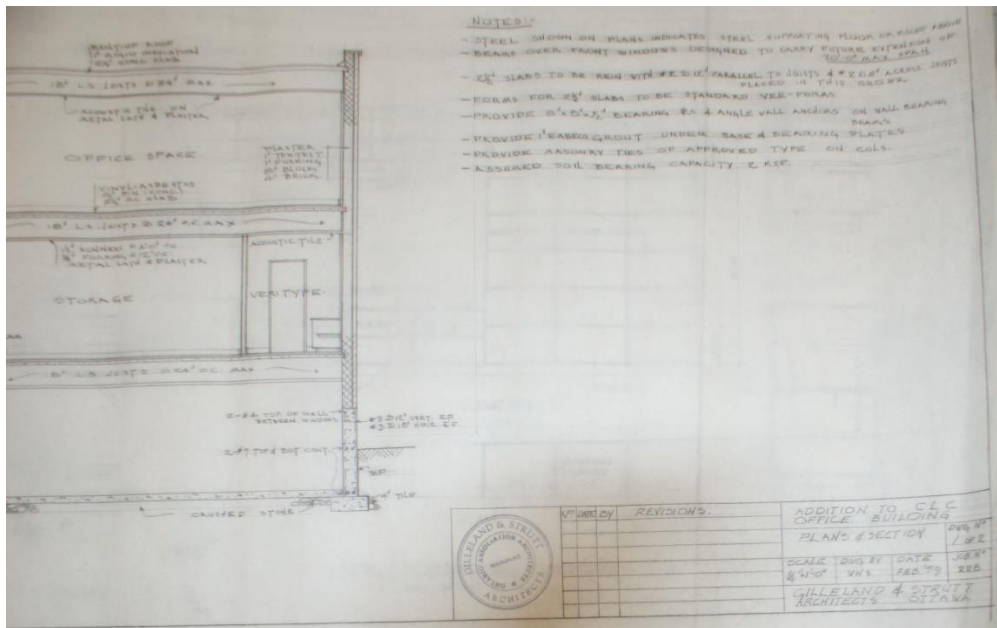
Figure 17: Partial plan and section of the 1959 addition. Note the steel columns embedded in the concrete block walls. Additionally, note the wide flange beams sizes supporting masonry walls above fenestrations as well as other locations. Source: LAC Lithwick Collection.
