LETTER REPORT

Consultancy Services
for Structural Assessment on the Chancery
located at

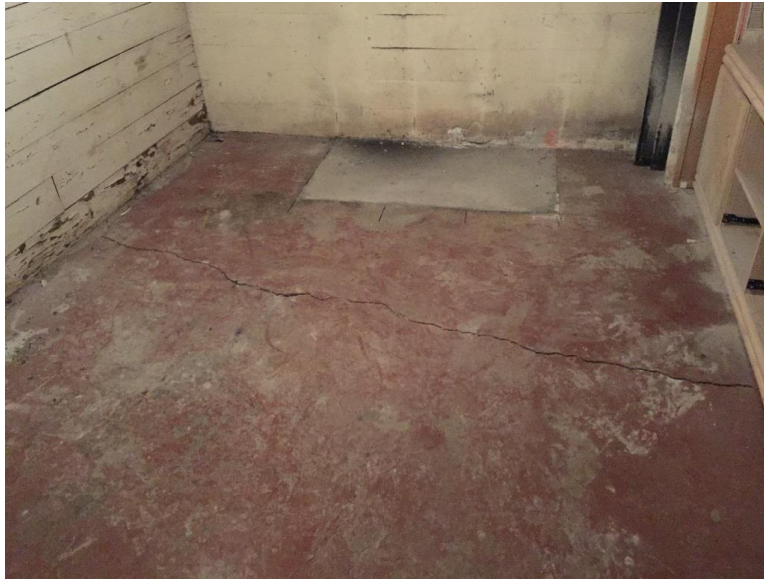
Photo 1: Crack in slab on grade noted basement utility room at southeast portion of the building.

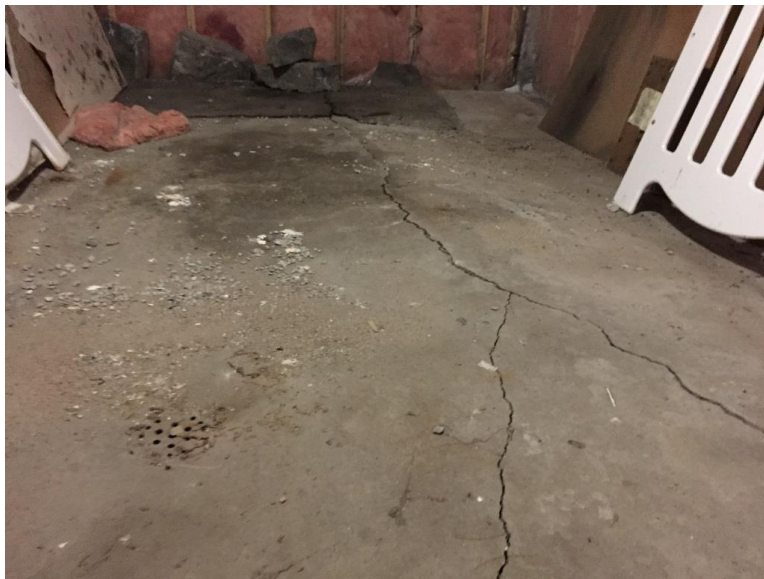
Photo 2: Extensive slab on grade cracking in former garage along northwest area of basement.

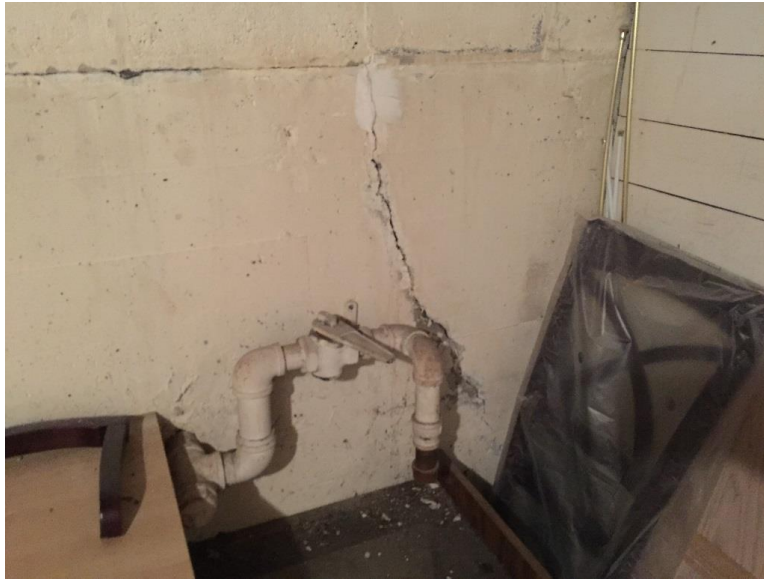
Photo 3: Cracking of poured in place concrete basement wall in the southeast corner of the building.

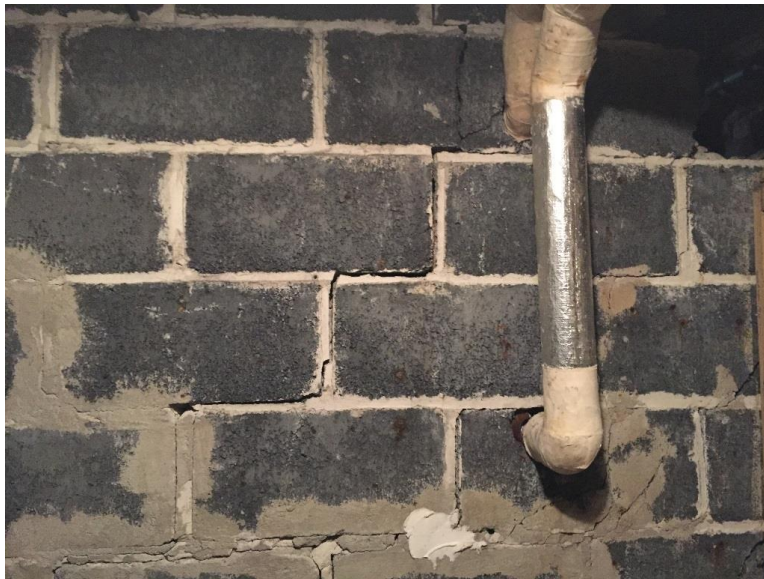
Photo 4: Block masonry walls in basement show multiple repairs and ongoing step cracking in numerous locations (typical).

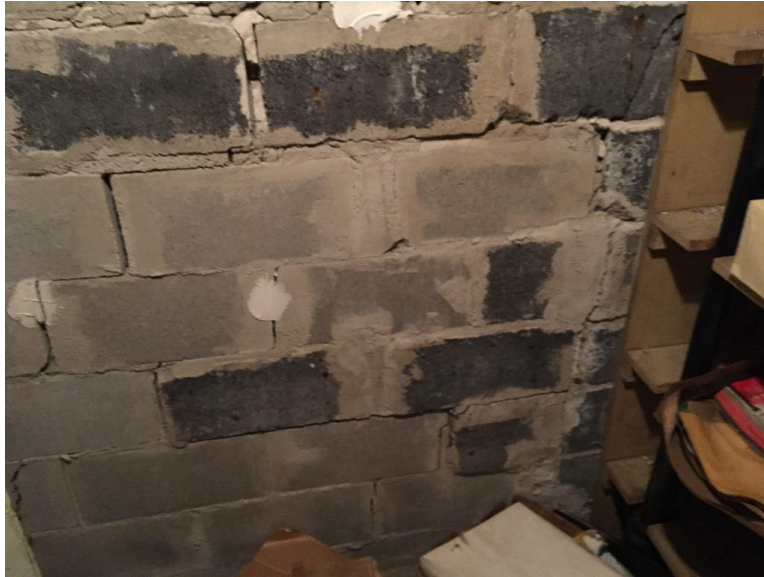
Photo 5: This location shows one of numerous repairs with ongoing step cracking (typical).

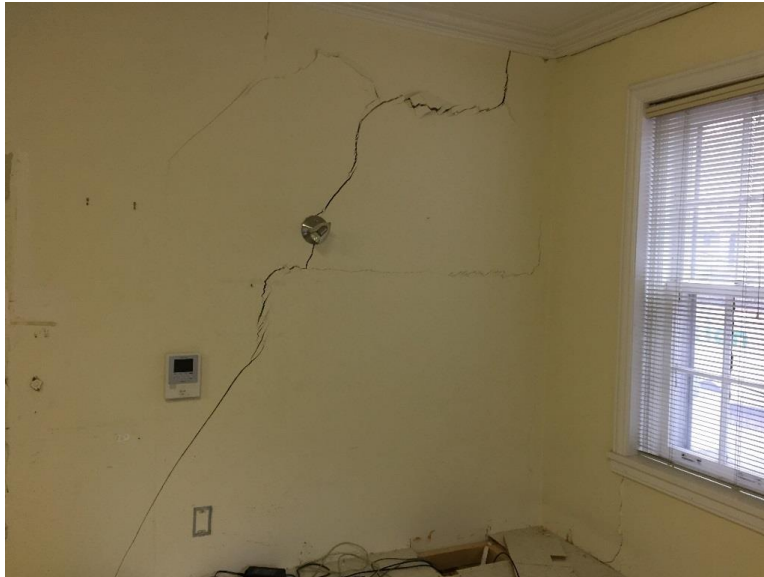
Photo 6: Extensive crack on interior wall along south elevation (Living Room - 113).

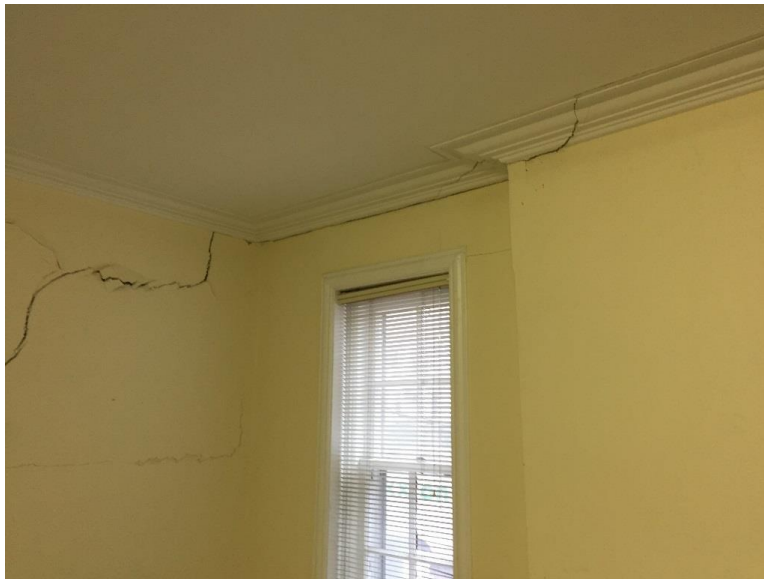
Photo 7: Cracking shown in photograph 6 continues along south wall.

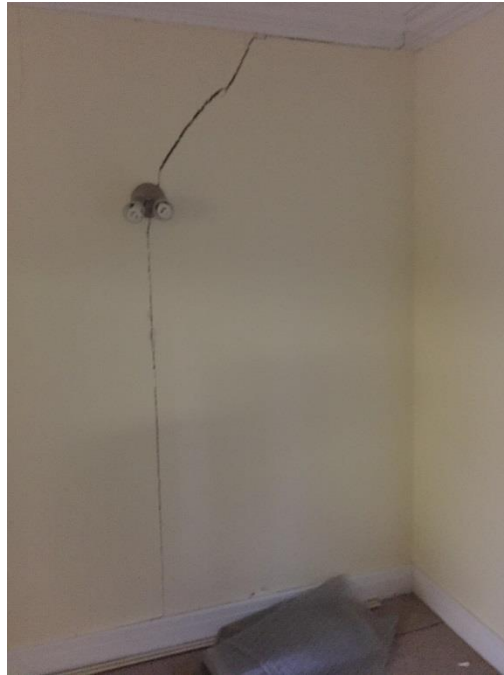
Photo 8: Crack complete height of wall northeast corner of dining room-111.

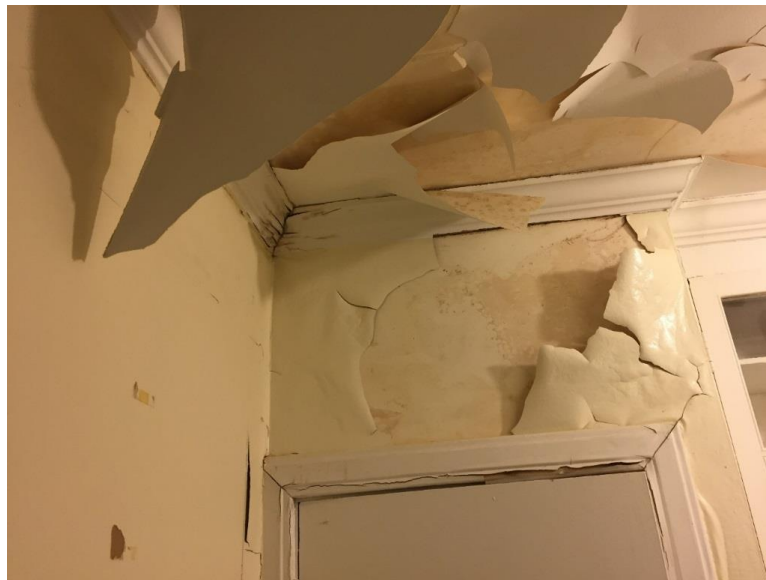
Photo 9: Severity of plaster and paint issues in kitchen effectively hide structural cracks. However, a number of cracks were noted including the doorframe visible in this photo.

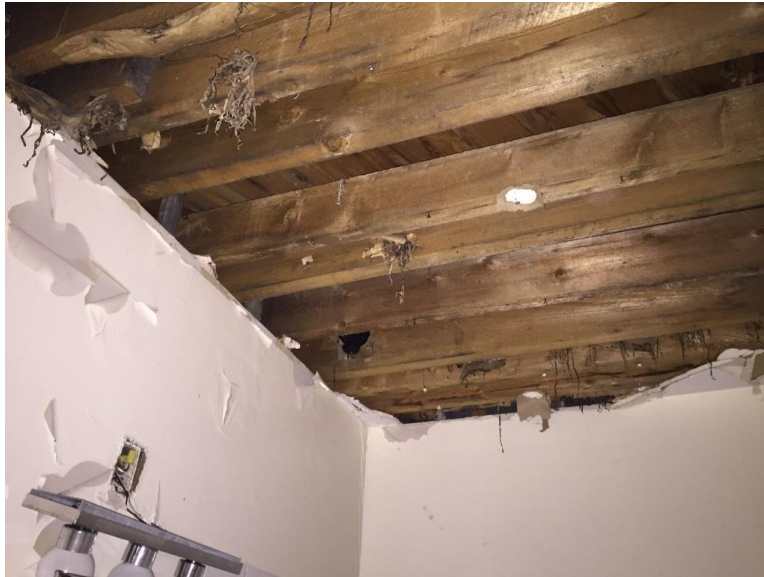
Photo 10: Failure of ceiling likely the result of ongoing water damage.

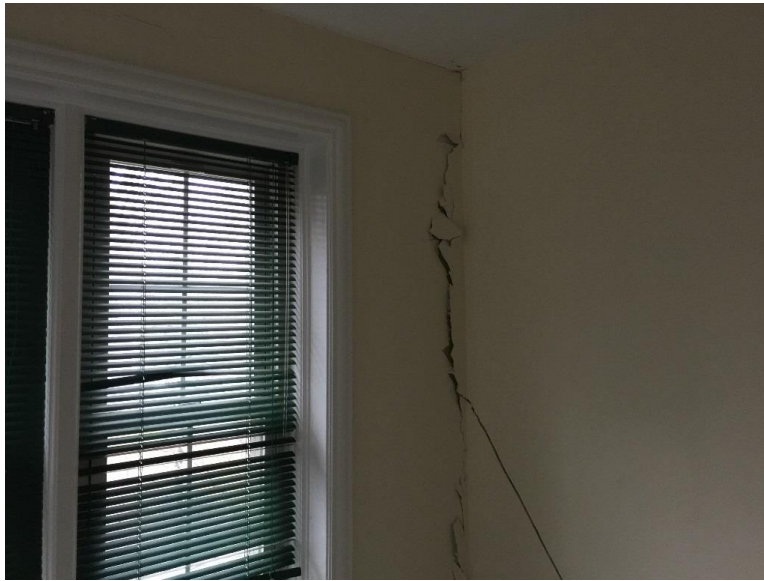
Photo 11: Similar to noted issue on level 1, some of the most severe wall cracking noted along south elevation (office - 209).

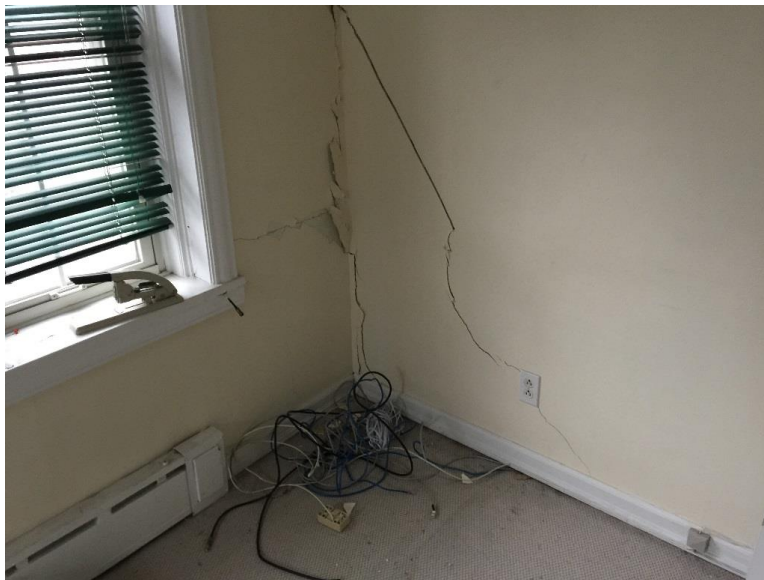
Photo 12: Continuation of cracking noted in photograph 16 above.

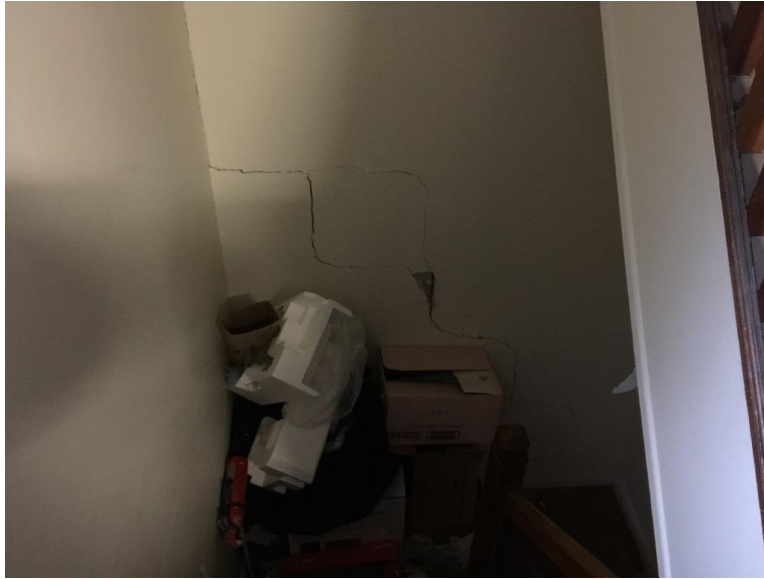
Photo 13: Step crack in stairway along east elevation.

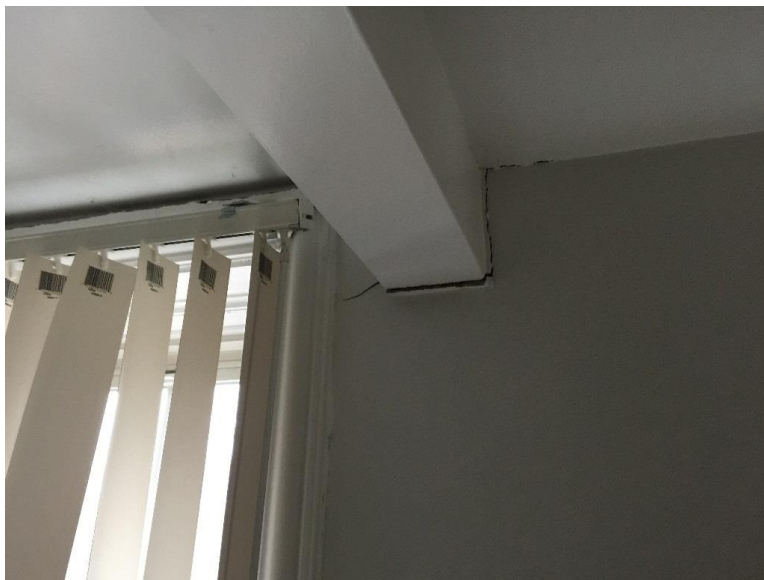
Photo 14: Significant movement indicated by pattern of cracks noted along north elevation at end of corridor.

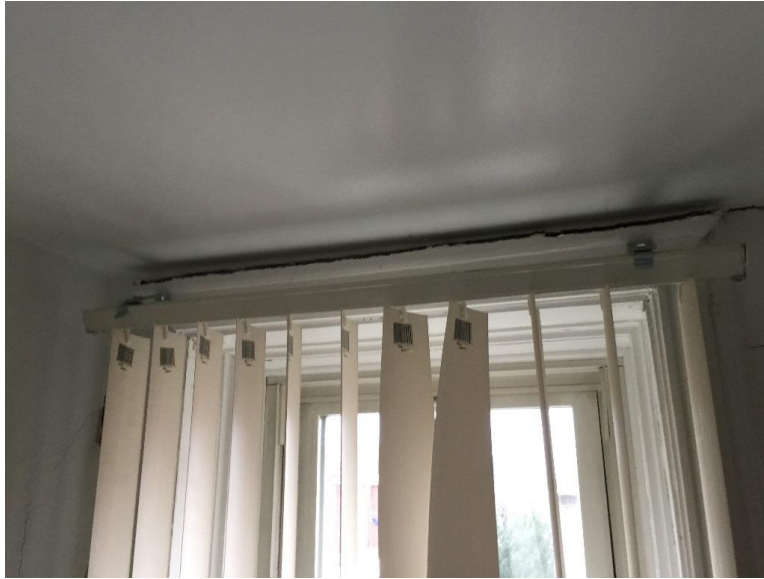
Photo 15: Continuation of cracking noted in photograph 25 above.

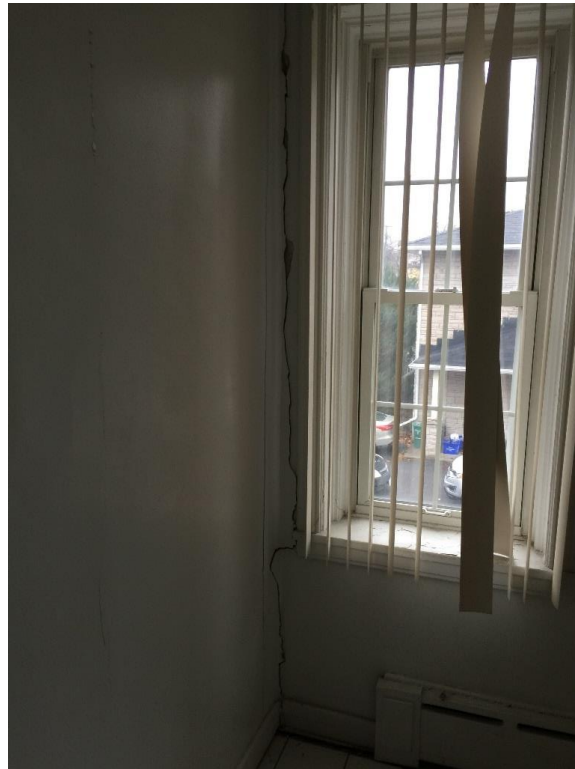
Photo 16: Continuation of elongated crack noted in photograph 26 above.

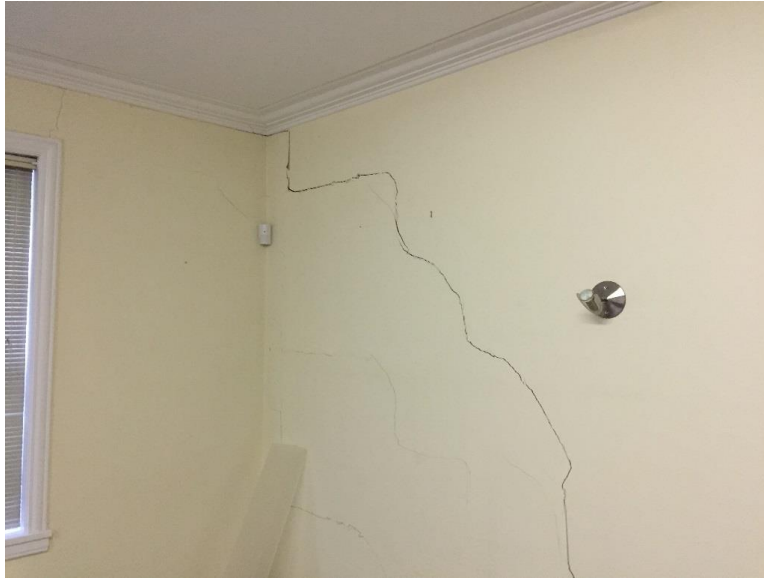
Photo 17: Extended crack at interior wall along west elevation in High Commissioners Office - 210. Although not clear in photograph, multiple separate horizontal cracks exist at roughly 3 ft. intervals down the wall.

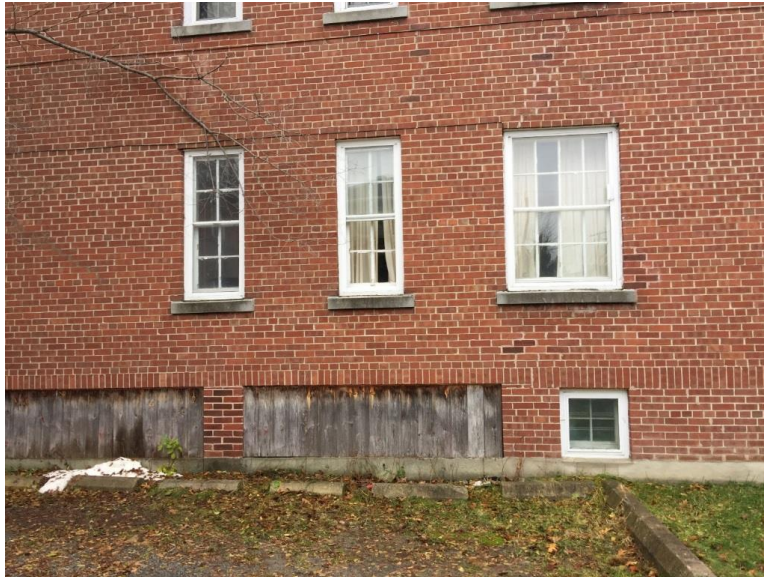
Photo 18: The exterior brick cladding shows multiple repairs.

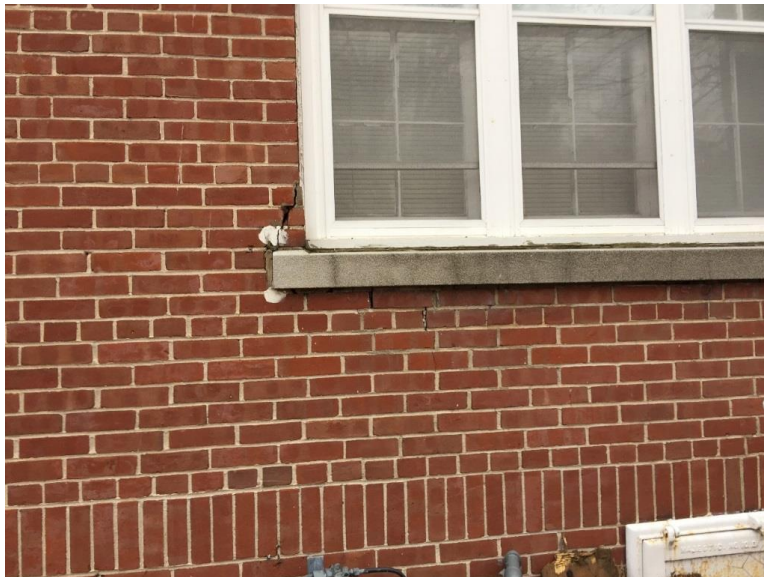
Photo 19: This large crack and step cracking beneath window sill on south elevation indicative of conditions throughout the building.

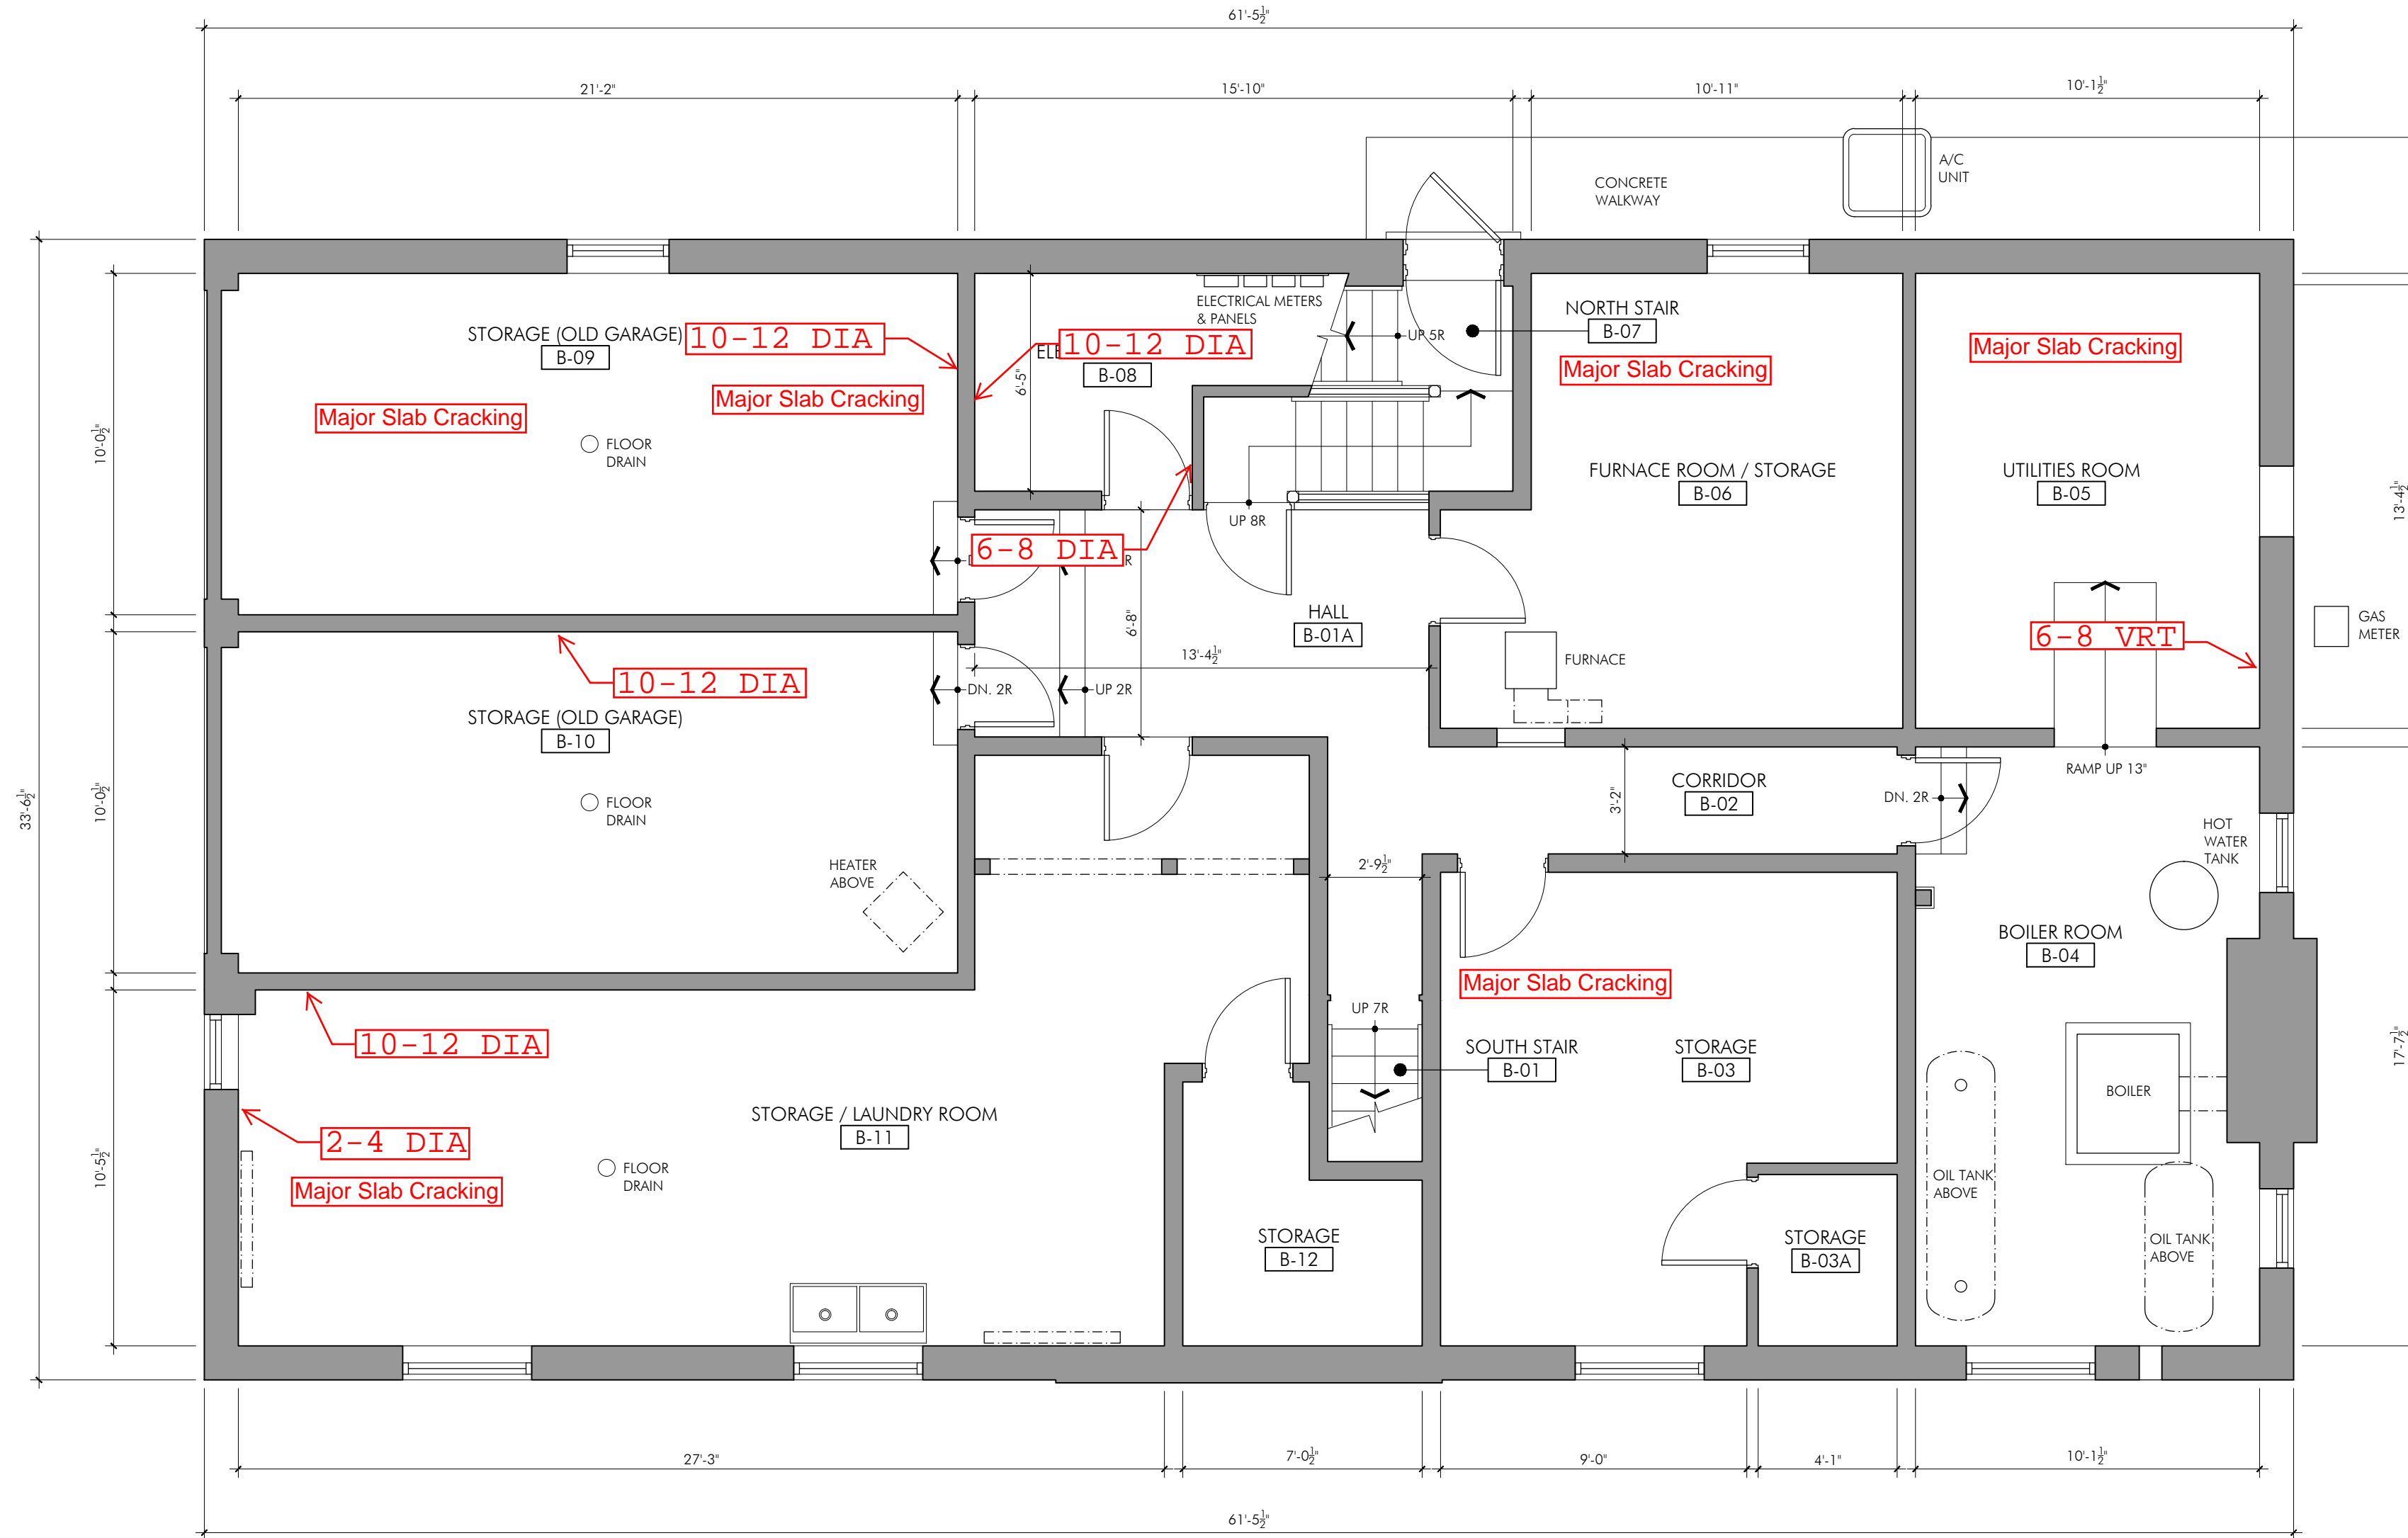
NOTE:
ESTIMATES SHOWN ARE APPROXIMATE WALL CRACK LENGTHS MEASURED IN LINEAR FEET (LFT)
LEGEND:
VERTICAL CRACKING (VRT)
HORIZONTAL CRACKING (HRZ)
DIAGONAL CRACKING (DIA)
SOFFIT CRACKING (SFT)
TOPSIDE CRACKING (TPS)

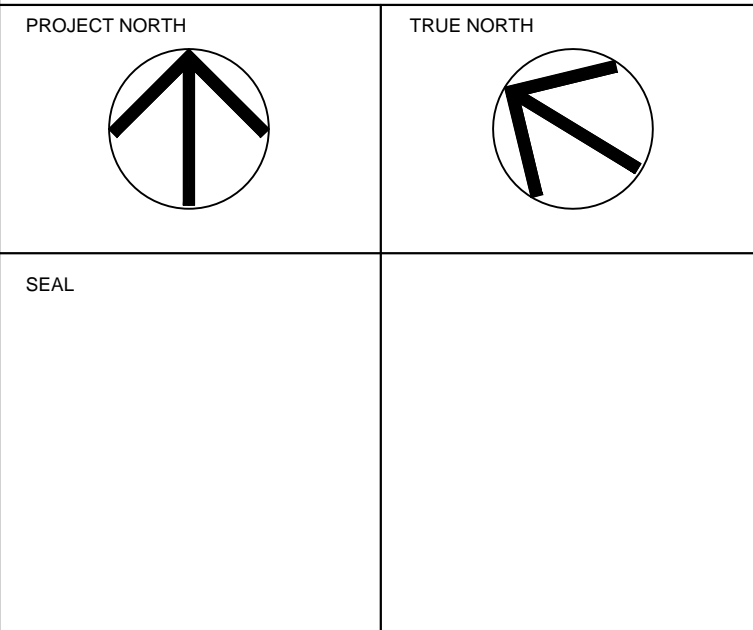
DRAWINGS ARE NOT TO BE SCALED.
CONTRACTOR TO CHECK AND VERIFY ALL DIMENSIONS AND CONDITIONS ON THE JOB AND REPORT ANY DISCREPANCIES TO THE ARCHITECT BEFORE PROCEEDING WITH THE WORK.
©ALL RIGHTS RESERVED. THE USE OF ANY PART OF THIS DRAWING REPRODUCED, TRANSMITTED IN ANY FORM OR BY ANY MEANS WITHOUT THE PRIOR CONSENT OF THE ARCHITECT IS AN INFRINGEMENT IS STRICTLY PROHIBITED.

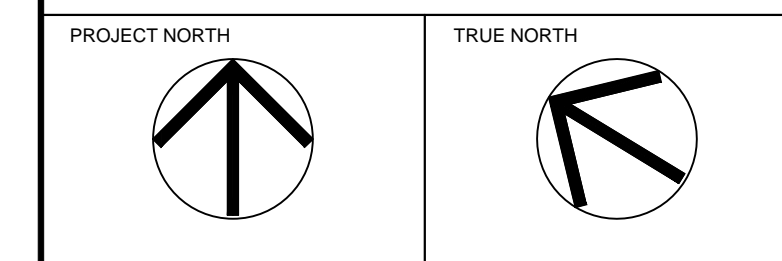
DRAWINGS ARE NOT TO BE SCALED.
CONTRACTOR TO CHECK AND VERIFY ALL DIMENSIONS AND CONDITIONS ON THE JOB AND REPORT ANY DISCREPANCIES TO THE ARCHITECT BEFORE PROCEEDING WITH THE WORK.
©ALL RIGHTS RESERVED. THE USE OF ANY PART OF THIS DRAWING REPRODUCED, TRANSMITTED IN ANY FORM OR BY ANY MEANS WITHOUT THE PRIOR CONSENT OF THE ARCHITECT IS AN INFRINGEMENT IS STRICTLY PROHIBITED.

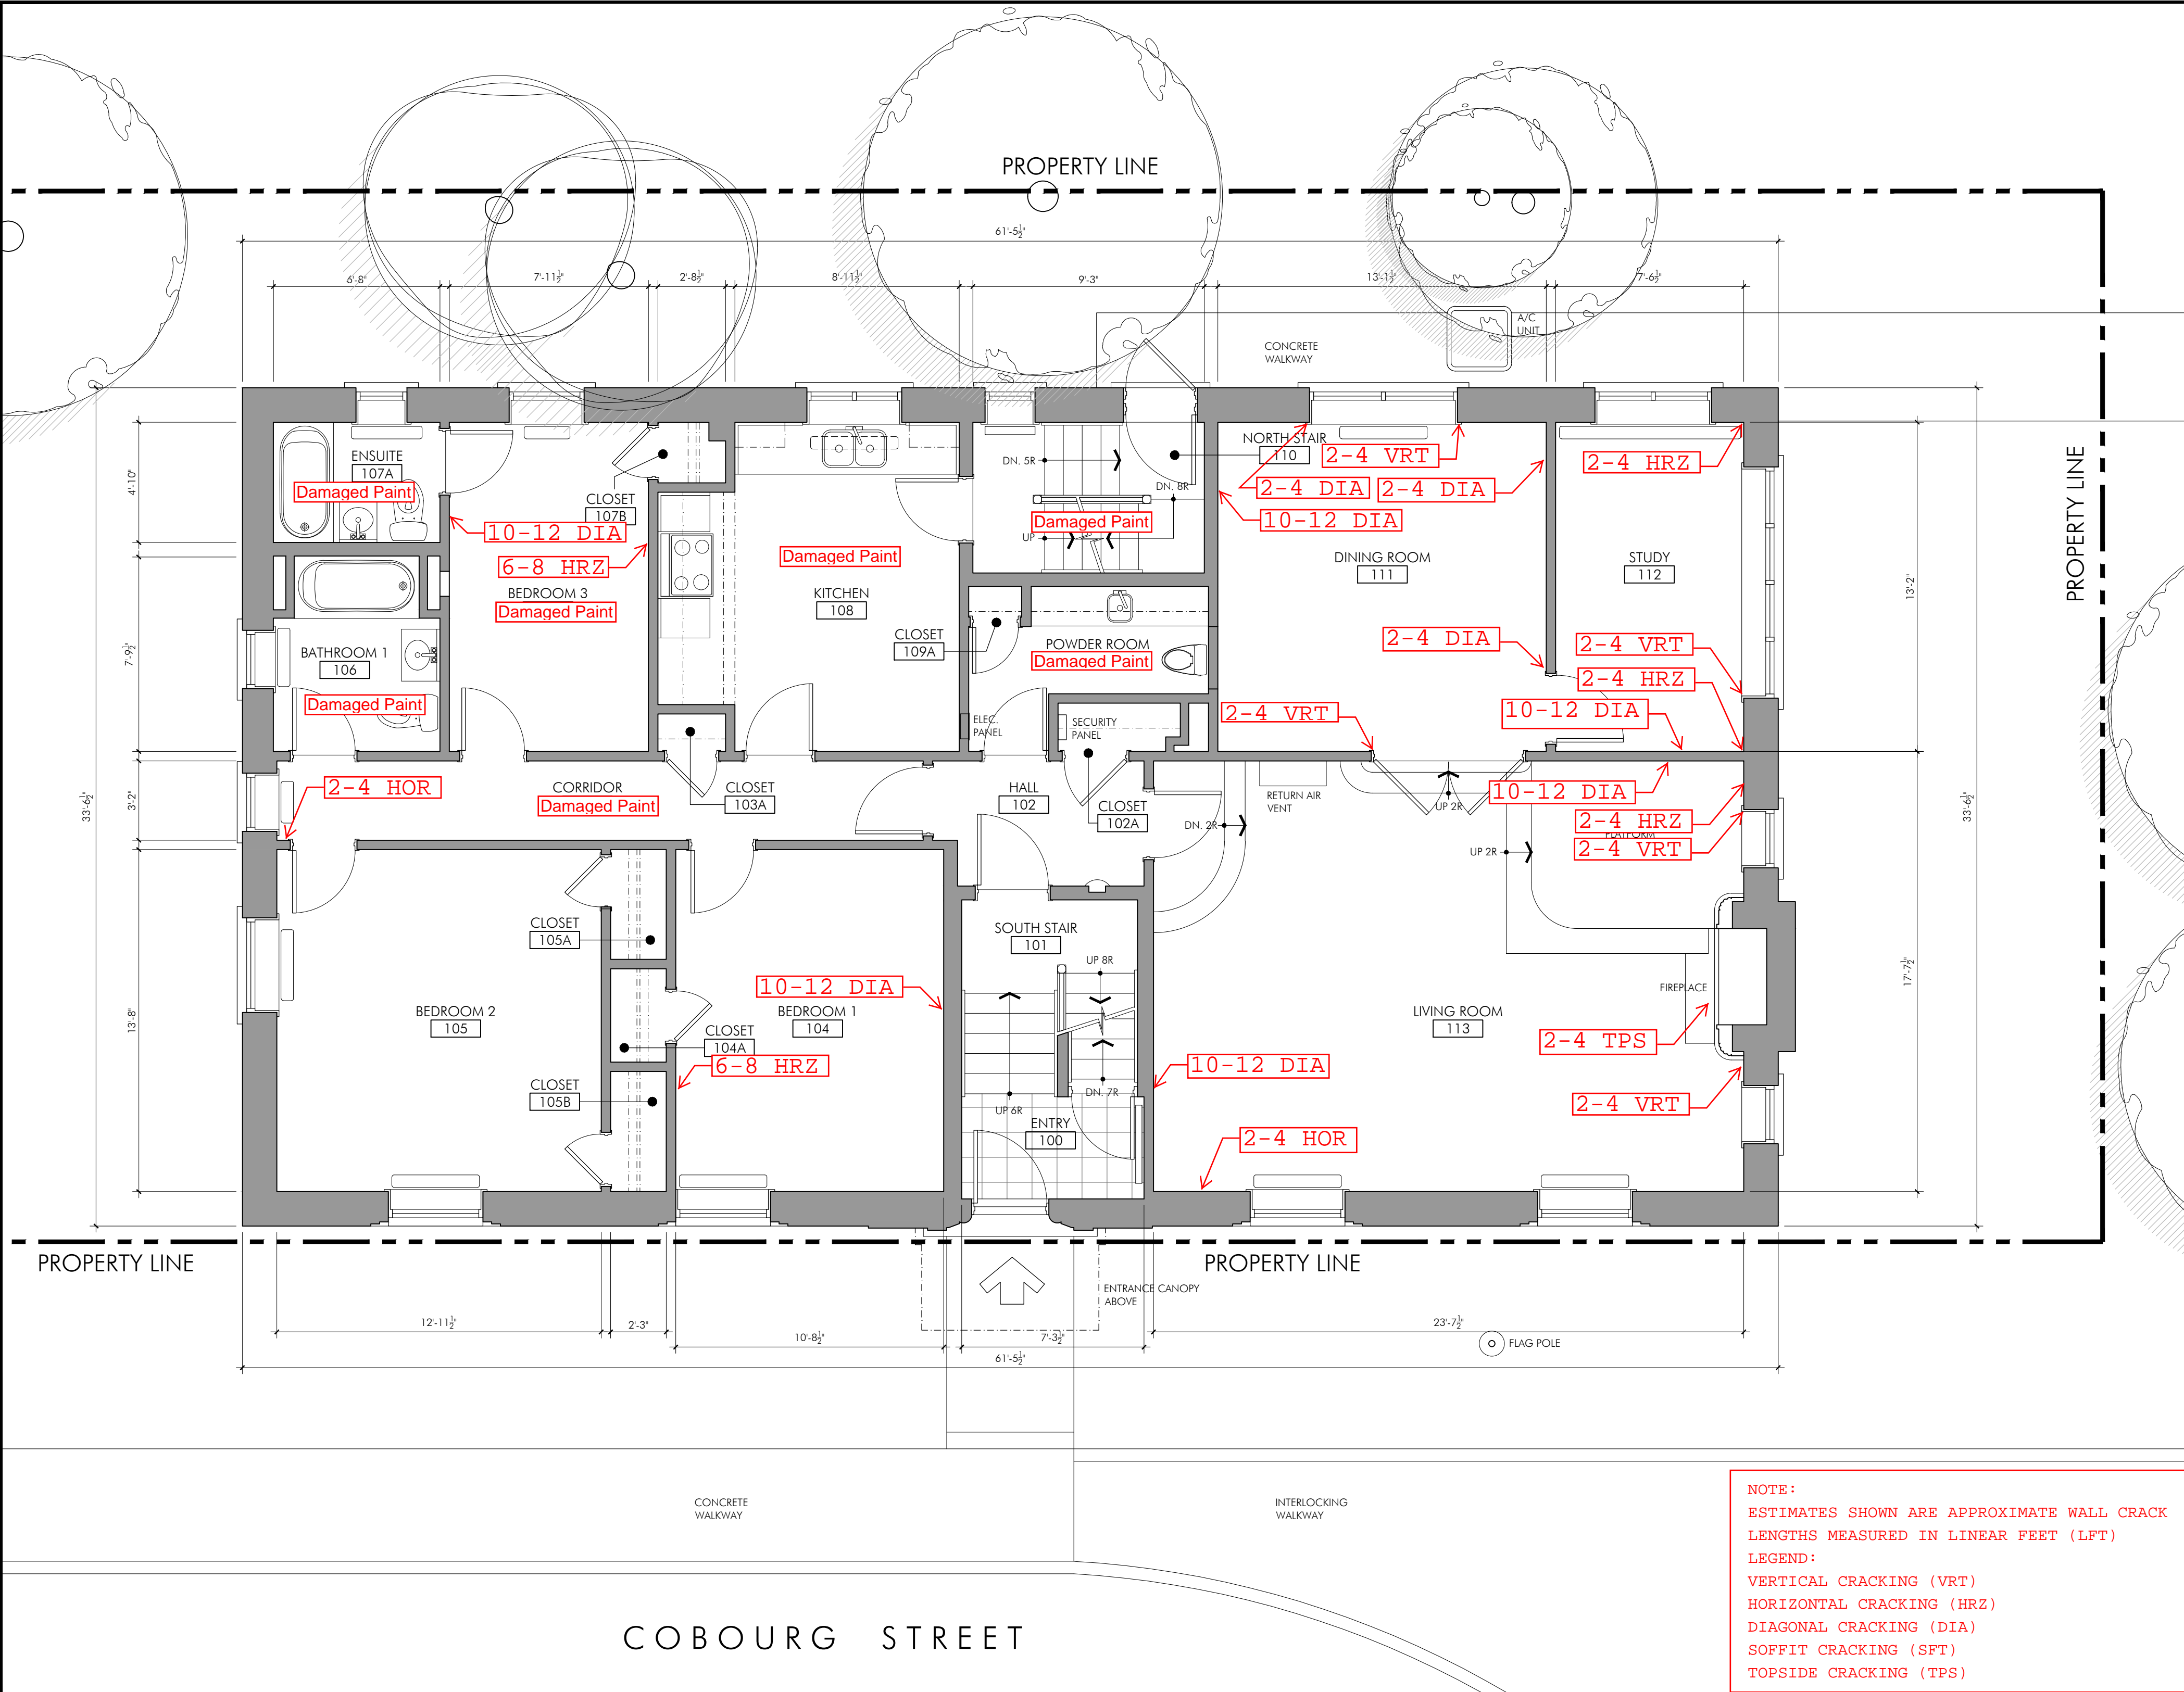
NOTE:
ESTIMATES SHOWN ARE APPROXIMATE WALL CRACK LENGTHS MEASURED IN LINEAR FEET (LFT)
LEGEND:
VERTICAL CRACKING (VRT)
HORIZONTAL CRACKING (HRZ)
DIAGONAL CRACKING (DIA)
SOFFIT CRACKING (SFT)
TOPSIDE CRACKING (TPS)

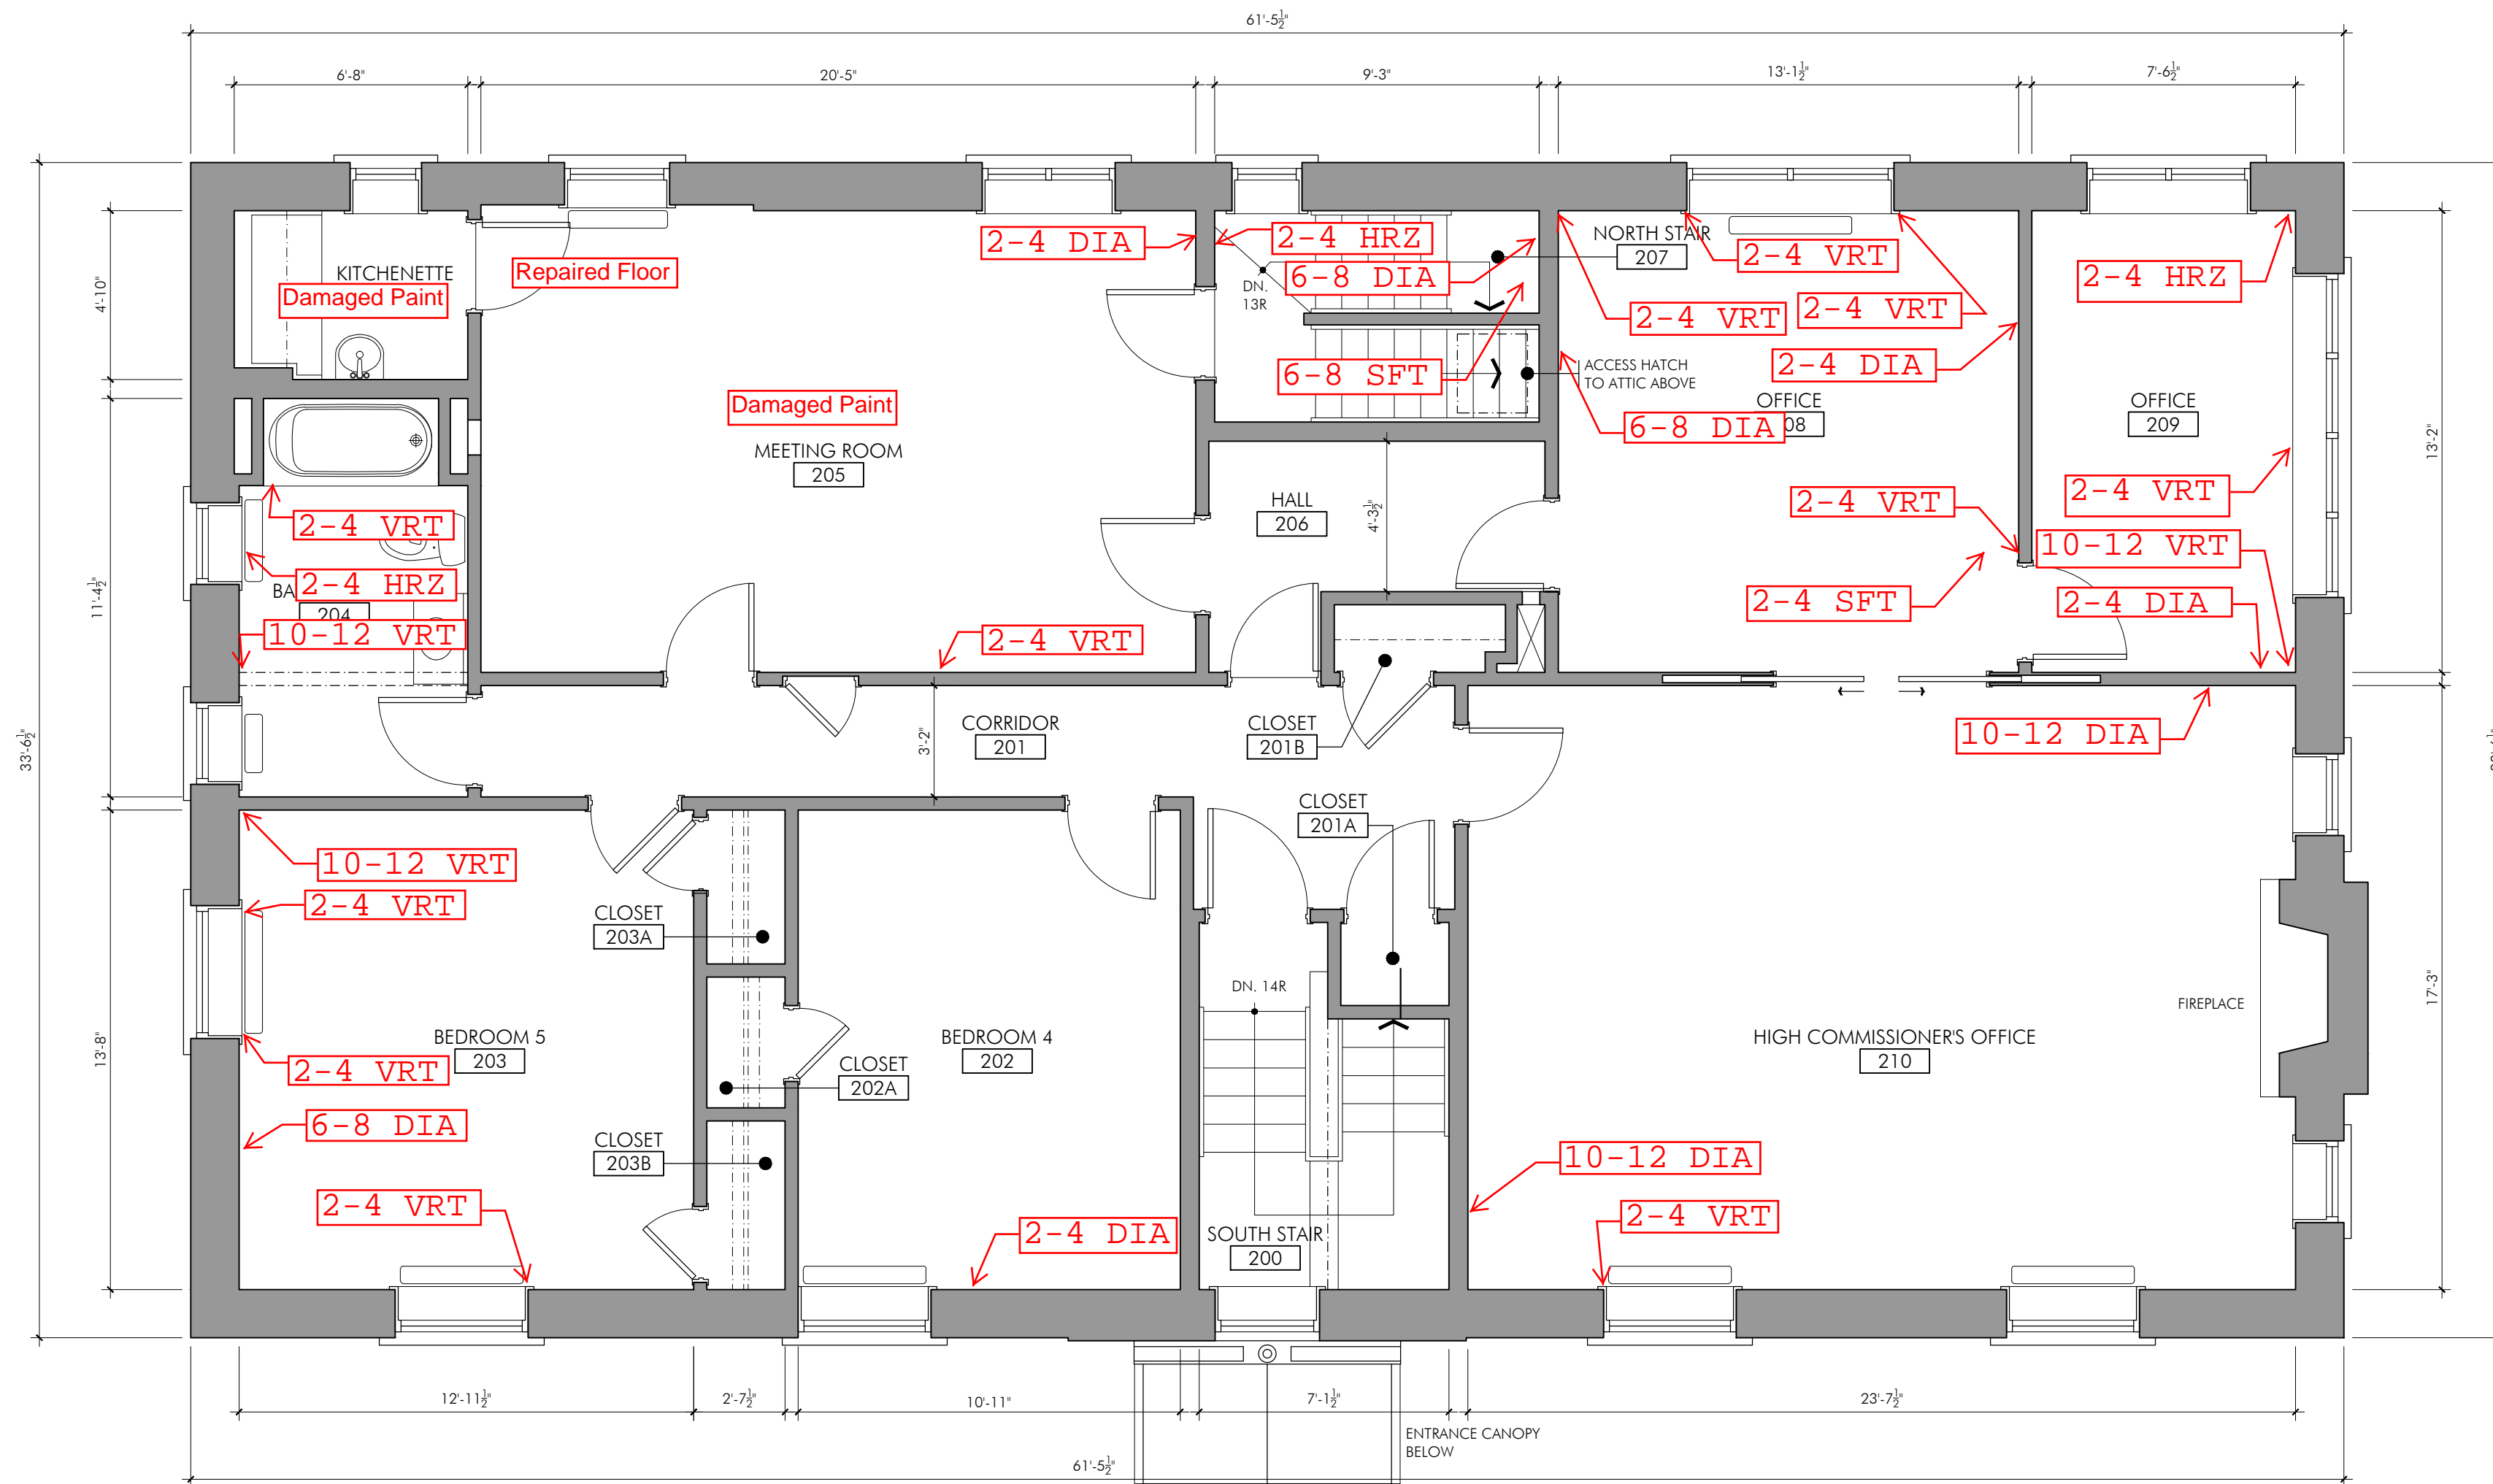
NOTE:
 ESTIMATES SHOWN ARE APPROXIMATE WALL CRACK LENGTHS MEASURED IN LINEAR FEET (LFT)
LEGEND:
 VERTICAL CRACKING (VRT)
 HORIZONTAL CRACKING (HRZ)
 DIAGONAL CRACKING (DIA)
 SOFFIT CRACKING (SFT)
 TOPSIDE CRACKING (TPS)

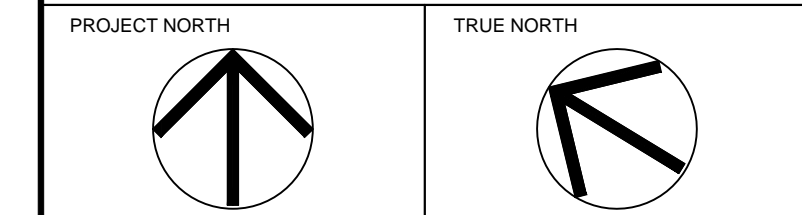
DRAWINGS ARE NOT TO BE SCALED.
 CONTRACTOR TO CHECK AND VERIFY ALL DIMENSIONS AND CONDITIONS ON THE JOB AND REPORT ANY DISCREPANCIES TO THE ARCHITECT BEFORE PROCEEDING WITH THE WORK.
 ©ALL RIGHTS RESERVED. THE USE OF ANY PART OF THIS DRAWING REPRODUCED, TRANSMITTED IN ANY FORM OR BY ANY MEANS WITHOUT THE PRIOR CONSENT OF THE ARCHITECT IS AN INFRINGEMENT IS STRICTLY PROHIBITED.
